**Operator: 8 NORTH LLC**

**Location Name: LARI-611N61W/33NWSW**

**Loc ID: 310705**

**Inspection: 696304943**

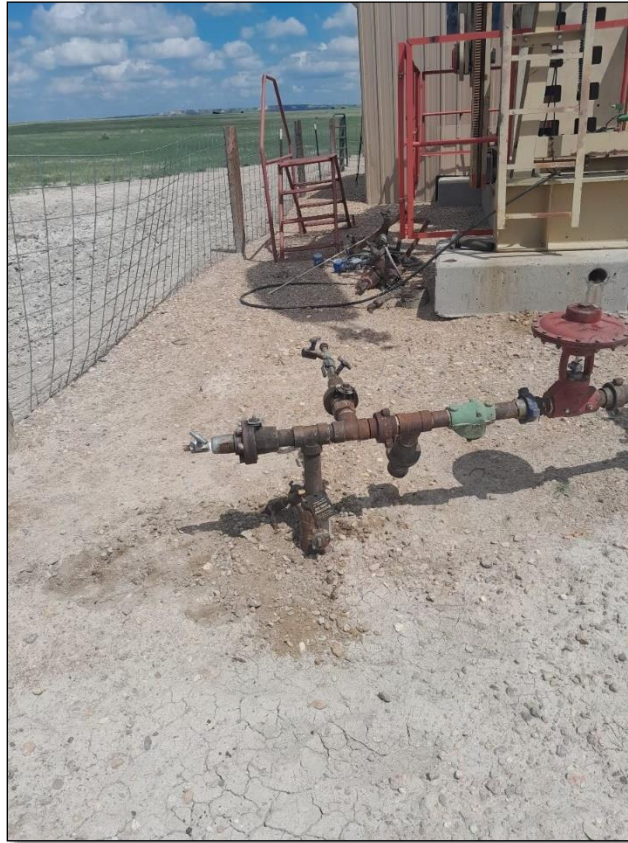
**Exhibit A**

**CA:** Stained Soil at Wellhead. For localized stained soils or oily waste - "Properly dispose of oily waste in accordance with 905.e."

**CA Resolution:** Operator has reported and provided photo evidence that the identified stained soils have been properly addressed and disposed of to comply with Rule 905.e.
