# Construction and Stormwater Inspection

Operator: BISON IV OPERATING LLC- 10670

Location ID: 470933

Inspection Photos  
Location Name: Koloa/Pad  
Location ID: 470933

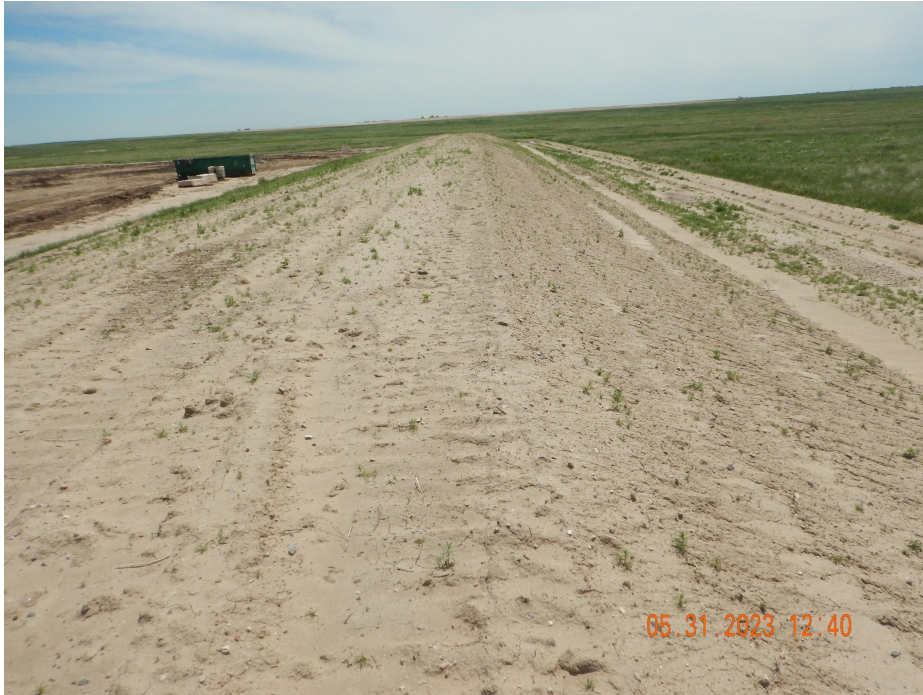
**Photo 1.** Photo taken from the northwestern location on the topsoil stockpile, facing South. Photo illustrates the stockpile has been temporarily stabilized; however, the equipment tracking was not conducted perpendicular to the slope. There is some evidence of erosion along the perimeter of the stockpile. Annual weedy growth is establishing on the stockpile.

Note- a perimeter ditch and berm BMP has been installed.

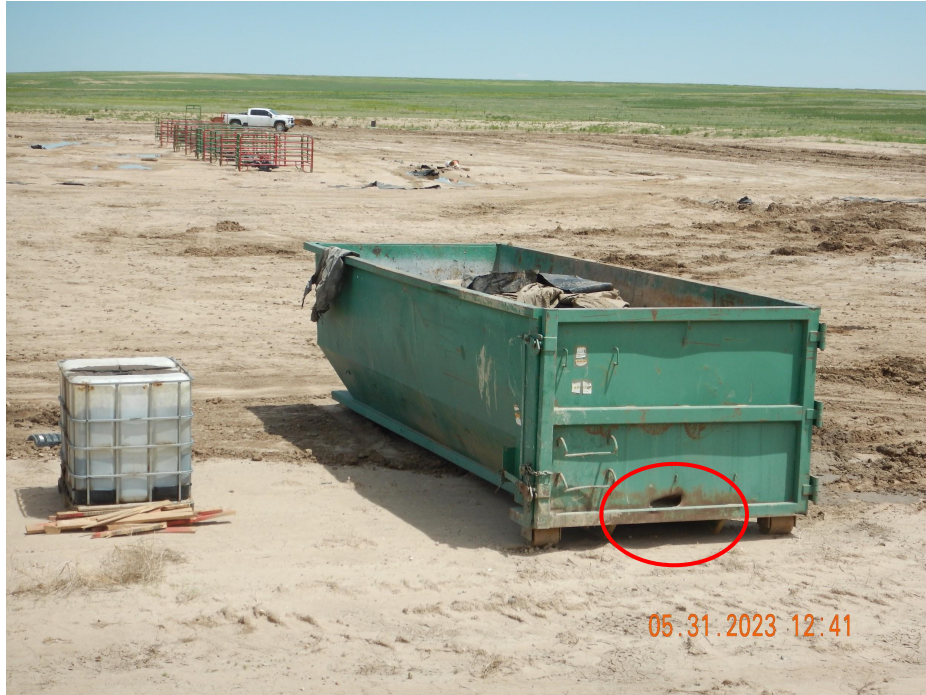
**Photo 2.** Photo taken from the northwestern location on the topsoil stockpile, facing East. Photo illustrates a dumpster without a cover and a hole along the bottom edge.

There was an observed steel drum that appeared to be for oil inside the dumpster. There was no observed leakage but this dumpster doesn't comply with Rule 606.d.

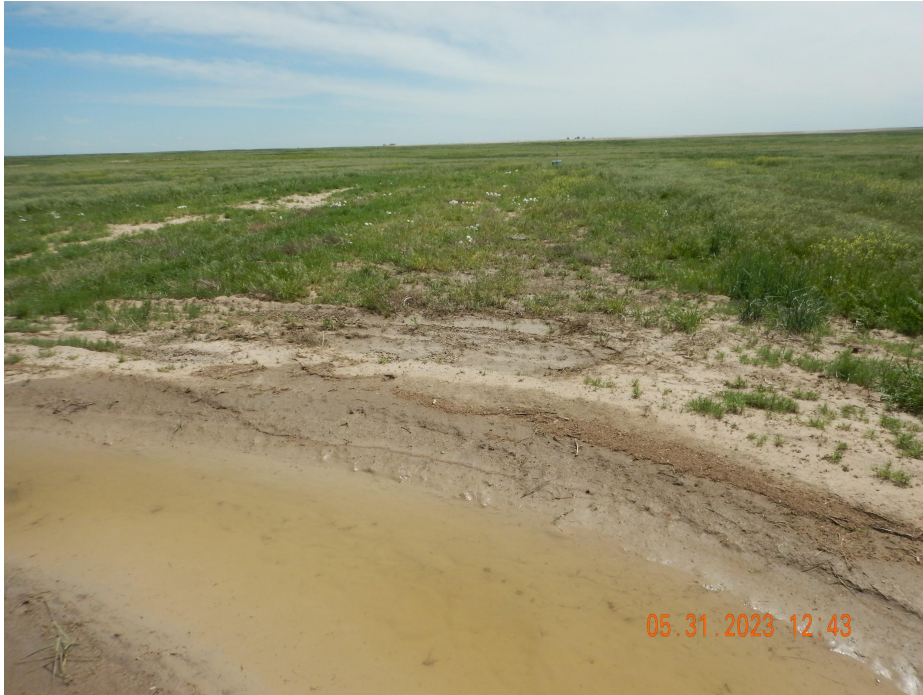
**Photo 3.** Photo taken from the southwestern perimeter of location, facing South. Photo illustrates sediment laden stormwater has discharged off location. The perimeter ditch and berm BMP is not sufficient.

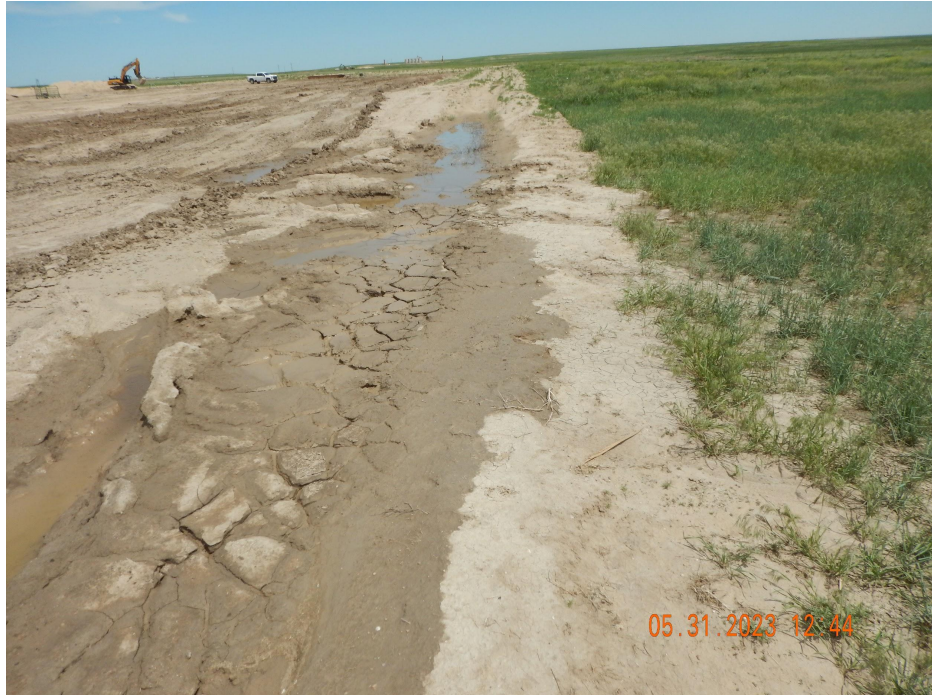
**Photo 2.** Photo taken from the southwestern perimeter of location, facing East. Photo illustrates vehicle traffic has driven over the perimeter ditch and berm BMP, which was the likely result of sediment laden stormwater discharging off location.

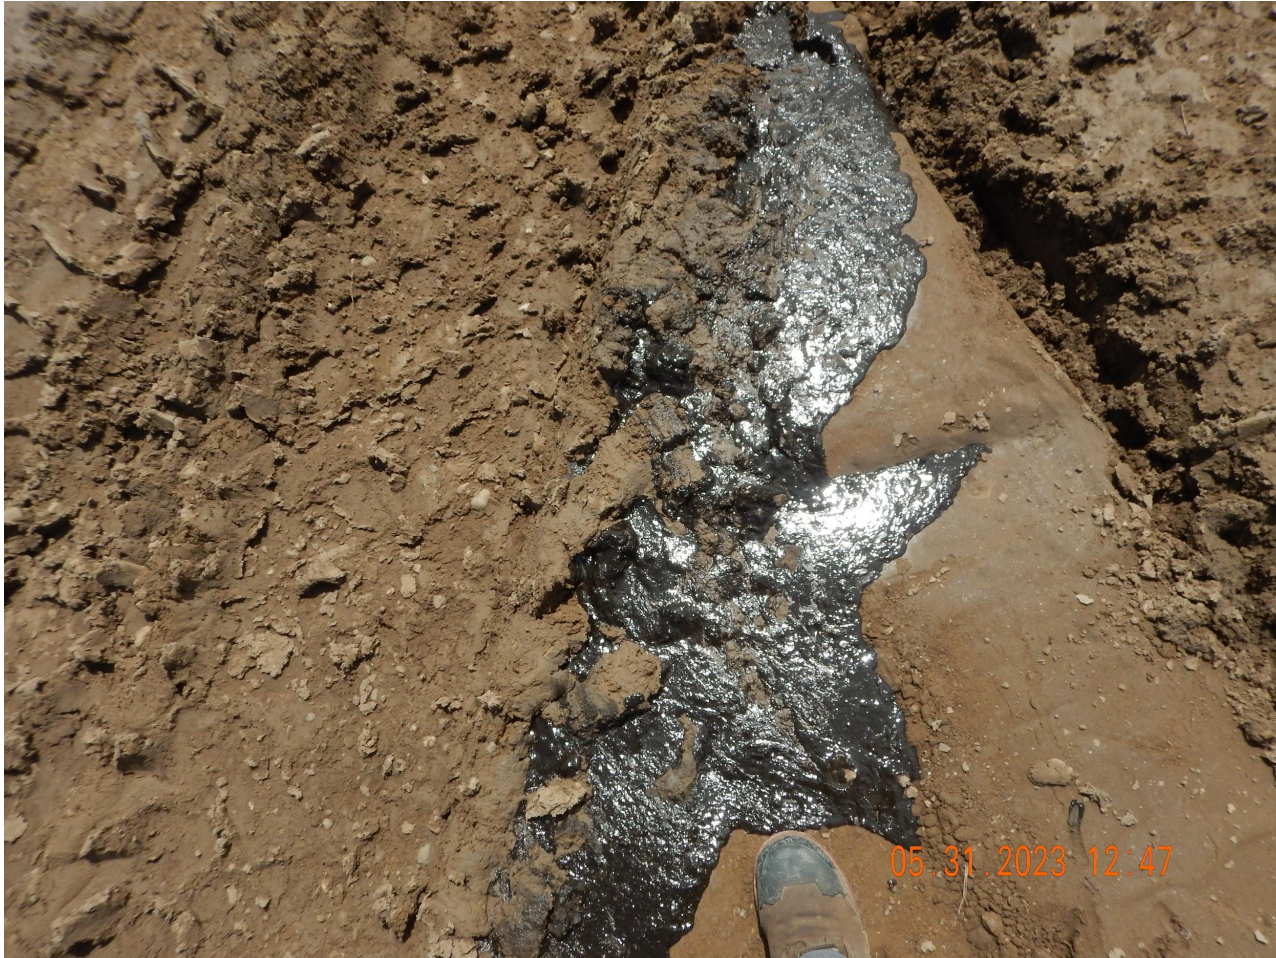
**Photo 5.** Photo taken from the southwestern well pad. Photo illustrates oily waste which has not been cleaned up and disposed of properly. The extent was unclear due to vehicle traffic but it appears to have mixed with stormwater. Note- there were pieces of rig liner throughout the western well pad that has been disturbed.

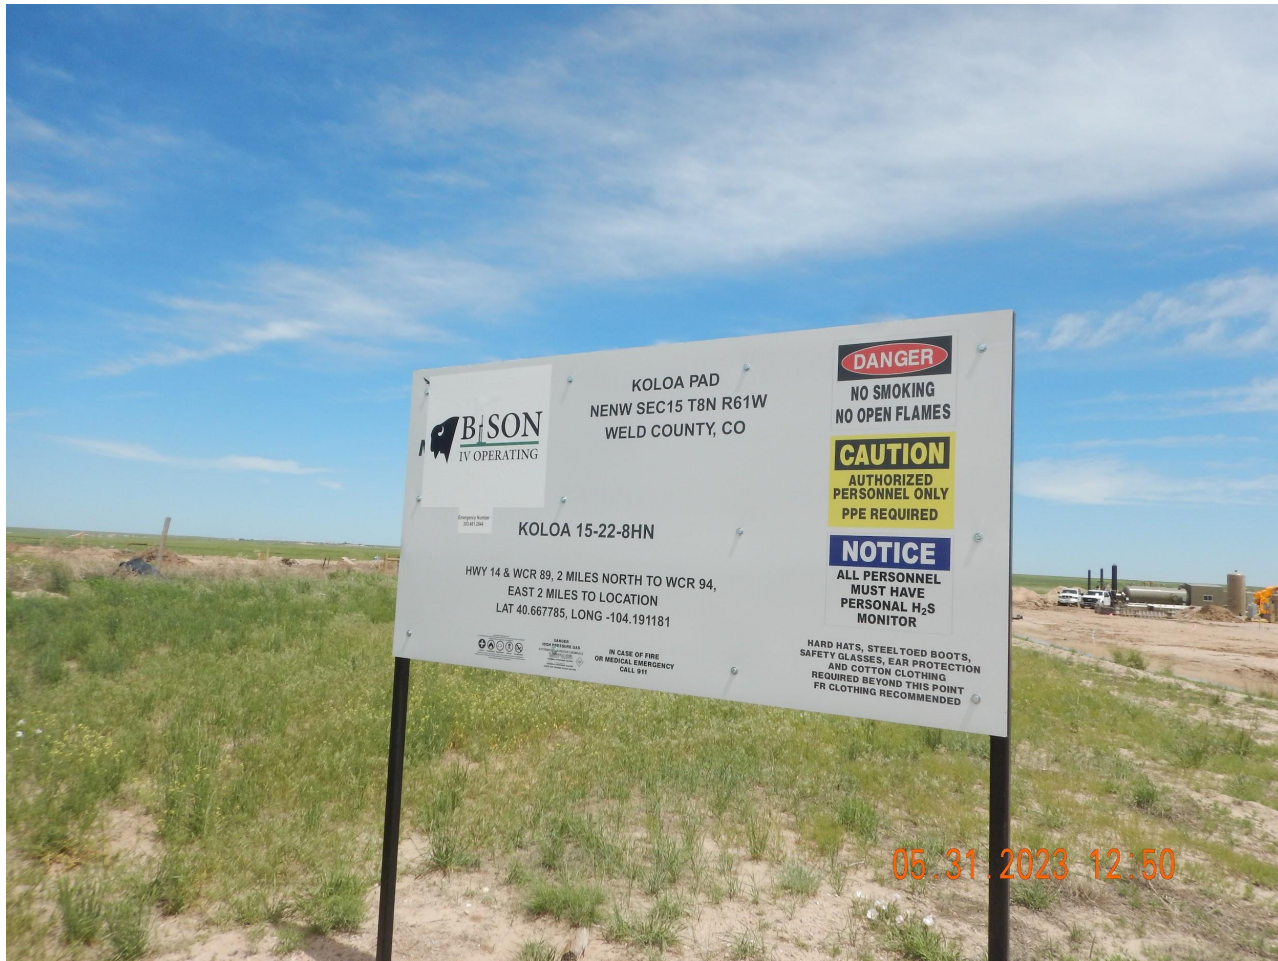
**Photo 6.** Photo taken from the entrance of location, facing East. Photo illustrates the Operator sign. There was no observed Form 2A on location.
