# Inspection Photos

API: 055-06186

Operator: EVERGREEN NATURAL RESOURCES

Inspection Date: 6/6/2023

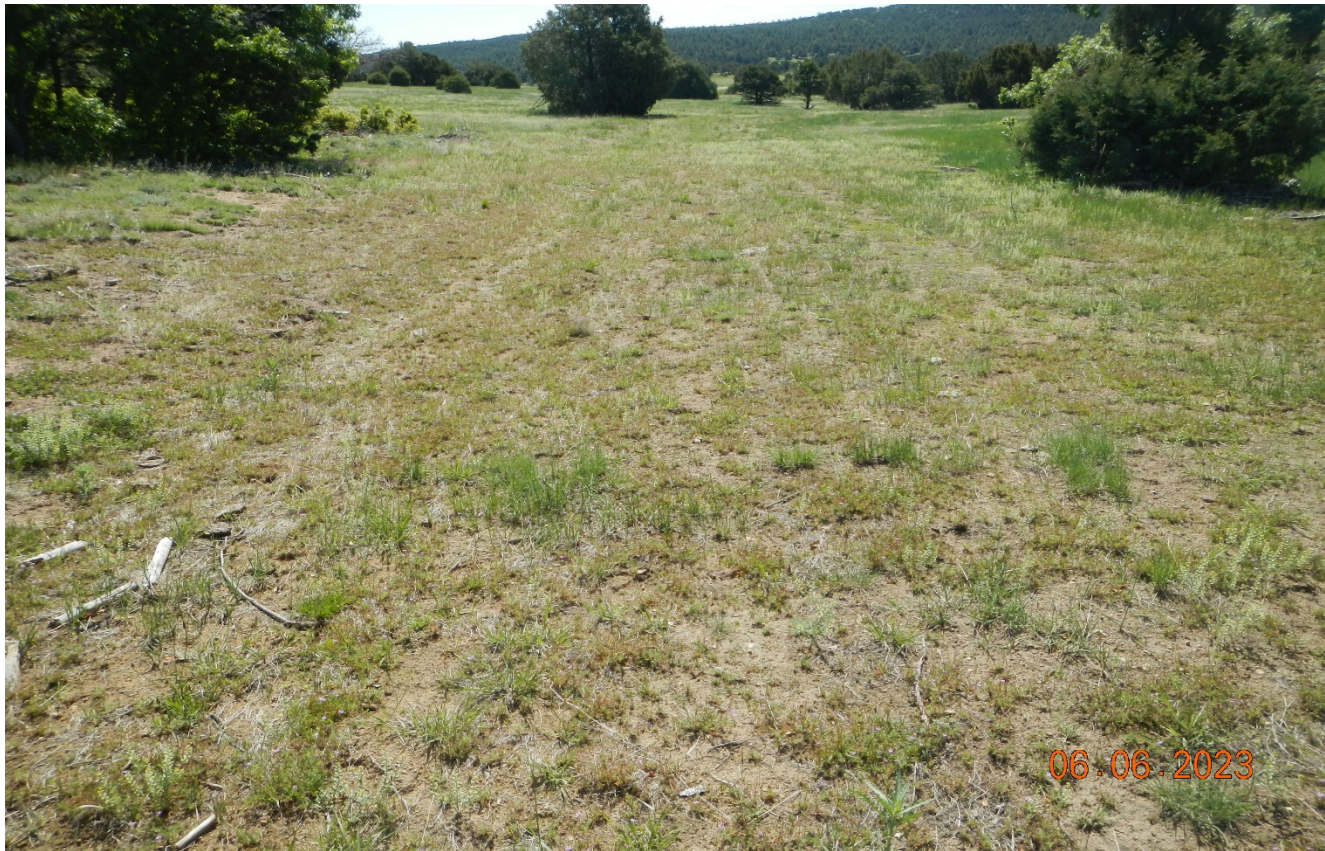
**Photo 1.** Facing east along the former access road. Perennial vegetation cover has not established and there are noxious weeds.

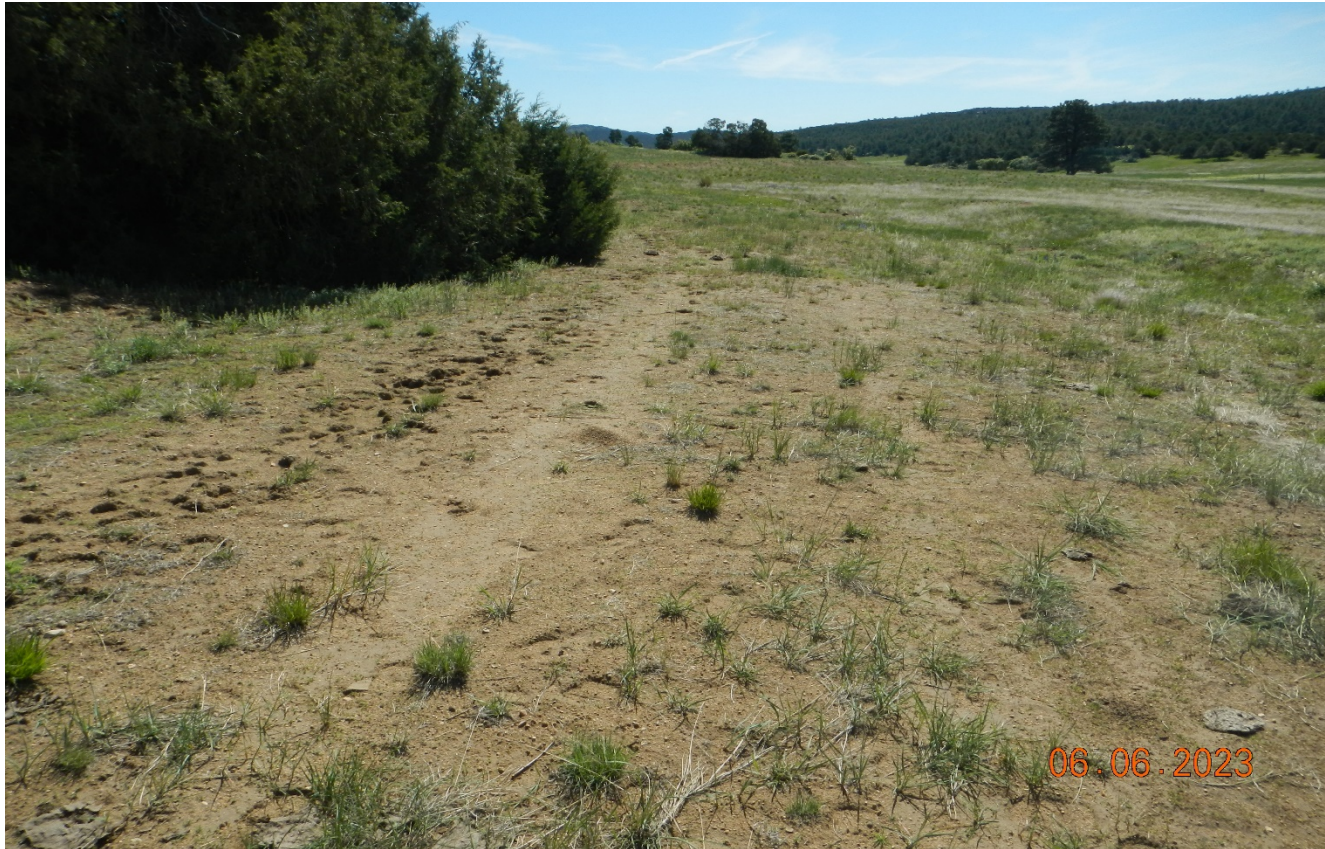
**Photo 2.** Facing northeast along the former road. The desirable vegetation has not re-established.

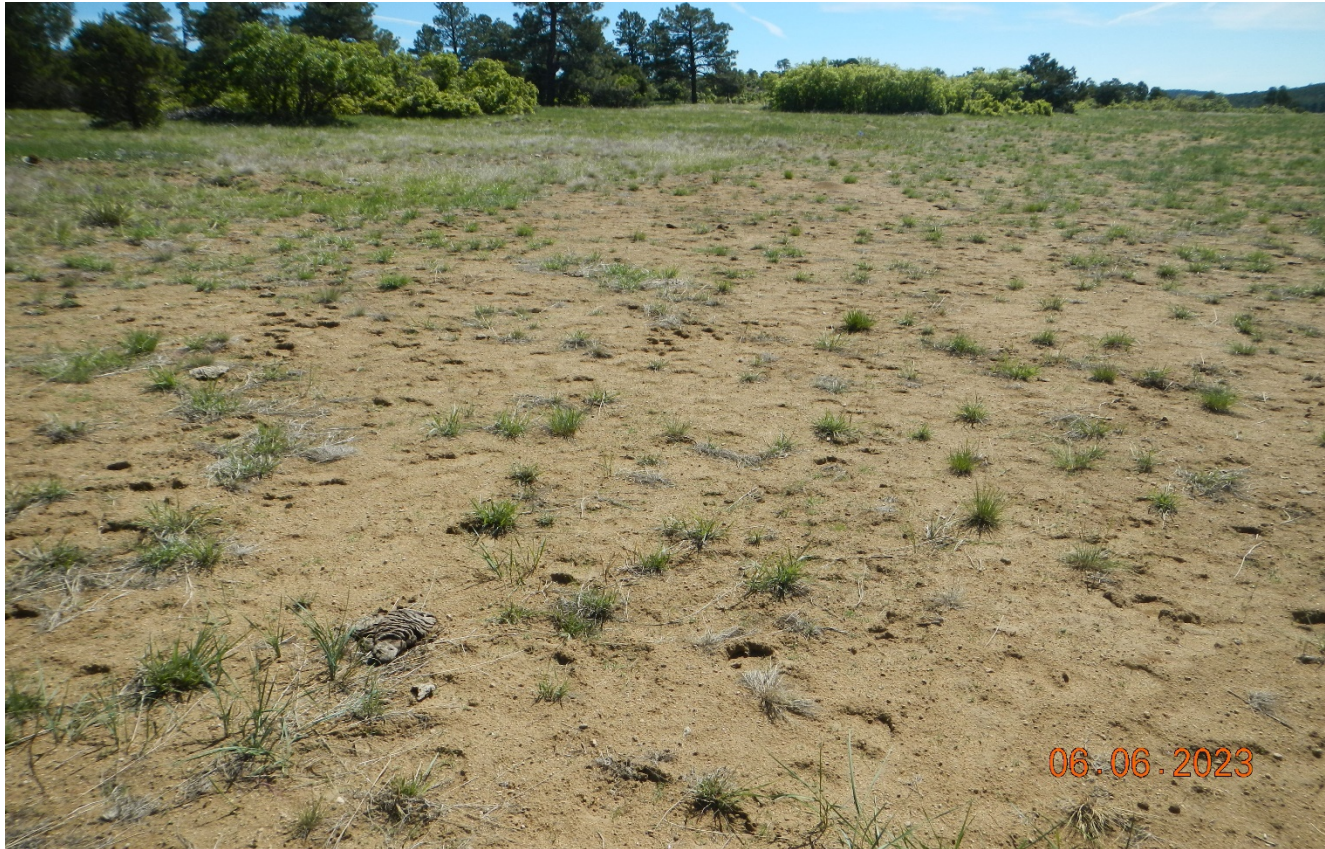
**Photo 3.** Facing northeast toward the location. The desirable vegetation has not re-established to at least 80% of reference area levels.

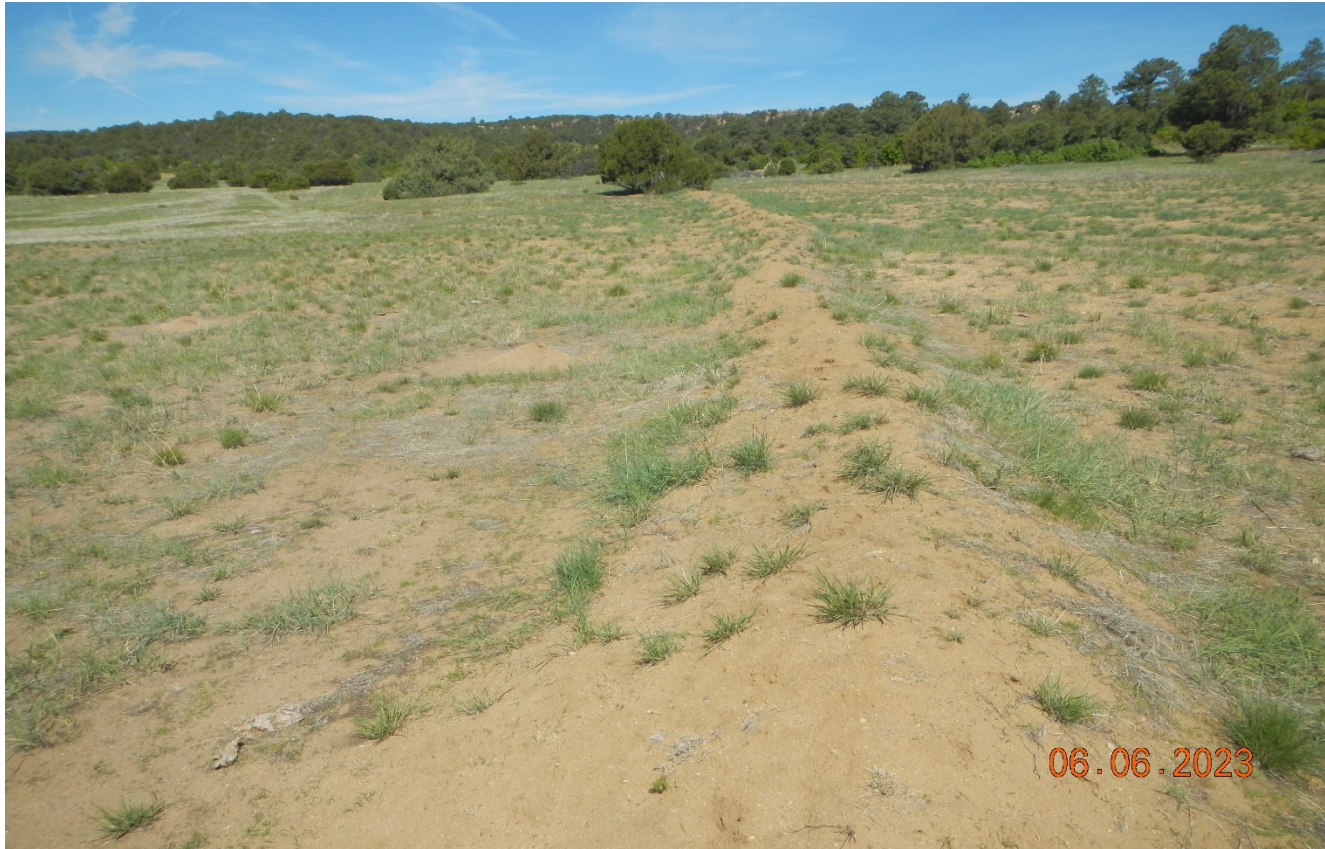
**Photo 4.** Facing northwest at the east side of the location.

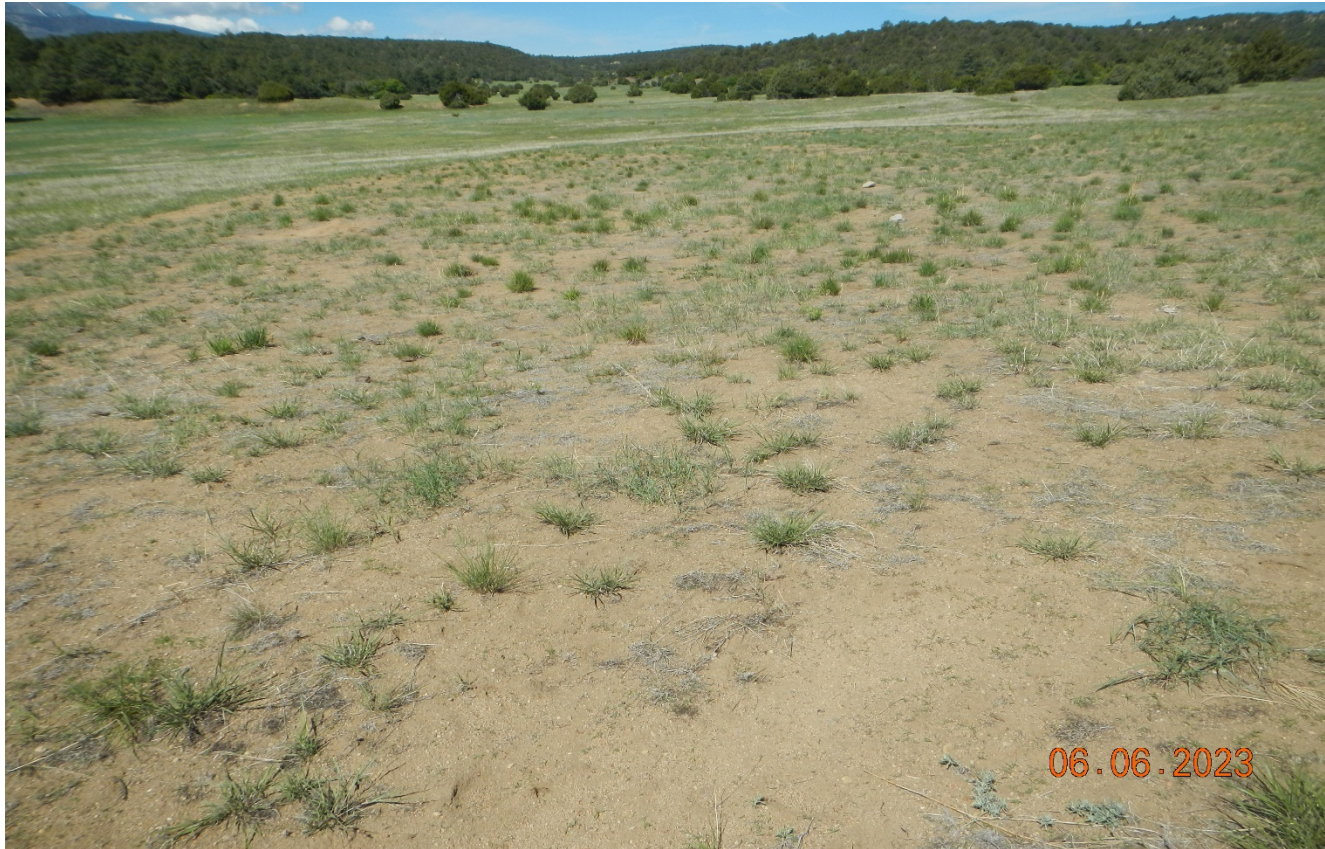
**Photo 5.** Facing west toward the location. The desirable vegetation has not re-established at the location.

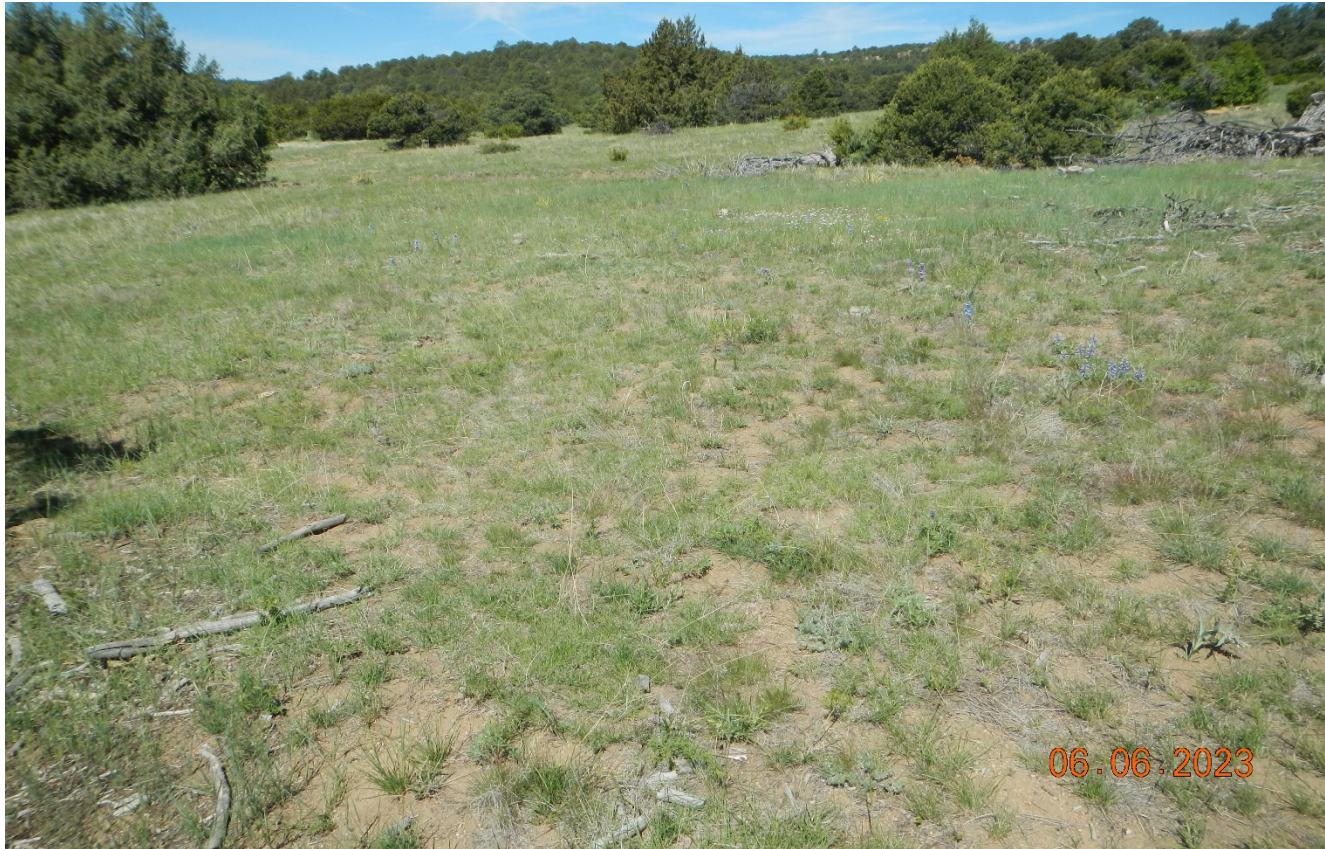
**Photo 6.** Facing northwest at the surrounding undisturbed vegetation which consists of Western wheat, Needle and thread grass, Sand drop seed, among other native species.

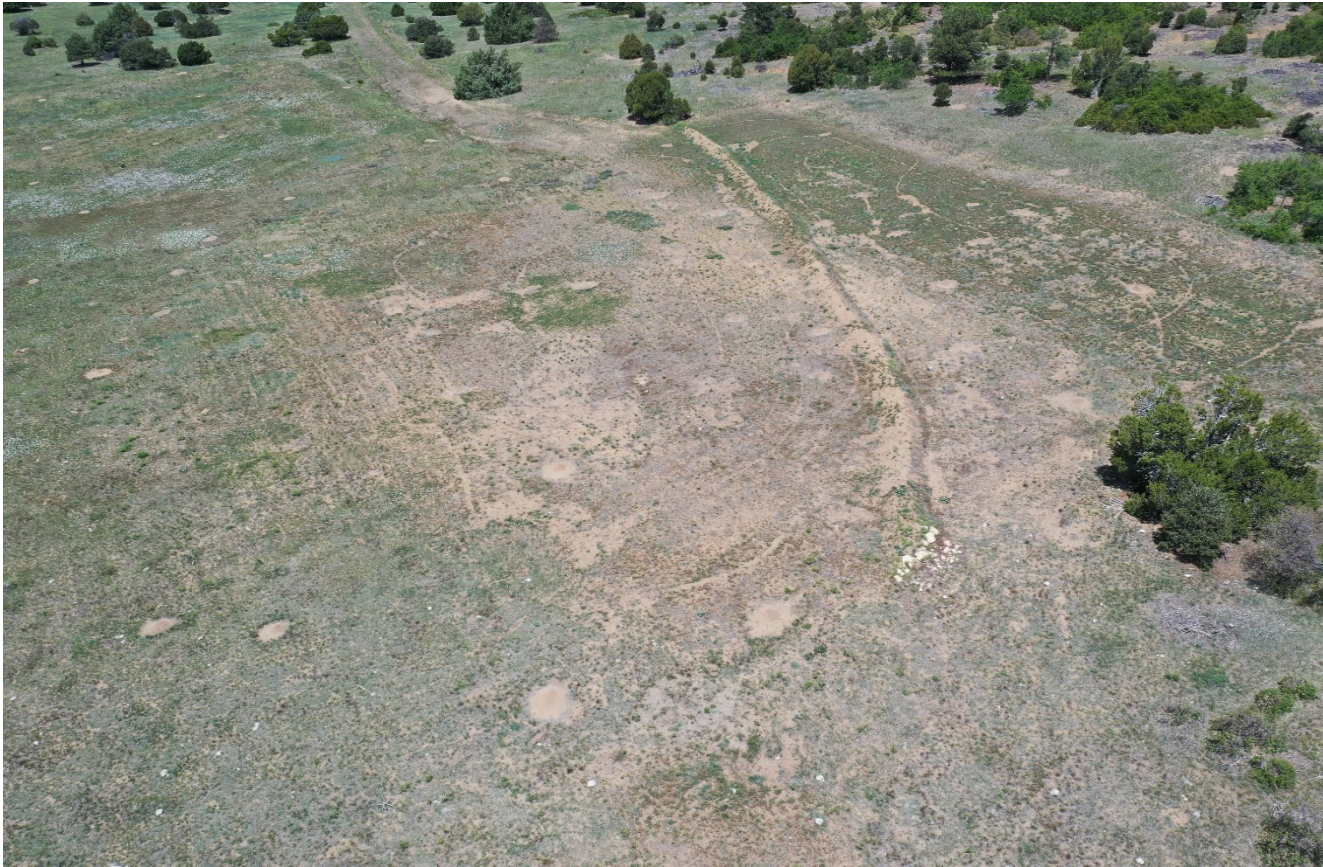
**Photo 7.** May 2022 Drone aerial photo facing northwest toward the location.

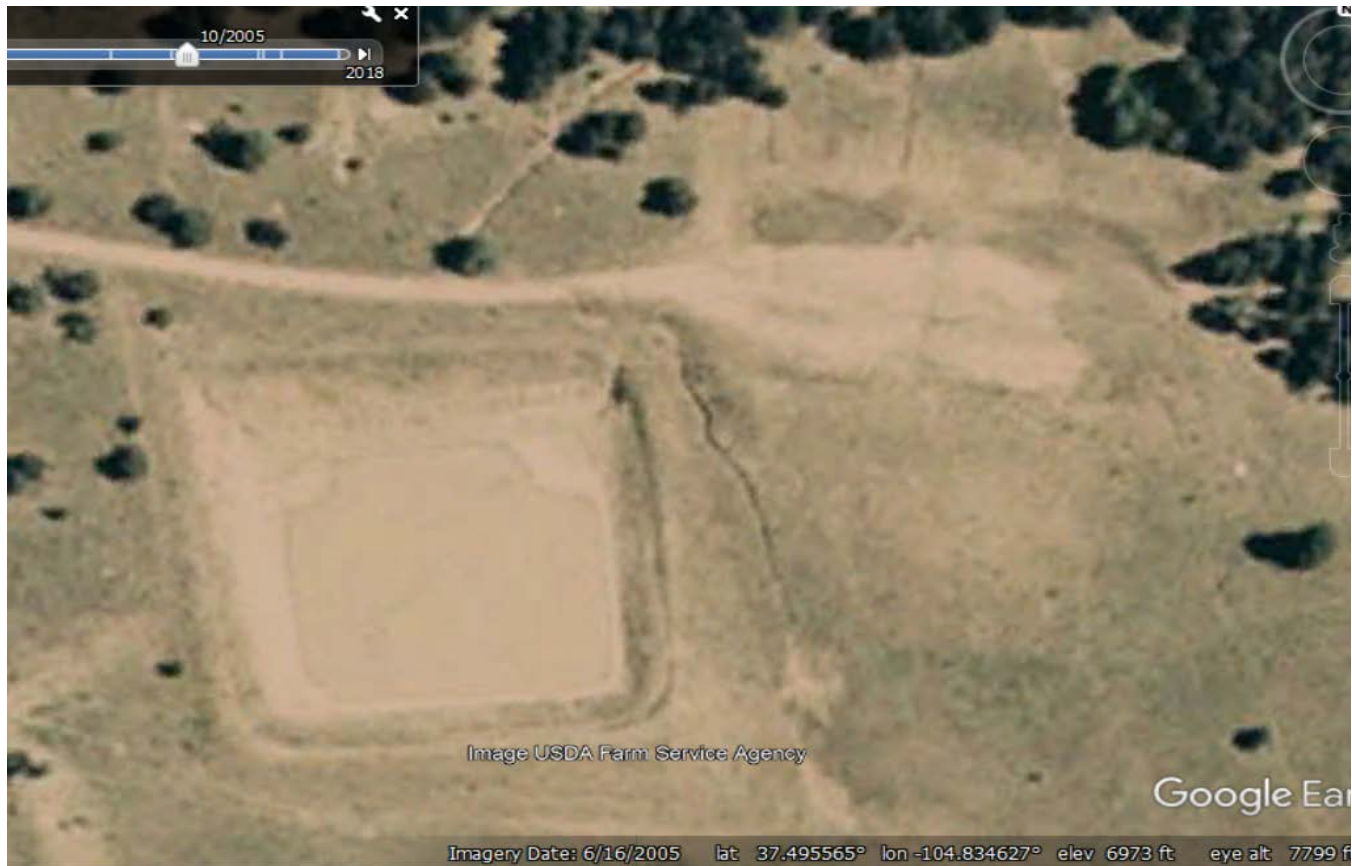
**Photo 8.** 2015 aerial image of the location shows the disturbance area of the location and pit. All associated disturbances must be reclaimed.
