**Operator: CIVITAS NORTH**  
**Location Name: Hunt Fed 8-60 6A**  
**Loc ID: 454627**  
**Inspection: 708200160**

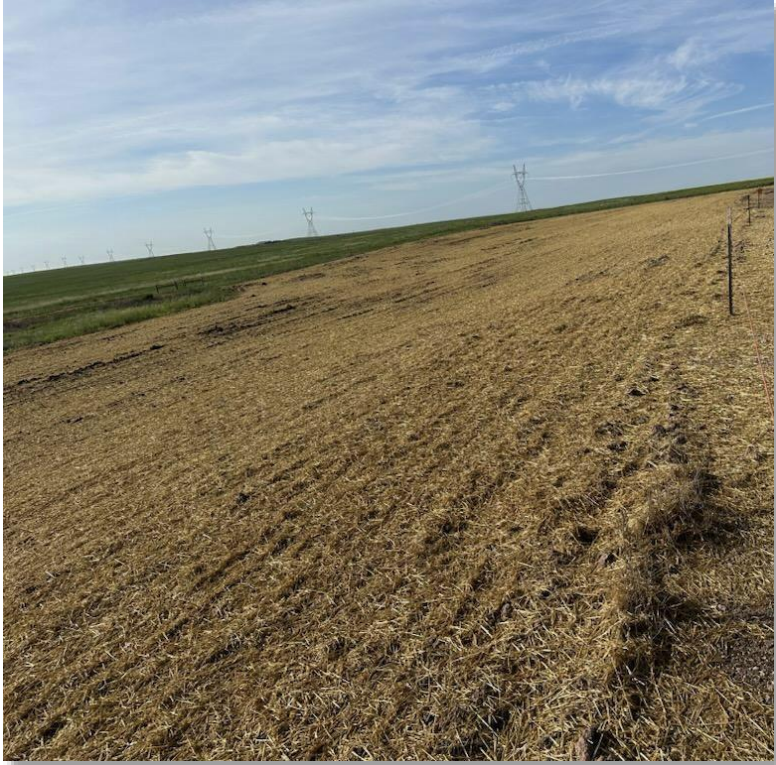
**Exhibit A**

**CA:** This location does not comply with Rule 1003. During this inspection, it was observed that the interim areas consist predominantly of bare soil with little germination of desirable plant species present. Undesirable plant species were also detected, including Russian thistle and kochia. It also appears that the northern production areas, around the wells, have not been reclaimed with approximately 1.8 acres of unused production pad observed. If the Operator is not going to commence additional drilling activities (7 wells w/expired permits) then the production area identified in the inspection photos shall be reclaimed. Refer to attached inspection photos for additional information. Perform reclamation in accordance to Rule 1003. Establish vegetation with total perennial, non-invasive uniform plant cover of at least eighty (80) percent of reference area levels. Use a seed mixture requested by the surface owner, or a mixture prescribed by the local county NRCS. Ensure erosion controls are implemented to stabilize the seeded soil and continue to monitor and manage this site until the location meets Rule 1003 standards. CA date is the date the location was observed out of compliance.

**CA Resolution:** Operator has reported that the location has been re-seeded to establish vegetation and to comply with Rule 1003.
