915.b. RECLAMATION PLAN	
Operator Location Name	Apache Canyon 06-09V
COGCC Location Name (ID)	APACHE CANYON / 06-09V (312120)
Legal Description	NESE Sec. 6 T34S-R67W
Coordinates (Lat/Long)	37.112225 / -104.924301
County (Number)	Las Animas (071)

Introduction

Custom Soil Resource Report for Las Animas County Area, Colorado

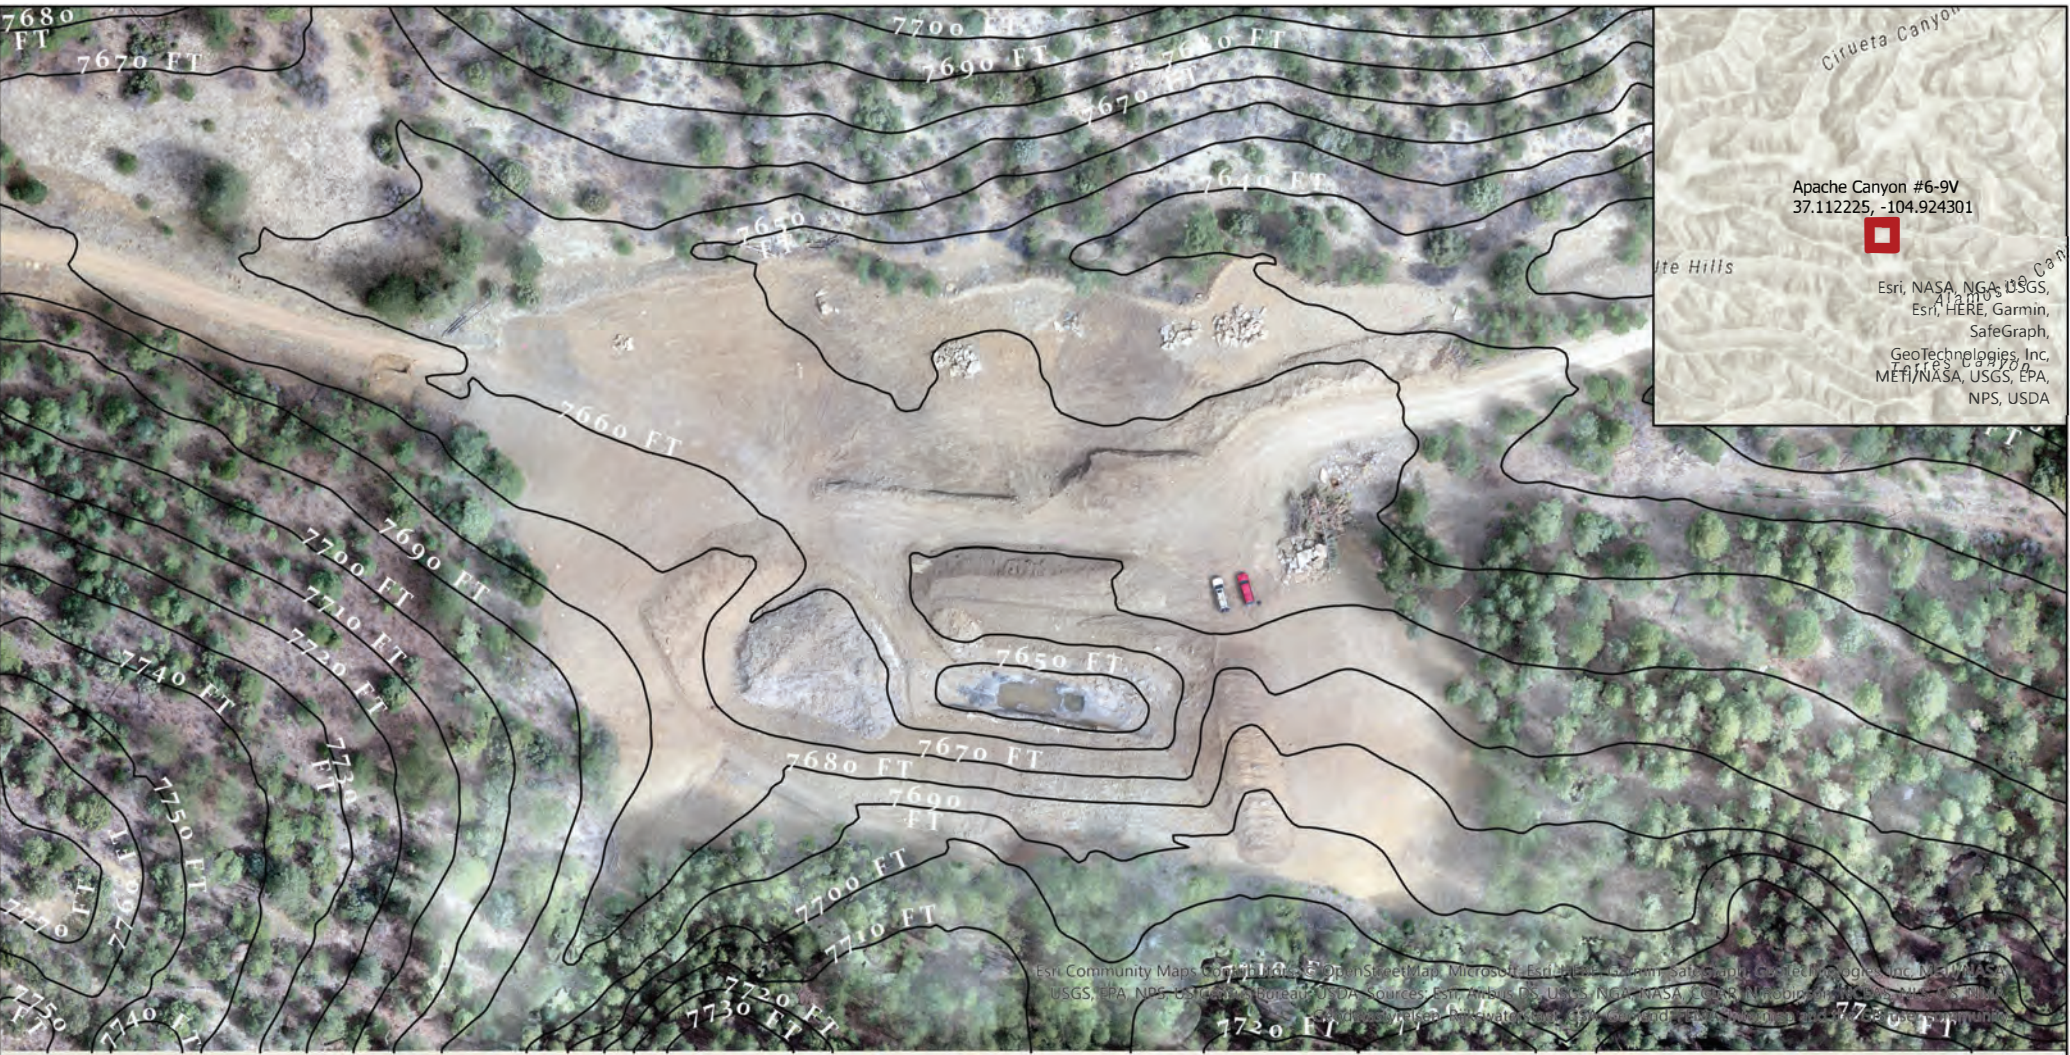
Topographic Map
Apache Canyon #6-9V
XTO Energy Inc.
COGCC Location ID: 312120
Las Animas County
NESE, Sec. 6, T34S - R67W

Remaining onsite impacts are documented in the attached Current Site Contours and Location Map Figure. Analytical results of soil samples collected from the sidewalls and base of the historical pit indicate levels of SAR and pH exceeding COGCC Table 915-1 Residential Soil Screening Levels remain in-situ.

A drone assessment using ground control points was completed at the Location to create a sub-centimeter accurate digital elevation model (DEM) and orthomosaic. Based on these data, impacted soil remaining at the site and is contained within the former pit and will be covered with between 14.5 and 37 feet of native fill material and topsoil during recontouring of existing cut and fill slopes. This coverage depth was estimated using undisturbed reference area contours illustrated in the attached Current Site Contours and Location Map Figure and visually assessing current and past aerial imagery and elevation data. With the shallowest identified soil impacts at 7 feet BGS, following final reclamation impacted soils will be a minimum of 37 feet below finished grade at the former pit location. See Table 2 for a summary of elevations and impact depths.

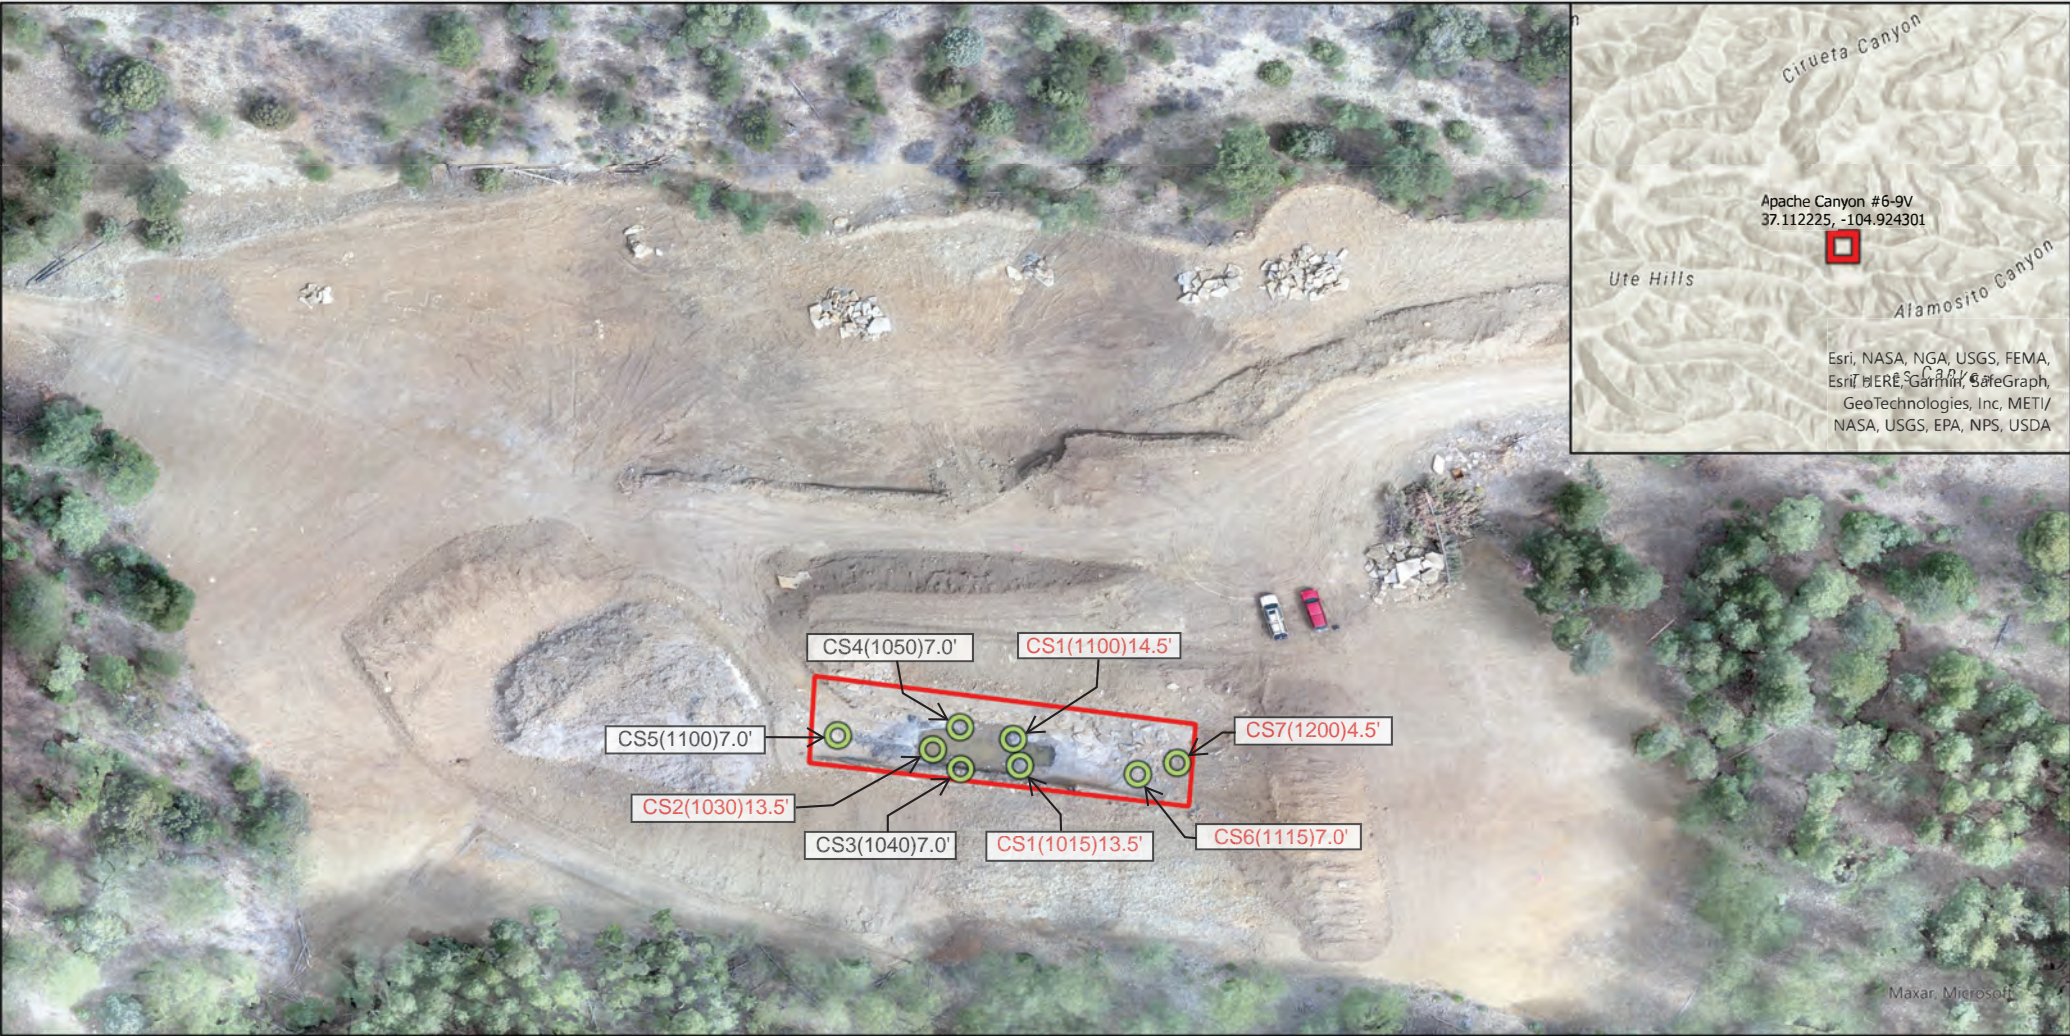
Delineation Samples
Apache Canyon #6-9V
XTO Energy Inc.
COGCC Location ID: 312120
Las Animas County
NESE, Sec. 6, T34S - R67W

- Pit base at 13.5 feet (220906_Apache_Bottom_CS2(1030)@13.5'): 8.57 pH
- Pit base at 13.5 feet (220906_APACHE_BOTTOM-HOLE_CS1(1015)13.5'): 8.09 SAR and 9.12 pH
- East sidewall of pit at 7 feet (220906_APACHE_SIDE-WALL_CS6(1115)7.0'): 8.86 pH
- Pit base at 14.5 feet (221006_Apache_Bottom-Hole_CS1(1100)14.5'): 17.2 SAR and 9.18 pH
- Adjacent to the former well, impacts were identified three and a half to four and a half feet BGS. Subsequent sampling around the former well head did not return exceedances of Table 915-1 Constituents of Concern.

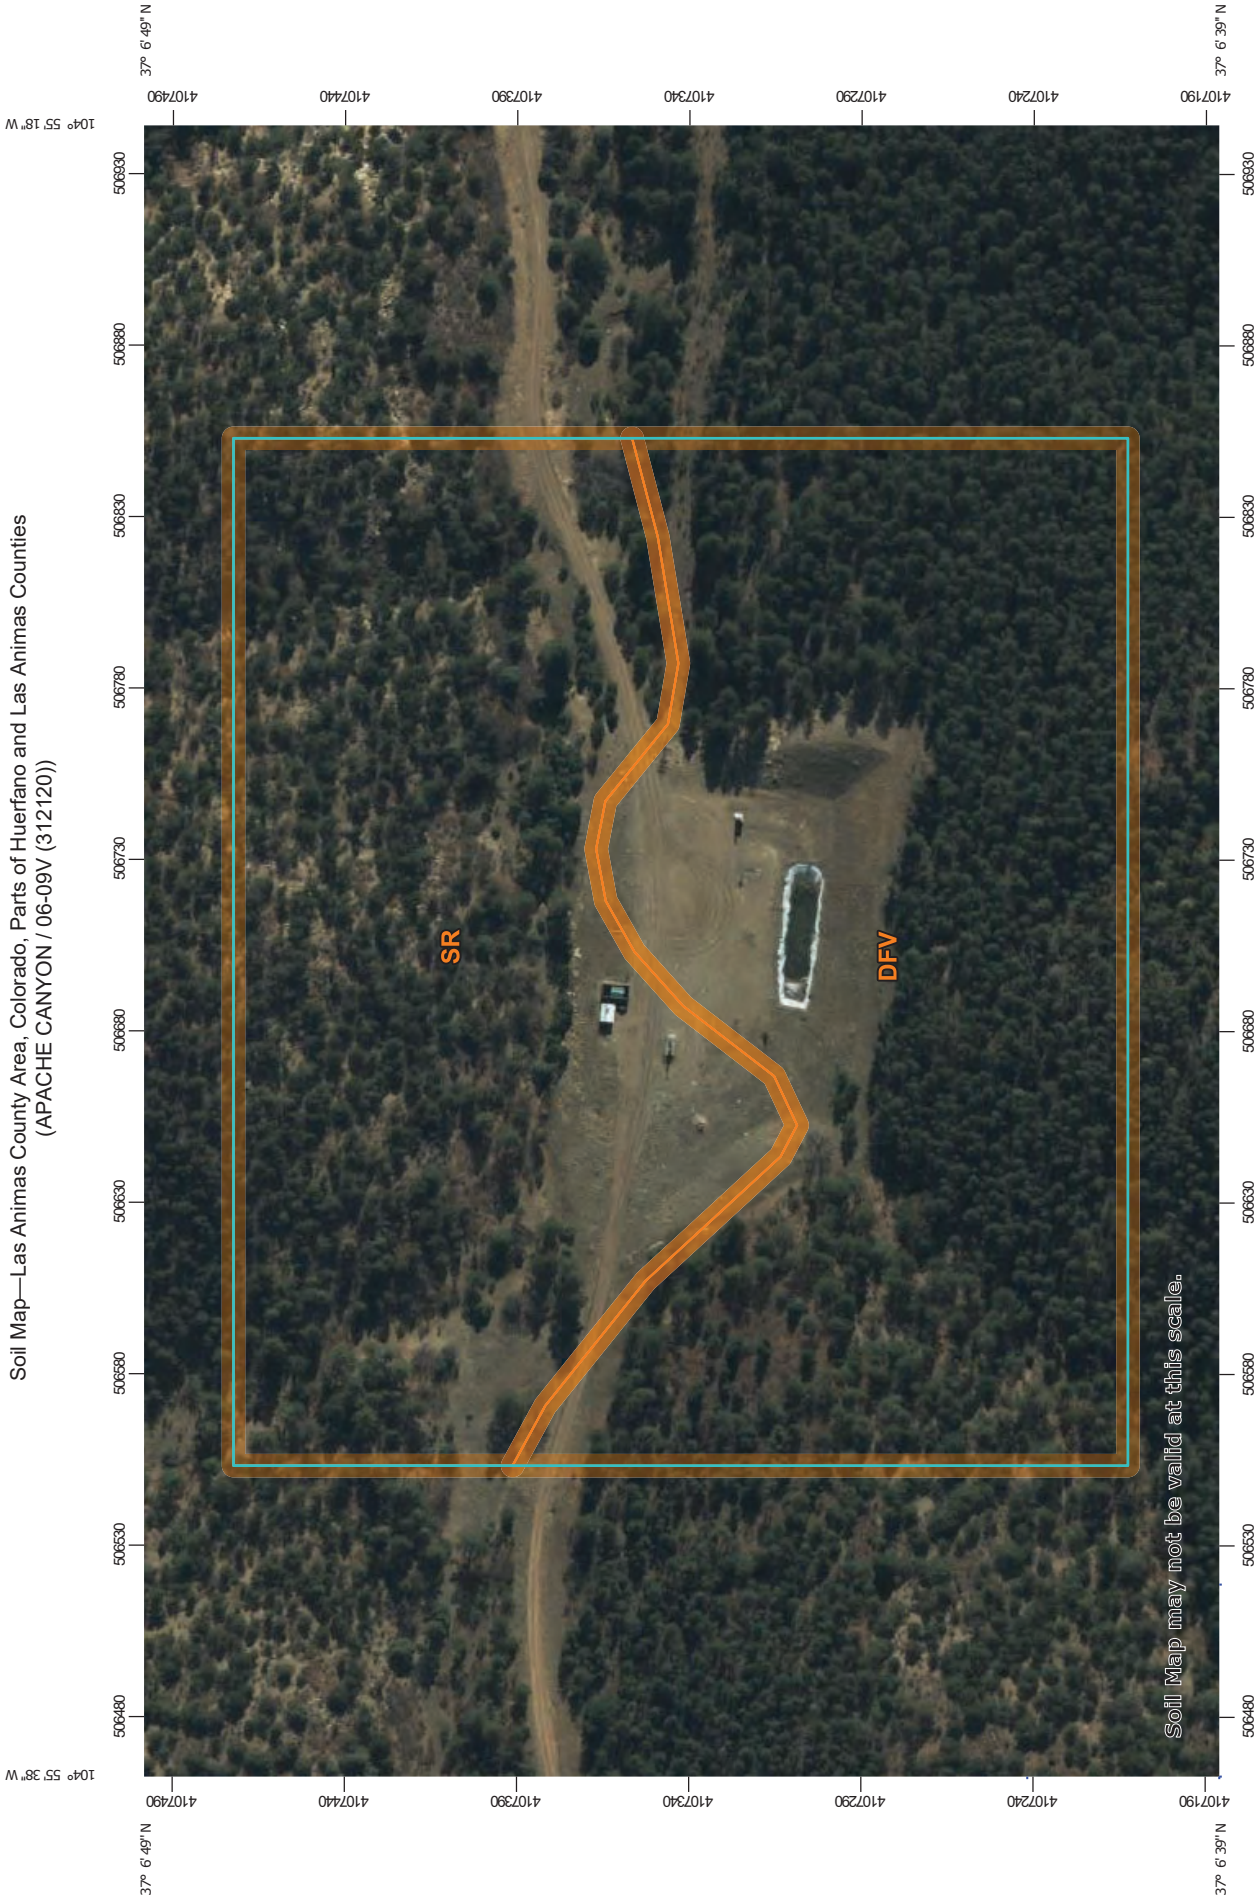
Soil Map—Las Animas County Area, Colorado, Parts of Huerfano and Las Animas Counties
(APACHE CANYON / 06-09V (312120))

The soil map section includes the soil map for the defined area of interest, a list of soil map units on the map and extent of each map unit, and cartographic symbols displayed on the map. Also presented are various metadata about data used to produce the map, and a description of each soil map unit.

According to the United States Department of Agriculture (USDA) Web Soil Survey, the Soil Map Units (SMU) present at this location include Fuera-Dargol-Vamer complex (DFV) and the Saruche-Rombo-Rock outcrop complex (SR) [3]. These SMU are typical of Major Land Use Resource Area (MLRA) 048A, the Southern Rocky Mountains, which are characterized by high elevation, steep rugged mountains, with both linear ranges and complex masses of peaks. Middle to high elevations have been glaciated [2].
