Inspection Photos

API: 067-07028

Operator: SIMCOE LLC

Inspection Date: 6/15/2023

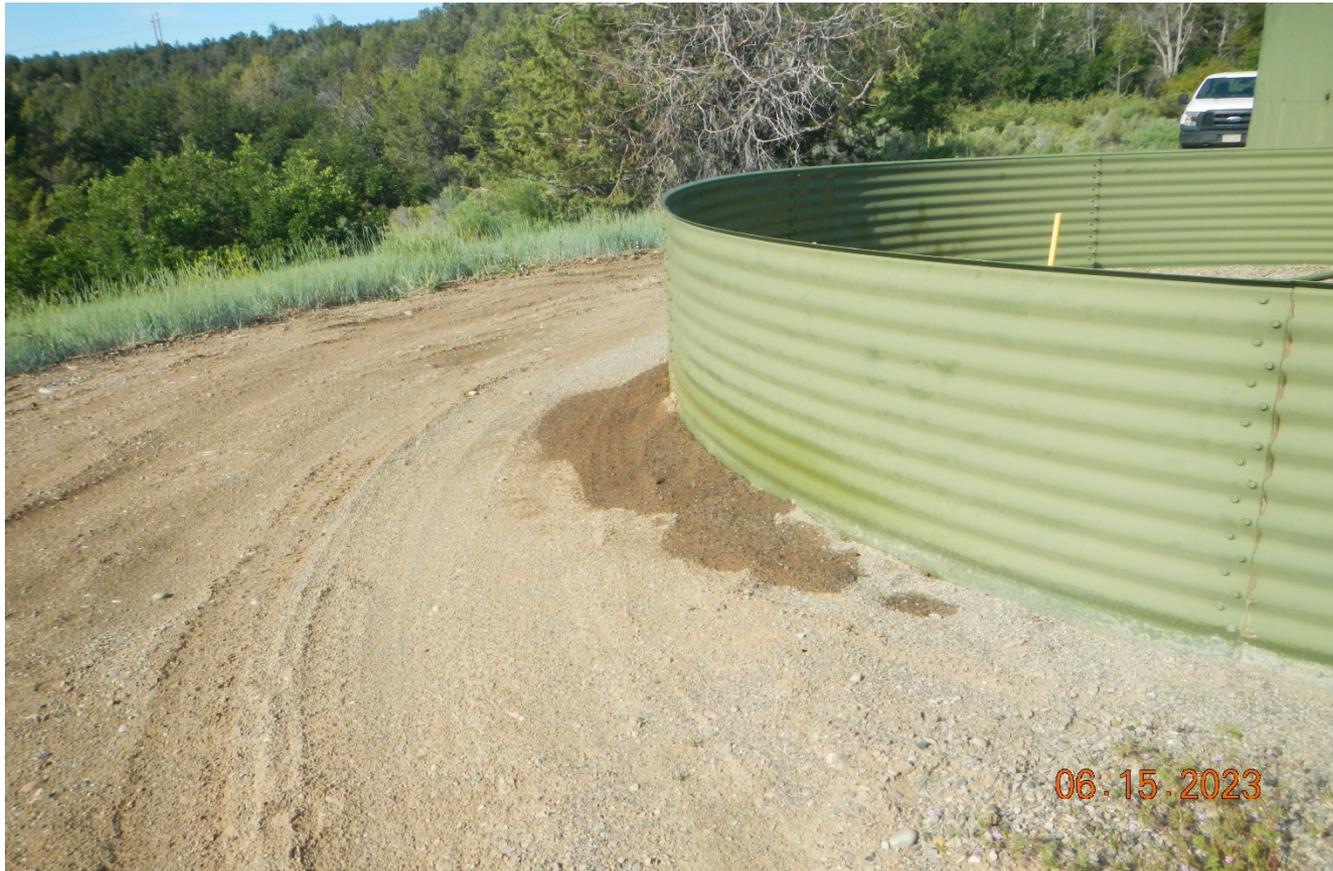
Photo 5. There is oil stained soils outside of containment at the buried tank.

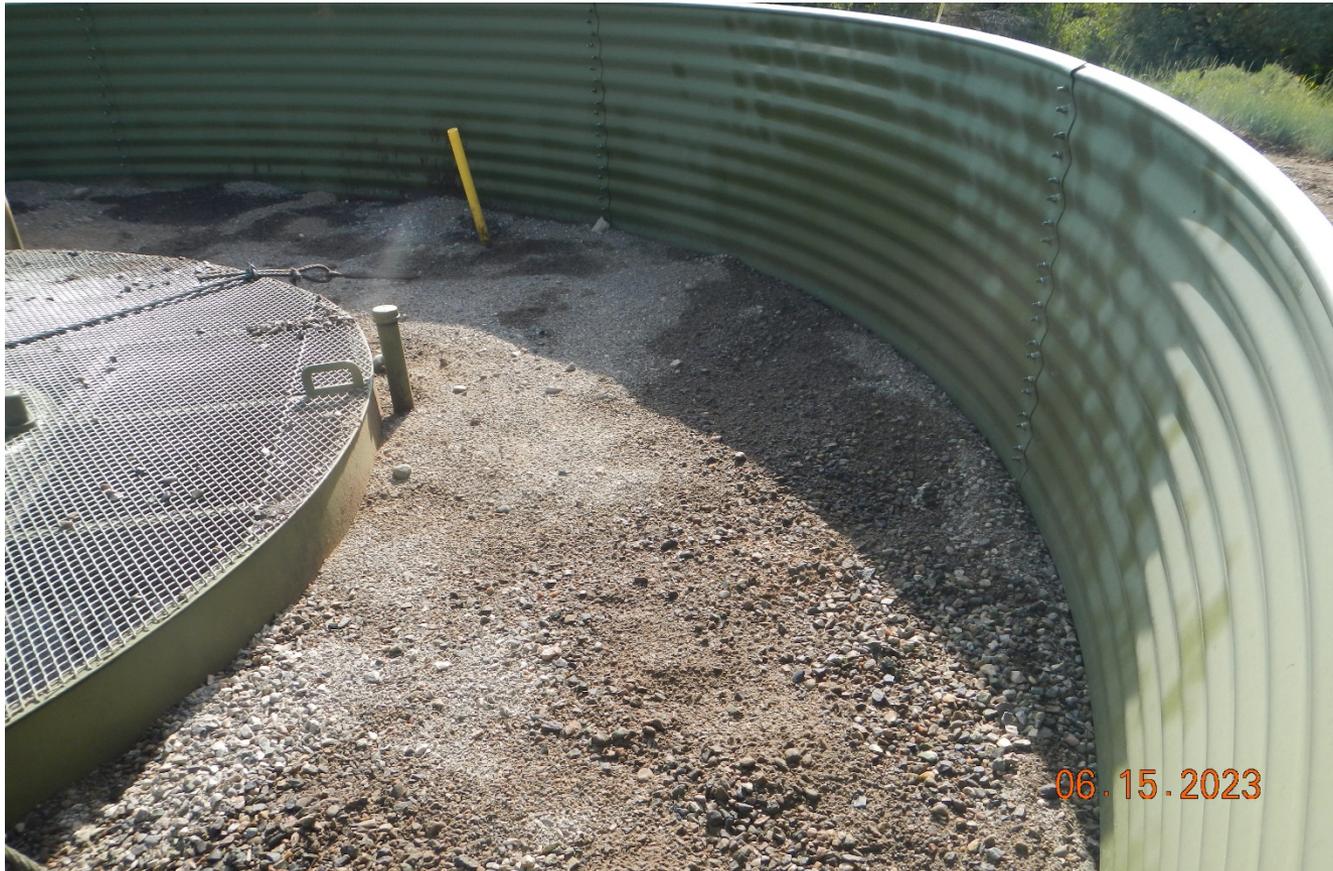
Photo 6. There are stain soils inside containment that need to be cleaned up.

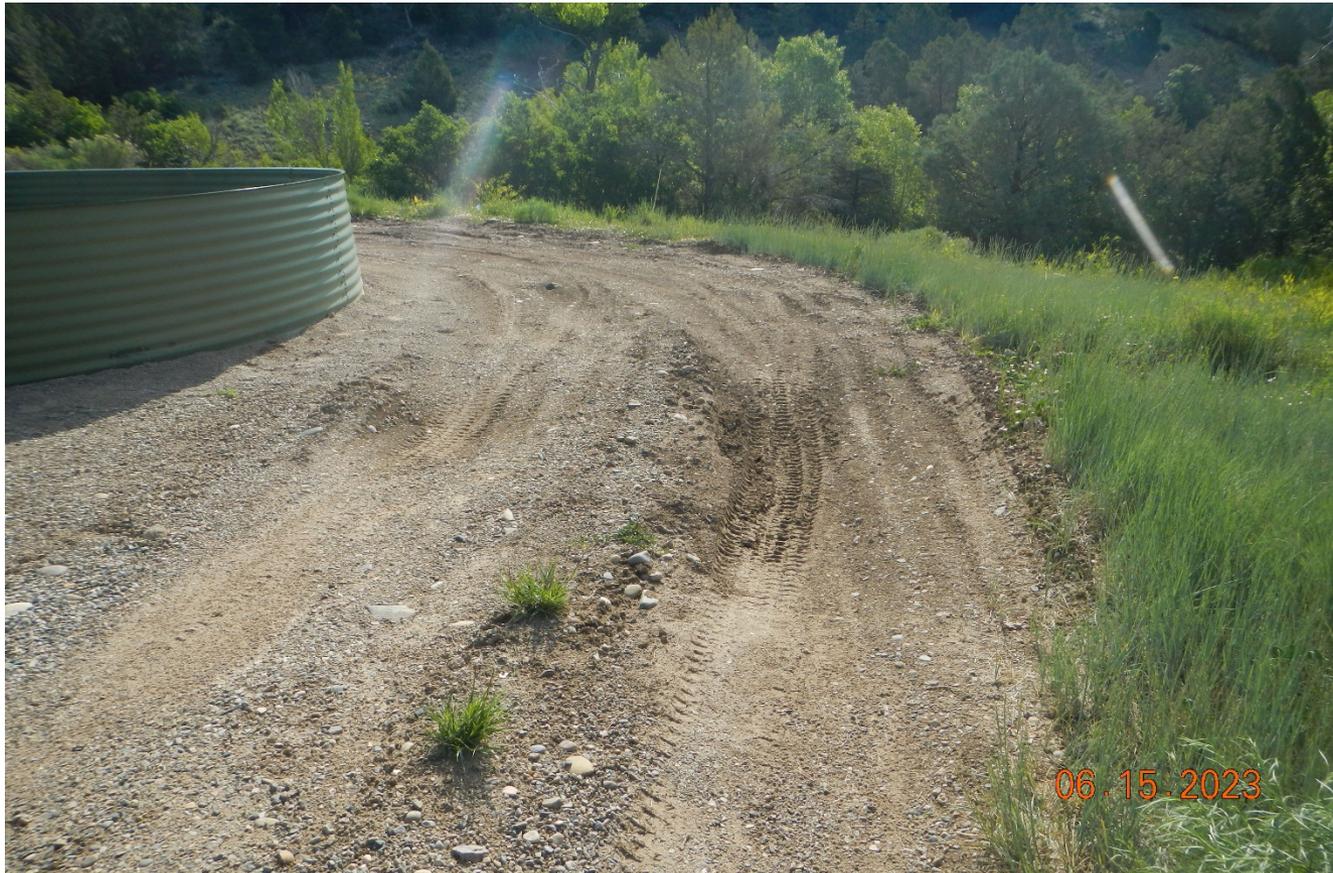
Photo 7. There is vehicle ruts where stormwater accumulates which need to be repaired.
