# Interim Reclamation and Stormwater Inspection

Operator: UPLAND EXPLORATION LLC- #10701

Location ID: 456651

Inspection Document #: 697504722

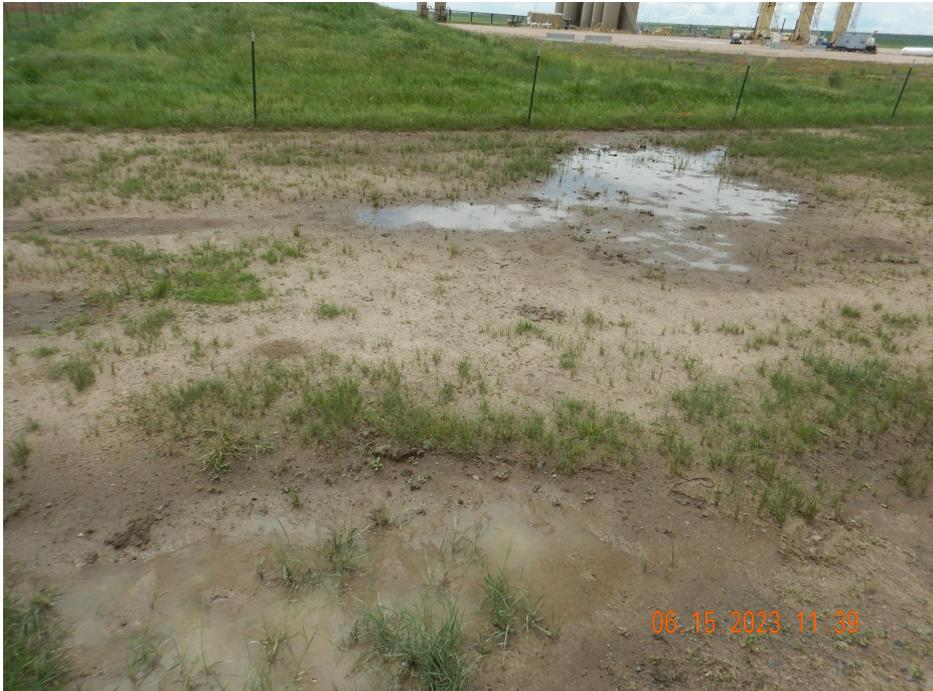
**Photo 1.** Photo taken from the entrance of location off CR57, facing South. Photo illustrates Upland disturbances along the access road have not been addressed which are related to the original Rule 1002.e. violations.

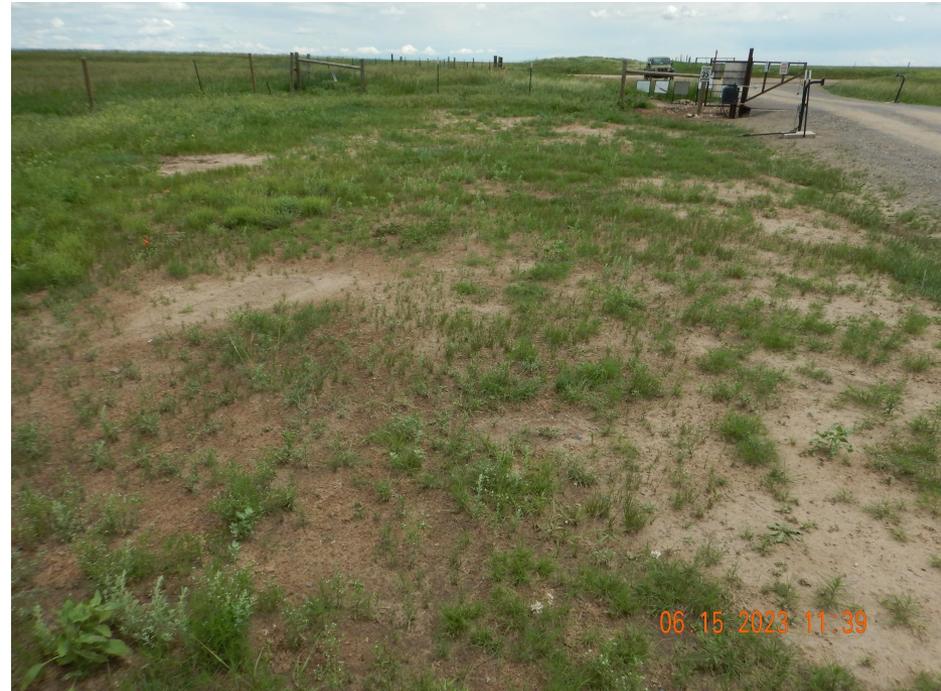
**Photo 2.** Photo taken from the entrance of location off CR57, facing East. See comments under Photo 1.

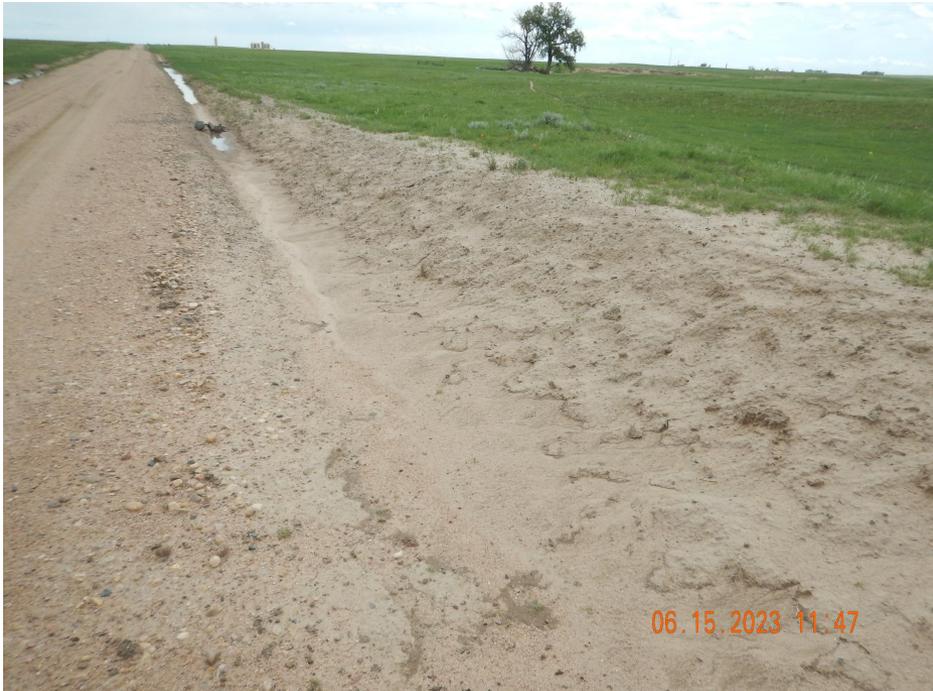
**Photo 3.** Photo taken east of Geary Creek, facing East. Photo illustrates Upland disturbances along a cut slope of the access road have not been addressed which are related to the original Rule 1002.e. violation and are now eroding into Geary Creek. Refer to Photos 5 & 6.

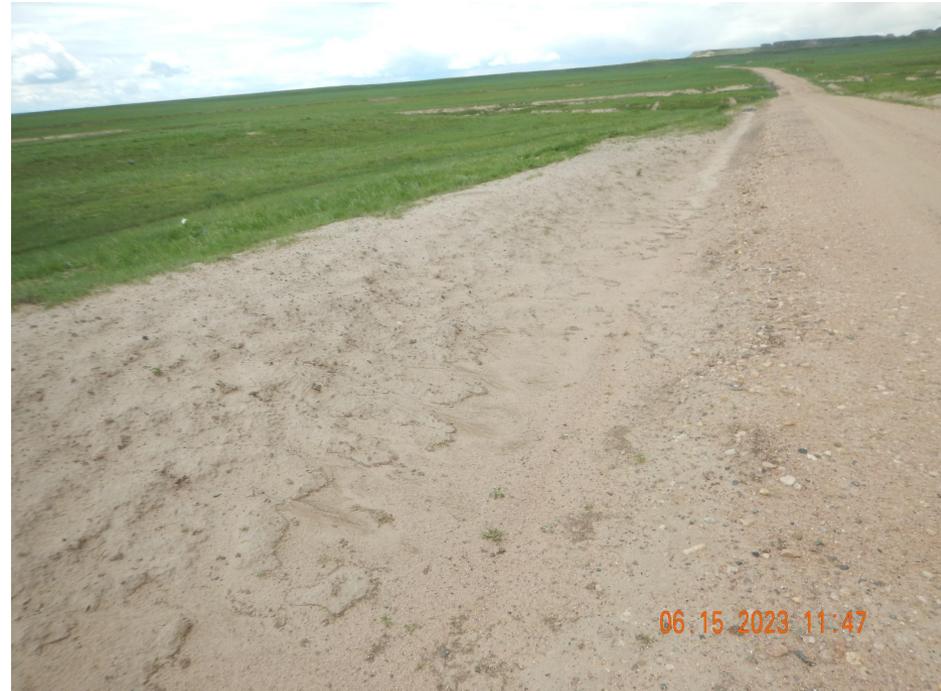
**Photo 4.** Photo taken east of Geary Creek, facing West. See comments under Photo 3.

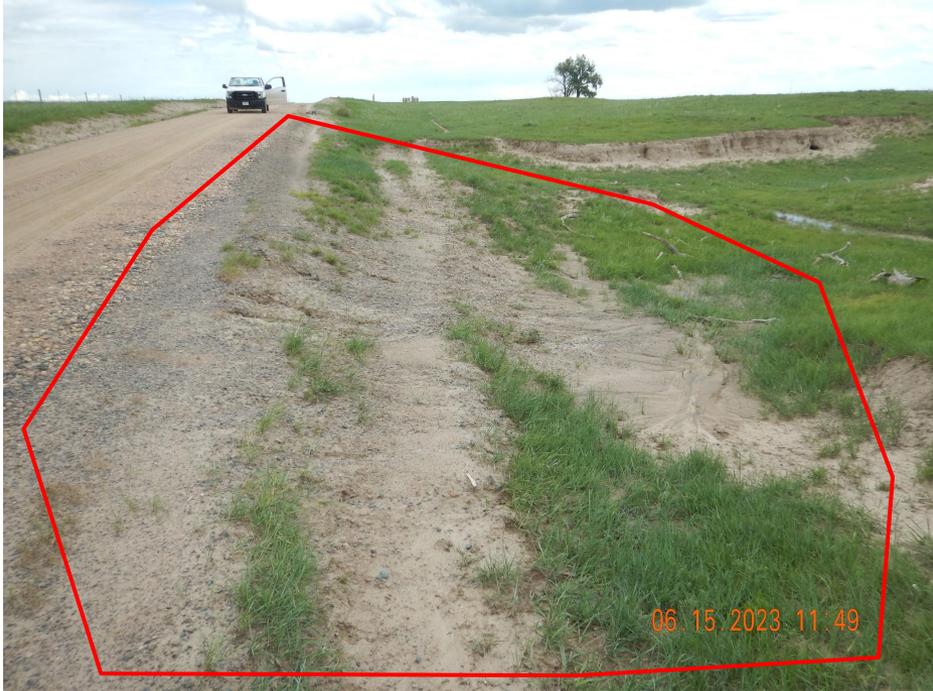
**Photo 5.** Photo taken from Geary Creek, facing East. Photo illustrates sediment laden stormwater discharging into Geary Creek from Upland disturbances without any stormwater BMPs.

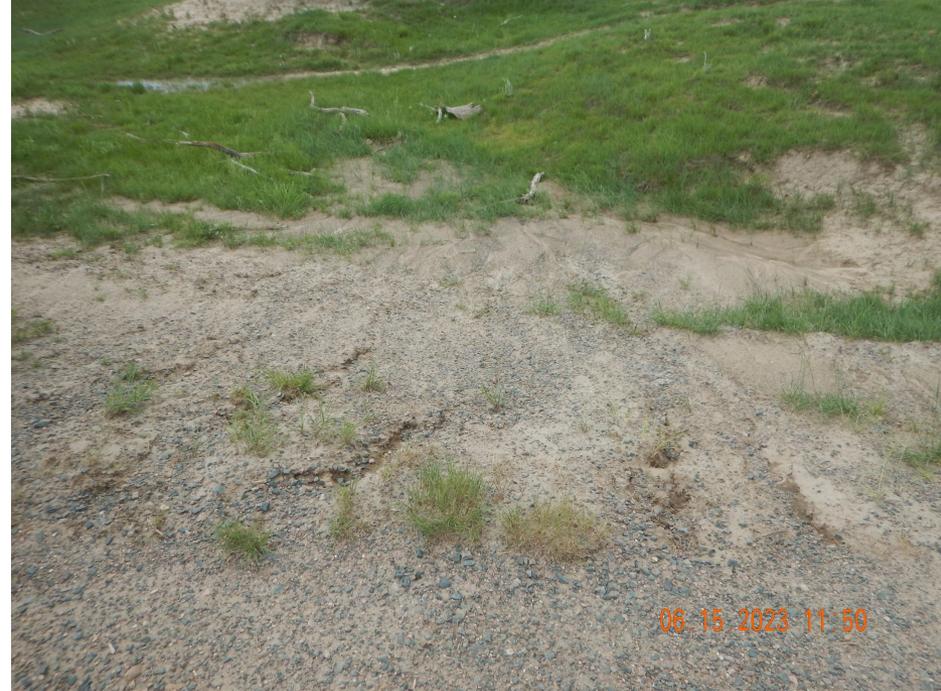
**Photo 6.** Photo taken east of Geary Creek, facing South. Photo illustrates sediment laden stormwater discharging into Geary Creek without any stormwater BMPs.

Note- Upland has imported a significant amount of road base material in this area which has created more runoff potential than previously observed.

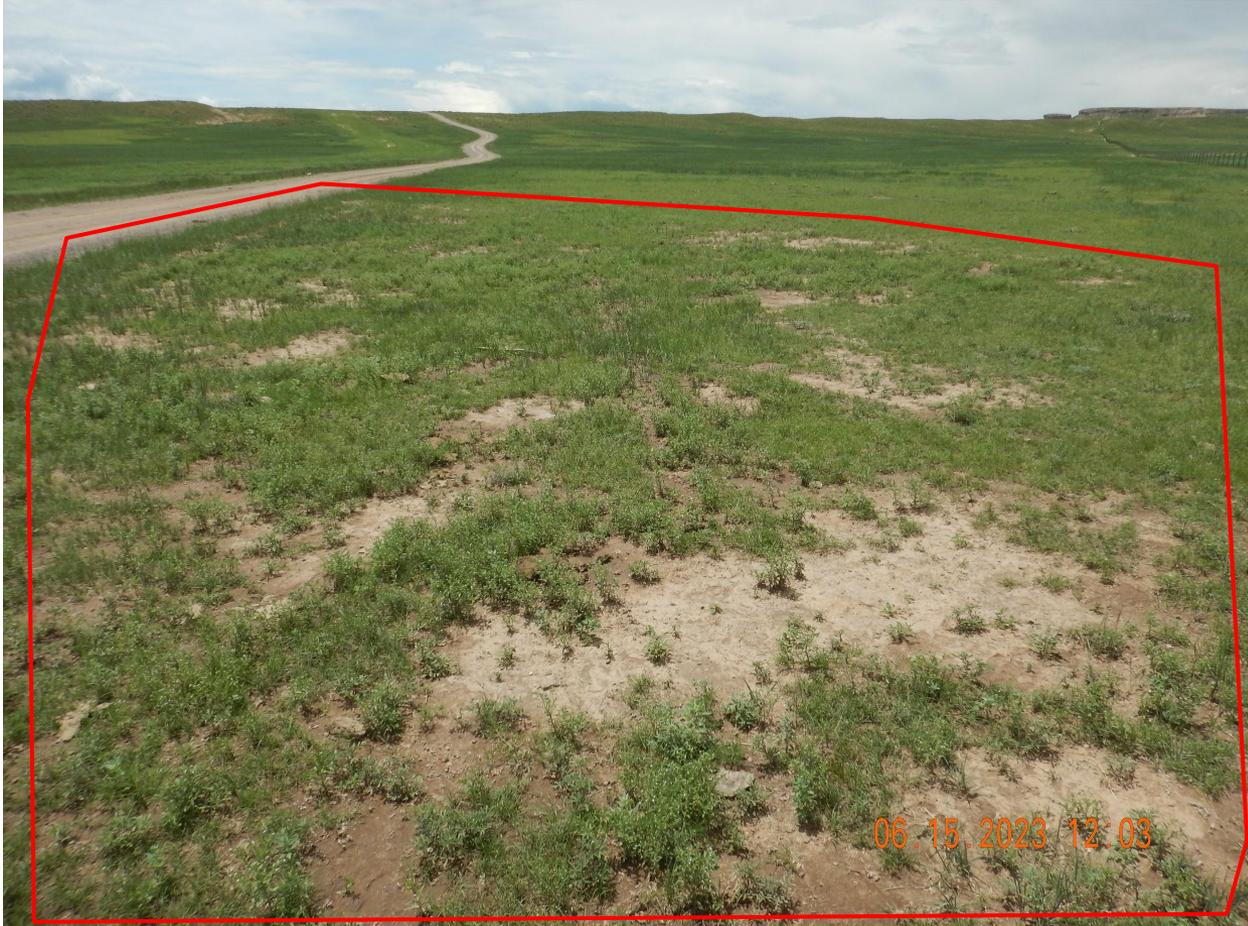
**Photo 7.** Photo taken from a section of Upland disturbance from vehicle traffic off the original access road boundary, facing West. Photo illustrates bare ground and annual, weedy vegetation.

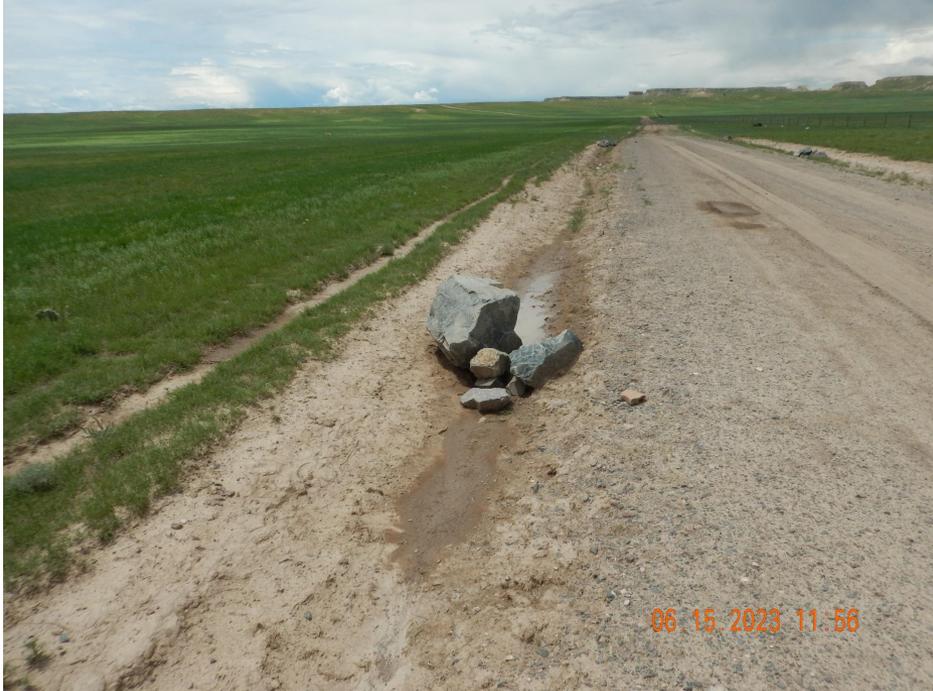
**Photo 8.** Photo taken from a section of the access road illustrating check dam BMP installation. Operator has not installed the BMP per good engineering practices.

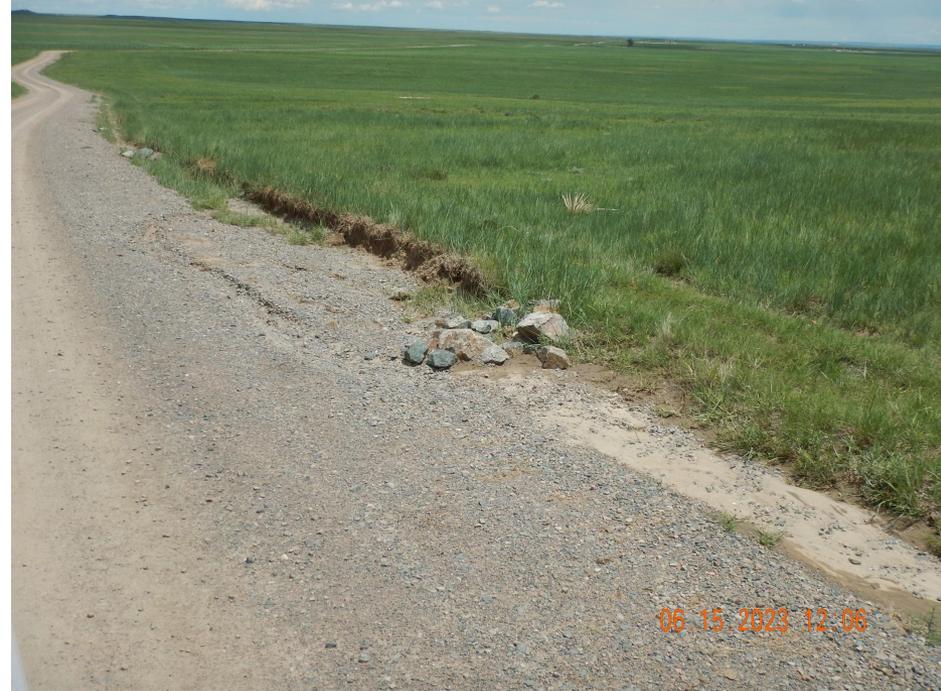
**Photo 9.** Photo taken from a section of the access road illustrating check dam BMP installation. Operator has not installed the BMP per good engineering practices. Stormwater is going around the BMP, some of which is going into the adjacent pasture.

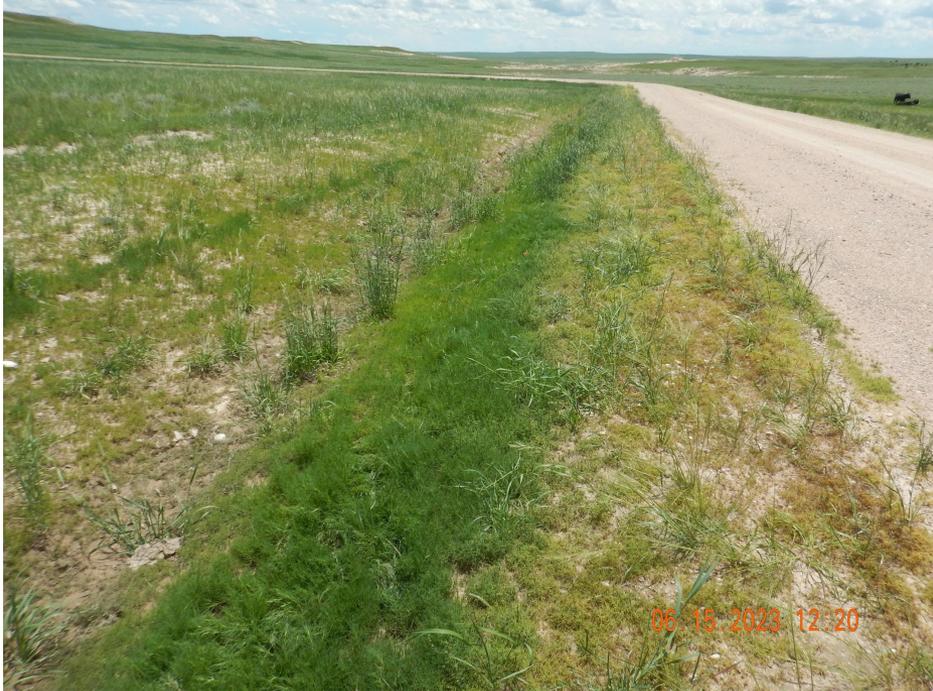
**Photo 10.** Photo taken from a section of the access road illustrating Russian thistle weed establishment. Operator has removed the weed debris by raking but has only sprayed a portion of the weed establishment.

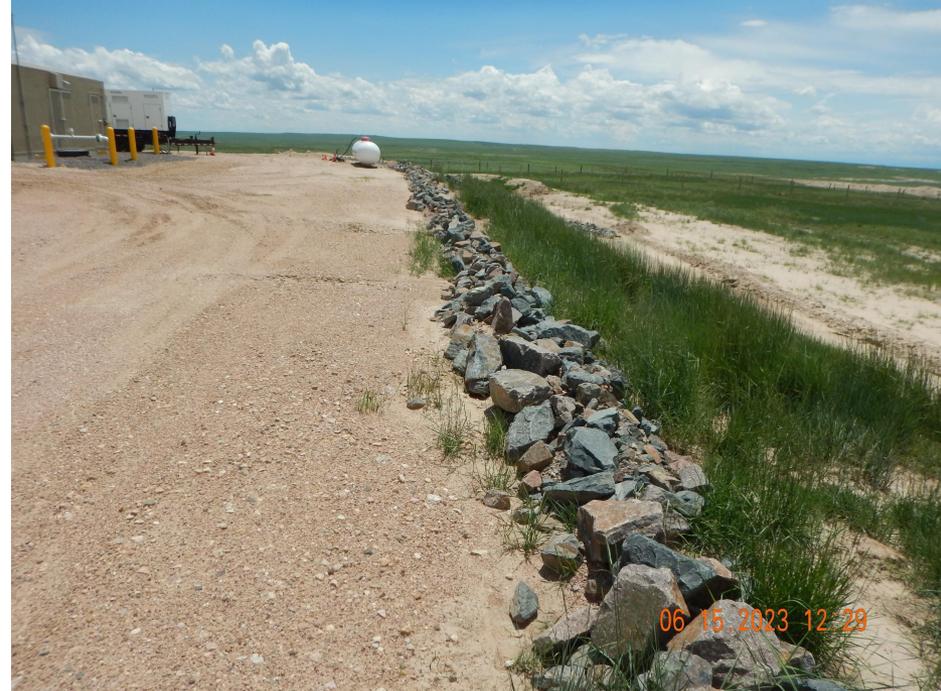
**Photo 11.** Photo taken from the western perimeter of location, facing South. Photo illustrates Operator has installed a riprap berm along the top of the fill slope.

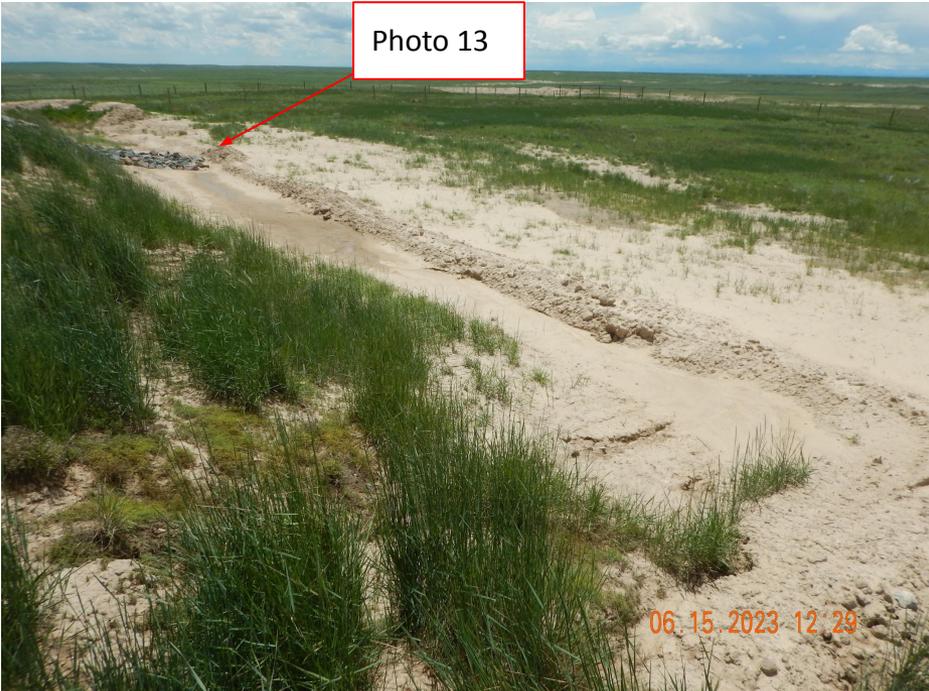
**Photo 12.** Photo illustrates a berm BMP installed along the toe of the fill slope, facing South. Berm BMP has not been installed per good engineering practices.

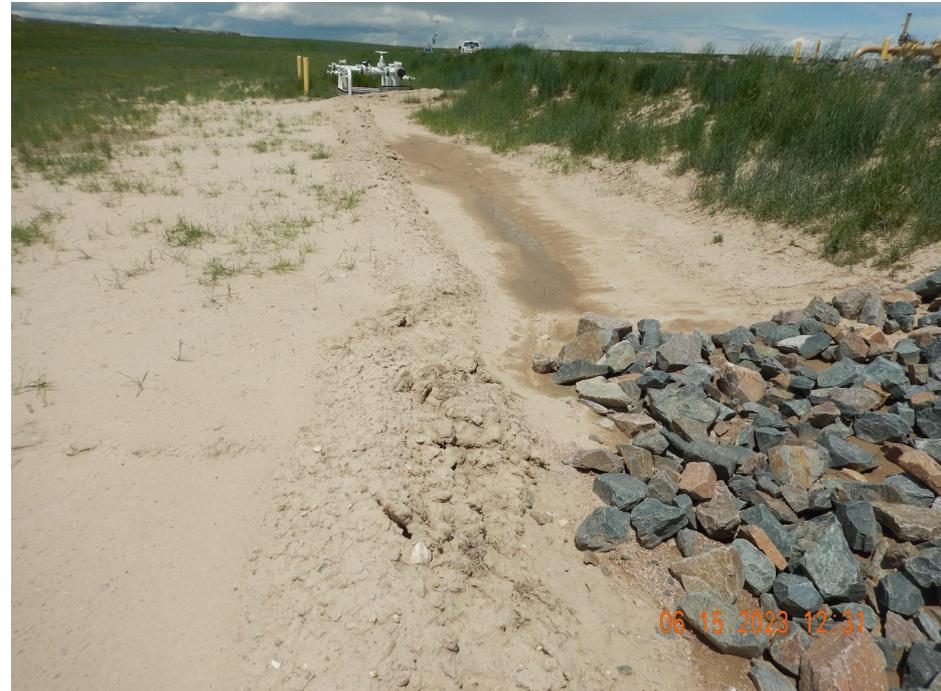
**Photo 13.** Photo taken from the berm BMP, facing North. See comments under Photo 12.

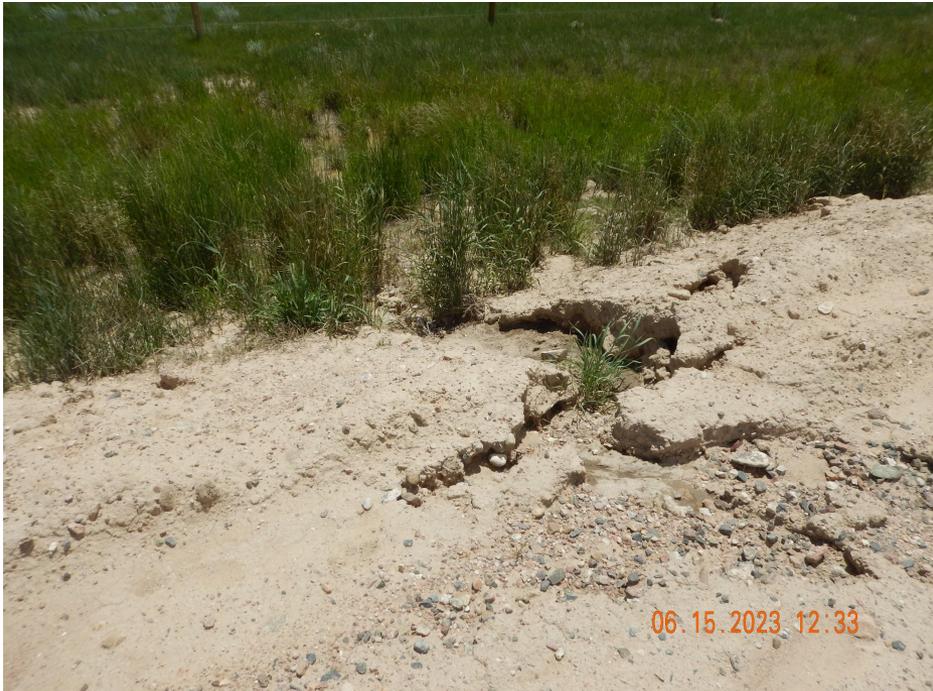
**Photo 14.** Photo taken from the southern perimeter of location, facing South. Photo illustrates gully erosion in need of repair.

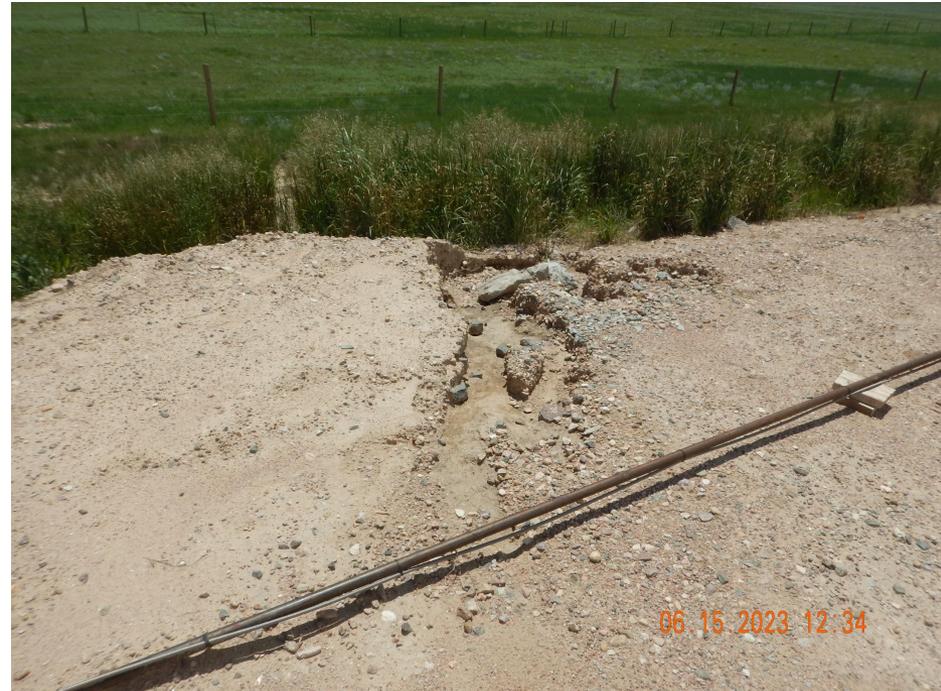
**Photo 15.** Photo taken from the southern perimeter of location, facing South. See comments under Photo 14.

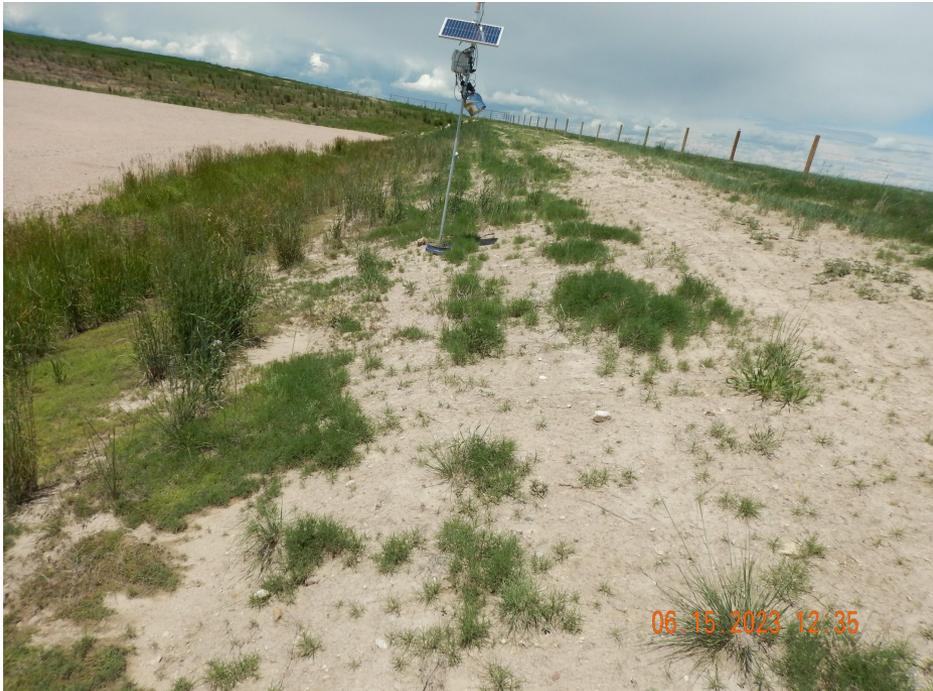
**Photo 16.** Photo taken from the eastern perimeter of location, facing North. Photo illustrates Russian thistle weed establishment and there is no evidence of desirable germination.

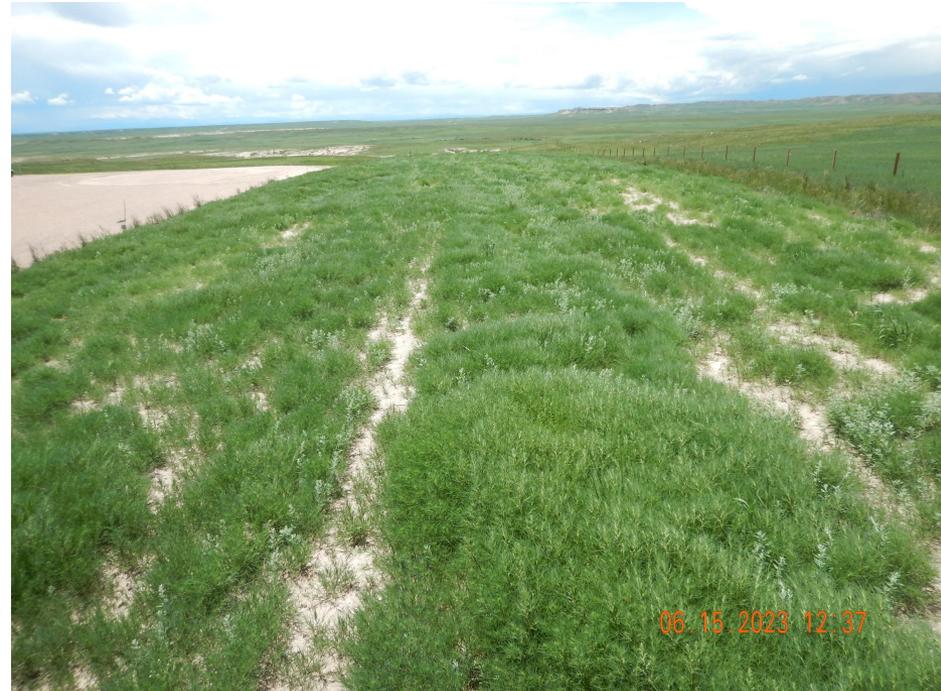
**Photo 17.** Photo taken from the topsoil stockpile, facing West. Photo illustrates annual, weedy vegetation and there is no evidence of desirable germination.
