Interim Reclamation and Stormwater Inspection

Operator: UPLAND EXPLORATION LLC- #10701

Location ID: 462919

Inspection Photos
Location Name: Little Lady 21/South Well Pad
Location ID: 462919

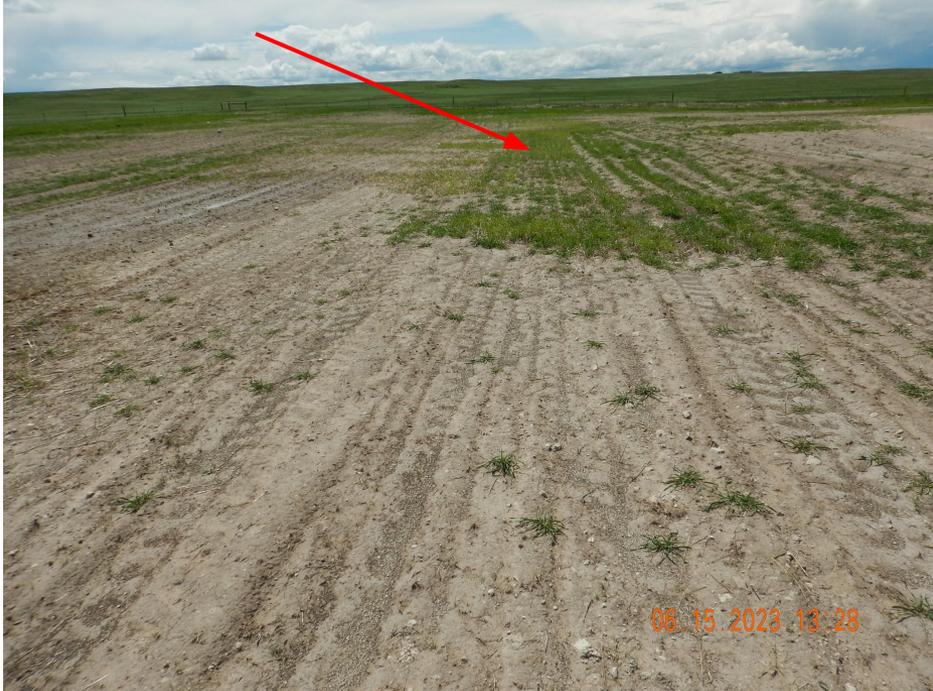
Photo 1. Photo taken from the southern location, facing West. Red arrow is pointing at new growth (green vegetation). COGCC believes this to be an introduced grass species which was not accurately reported to COGCC.

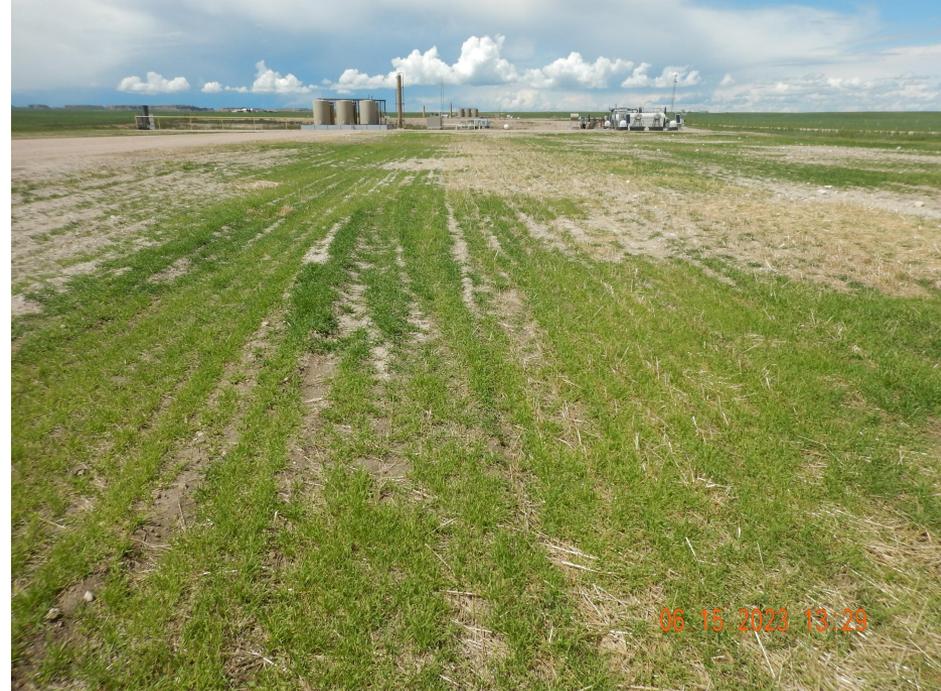
Photo 2. Photo taken from the southern location, facing North. Photo illustrates much of the new growth to be an introduced grass species. See comments under Photo 1.

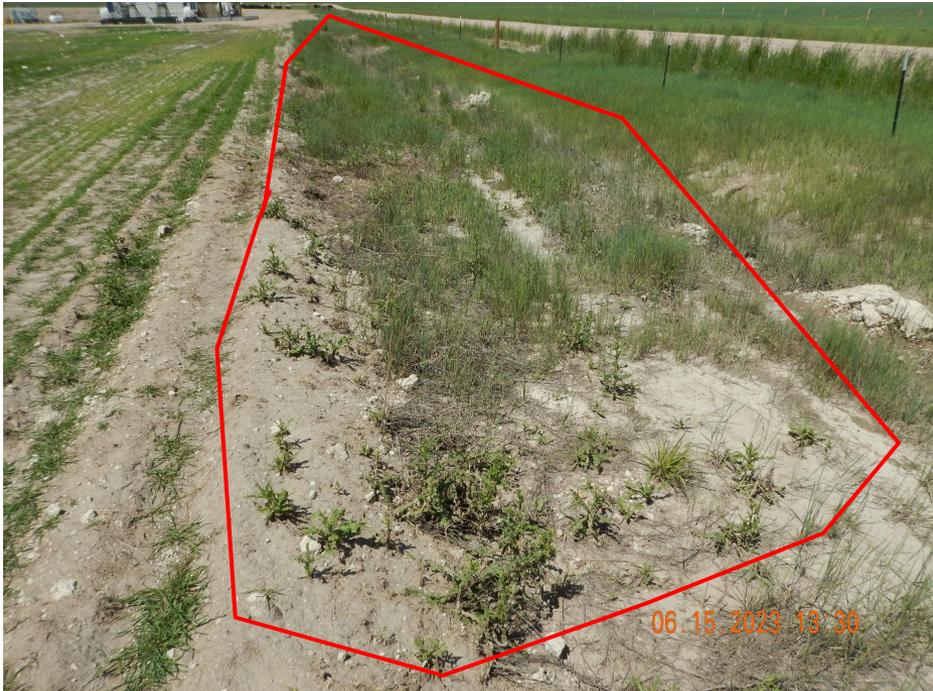
Photo 3. Photo taken from the southeastern perimeter of location, facing North. Red polygon illustrates the approximate area with a List B Colorado noxious weed, Canada thistle.

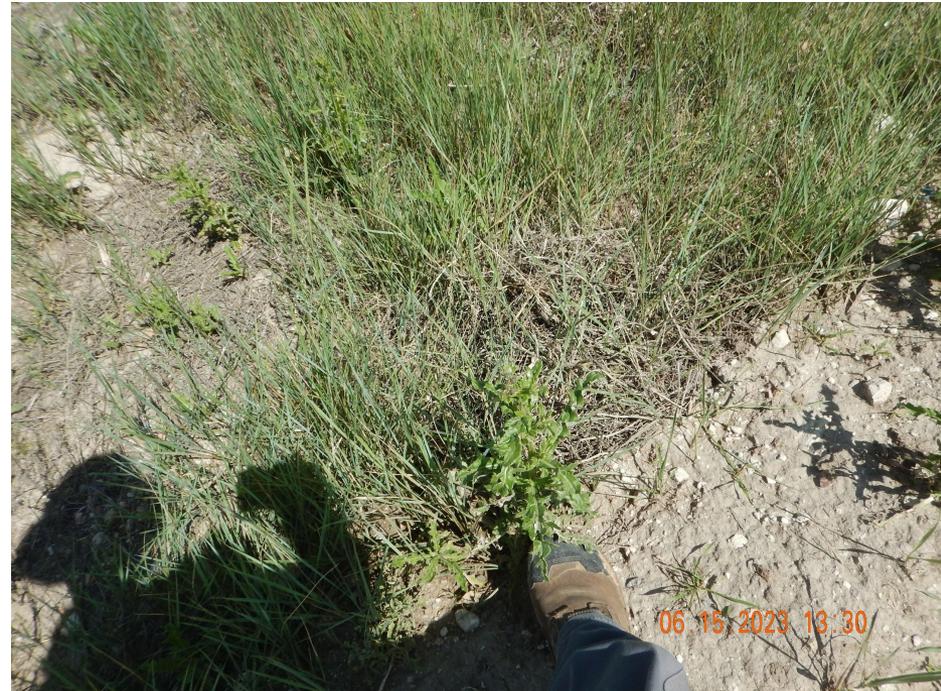
Photo 4. Close up photo taken of some Canada thistle.

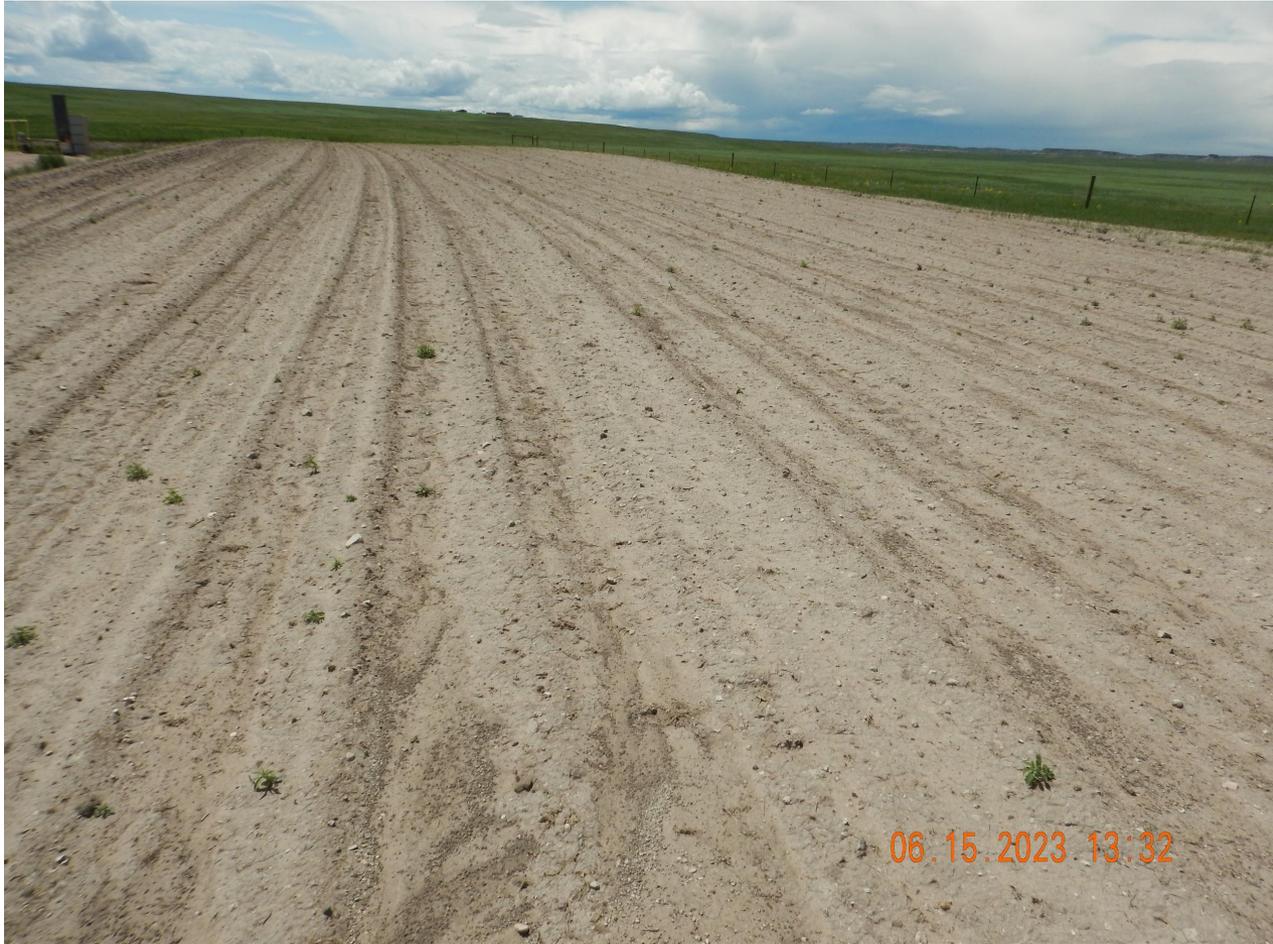
Photo 5. Photo taken from the topsoil stockpile, facing West. Photo illustrates the topsoil stockpile remains unstabilized and no desirable vegetative growth. Weedy annual growth is starting to establish.
