Interim Reclamation and Stormwater Inspection

June 15, 2023

Location ID: 462908

Inspection Photos
Location Name: Little Lady 21/North Well Pad
Location ID: 462908

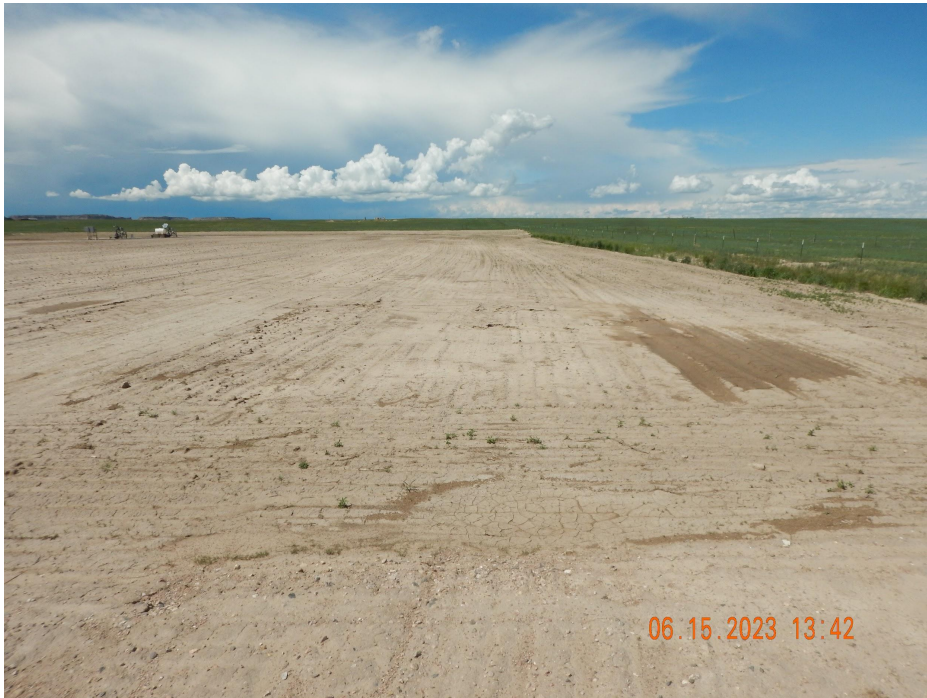
Photo 1. Photo taken from the southeastern location, facing North. Photo illustrates interim reclamation has been performed; however, interim reclamation is not complete due to the lack of soil stabilization. Erosion was evidence and much of the interim reclamation area had no desirable establishment.

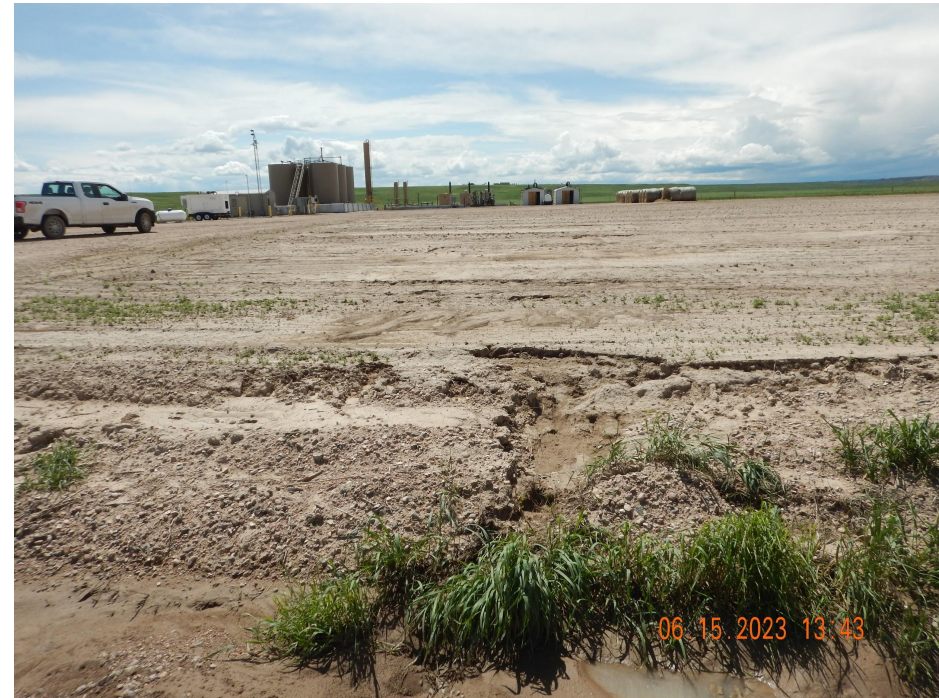
Photo 2. Photo taken from the southeastern location, facing West. Photo illustrates erosion and no soil stabilization.

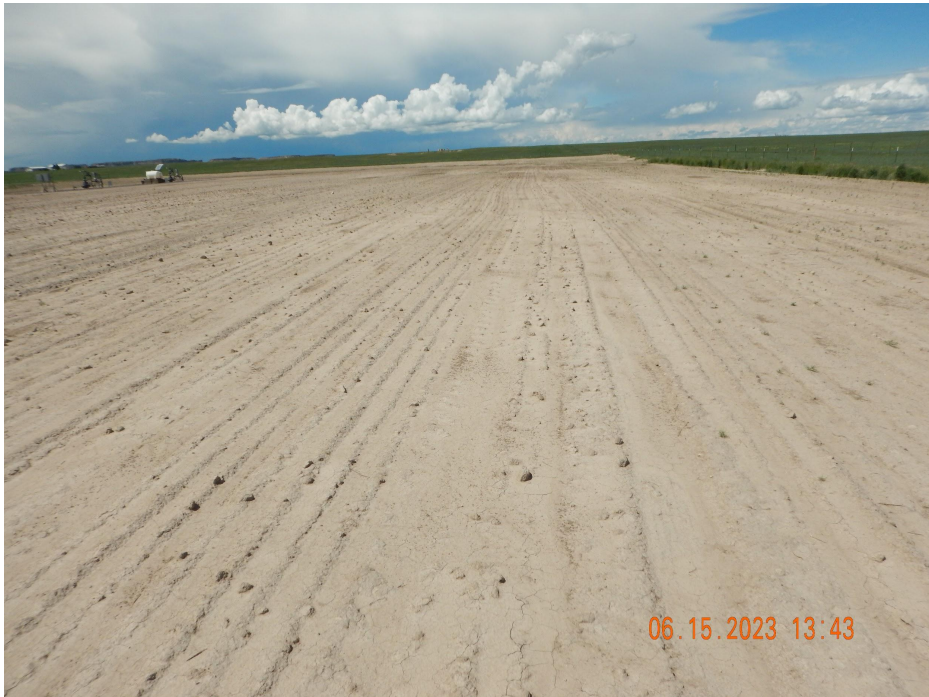
Photo 3. Photo taken from the eastern interim reclamation area, facing North. See comments under Photo 1.

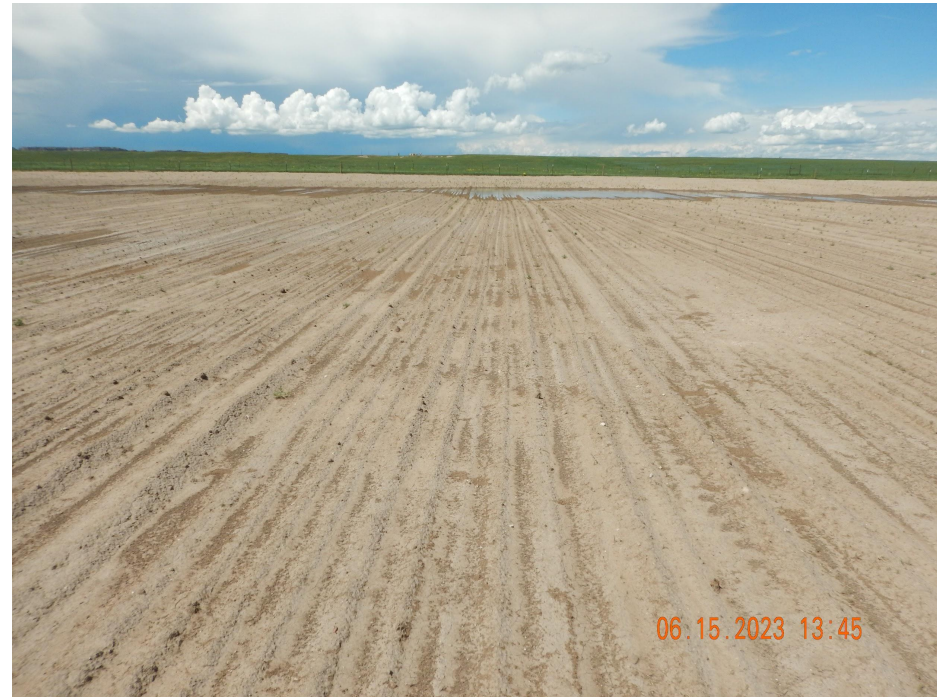
Photo 4. Photo taken from the north central interim reclamation area, facing North. See comments under Photo 1.

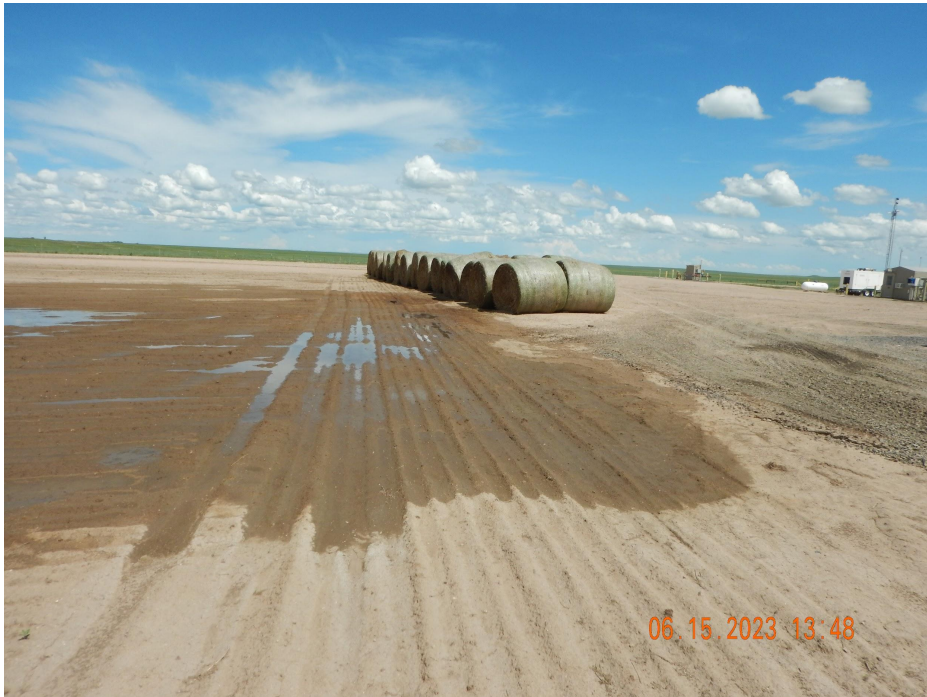
Photo 5. Photo taken from the western interim area, facing East. Photo illustrates straw mulch that appears to be staged for soil stabilization.

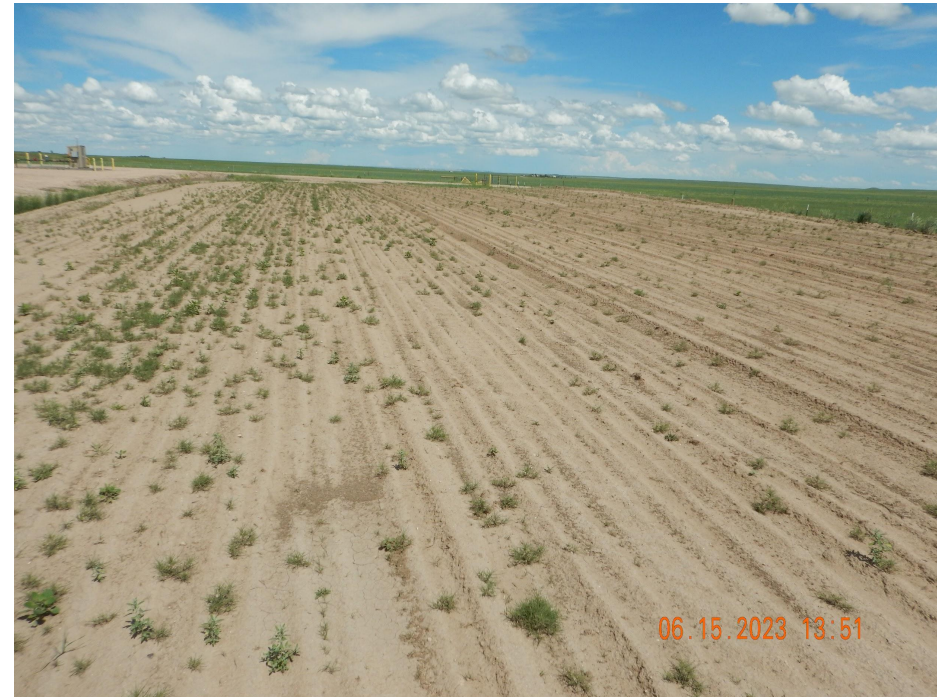
Photo 6. Photo taken from the topsoil stockpile, facing East. Photo illustrates the topsoil stockpile which has been seeded; however, the topsoil stockpile lacks soil stabilization. Some germination of desirable establishment was observed but again lacks soil stabilization.
