Inspection Photos

6/21/2023

Operator: D & G ROUSTABOUT SERVICE -
22370

Location Number: 322318
Garfield County, CO

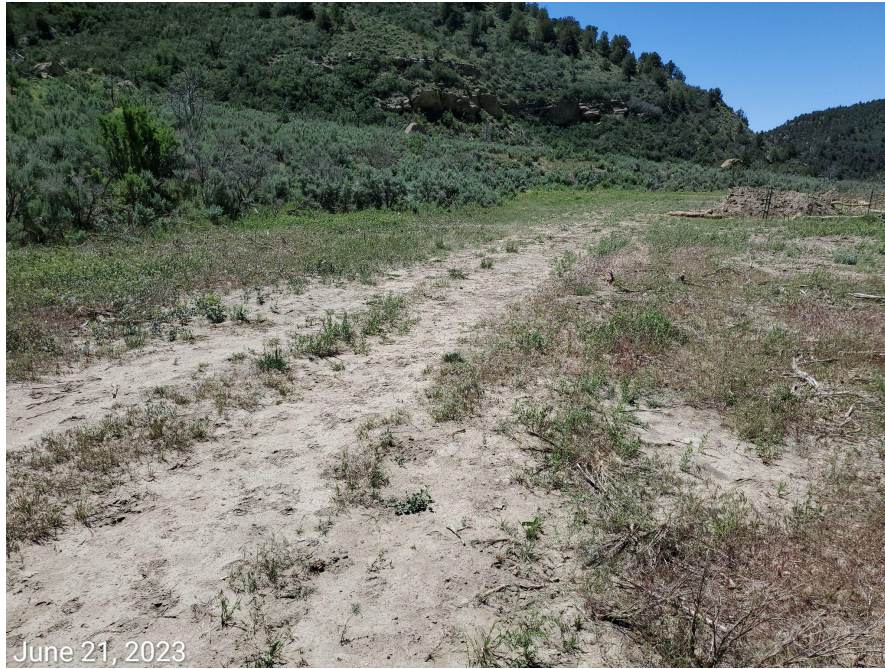
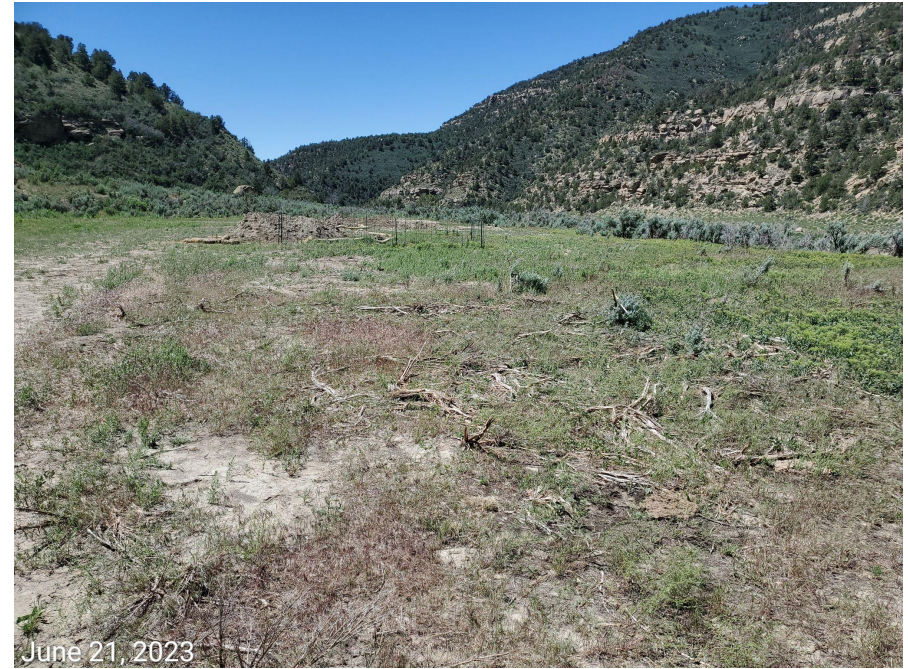
Photo 1: Photos taken from the north end of the Location. Photos provide an overview of the site facing south and southwest.

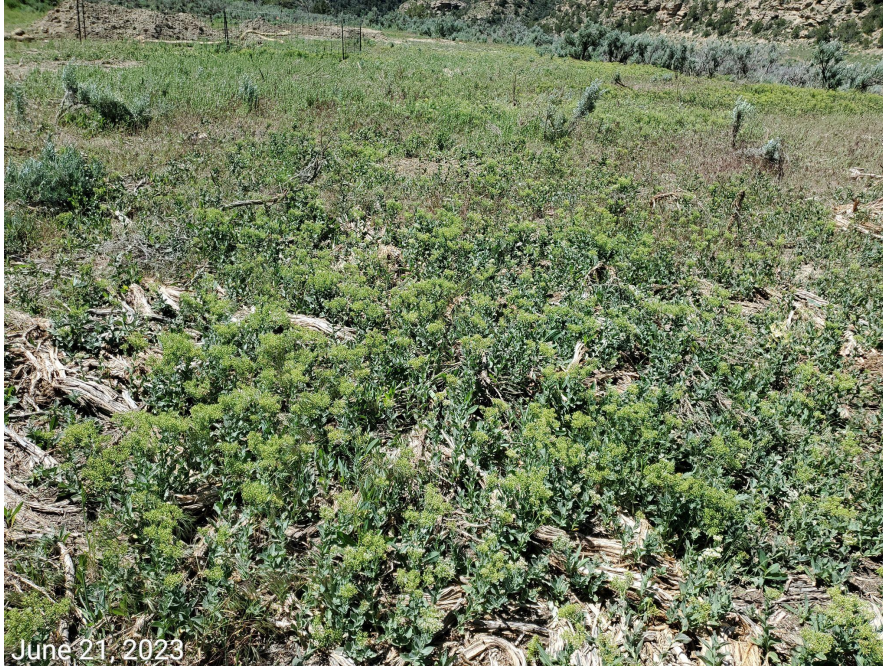
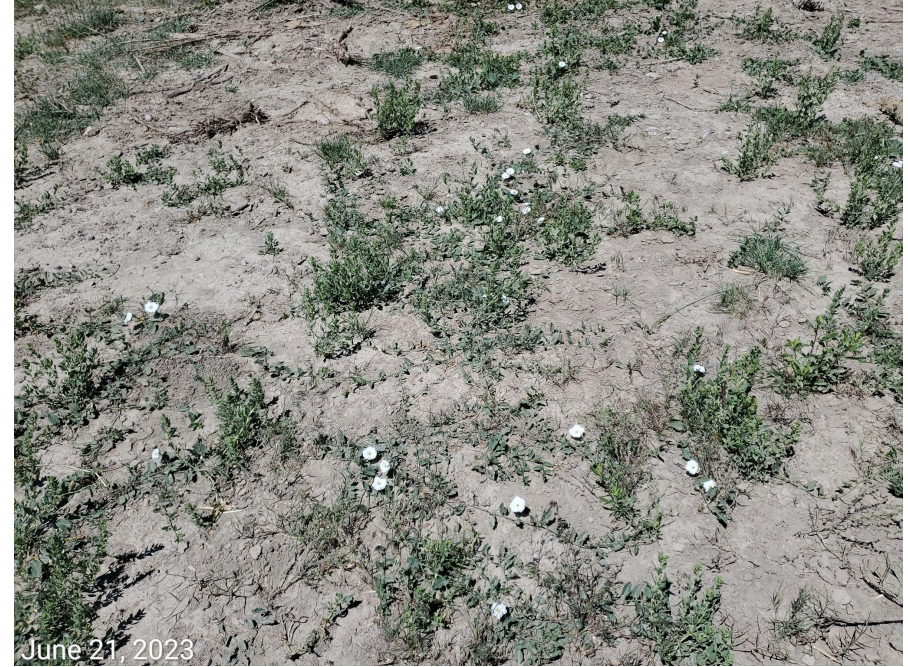
Photo 2: Photos example showing Undesirable Plant Species such as Hoary cress (light green plants, photo left) bindweed, redstem filaree, knotweed, etc... establishing on the Location. Ongoing weed management activities insufficient.

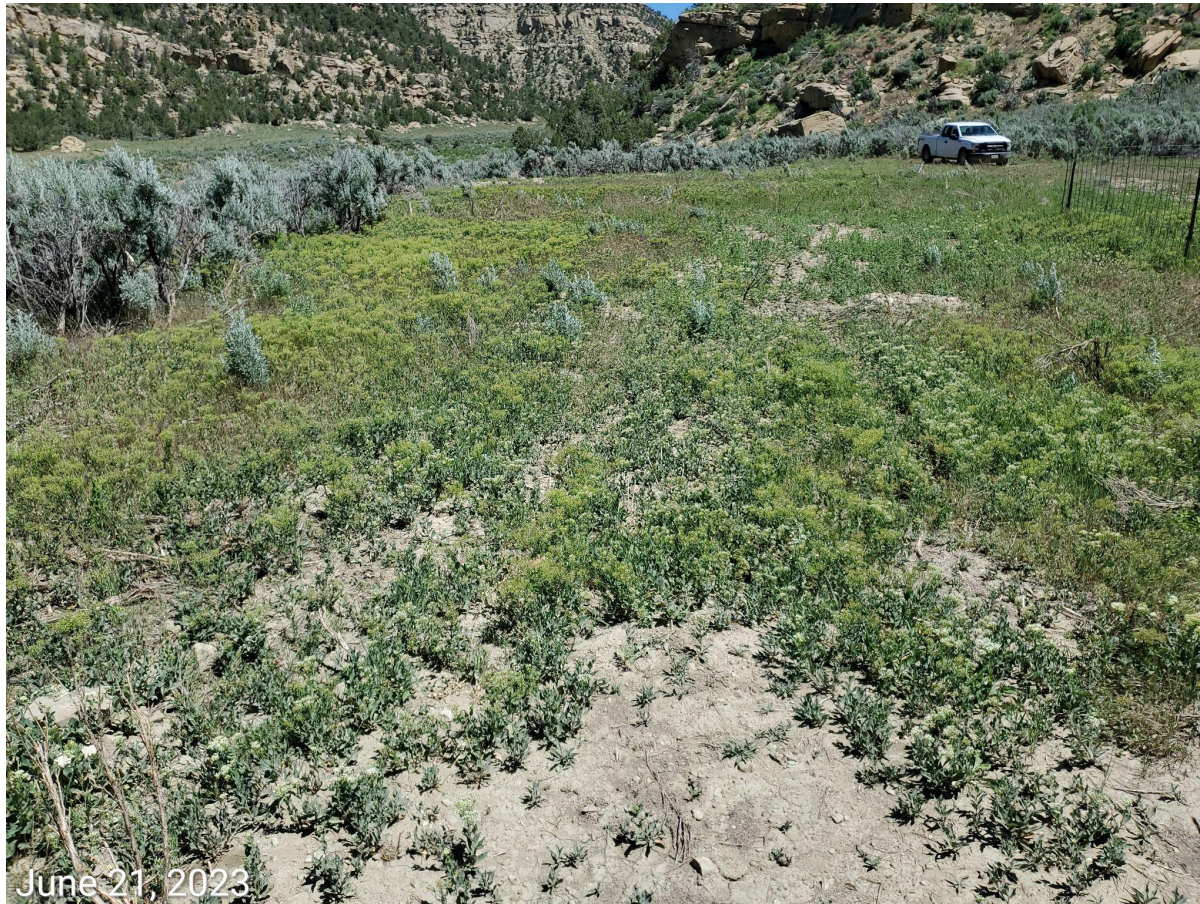
Photo 3: Photo example showing Undesirable Plant Species such as Hoary cress (light green plants, photo left) bindweed, redstem filaree, knotweed, etc... establishing on the Location.

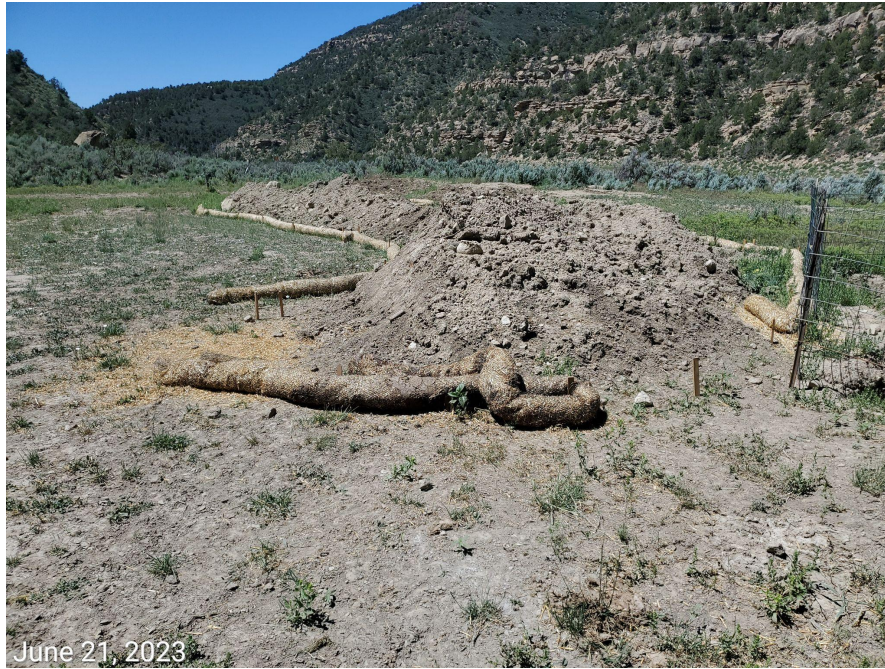
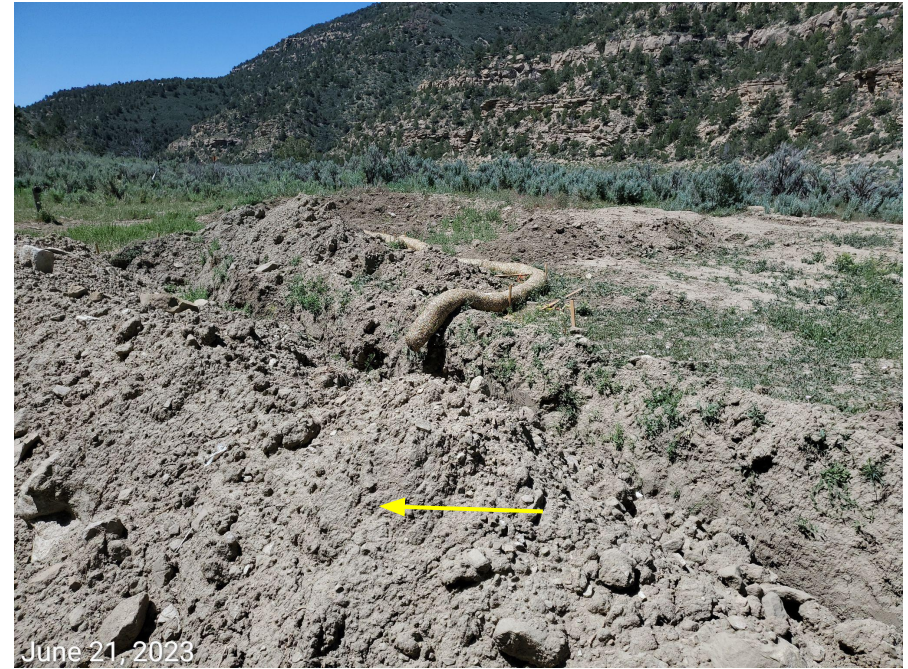
Photo 4: Photos show operator's attempt to comply with Rule 1002.c. Photos show erosion logs placed at the base of soil stockpiles on the Location have not been installed in accordance with good engineering practices, or maintained in proper functioning condition.

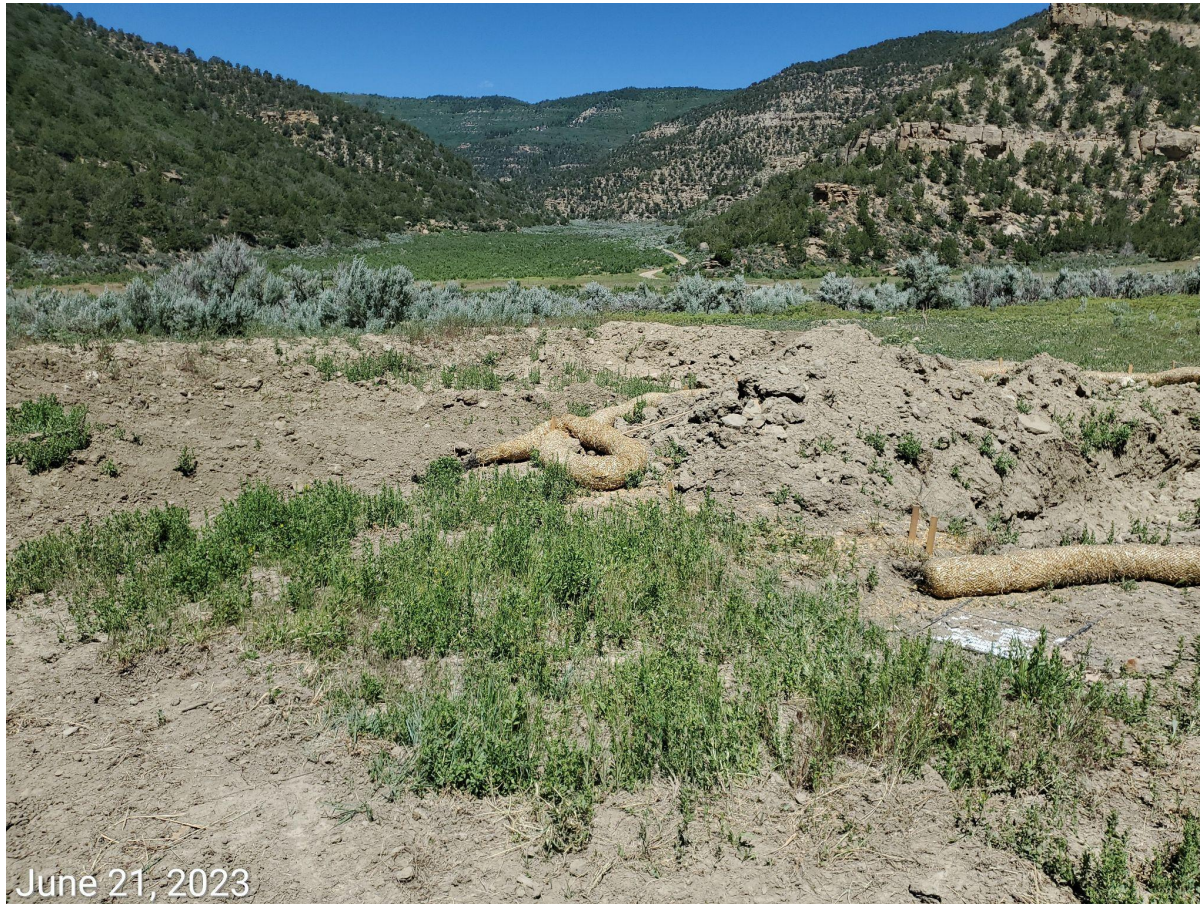
Photo 5: See comment under photo 4.

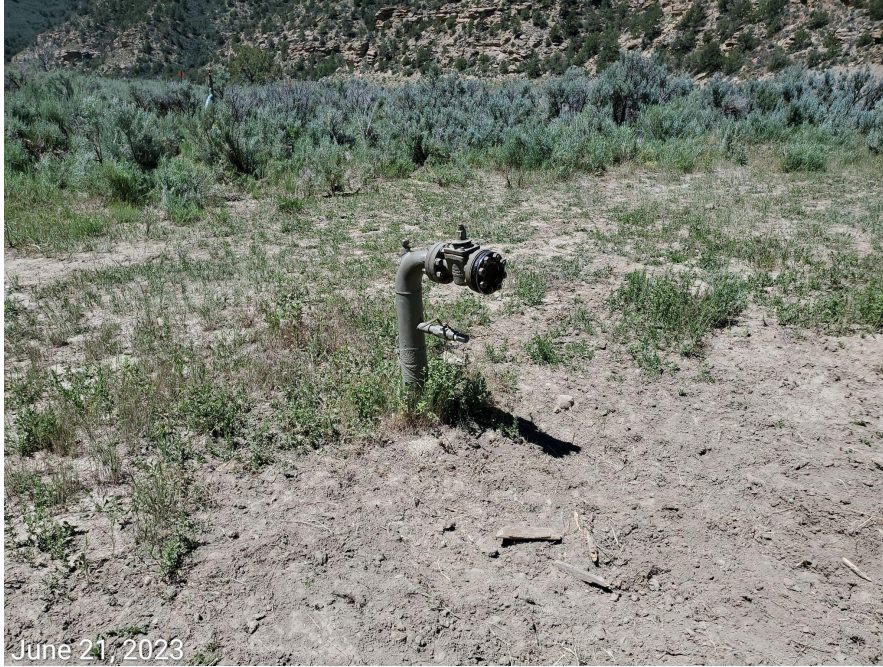
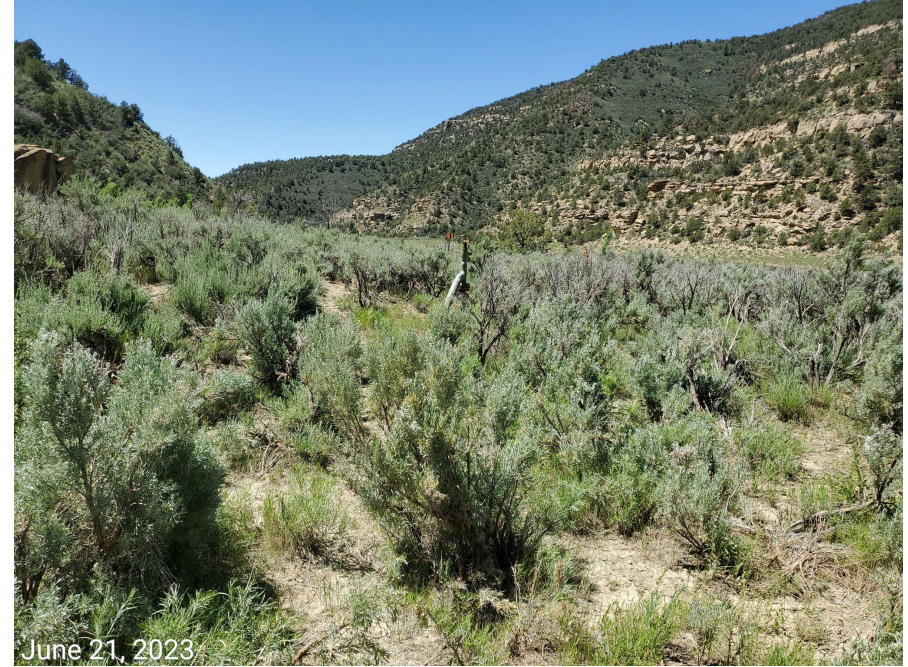
Photo 6: Surface equipment remaining on Location.

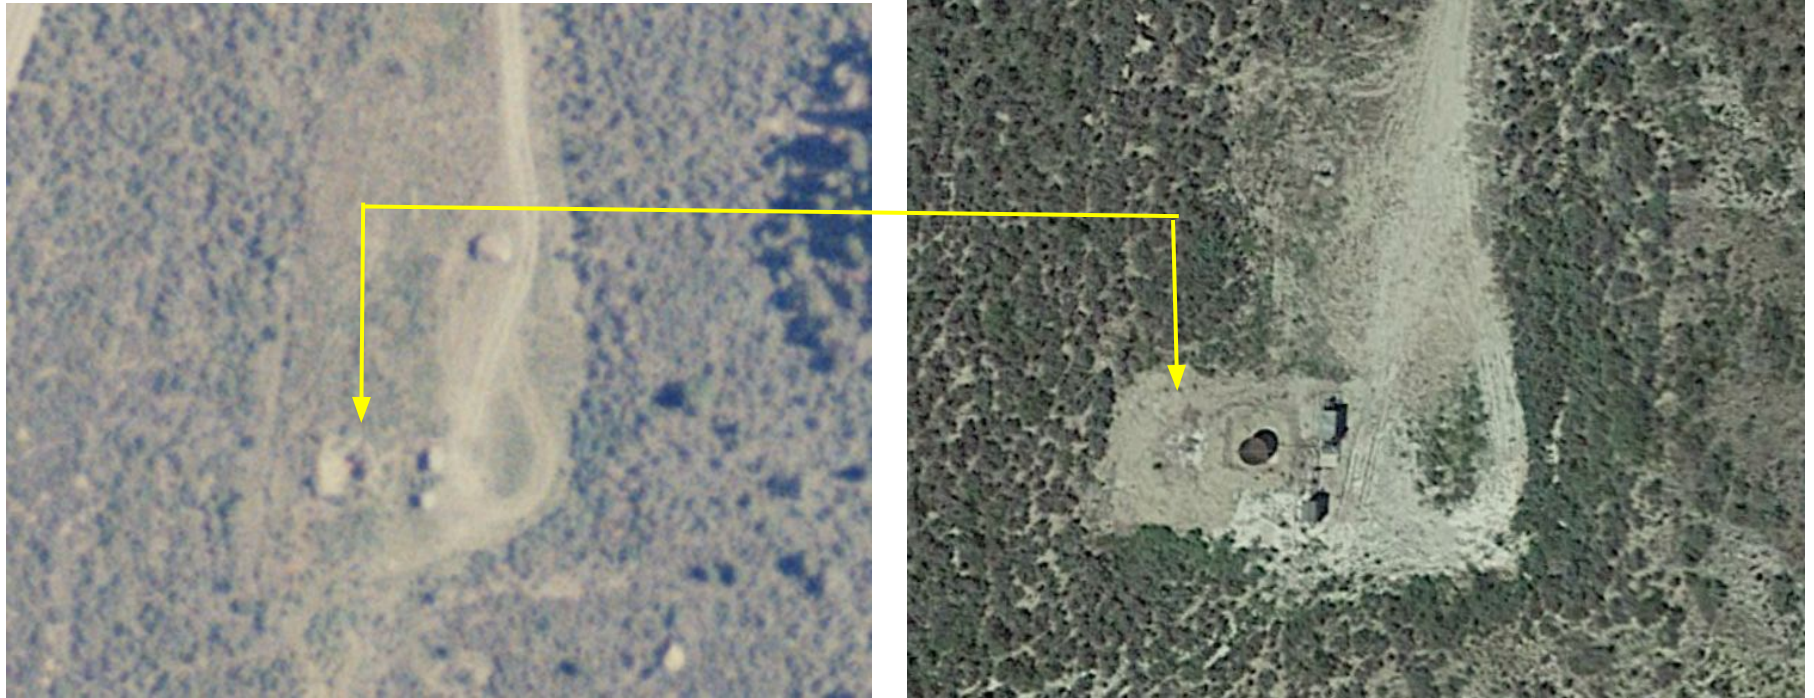
Photo 7: Photo right 1994 USGS Historic Aerial imagery. Photo right 2011 Google Earth Aerial Imagery. Photos show presence of a historic pit located to the west of the tank facility.
