Final Reclamation and Stormwater Inspection

Operator: STANCO PETROLEUM INC - 81650

Location ID: 389910

Inspection Photos
Location Name: Myrtle Rossen 1
Location ID: 389910

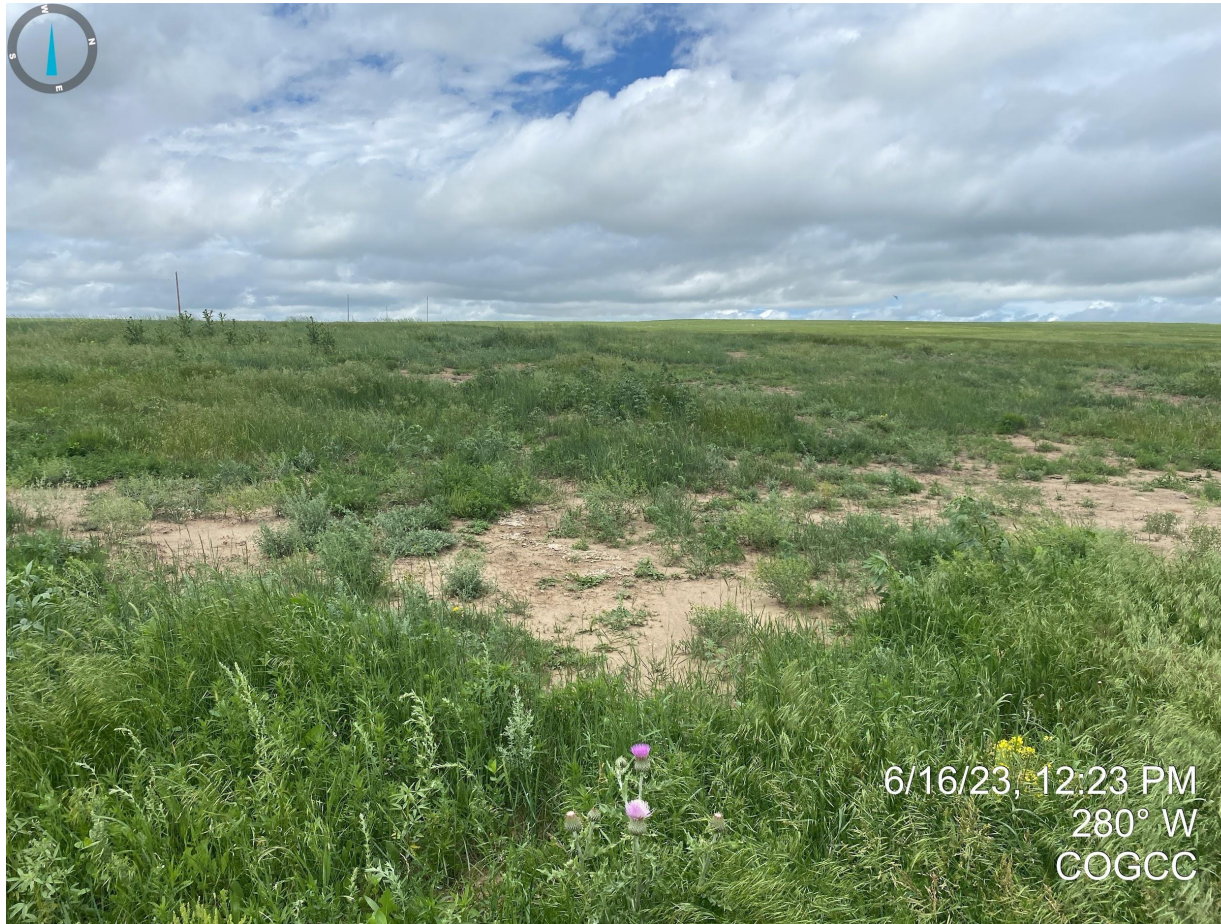
Photo 1. Taken from the eastern edge of the apparent salt kill area. During this inspection staff observed Colorado List B & C Noxious weeds (musk thistle, and cheatgrass) growing throughout the impacted area. These undesirable species were not observed in adjacent reference areas. Also pictured, non-uniform vegetation cover resulting in areas of exposed soils.

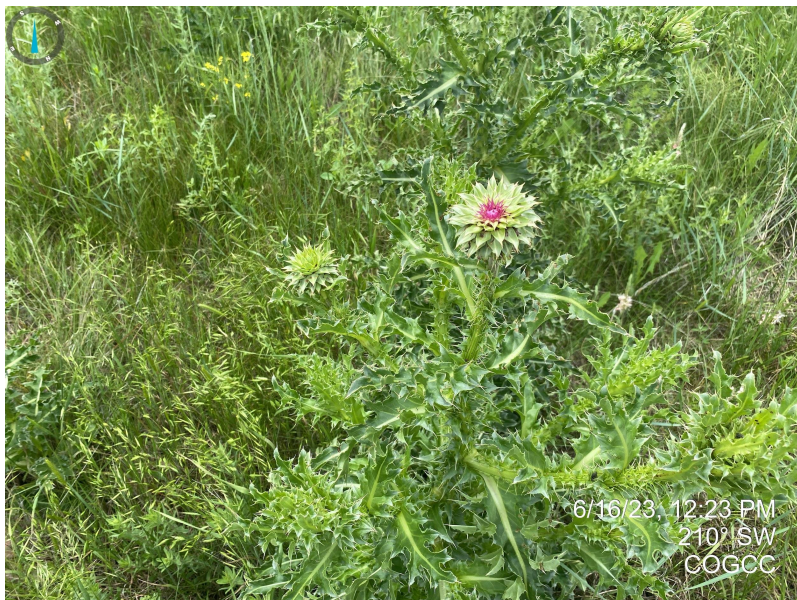
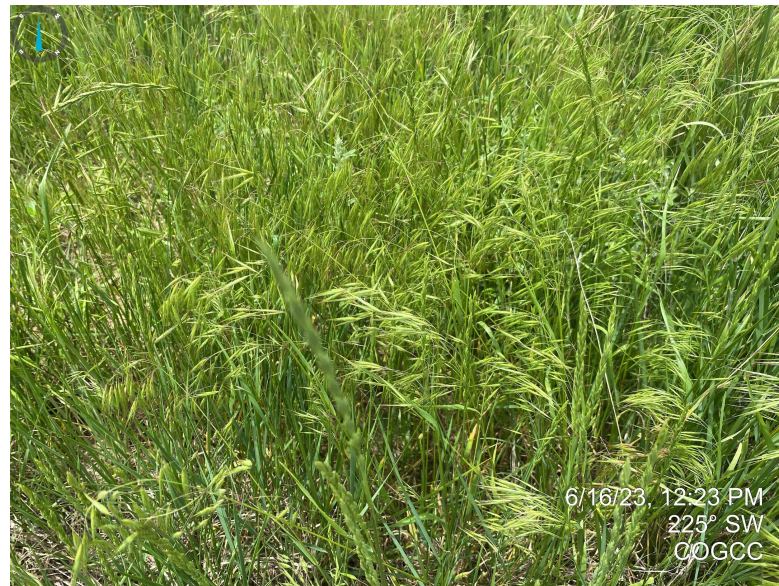
Photo 2. Close up photos of Colorado List B Noxious Weed musk thistle (left) and Colorado List C Noxious Weed cheatgrass (right) observed within the apparent salt kill area. Management of these undesirable species is required to prevent spread onto adjacent lands.

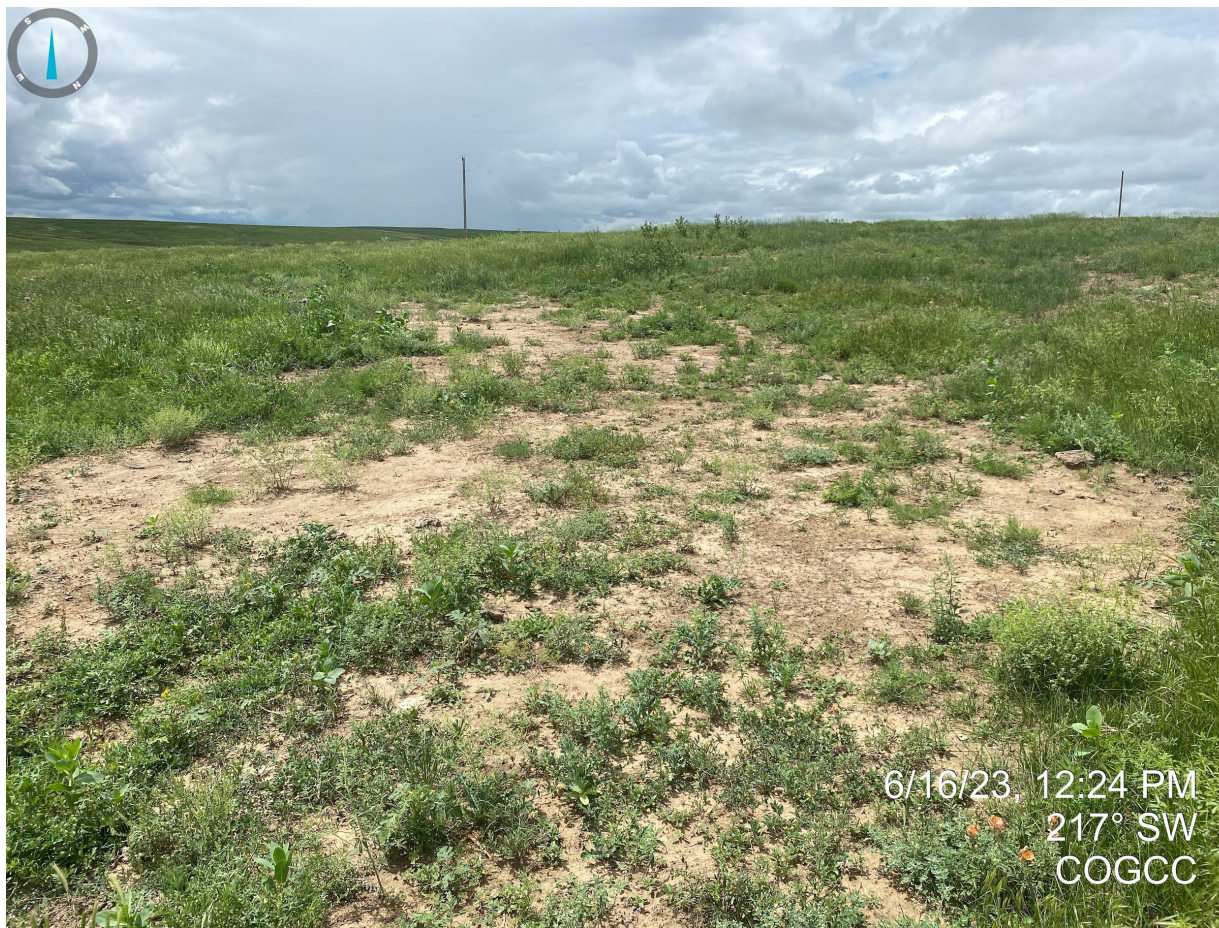
Photo 3. Taken from the midpoint of the salt kill impacts, facing southwest; see comments in Photo 1.

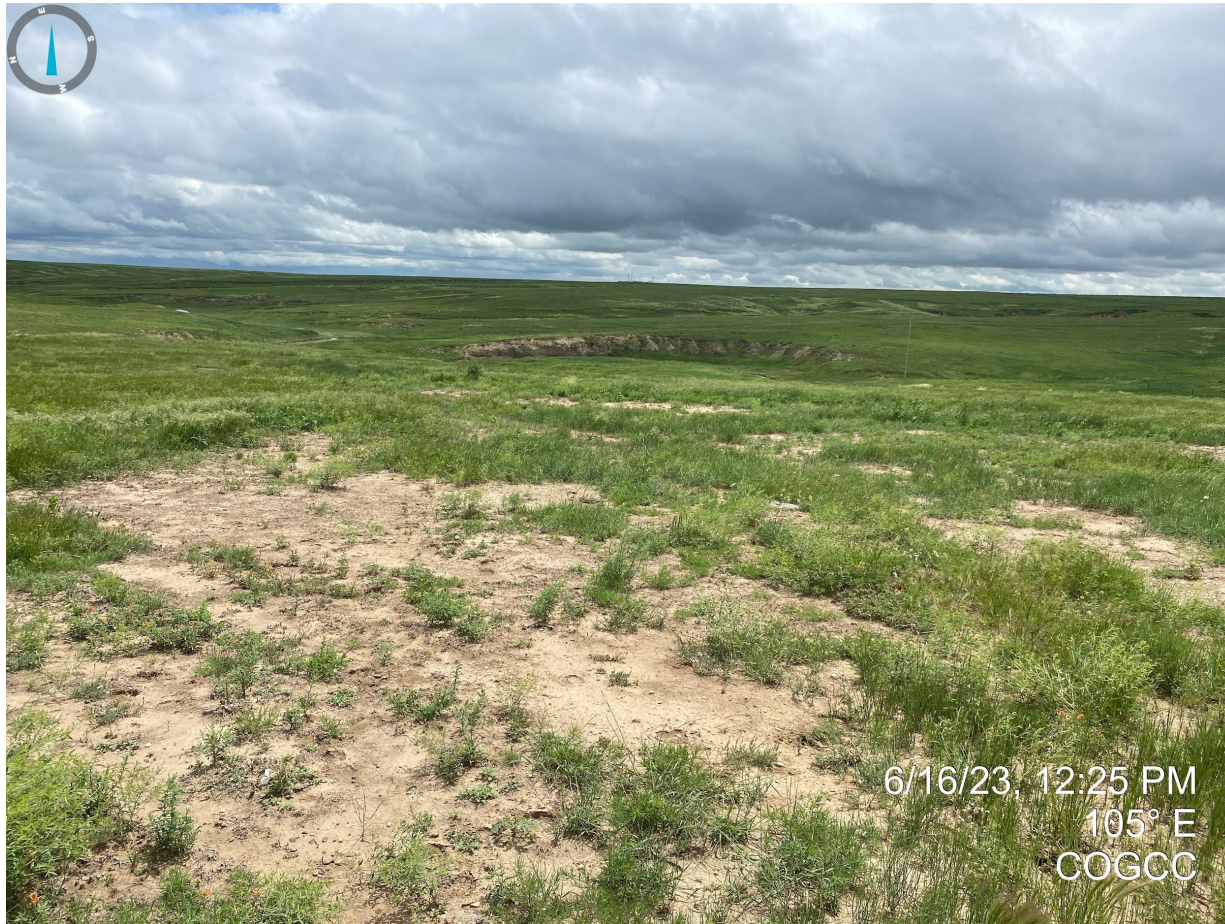
Photo 4. Midpoint, facing east; see comments in Photo 1.

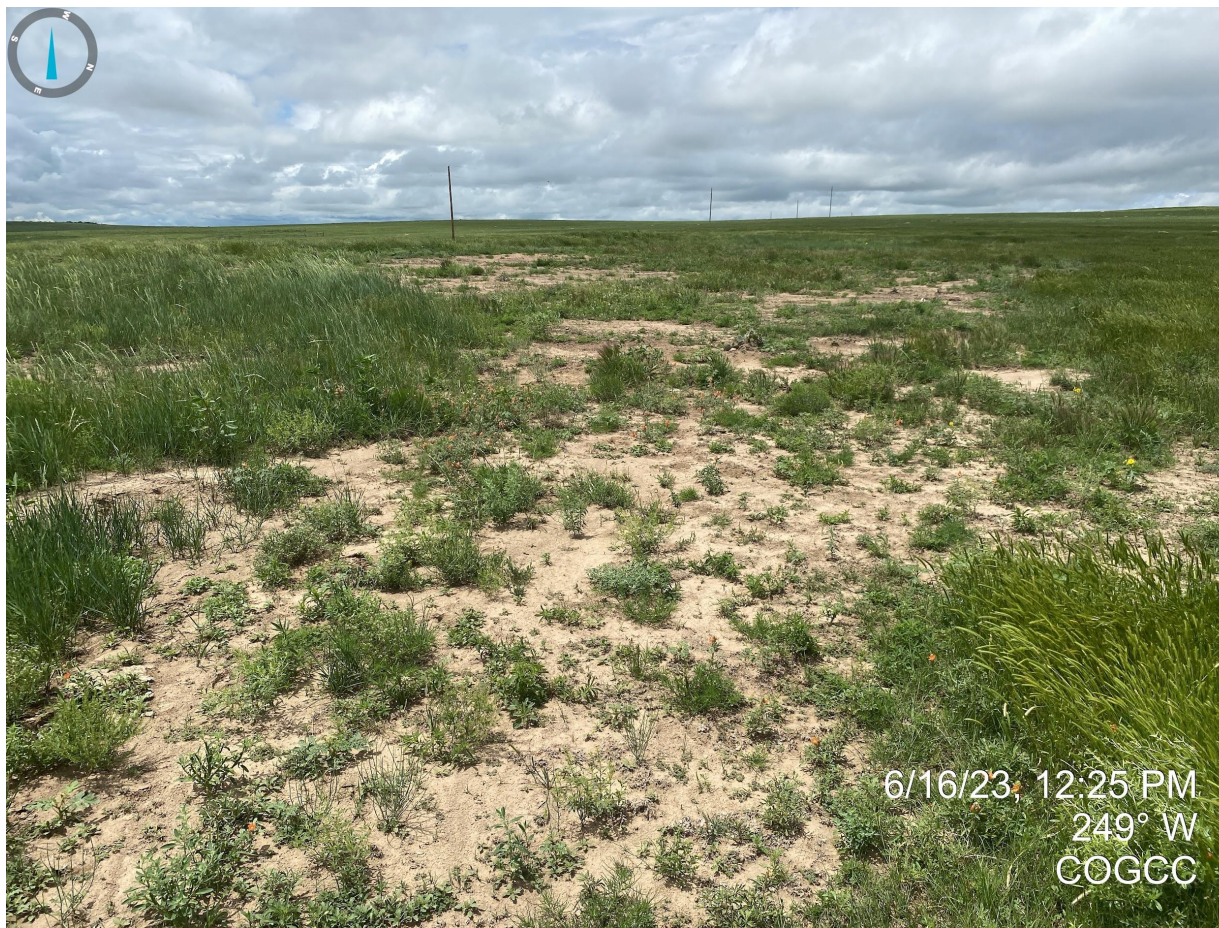
Photo 5. Midpoint, facing west; see comments in Photo 1.

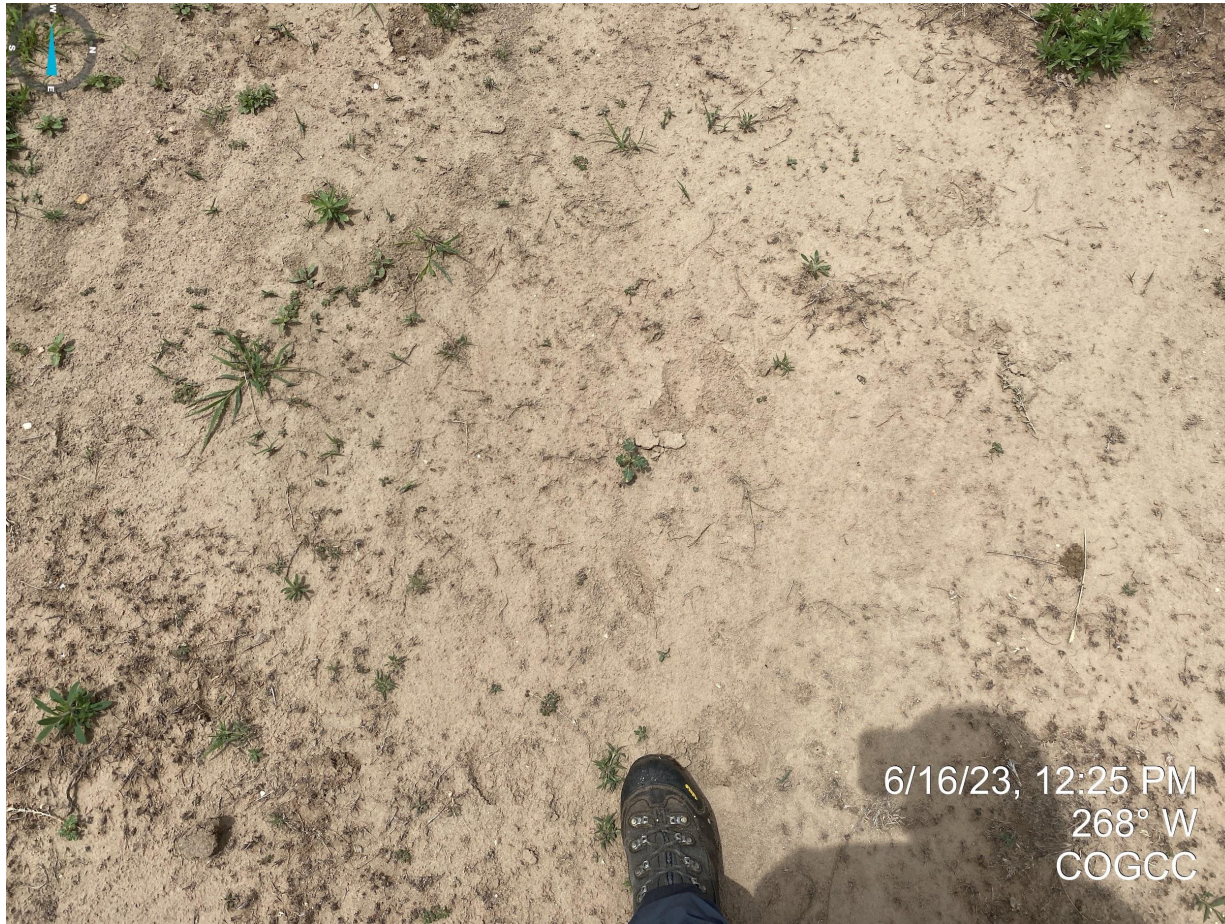
Photo 6. Close up of exposed soils.

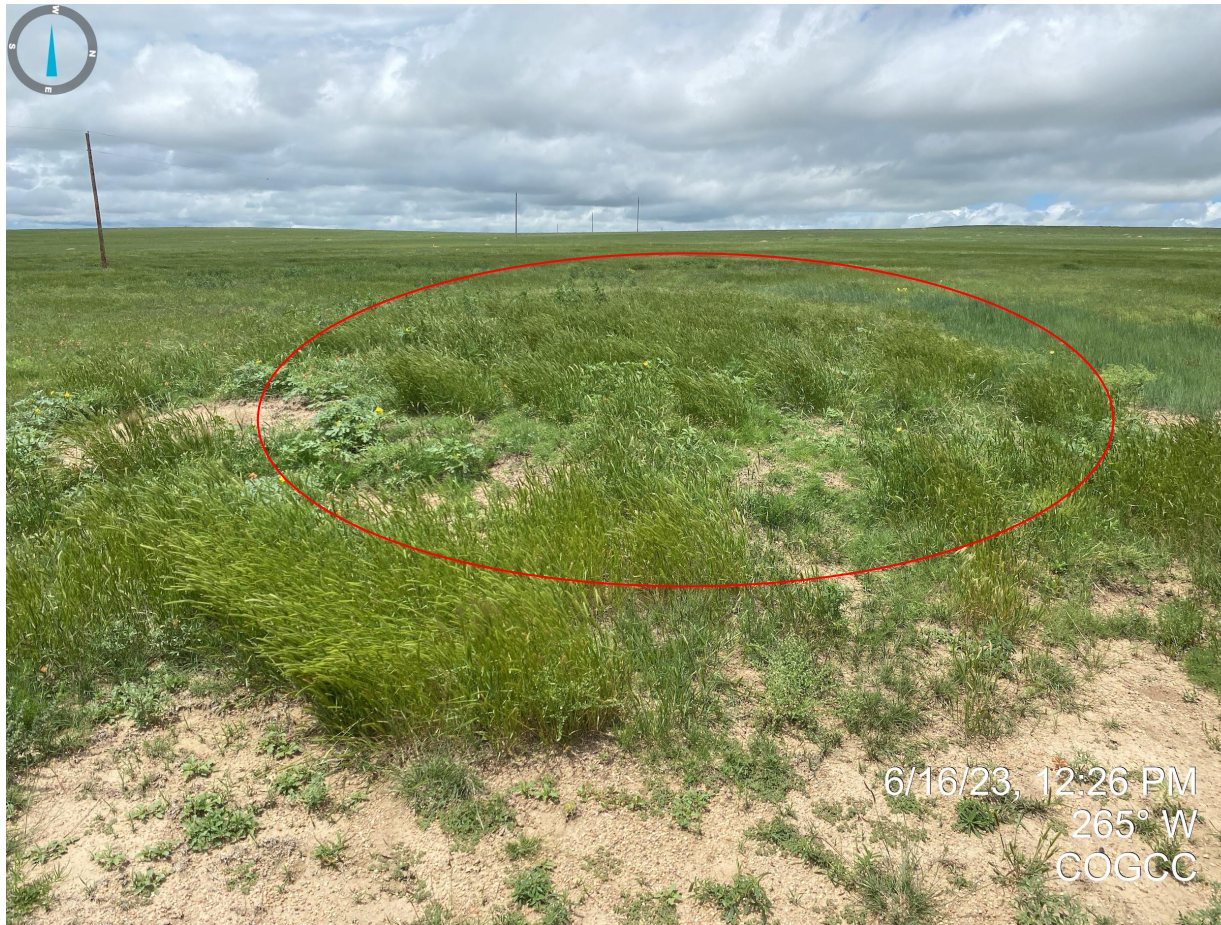
Photo 7. Taken near the western edge of the salt kill area. Red outline illustrates an apparent foundation used for equipment that has not been recontoured/graded to reflect adjacent topography. Presence of gravel/road base was evident (see Photo 8).

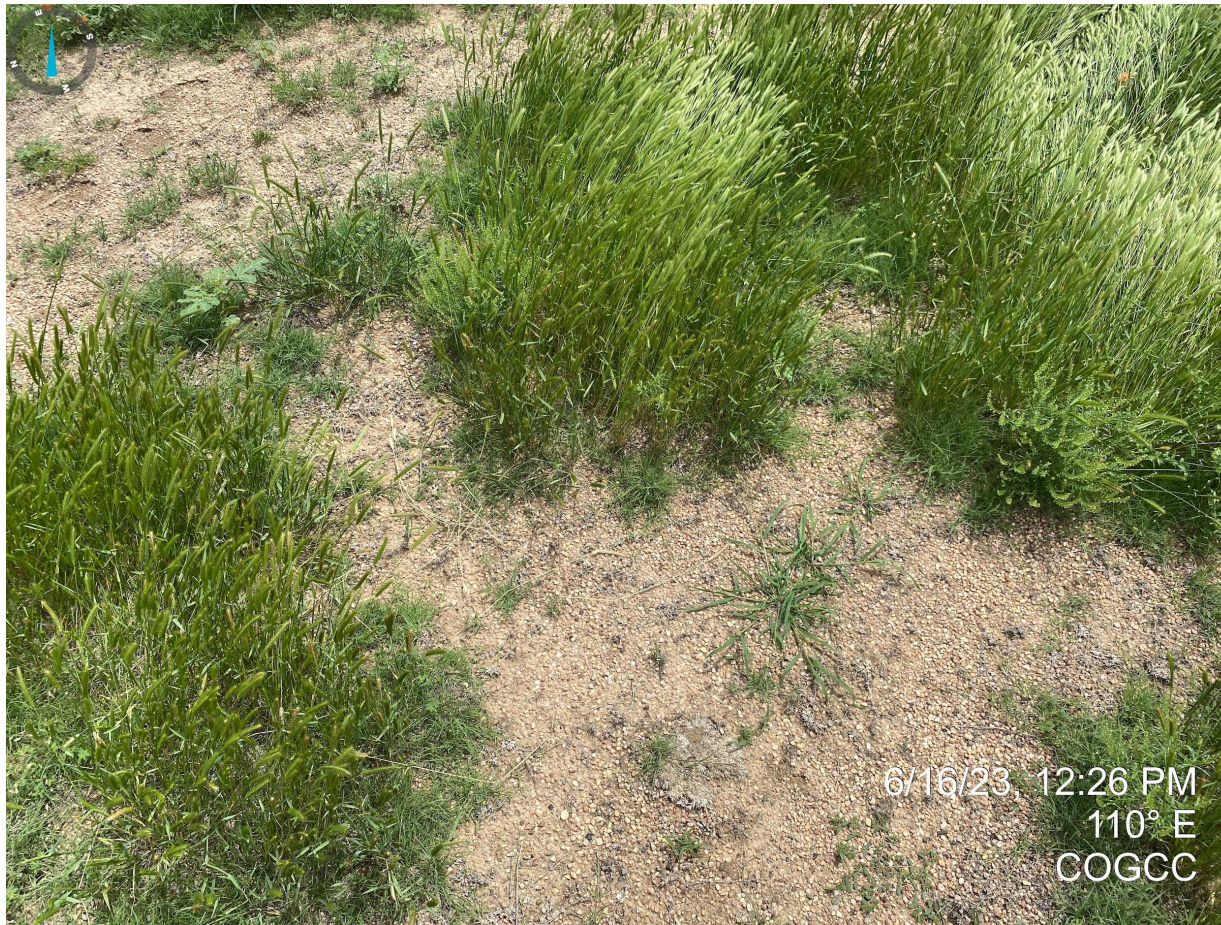
Photo 8. Close up of gravel/road base observed around the former equipment foundation, on the western side of the salt kill area.

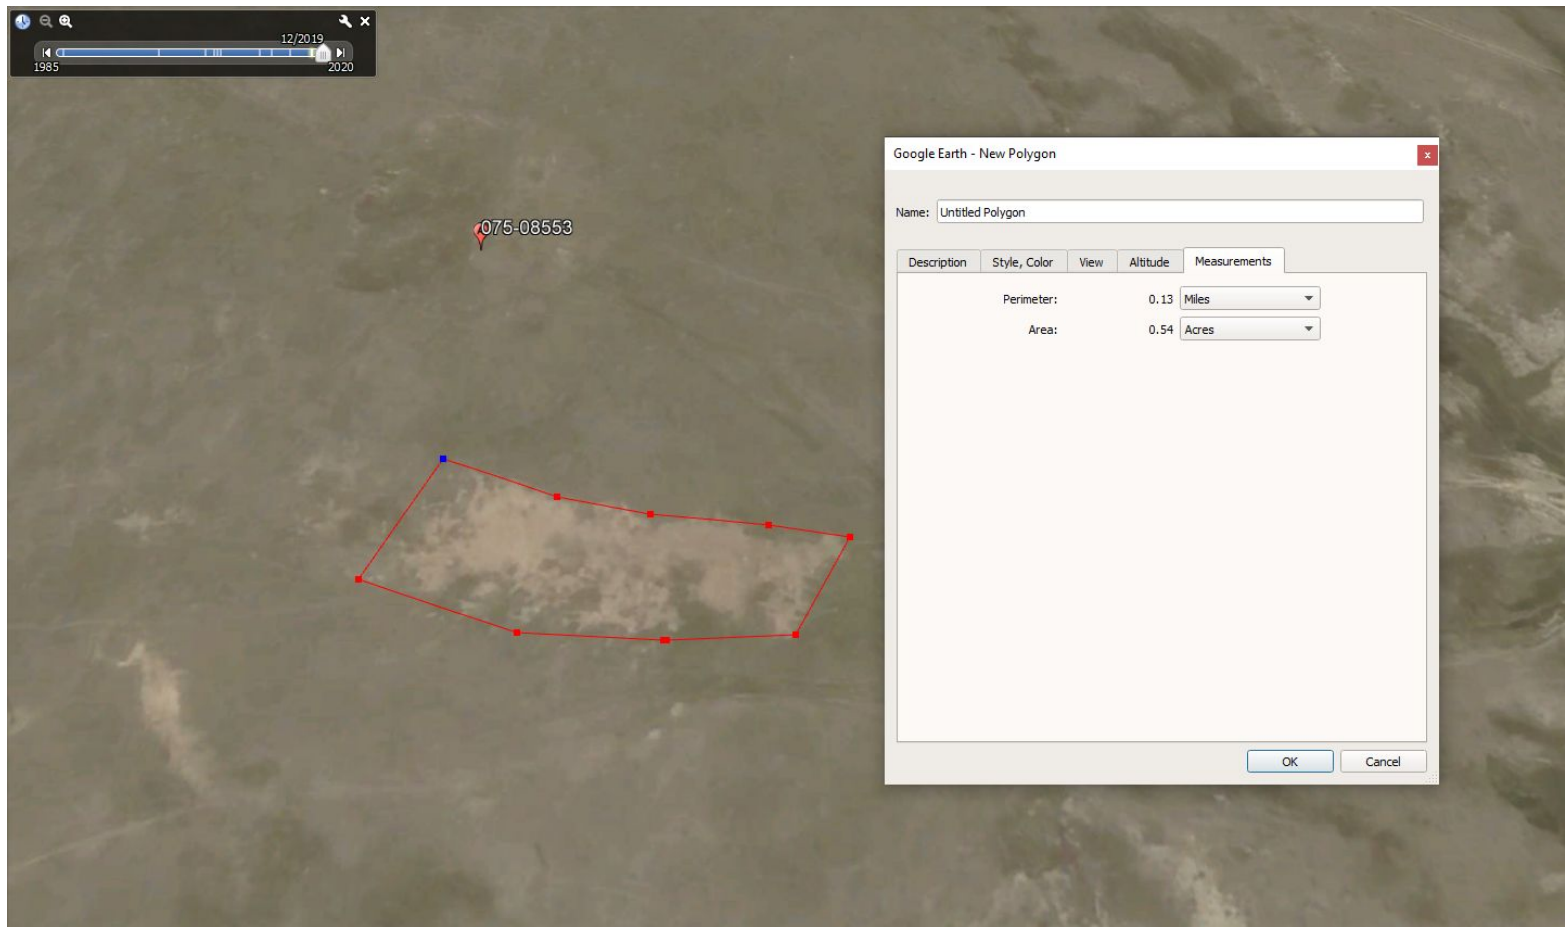
Photo 9. Google Earth aerial imagery taken circa 12/2019 illustrating the apparent historical salt kill area in relation to the former well location. The impacted area is approximately 0.5 acre as mapped using Google Earth. Additional remediation and reclamation activities are required in order for the location to meet 1004 rules and standards.

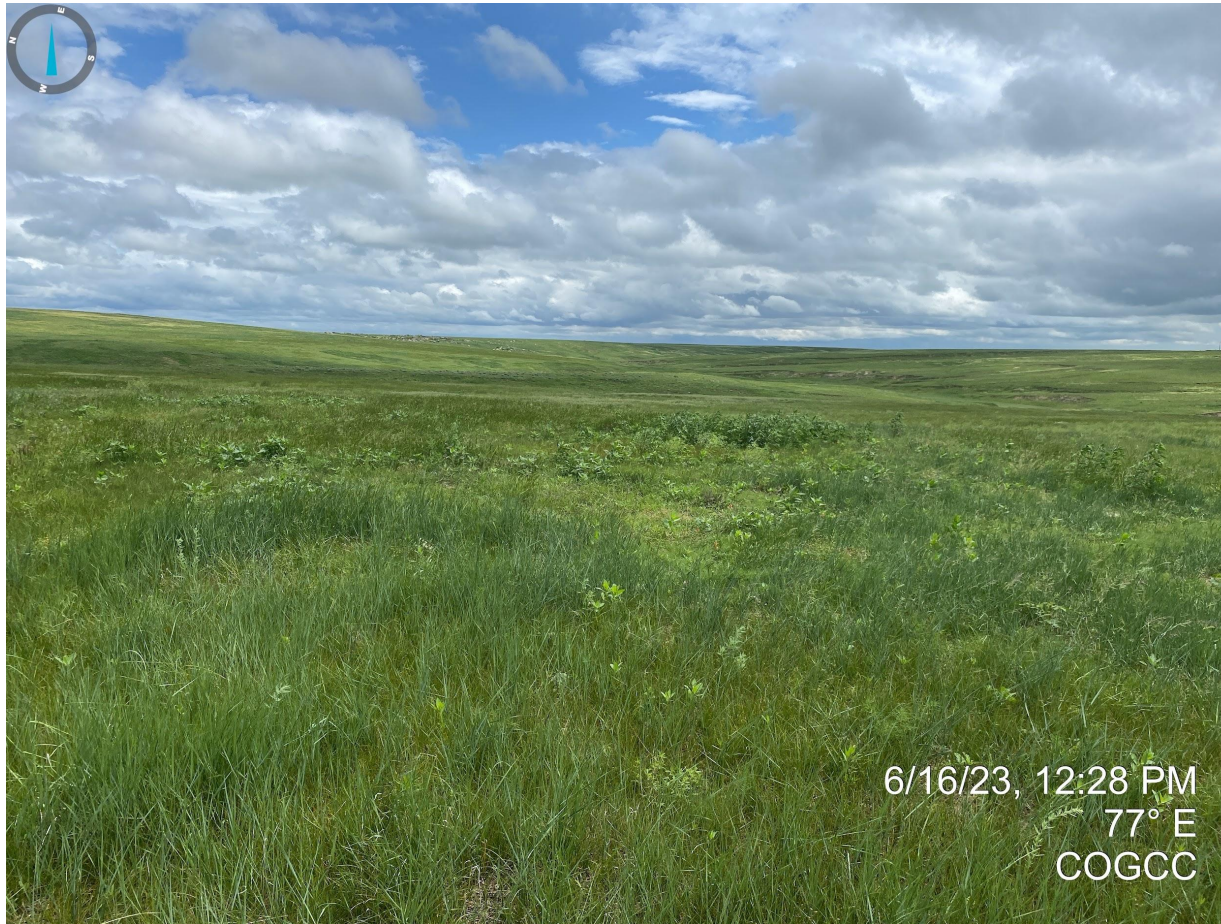
Photo 10. The former well location appears to be progressing towards Rule 1004 standards with the presence of native perennial vegetation reflective of adjacent reference areas. Further reclamation activities are required south of this well location, within the impacted salt kill area, in order for the location to pass final reclamation.
