Inspection Photos

Loc: 484496

Operator: NUEVIDA RESOURCES LLC

Inspection Date: 6/15/2023

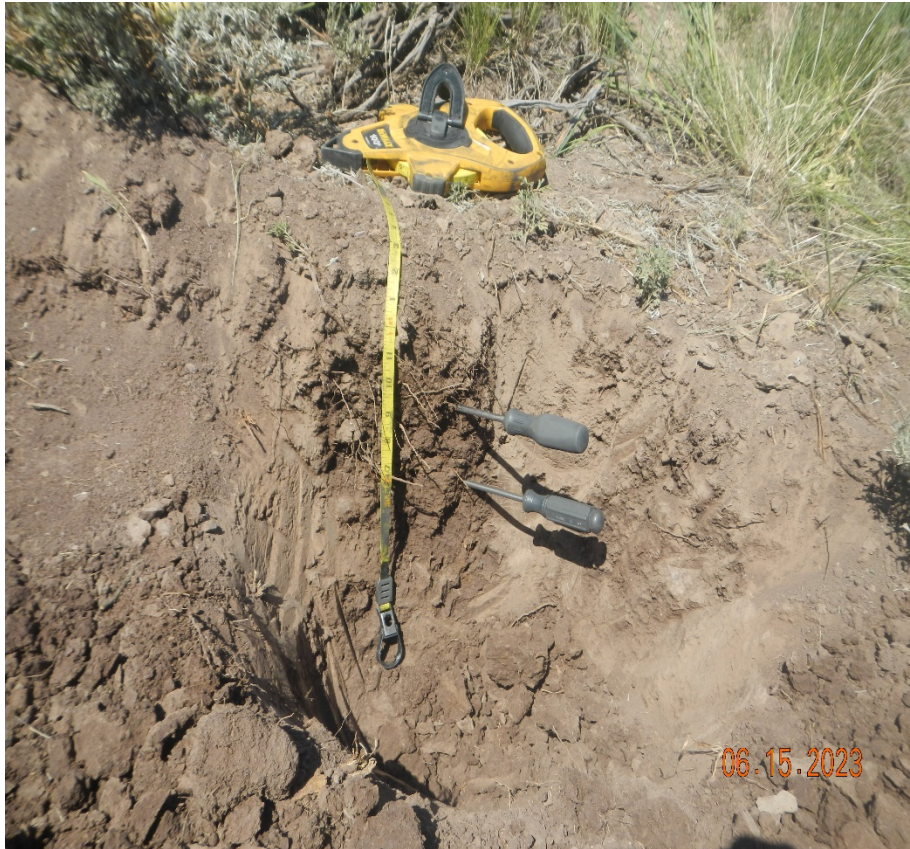
Photo 1. View of test hole for topsoil evaluation. Taken at the Ardourel tank pad Lat/Long:37.09858,-107.76772. It appears there is 8-10" soil horizon that should be salvaged.

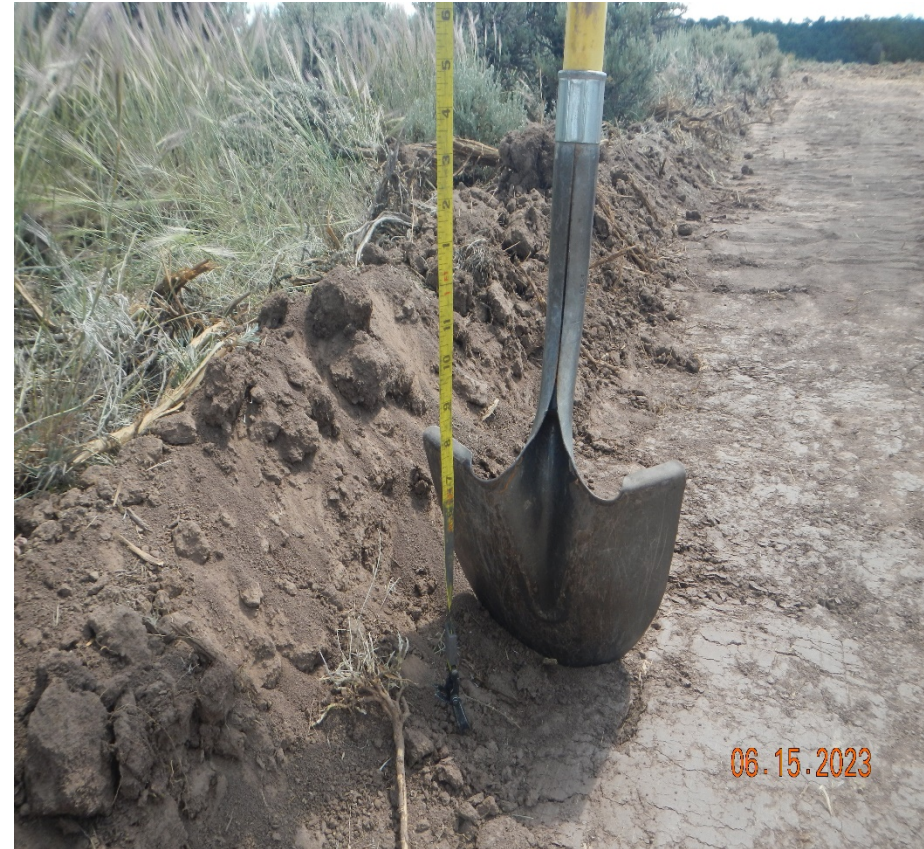
Photo 2. Northeast corner of the location facing southwest. It appears topsoil was being salvaged around 6-8" in some areas and less in other areas but salvaging was still ongoing.

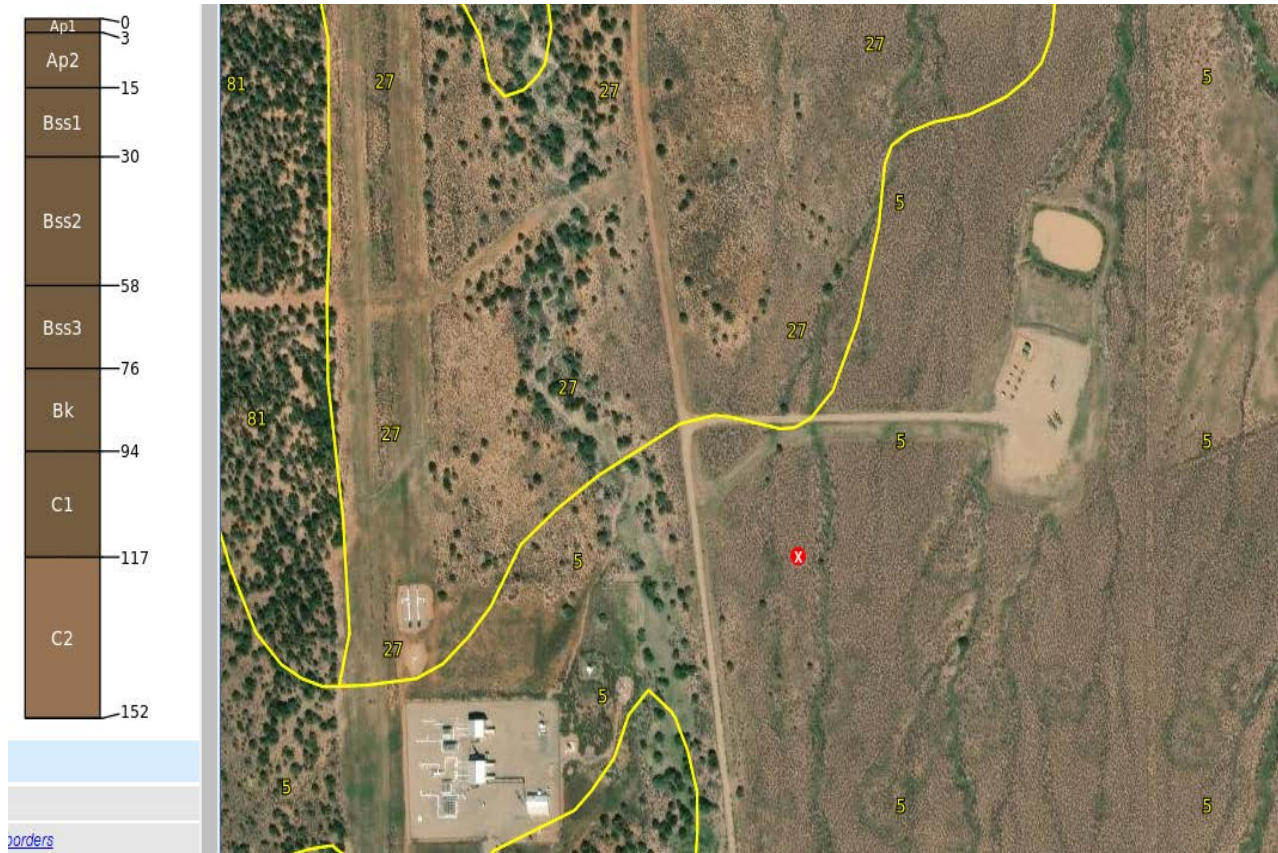
Photo 3. The soil Data (#5) which is where the Ardourel tank Pad is located. There is a Bss1 horizon that extends to about 11”.

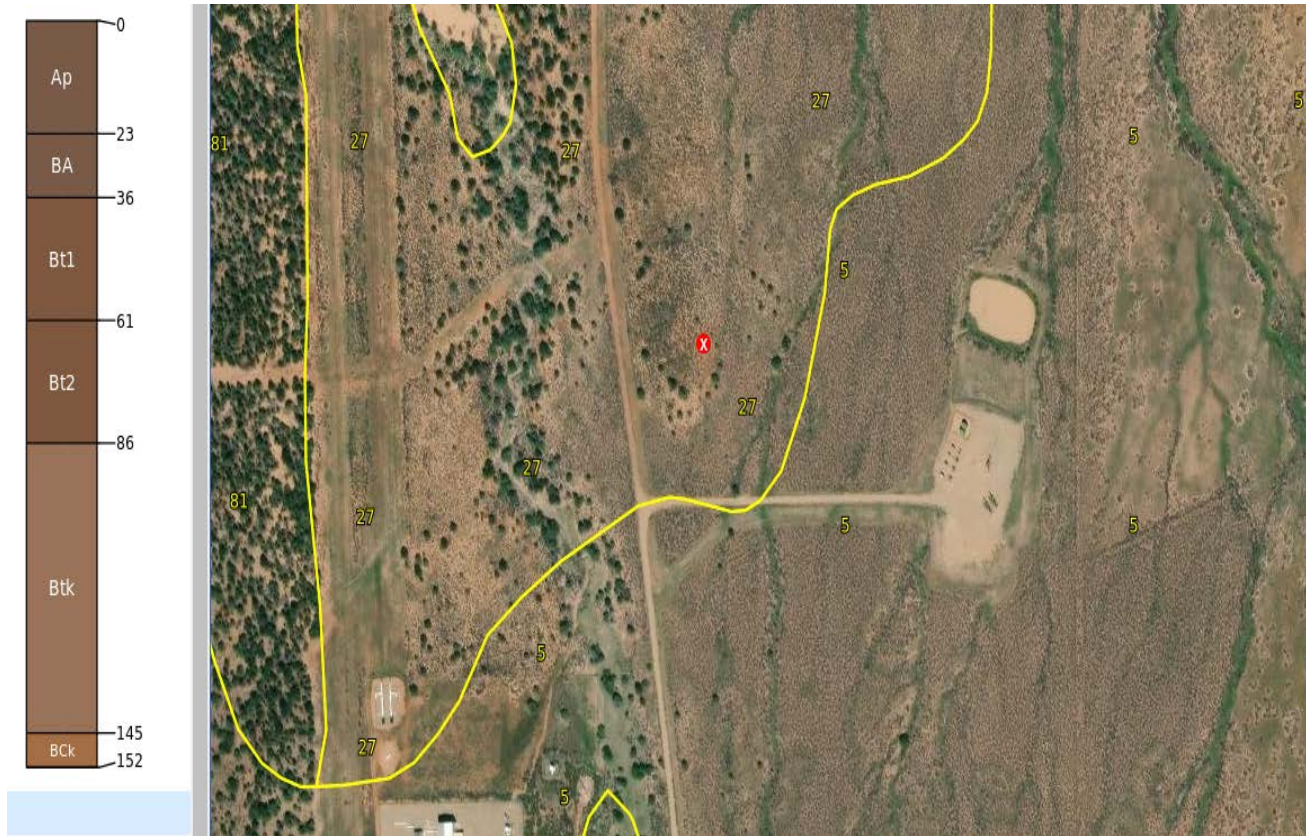
Photo 4. The soil Data (#27) which is where the Ardourel well Pad is located. There is a BA horizon that extends to about 14”.
