HYDROLOGY MAP
DENALI STATE 5N67W13 1-23 PAD
PDC ENERGY

(3301-23) Denali State 1-23 Pad

Environmental Map
Figure 1

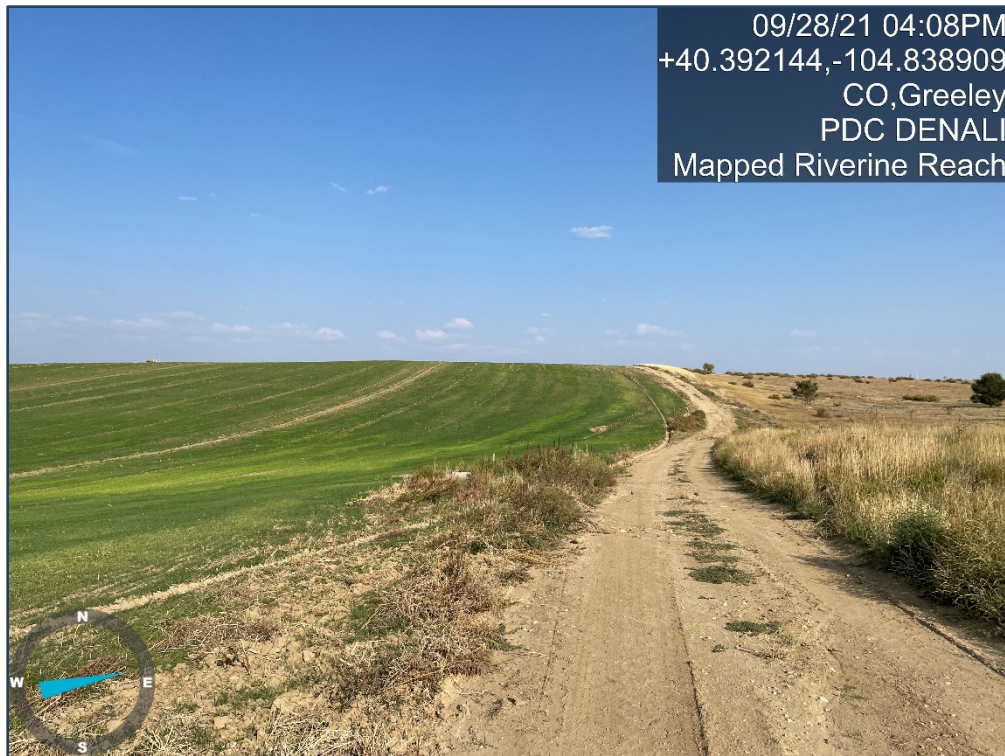
Photo Point 1. No riverine feature observed. Localized depression is visible.

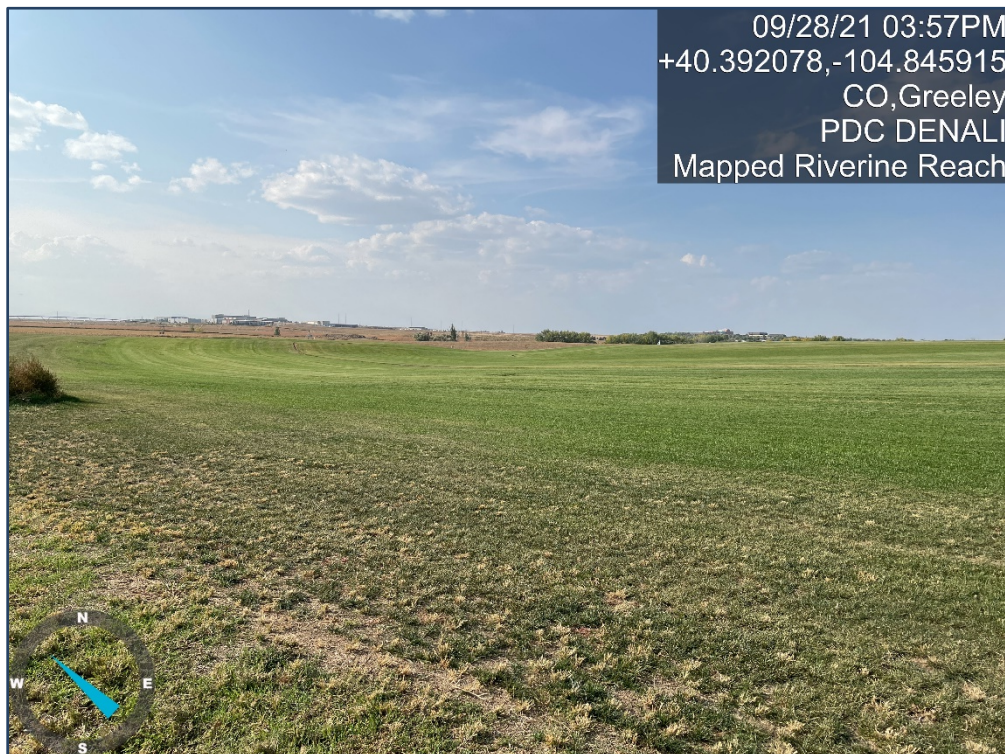
Photo Point 2. No riverine feature observed. Surface is gentle westward facing slope.

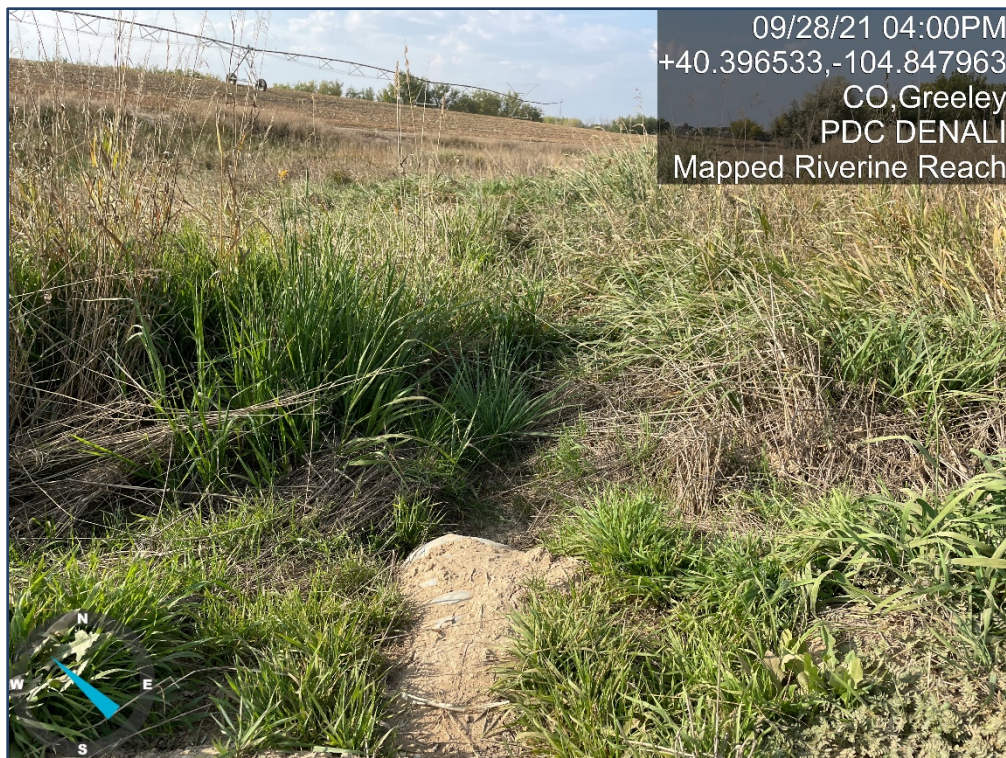
Photo Point 3. Culvert observed and appears to convey water under agricultural road. Potential wetlands are located north of Photo Point 3, in the uncultivated drainage. No wetlands or riverine features observed south of Photo Point 3.

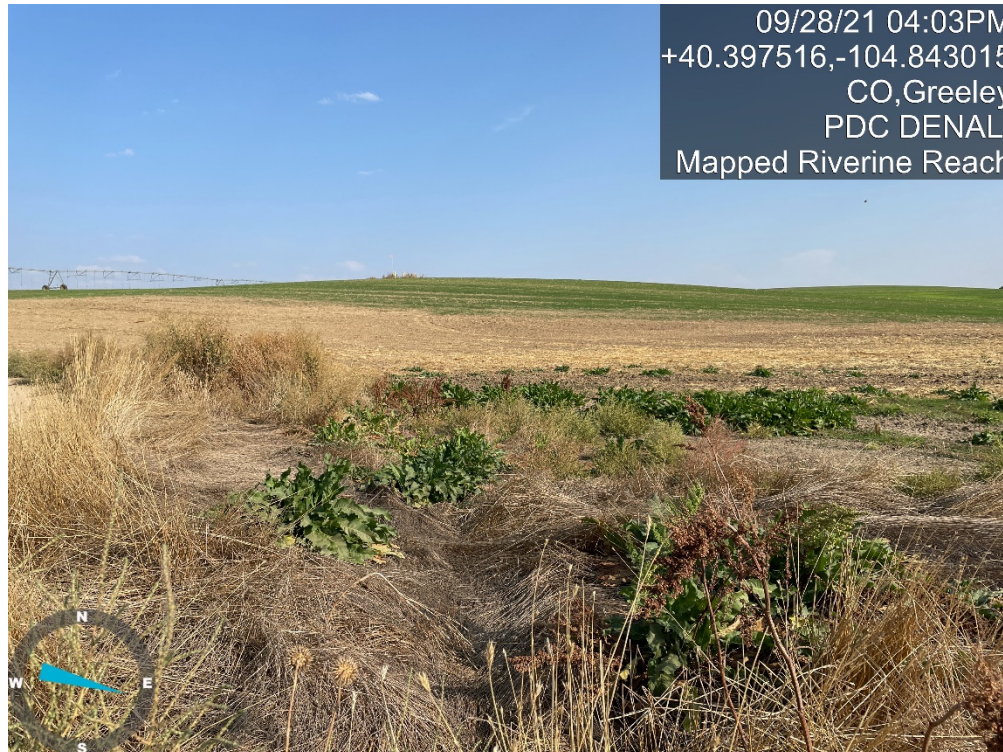
Photo Point 4. No riverine or wetland features observed. Both riverine and wetland features are present immediately south of Photo Point 4, see Photo Point 5.

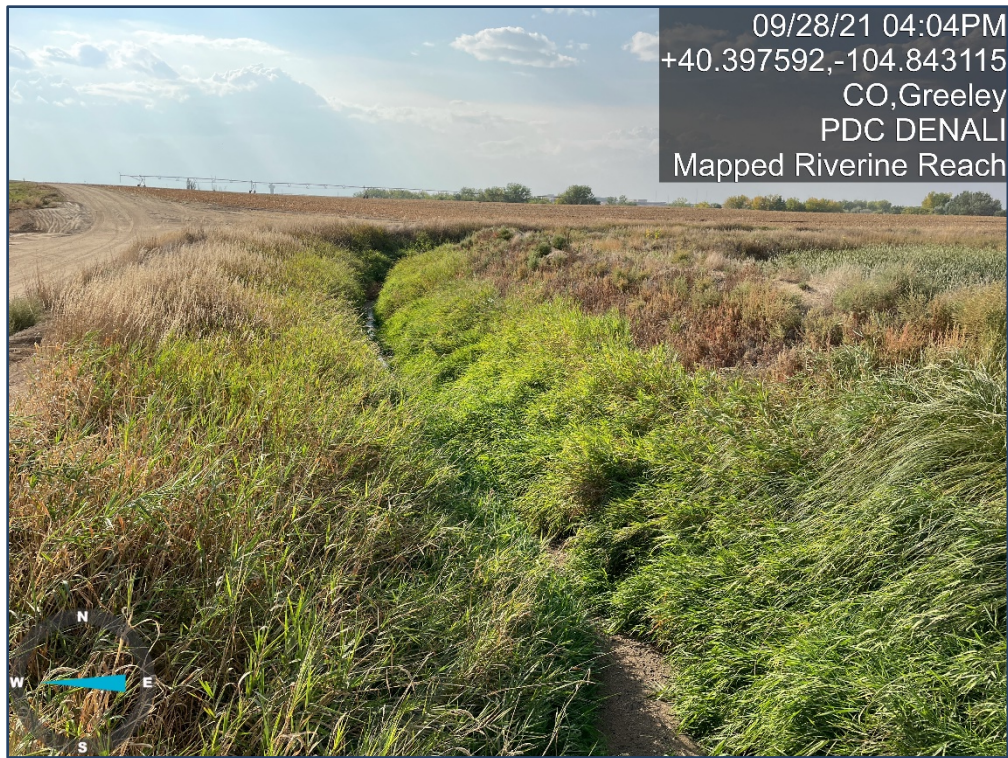
Photo Point 5. Riverine and wetland feature present (i.e., Boomerang Ditch) is present.
Surface water was observed in the Ditch.
