Inspection Photos

6/21/2023

Operator: UTAH GAS OP LTD DBA UTAH GAS

Location Number: 322479

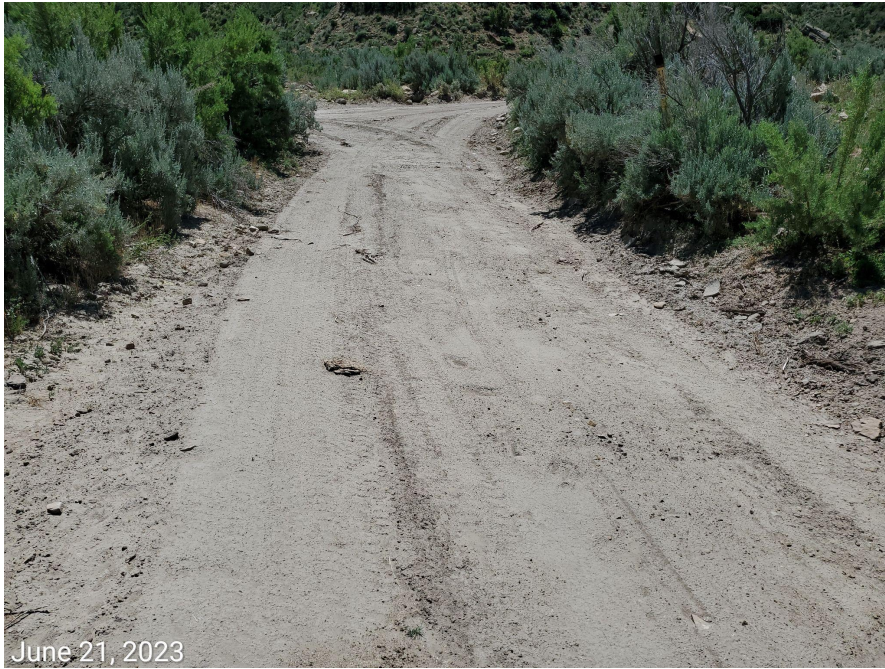
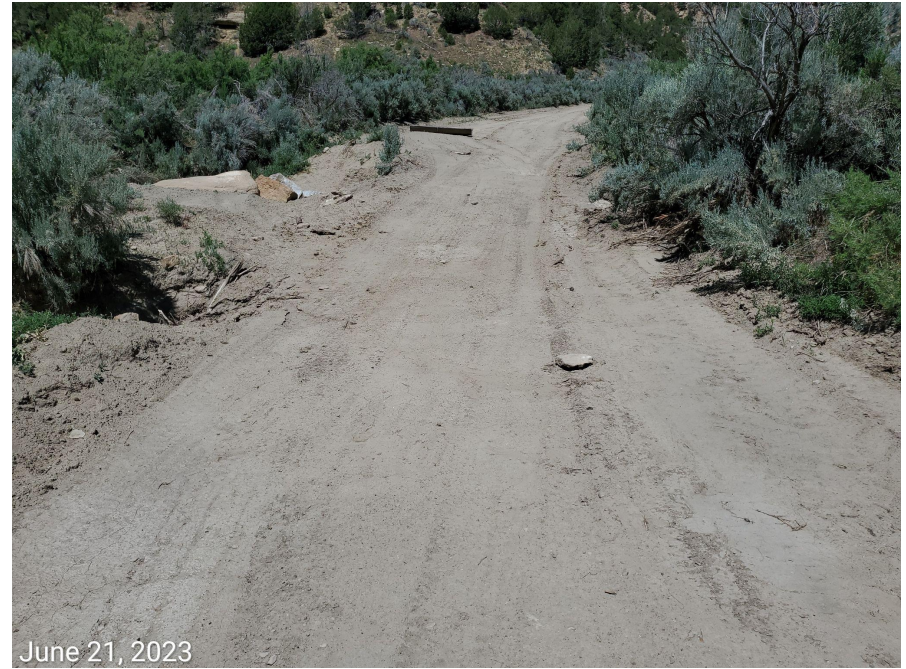
Photo 1: Photos taken from the stream crossing at the access road. Photo shows degradation issues have been repaired, and the culvert BMP has been maintained.

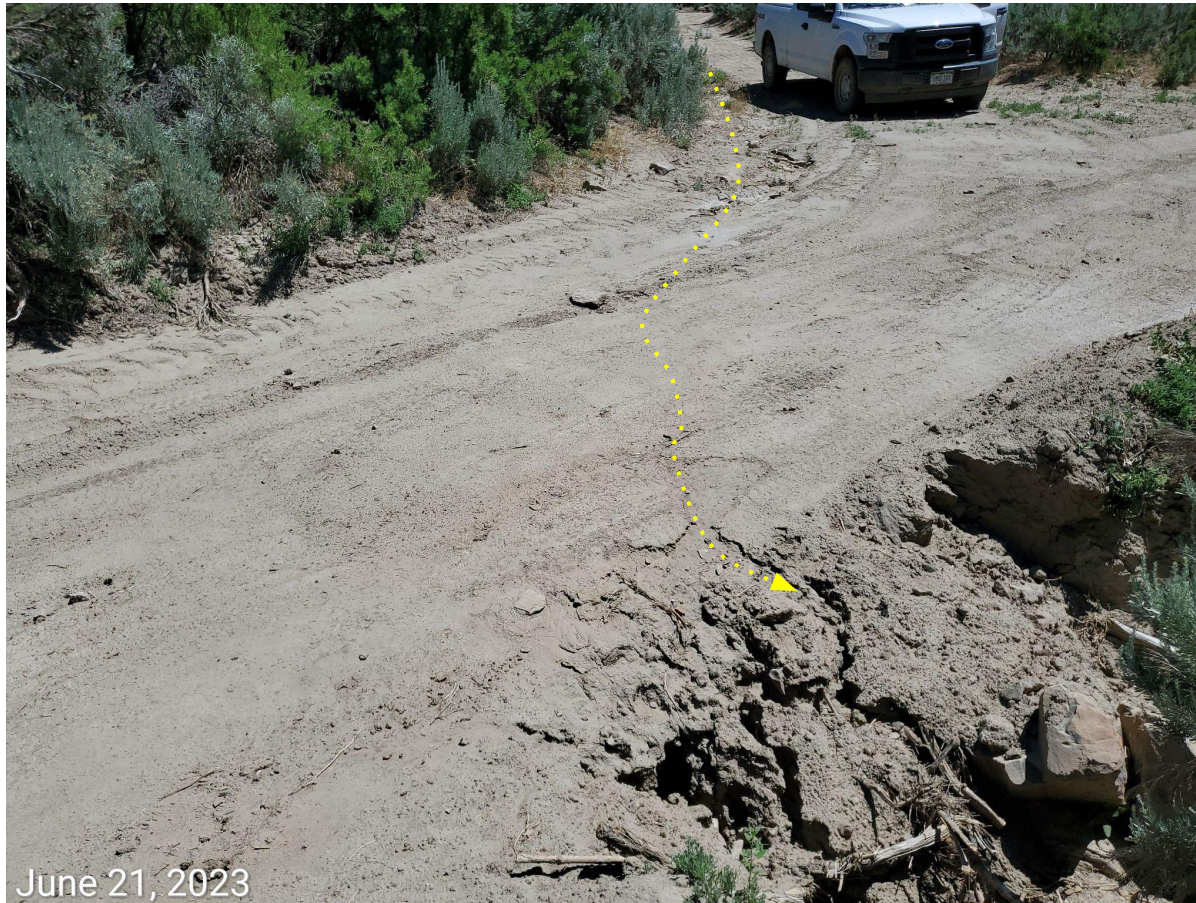
Photo 2: Photo shows areas where runoff from the northern fork of the access road appears to be discharging at the same point where erosion degradation at the road was observed. This area of the access road remains at risk to further degradation and maintenance/additional BMPs are advised.

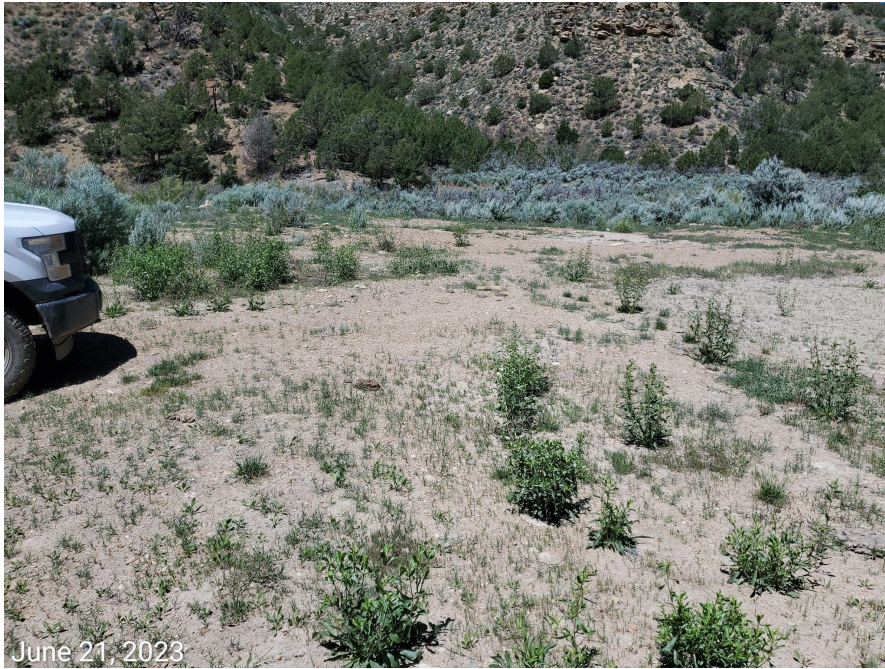
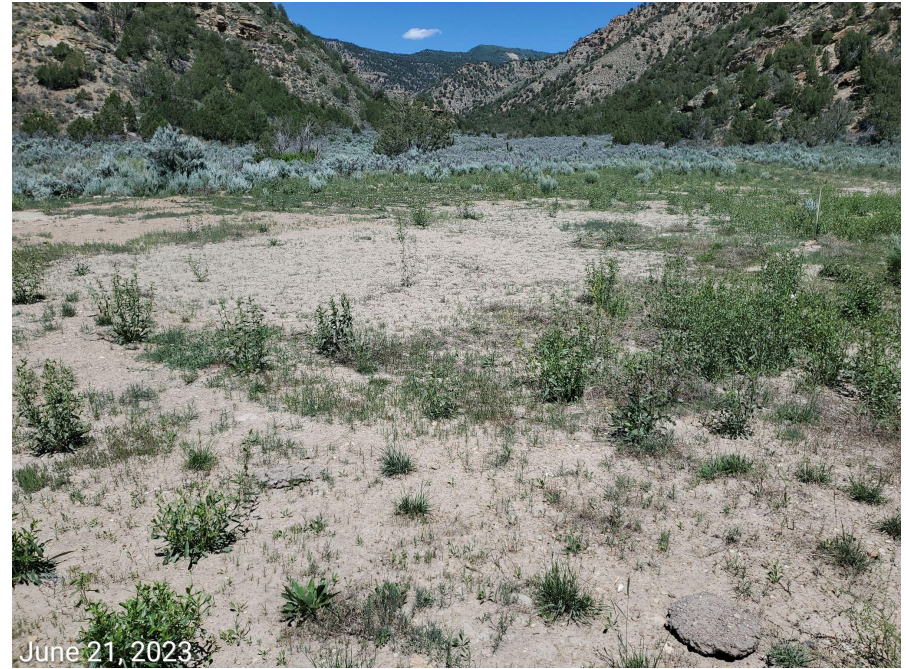
Photo 3: Photos 3-4 taken from the south end of the Location. Photos provide an overview of the Location from west, northwest, northeast to east. Vegetation observed within photos are predominantly Undesirable Plant Species such as Bindweed, Knotweed, and Russian thistle.

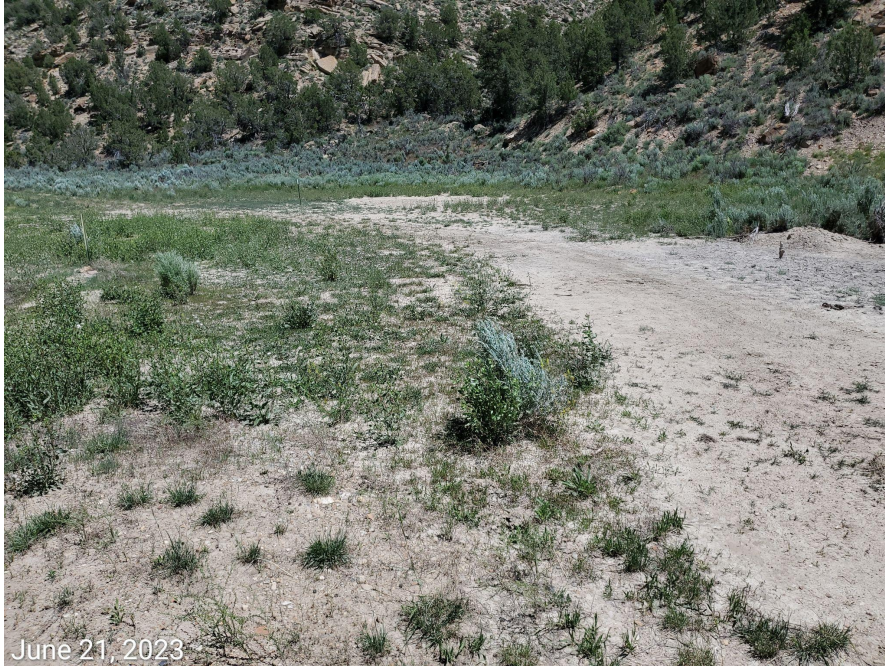
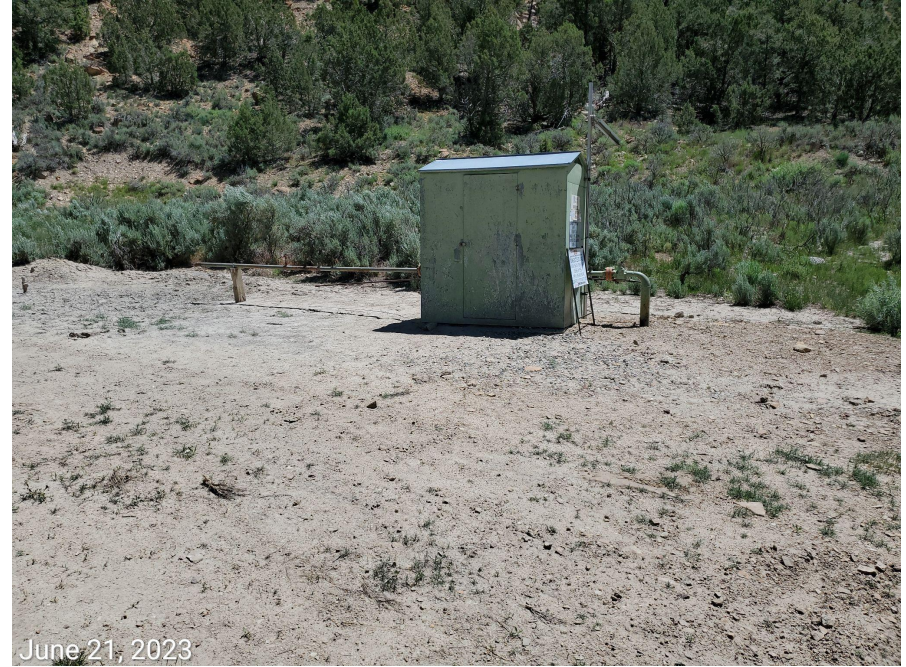
Photo 4: See comments under photo 3. Photo also shows surface equipment remaining-records show well was PA 5/2021, all surface equipment was required to be removed within 3 months of abandonment.

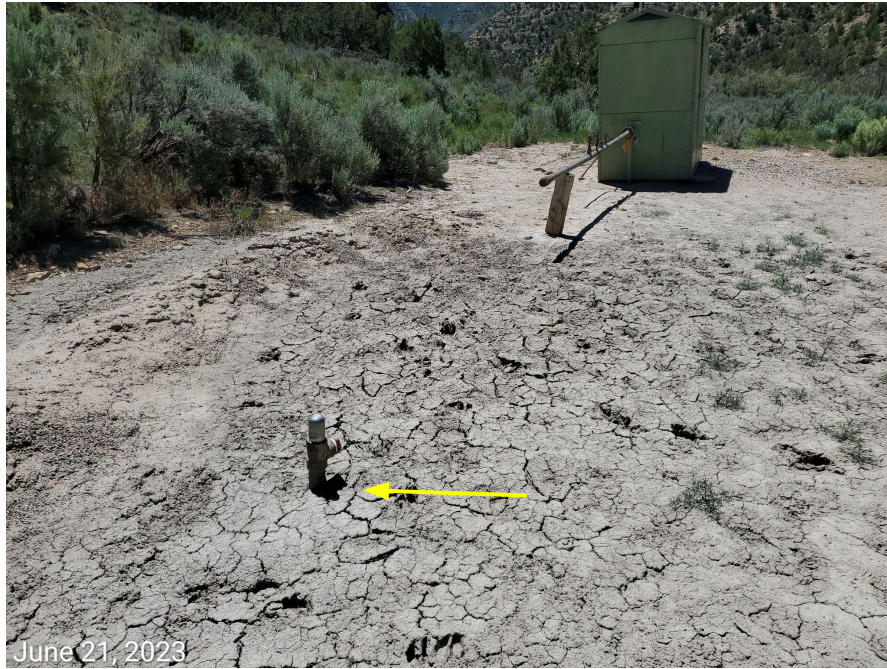
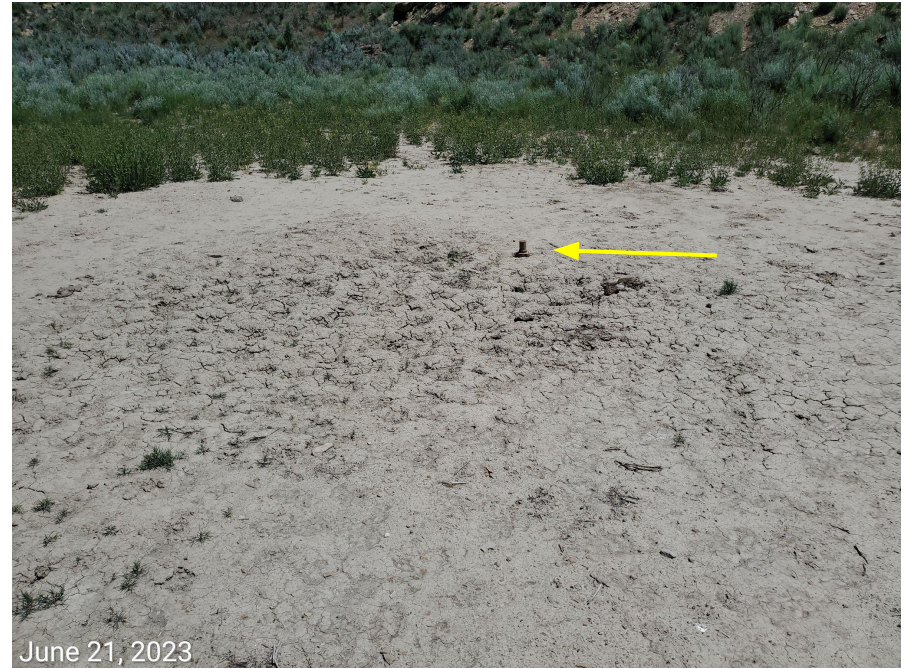
Photo 5: Photos examples showing surface equipment remaining on Location. Photo left shows riser remaining from what appeared to have been separator equipment. Meter shed and associated lines/risers also shown in photo. Photo right shows former well site with a flowline riser remaining. Records show well was PA 5/2021; all surface equipment was required to be removed within 3 months of abandonment.

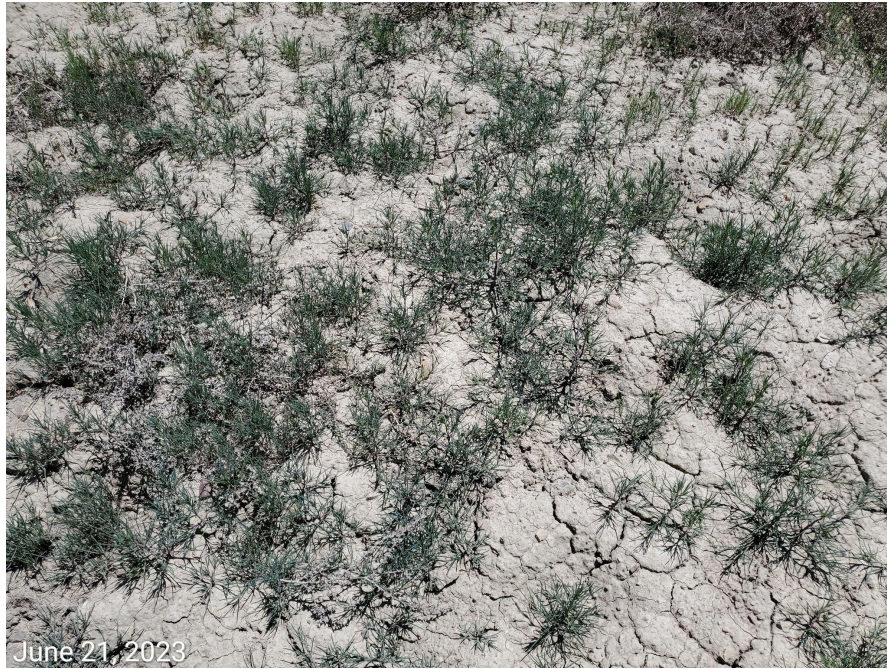
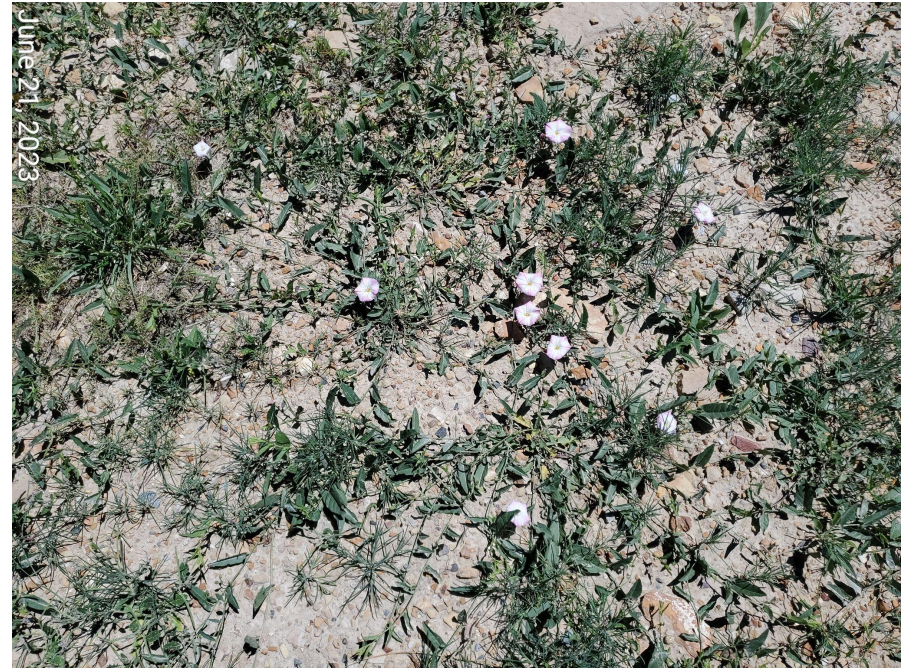
Photo 6: Photos examples showing vegetation observed is predominantly Undesirable Plant Species such as Bindweed, Knotweed, and Russian thistle.

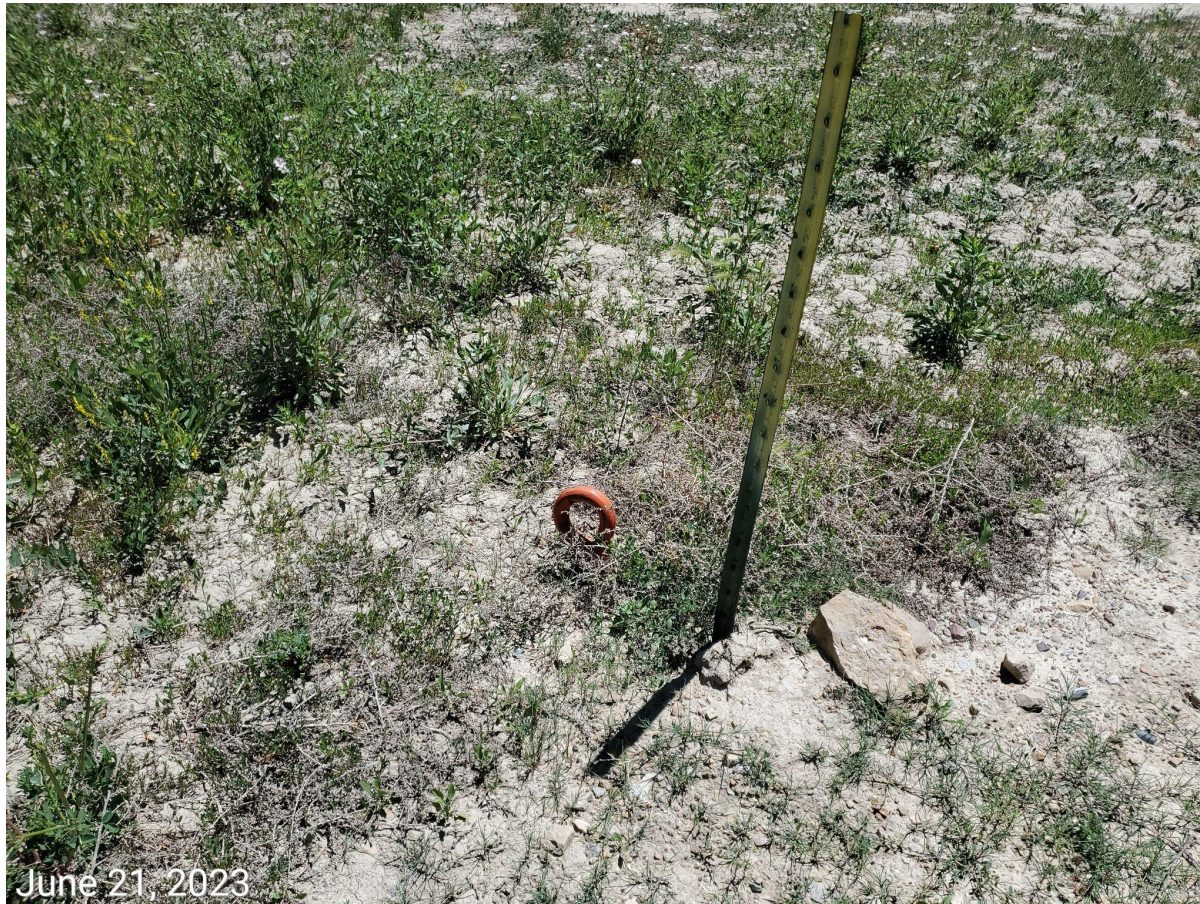
Photo 7: Photo shows anchor equipment remaining on the Location. Well has been P&A, all surface equipment should have been removed.

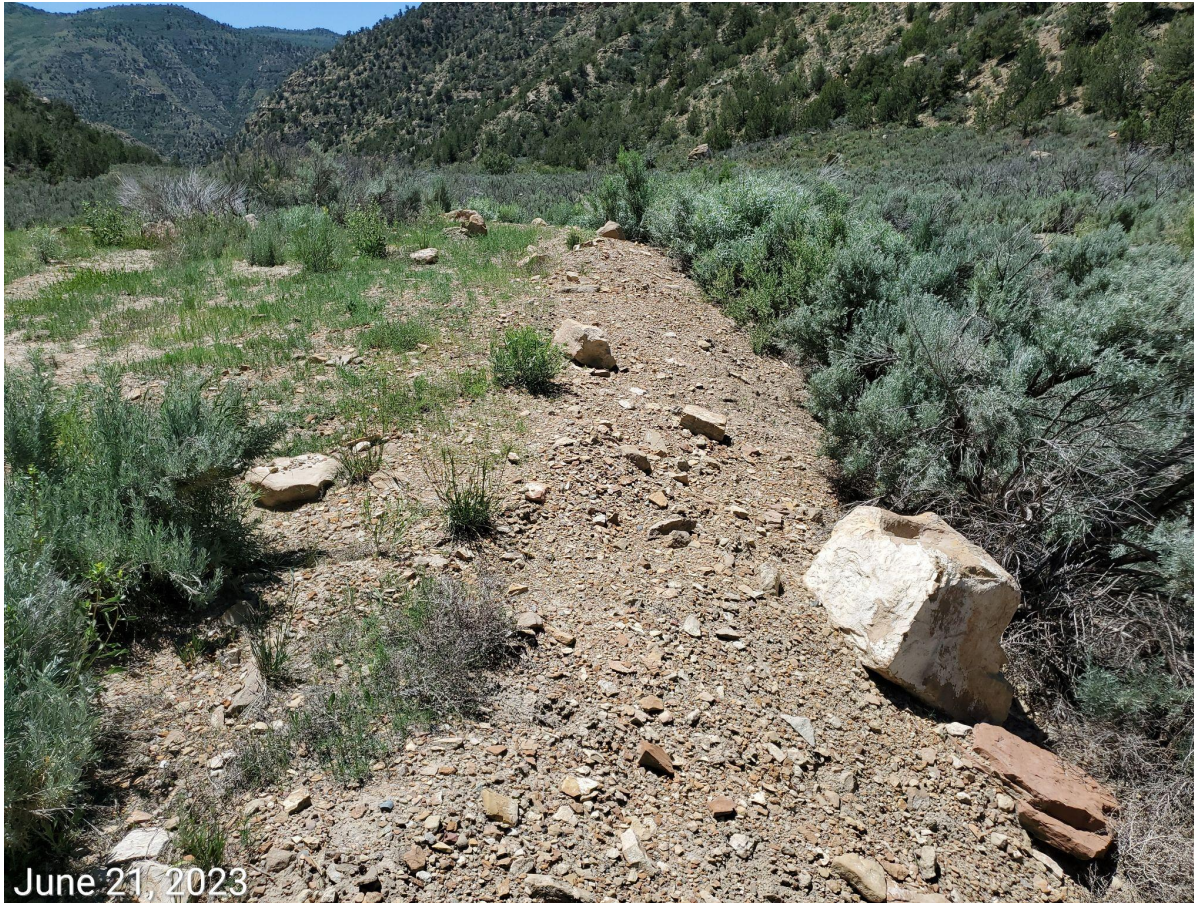
Photo 8: Fill slopes. Location requires compaction alleviation, recontouring/regrading and reclamation.
