# SITE-SPECIFIC QUALITY ASSURANCE & QUALITY CONTROL AUDIT

## PERMIT CLOSURE REPORT – RANGELAND

Location ID 331380

Location Name DOW/23-28 PAD

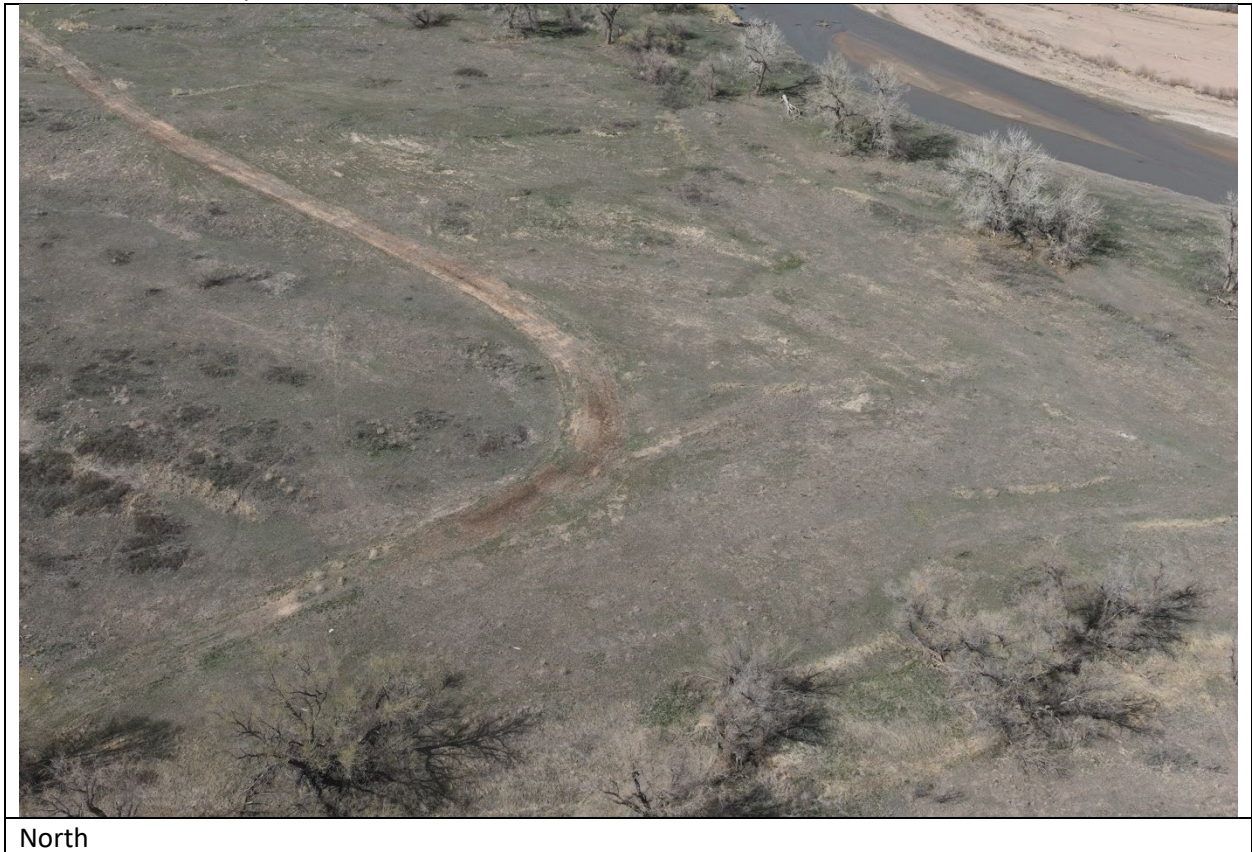
North

Cardinal directional photos of the site

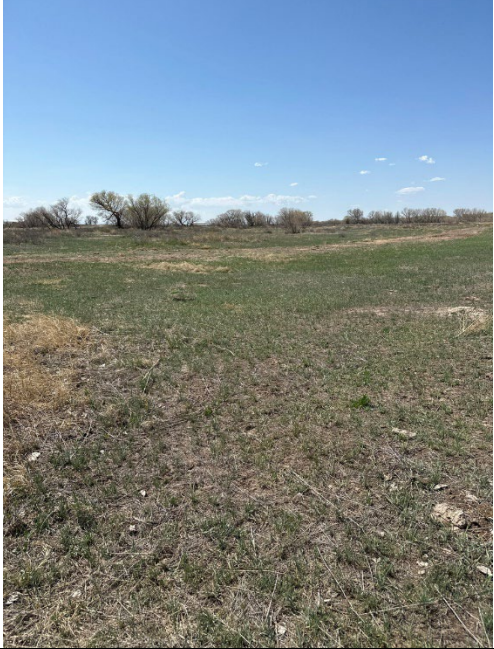
<p>Veg – West</p>	<p>Tansy Mustard – <i>Descurainia pinata</i> – Common Weed</p>

Disc	Disc the site to a depth of 6.0-inches using a disk and harrow, field cultivator, vibrashank, or another alternative suitable to site conditions	
	Seed	CPW Mix	15 LBS/acre
	Straw	Spread certified weed free straw	2 Tons/acre
	Crimp	Crimp Straw	
<b>Monitoring</b>	Continuous	Site should be monitored post reclamation to ensure success	
<b>Weed Management</b>		Due to the seed bank of cheatgrass, thistle and kochia monthly monitoring is recommended with appropriate herbicide control

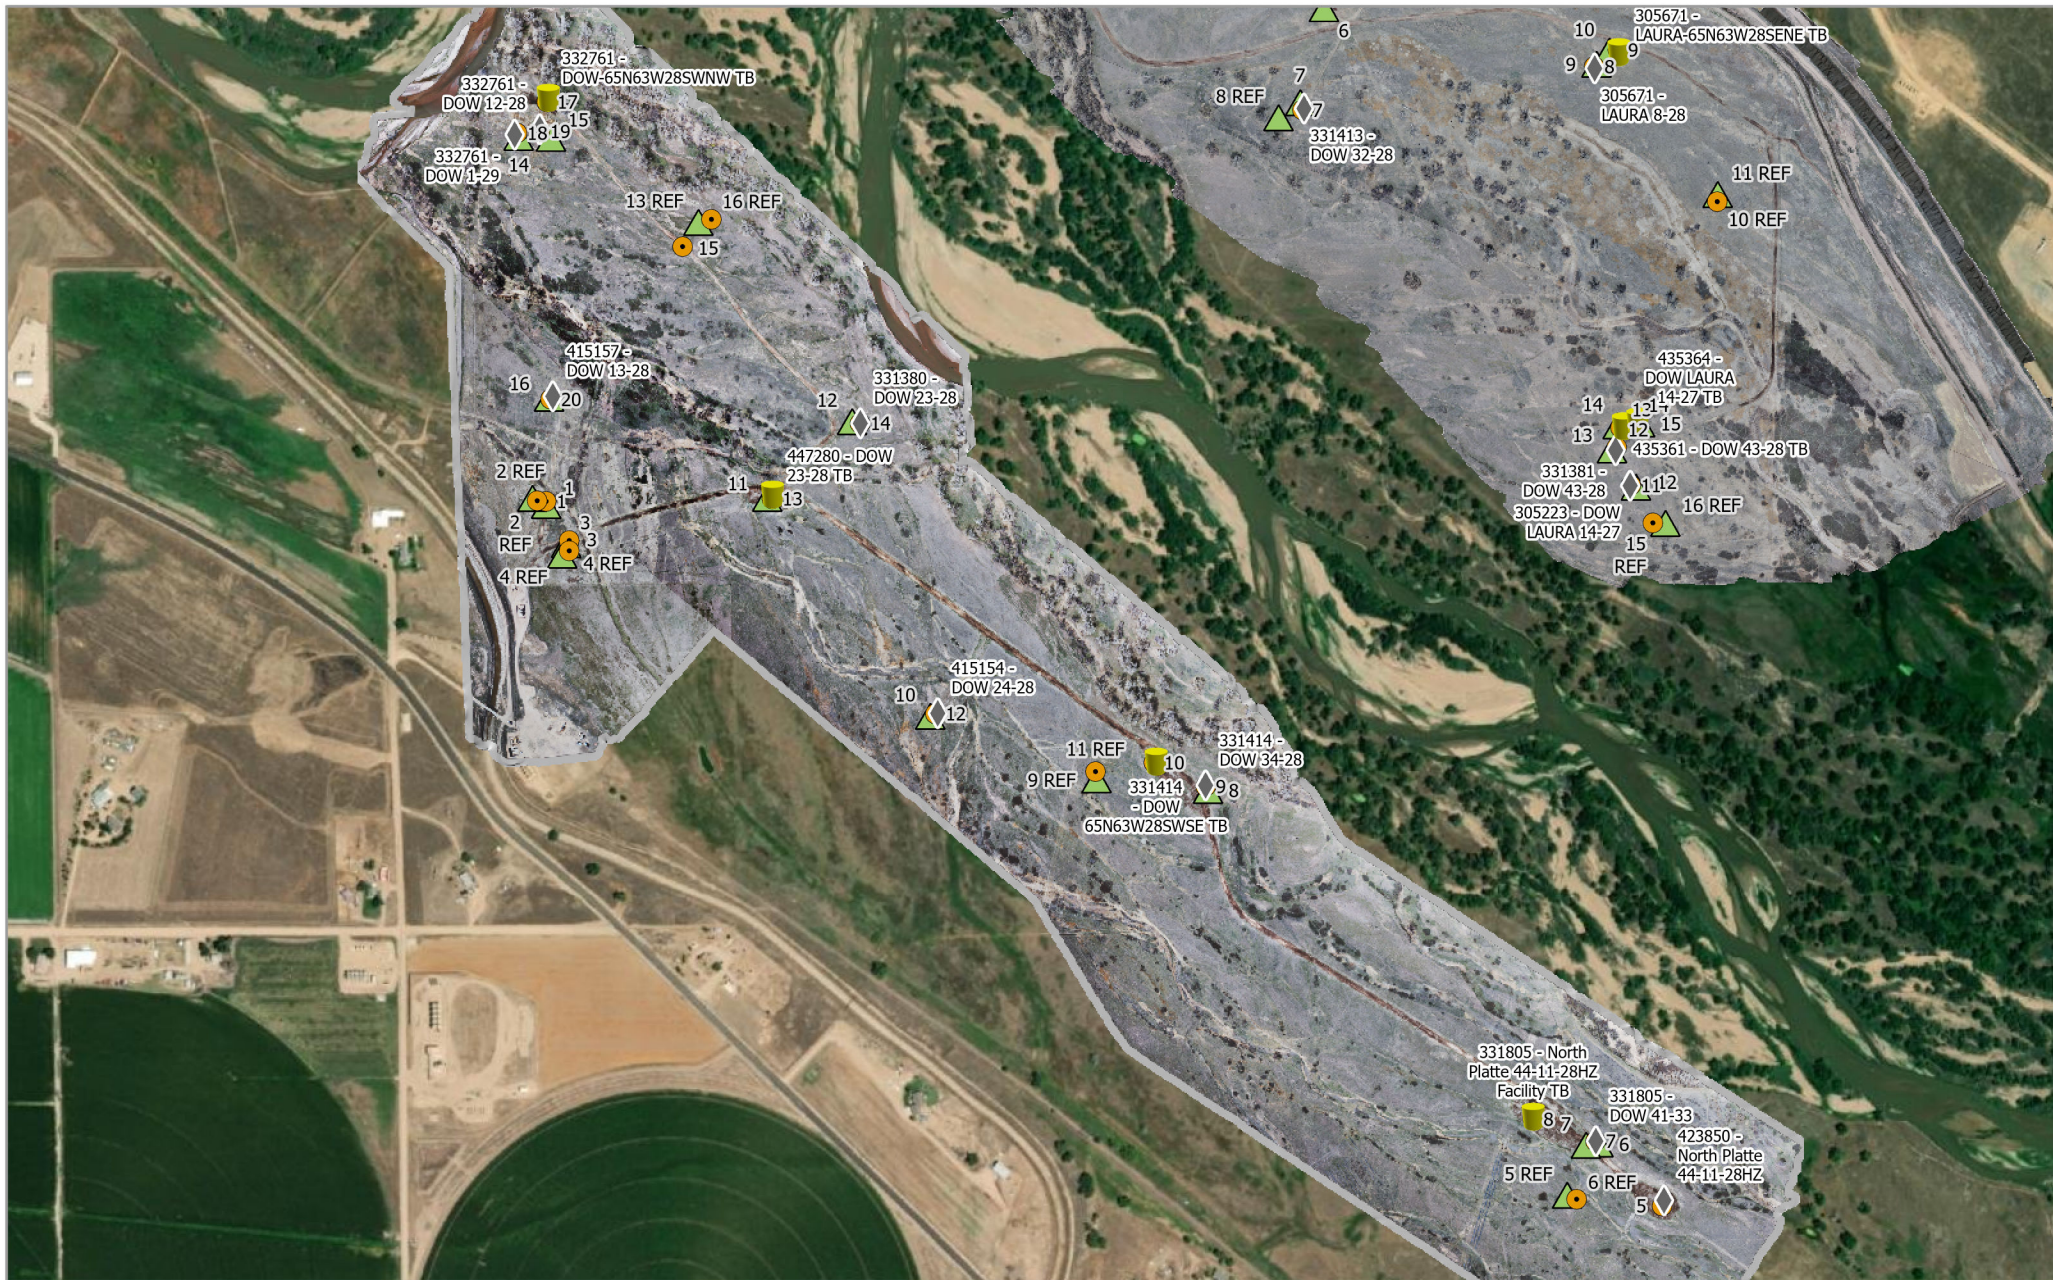
# **CIV - CPW South Side** **Map Extent - Overview Soil & Veg Points**

Imagery: RS Orthomosaic & DSM  
 Imagery Date: 2 May 2023  
 Map Date: 29 May 2023  
 Datum: WGS 1984 UTM Zone 13N  
 POC: Soil Sage

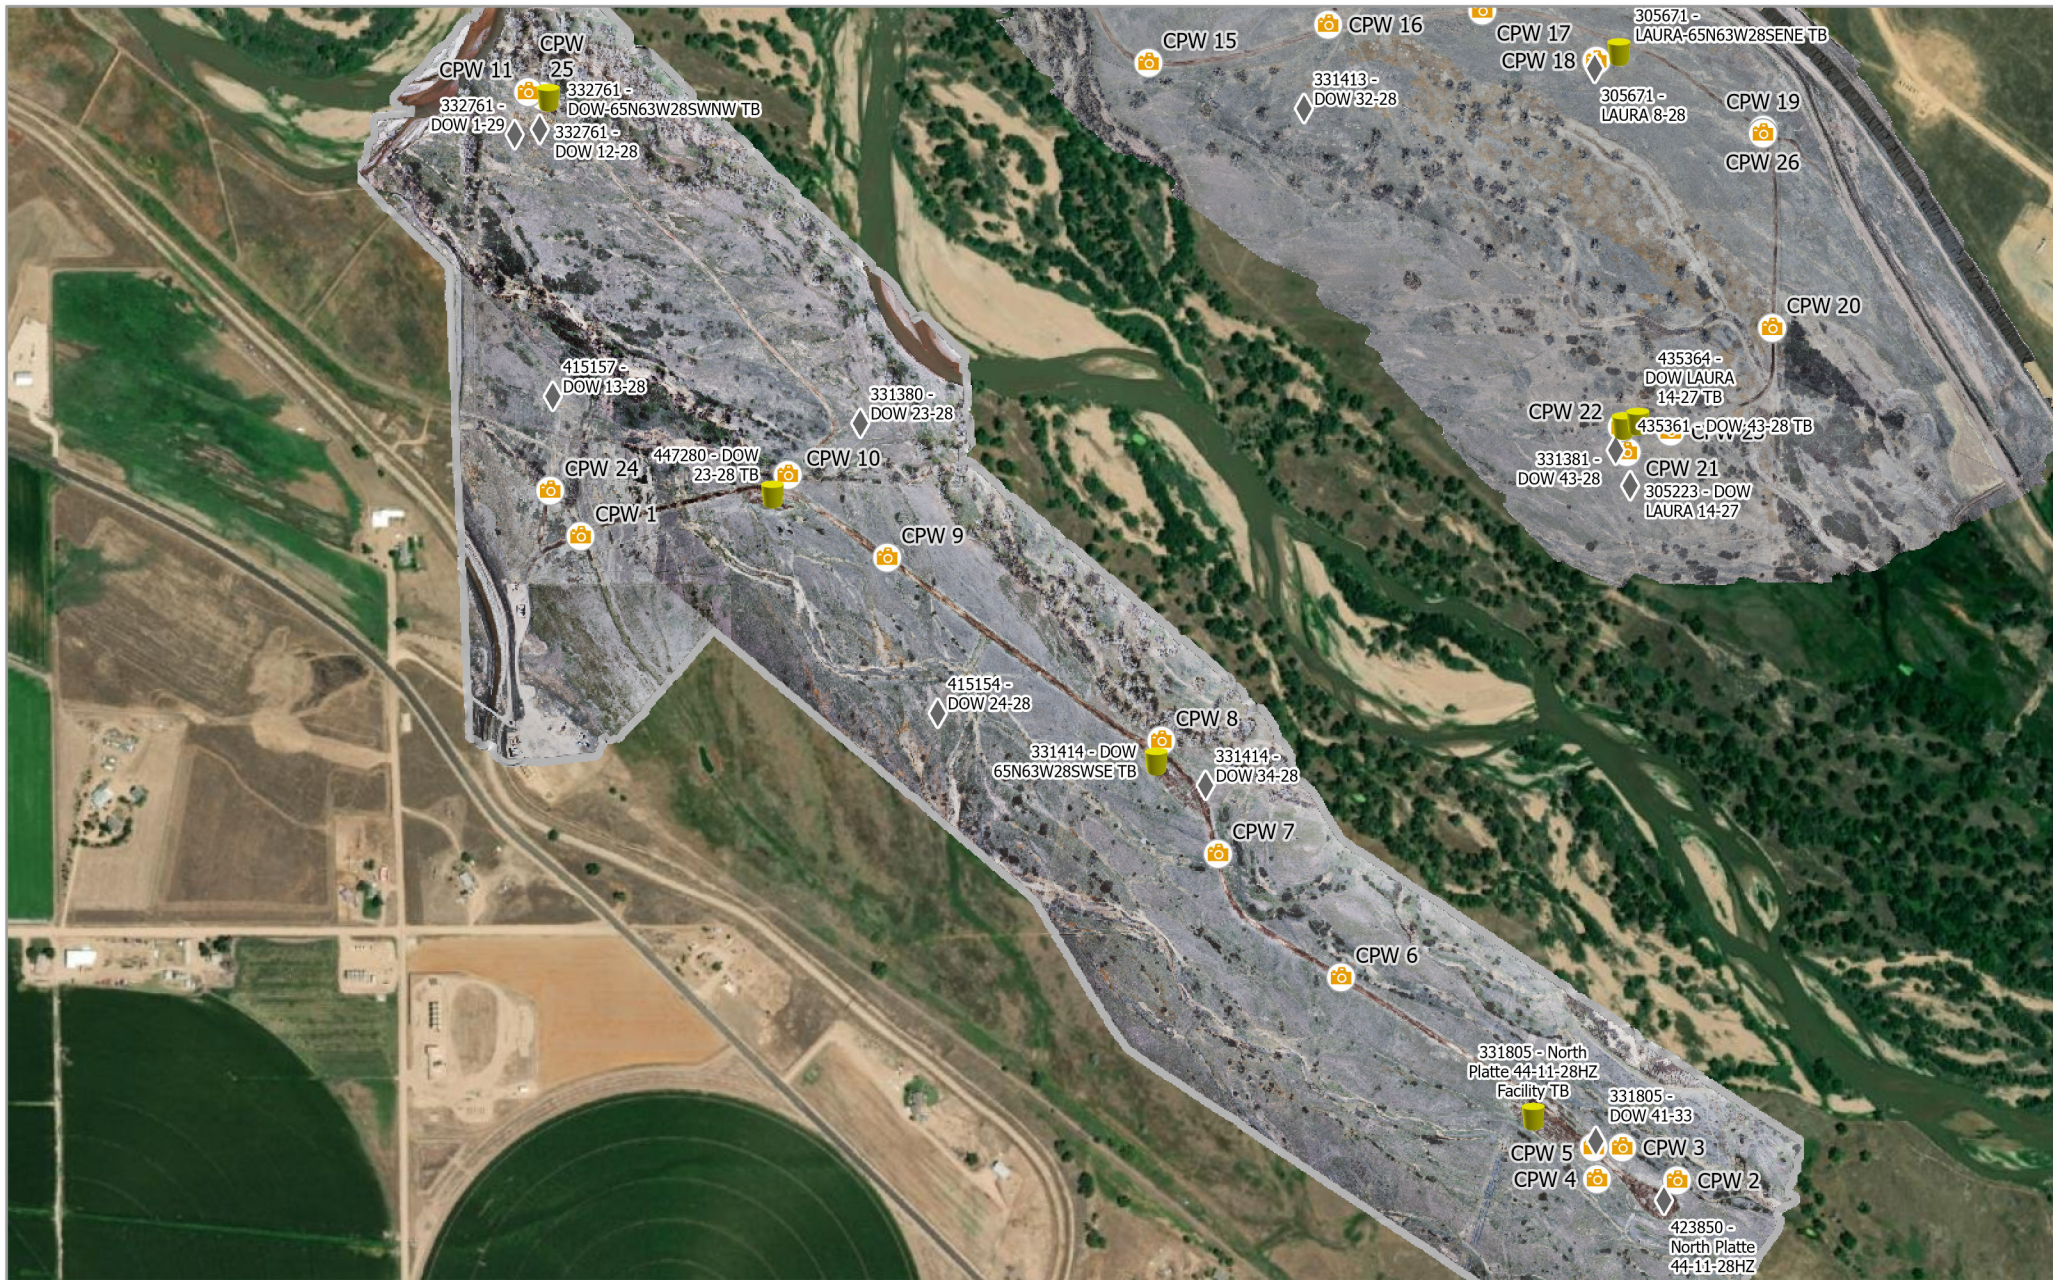
# **CIV - CPW South Side** **Map Extent - Overview Observation Points**

Imagery: RS Orthomosaic & DSM  
 Imagery Date: 2 May 2023  
 Map Date: 29 May 2023  
 Datum: WGS 1984 UTM Zone 13N  
 POC: Soil Sage

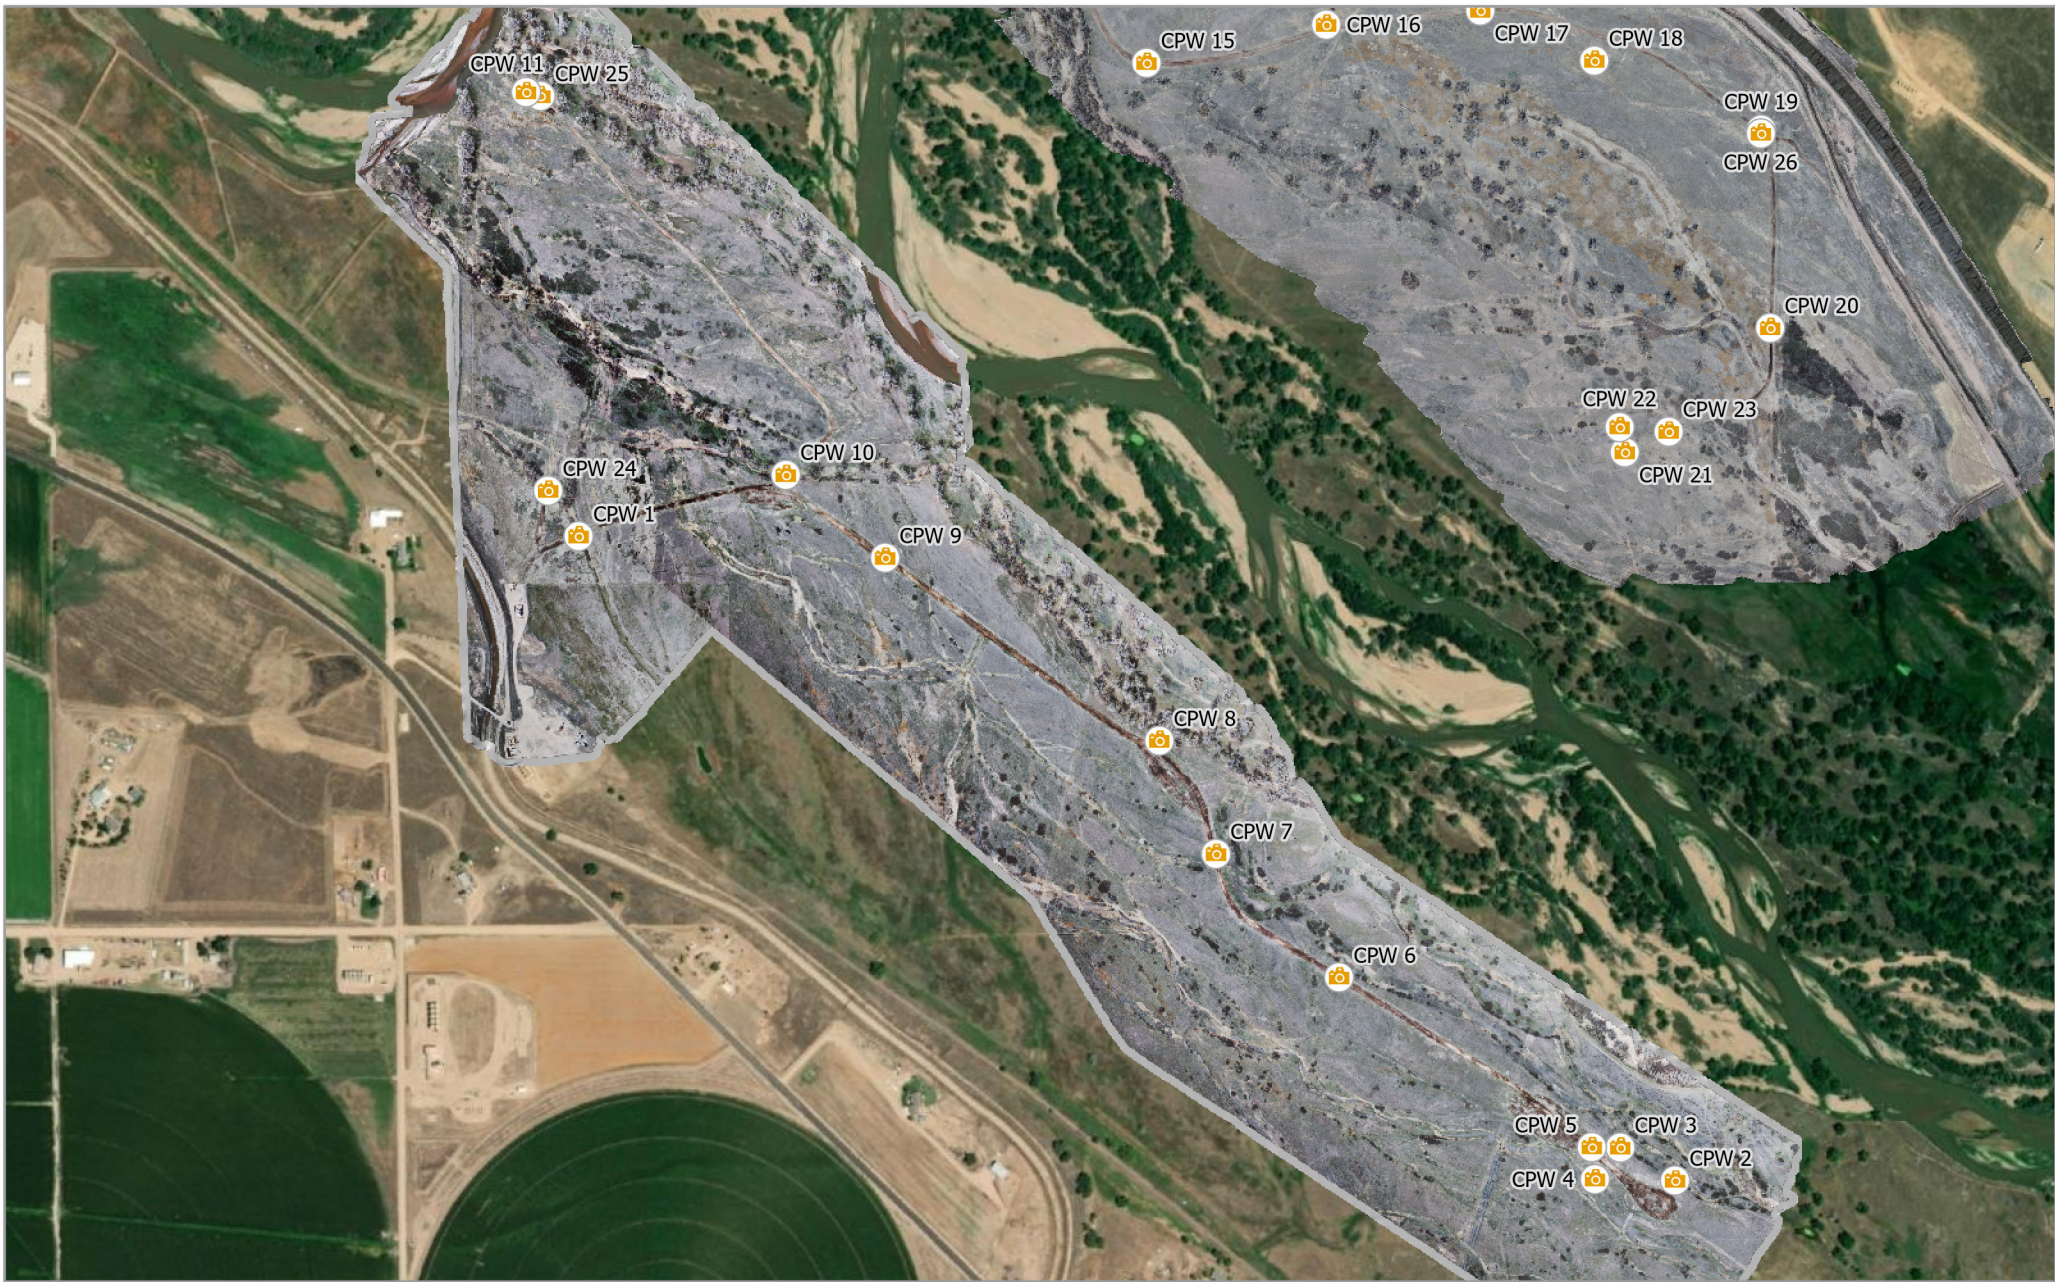
**CIV - CPW South Side**  
**Map Extent - Overview Observation**  
**Points**

Imagery: RS Orthomosaic & DSM  
Imagery Date: 2 May 2023  
Map Date: 29 May 2023  
Datum: WGS 1984 UTM Zone 13N  
POC: Soil Sage

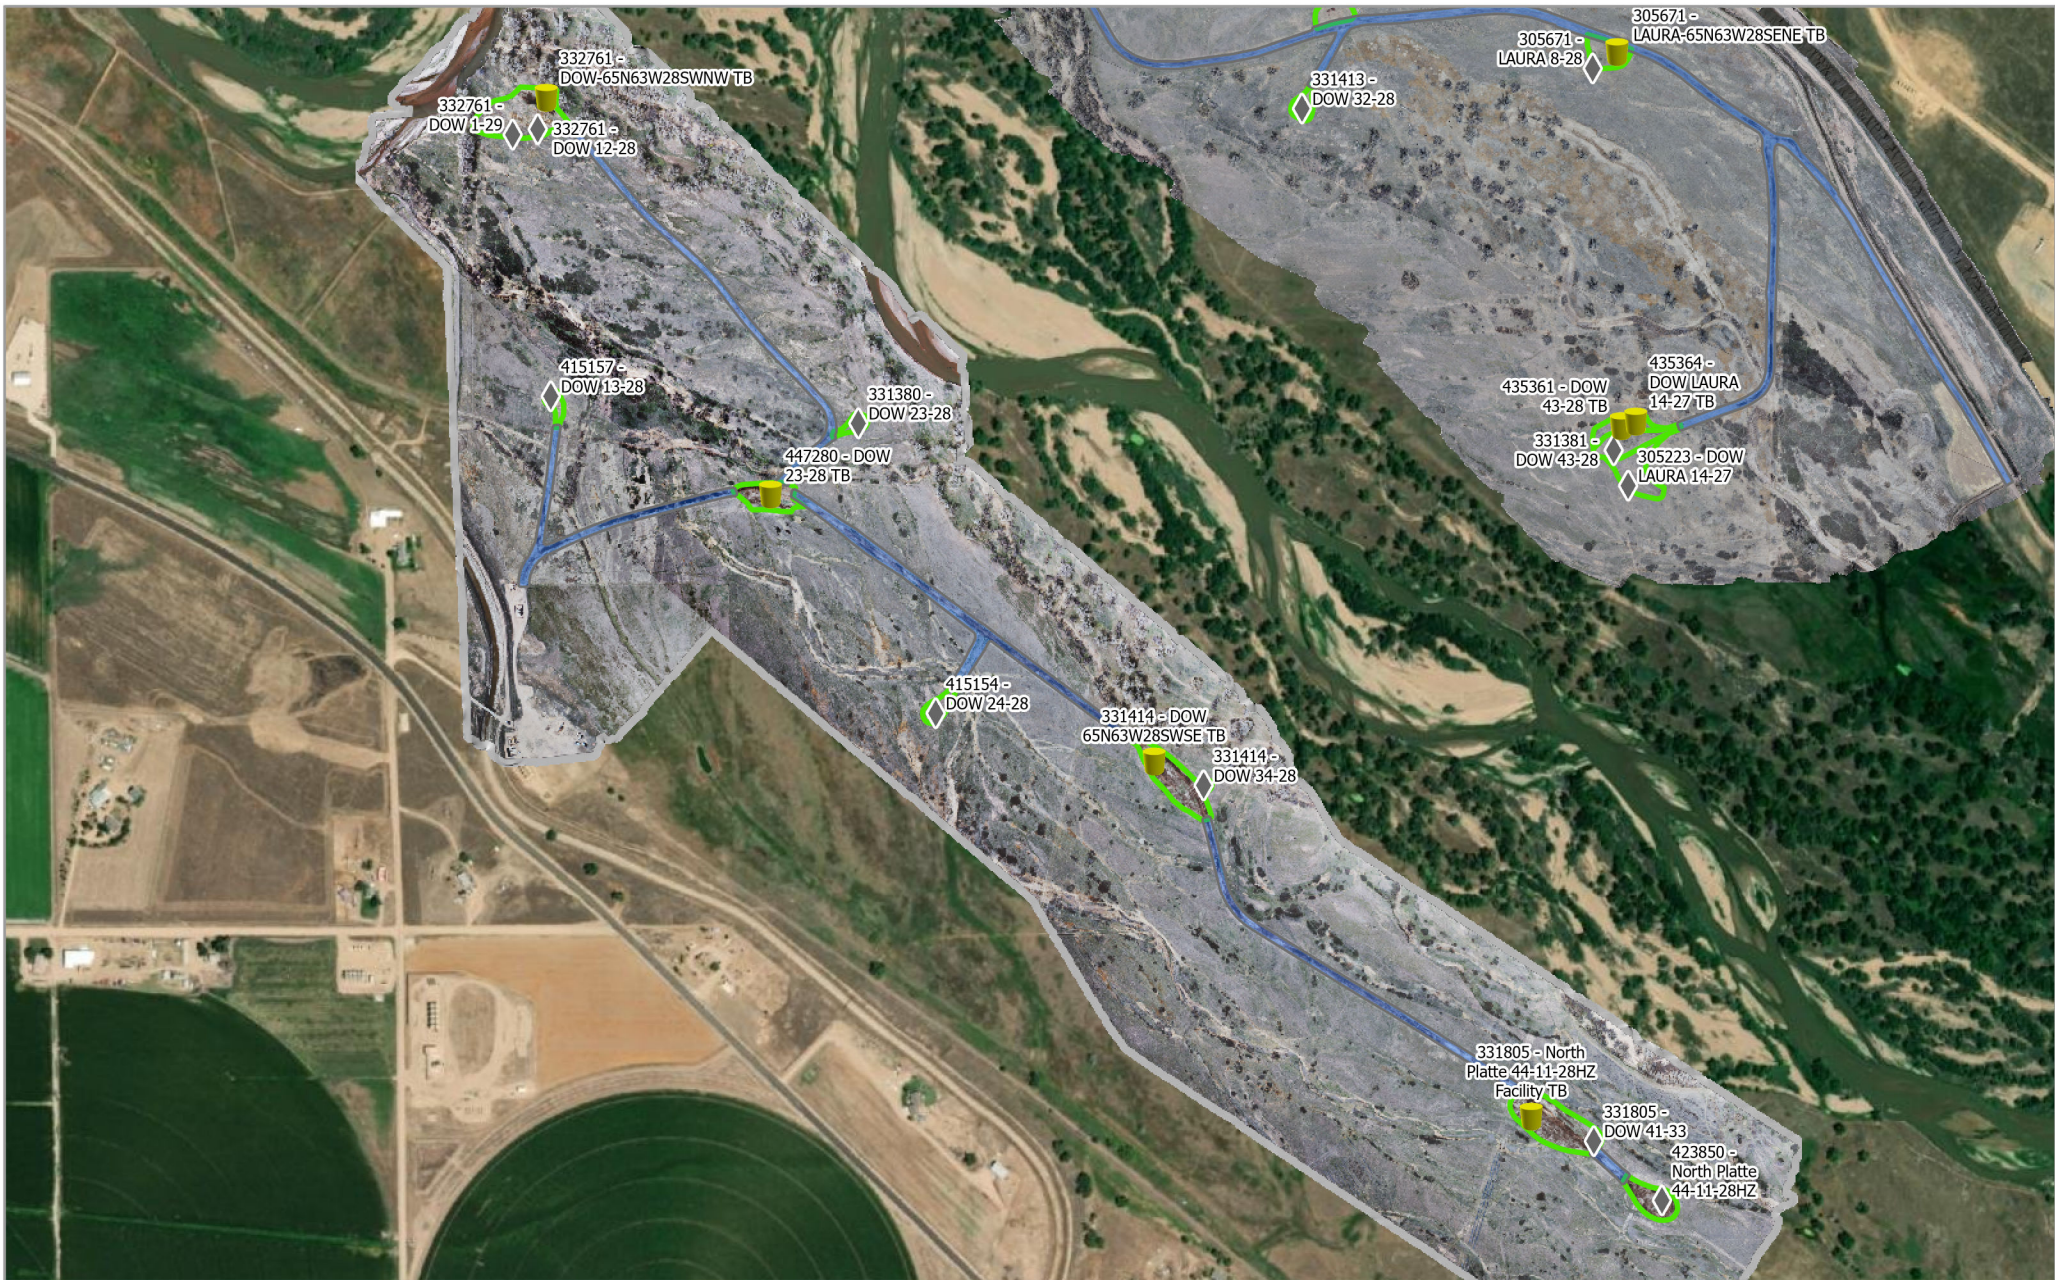
# **CIV - CPW South Side** **Map Extent - Overview Reclaim & Road** **Reclaim Extent**

Imagery: RS Orthomosaic & DSM  
 Imagery Date: 2 May 2023  
 Map Date: 31 May 2023  
 Datum: WGS 1984 UTM Zone 13N  
 POC: Soil Sage

Road: 12 inches remove and replace

Pad: 12 inches remove and replace

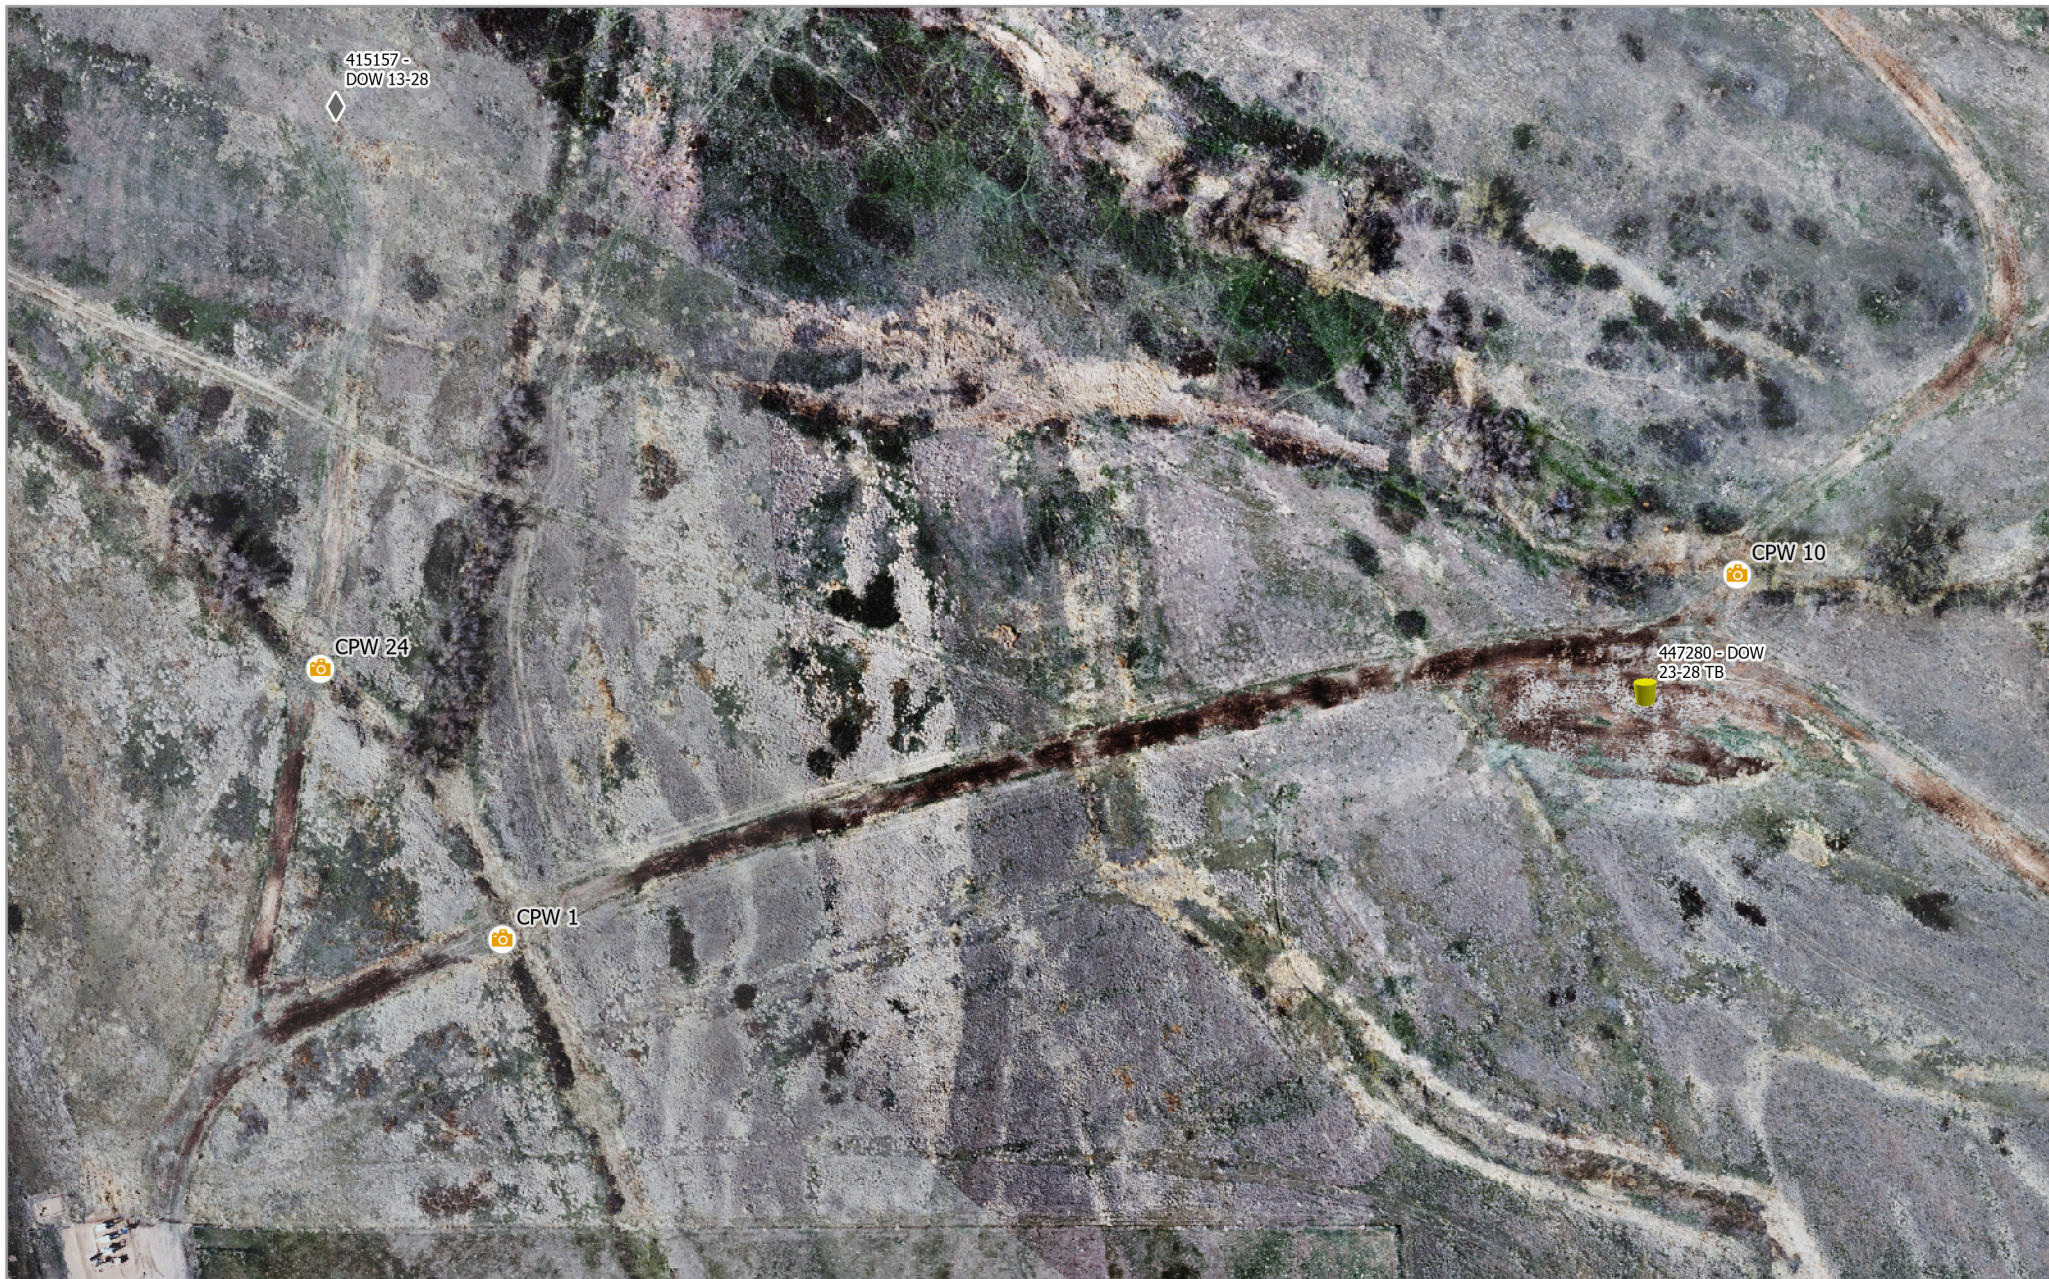
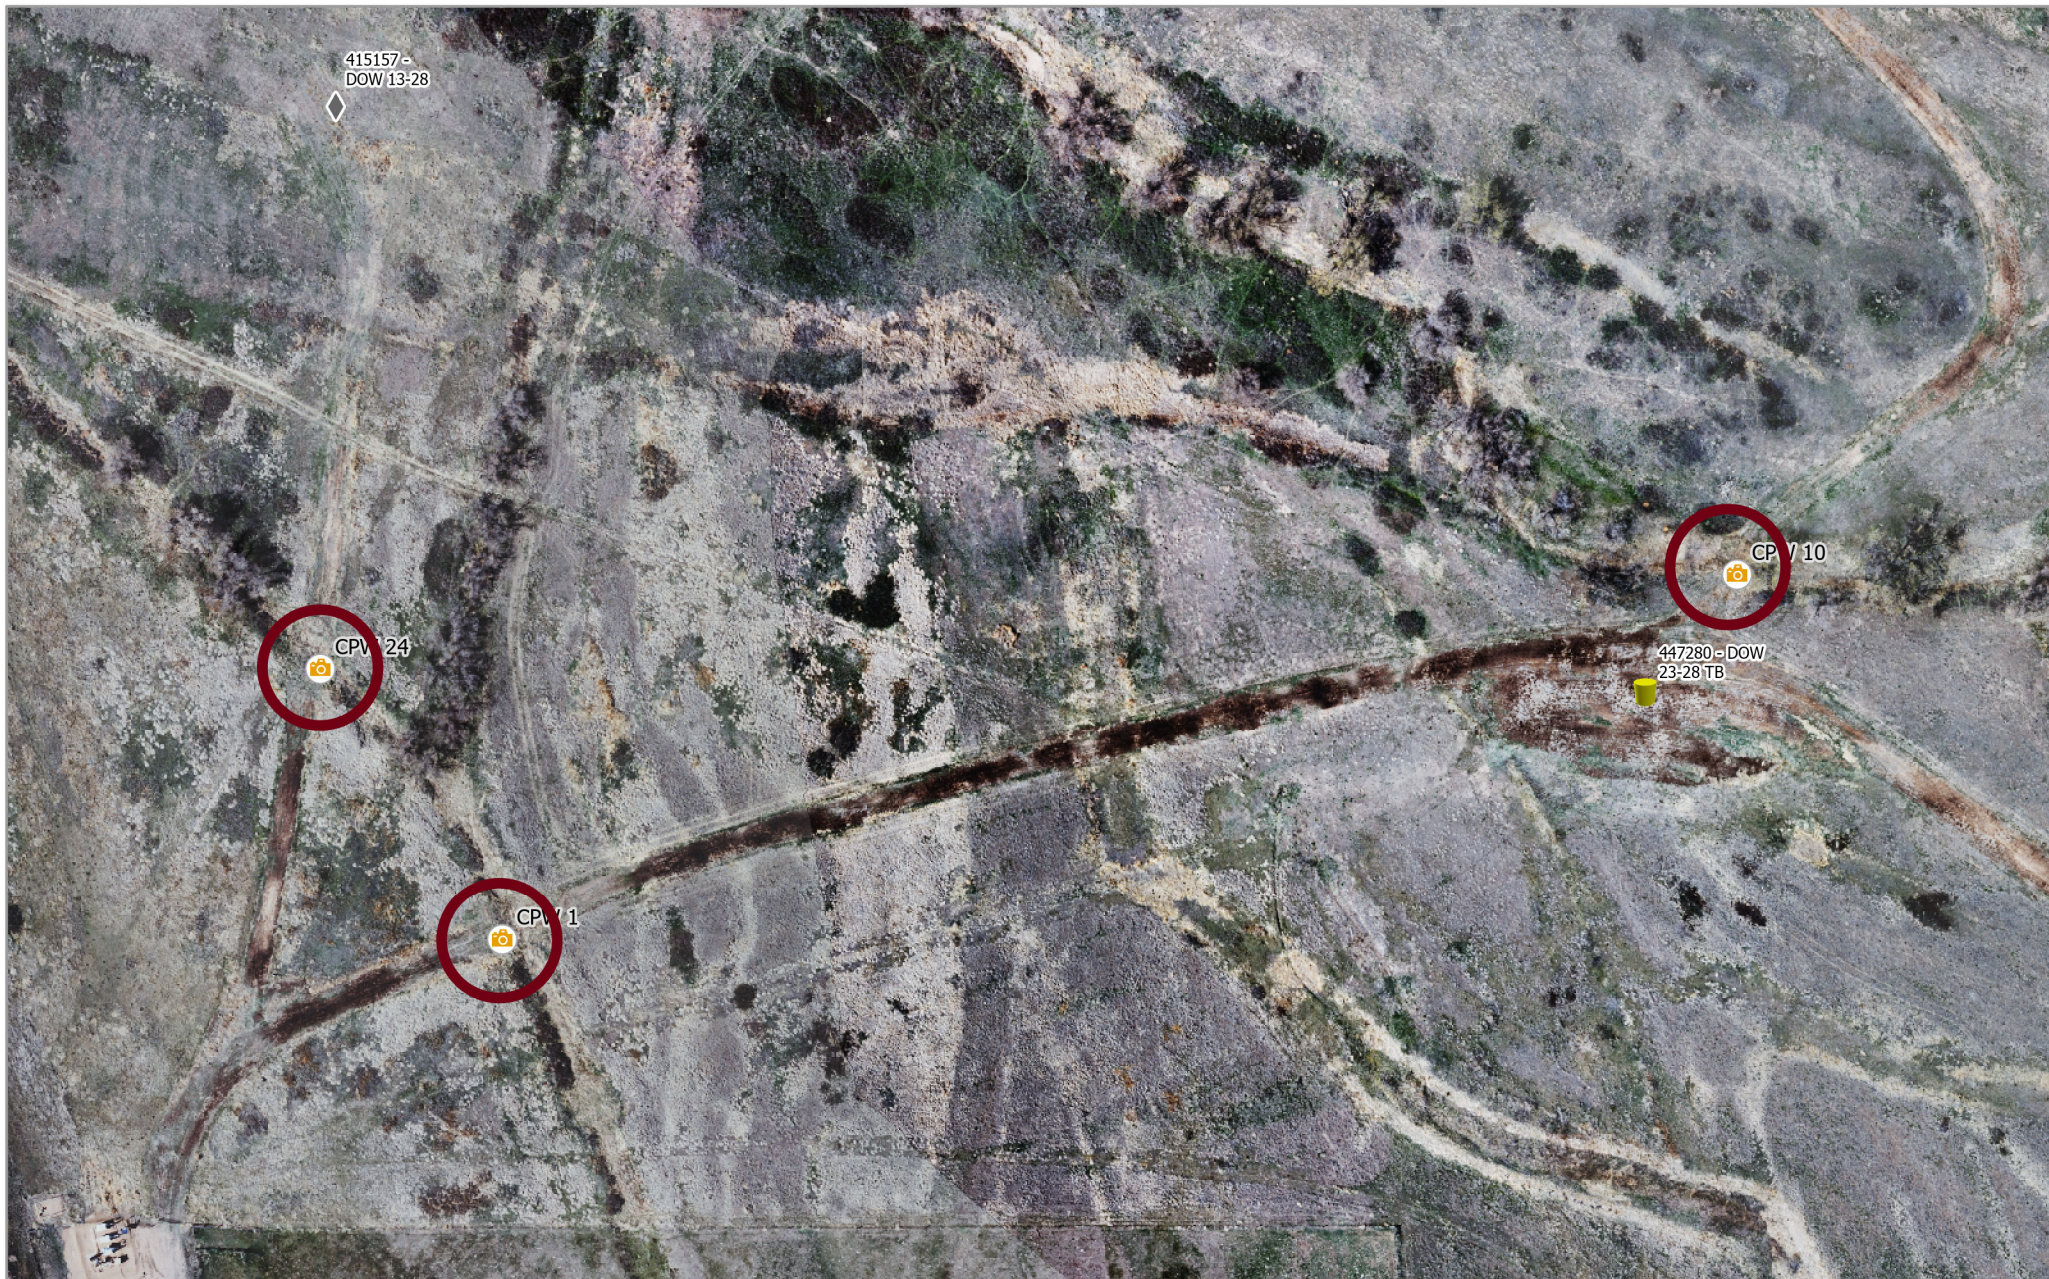
# **CIV - CPW South Side** **Map Extent - Overview Gully Reclaim**

Road Extents includes a Gully repair CPW 10. Extents from Location 447280.

\* Refer to this Site Overview map and the CPW Observation Overview map and Observation document for additional information on the gully area.

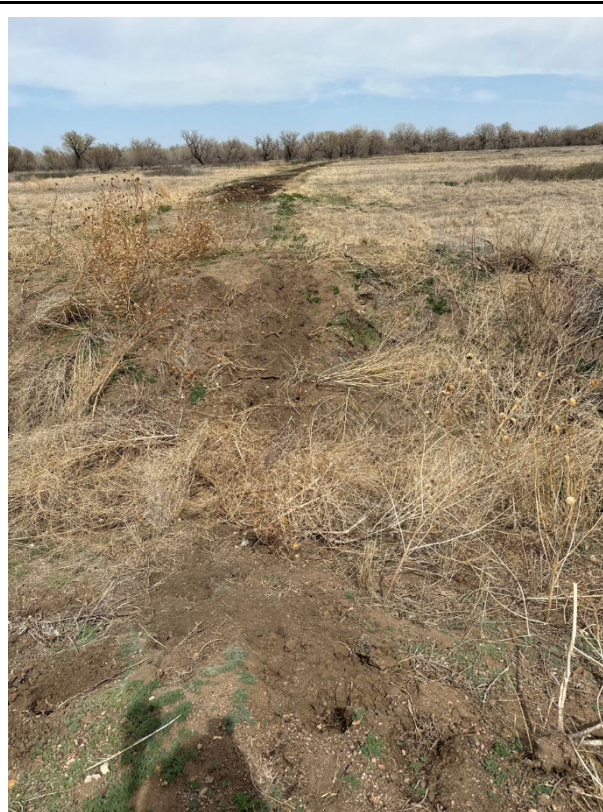
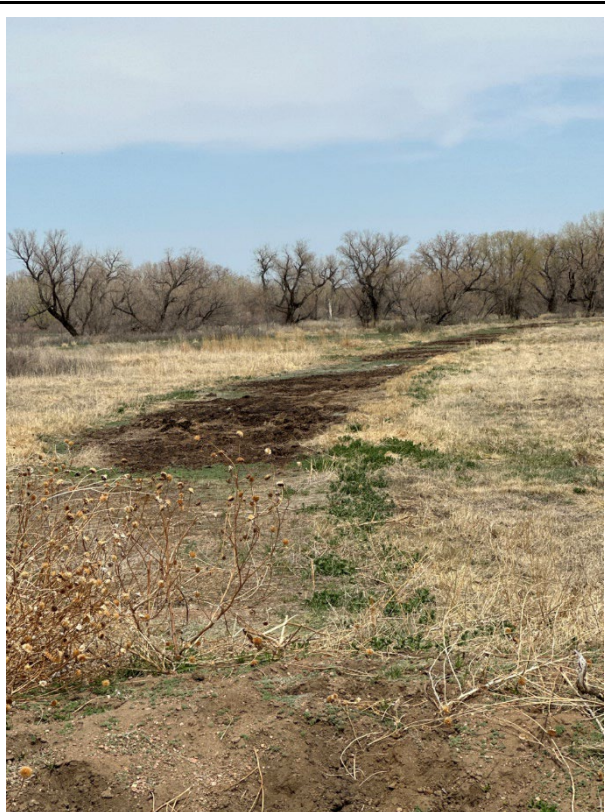
### *Observation 1 - South*

Ditch repair is required after the culvert was removed. Gravel, steep slopes, and contouring.

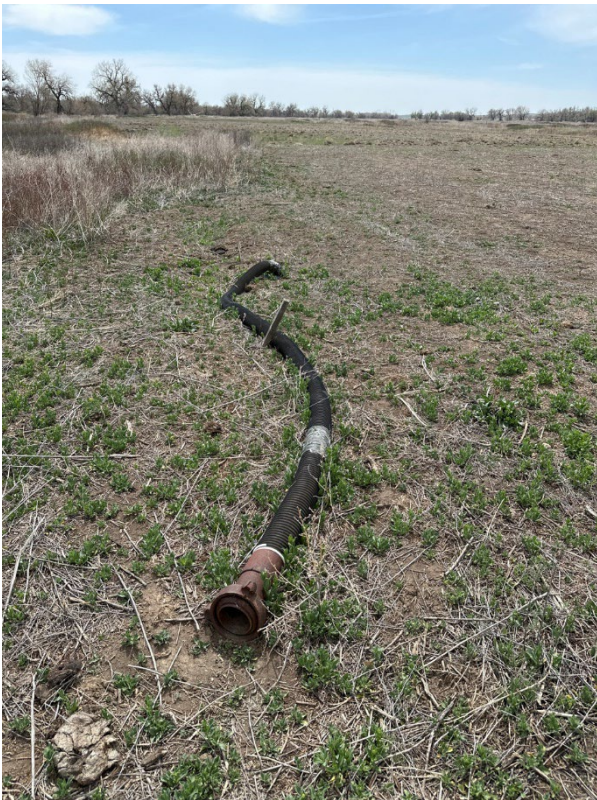
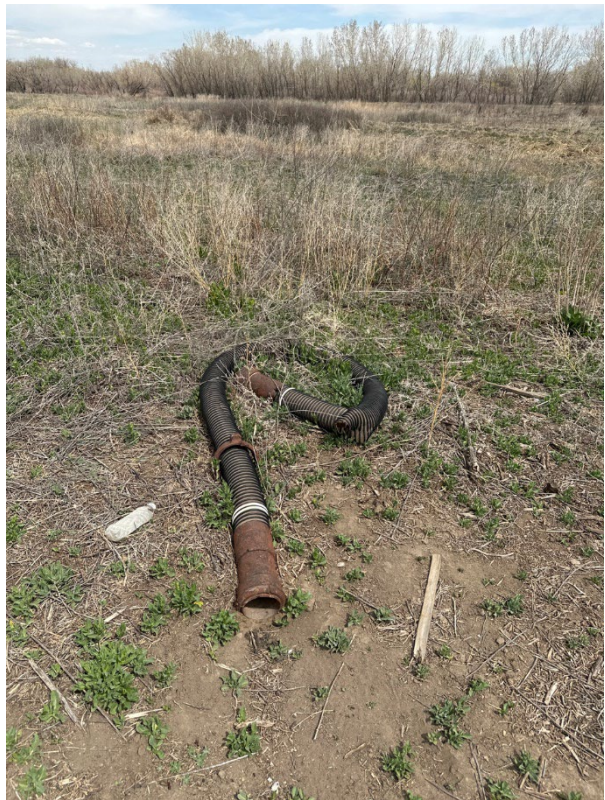
**Observation 2 - South**

Oil field equipment remaining on site

- There are active and abandoned midstream assets in both the northern and southern parts of the reclamation area.
- Remove silt fencing, waddles and remaining oil and gas operational equipment.

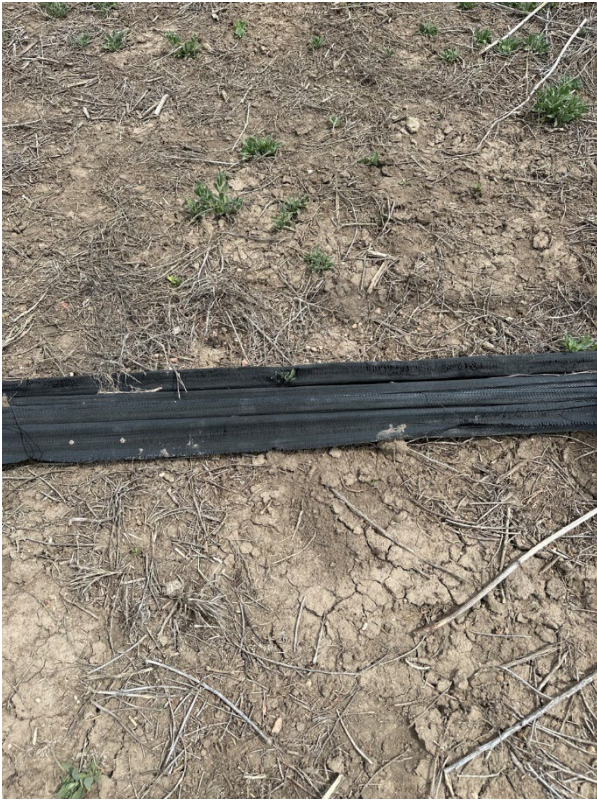
**Observation 3 - South**

Silt Fence

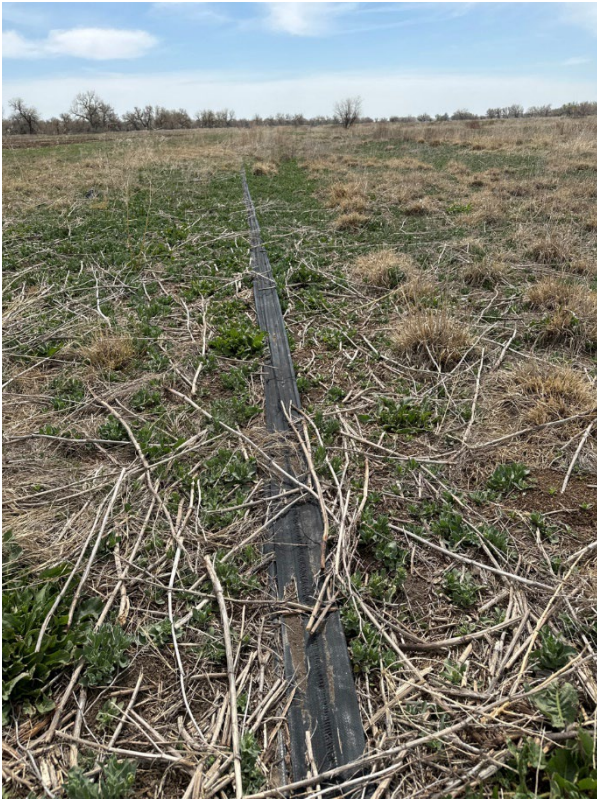
**Observation 4 - South**

Silt Fence

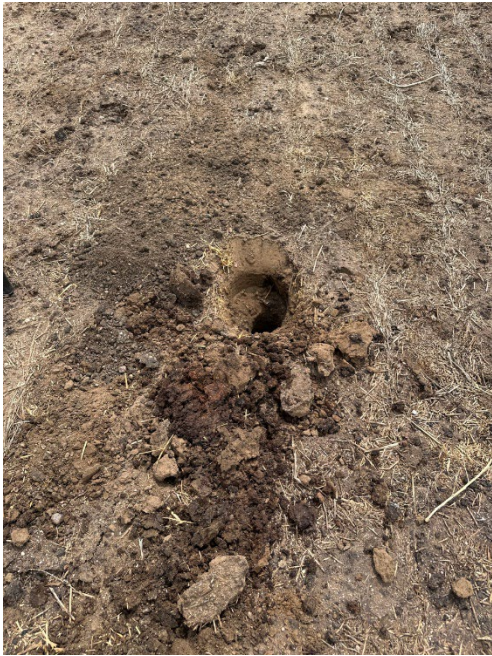
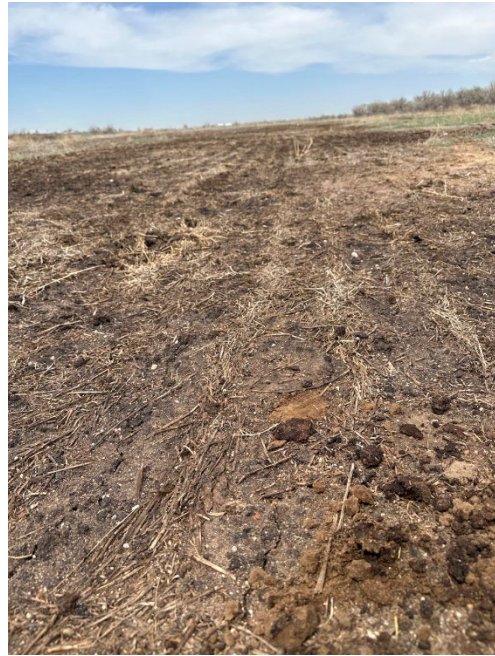
**Observation 5 – ROAD - South**

Road observation point - 18 inches to sand – top 6 inches cow manure, gravel, sand, no vegetative growth or weeds

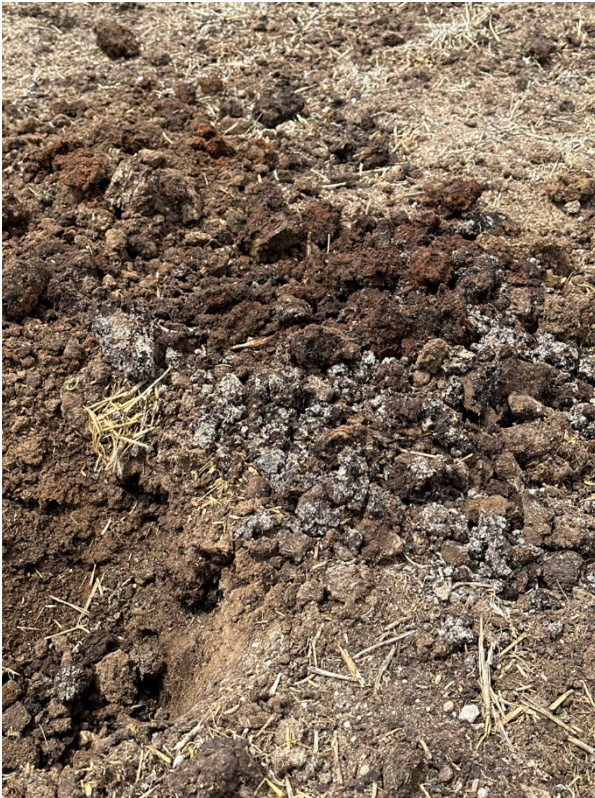
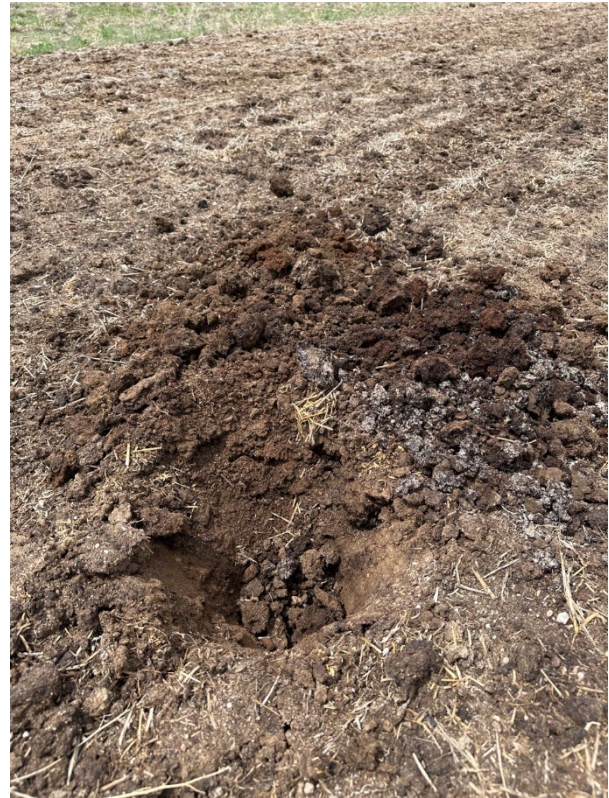
**Observation 6 – ROAD - South**

Road observation - 12 in of manure that has mold during anaerobic processes – compaction layer

White mold and unincorporated manure

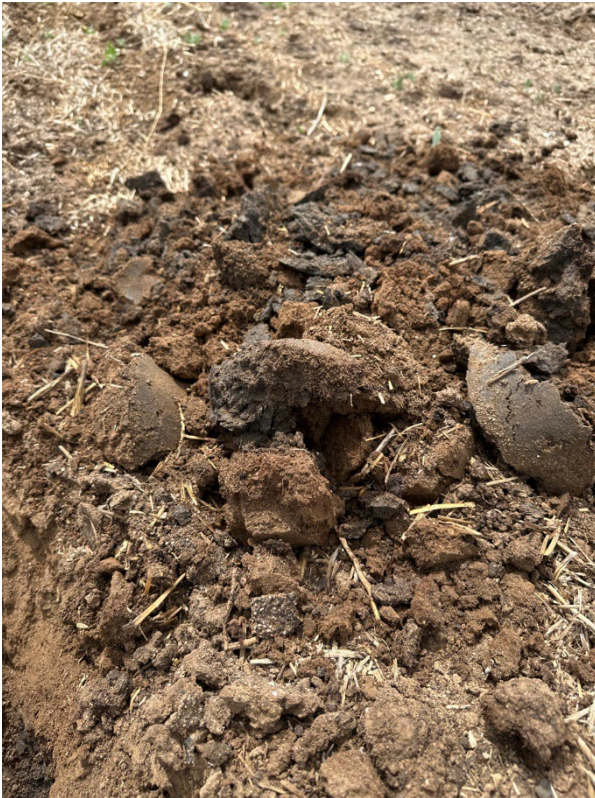
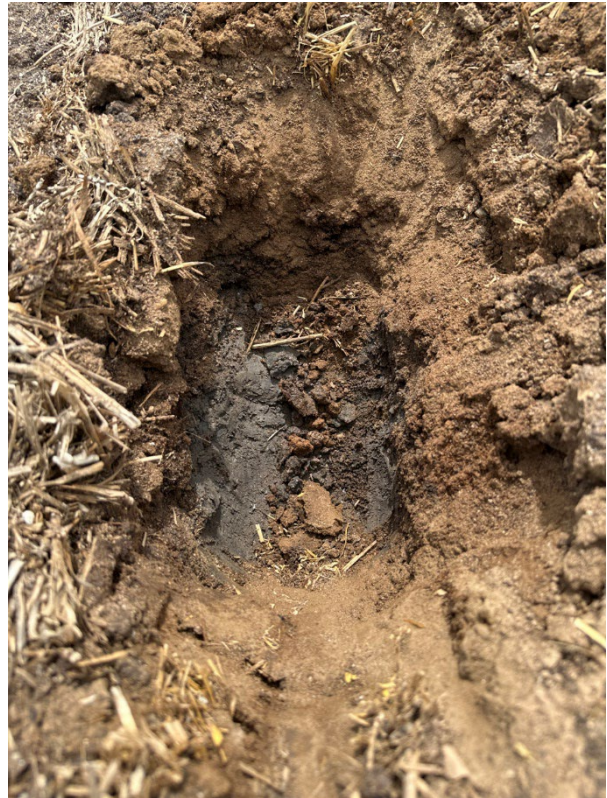
**Observation 7 – ROAD - South**

Road observation - 9 inches of manure
