# SITE-SPECIFIC QUALITY ASSURANCE & QUALITY CONTROL AUDIT

## PERMIT CLOSURE REPORT – RANGELAND

Location ID 331380

Location Name DOW/23-28 PAD

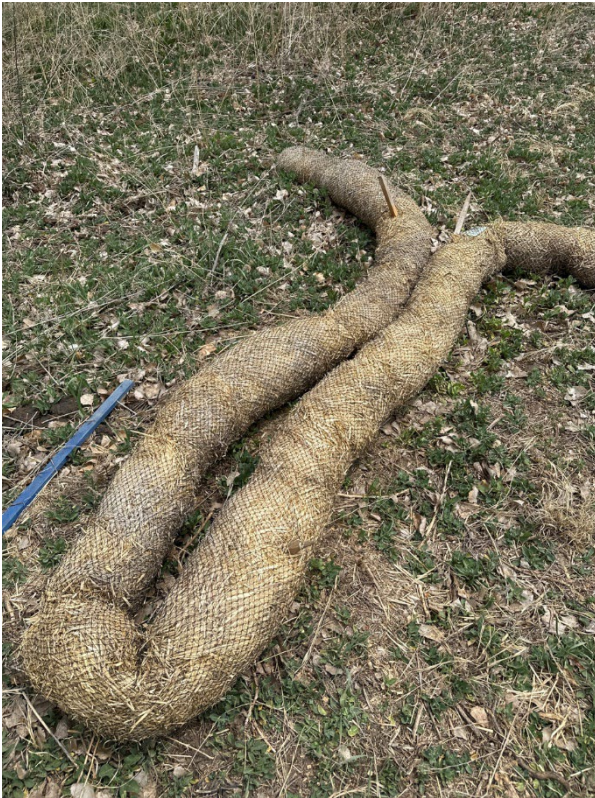
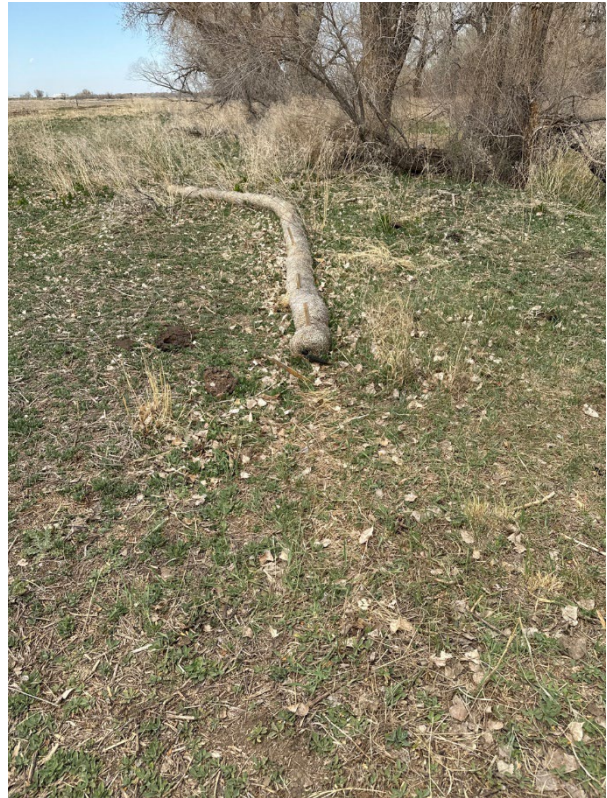
***Observation 8 – Adjacent to Riparian - South***

Straw waddles

- There are active and abandoned midstream assets in both the northern and southern parts of the reclamation area.
- Remove silt fencing, waddles and remaining oil and gas operational equipment.

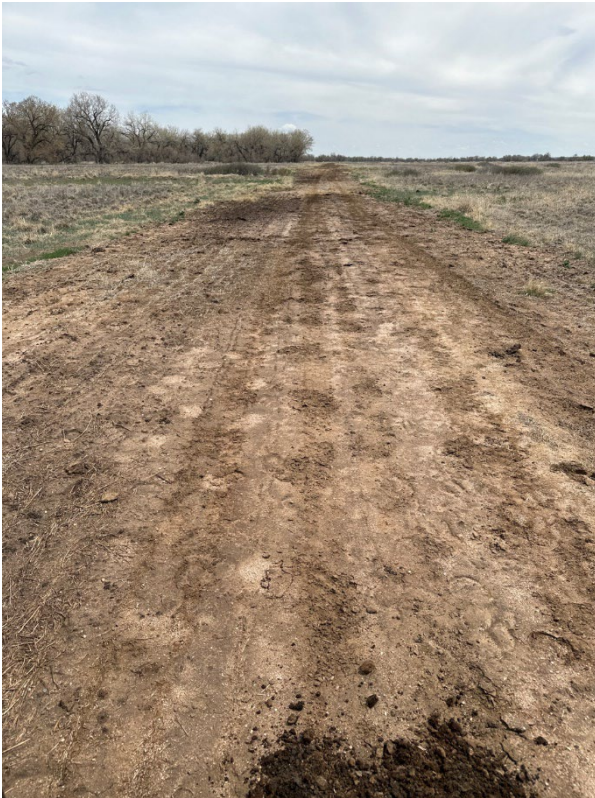
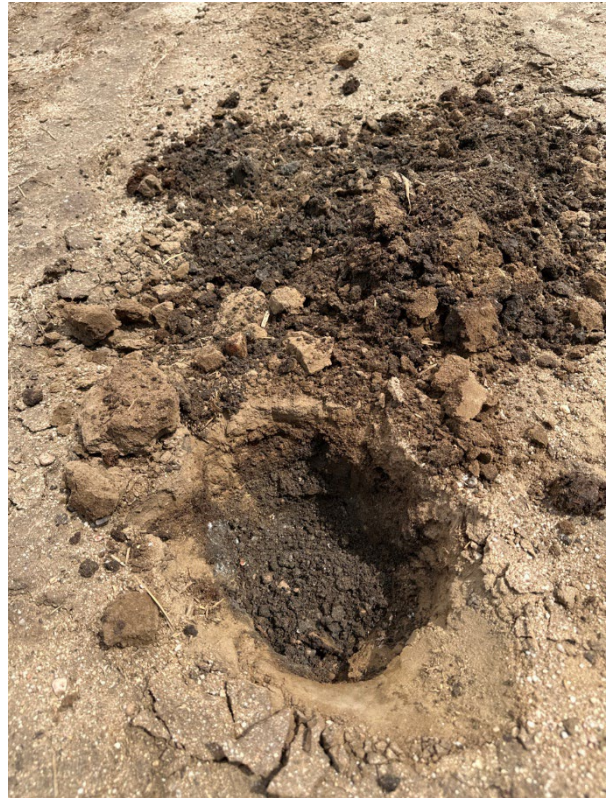
**Observation 9 – ROAD - South**

Road observation - 6 in manure – no vegetative growth or weeds

Road: 12 inches remove and replace

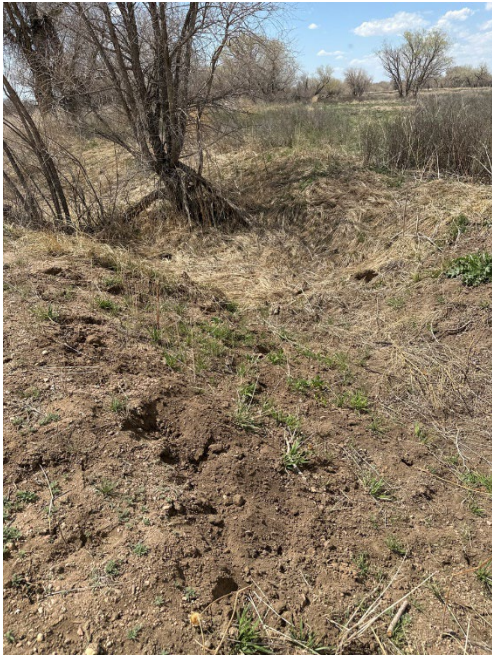
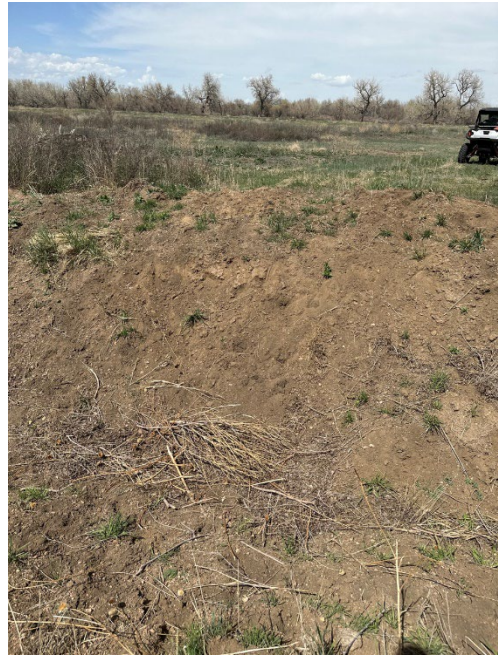
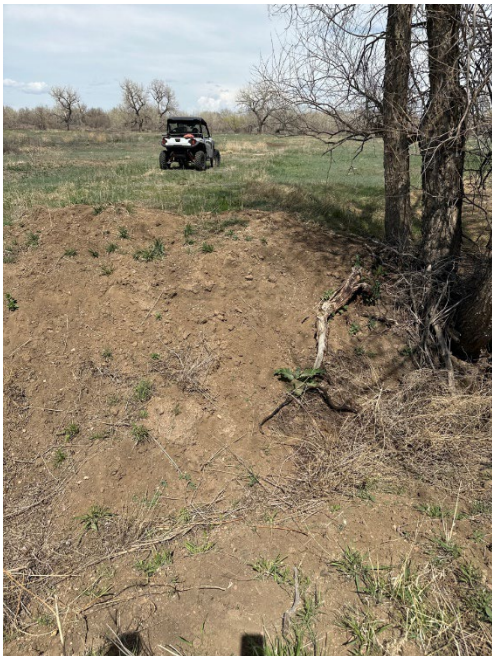
**Observation 10 – GULLY - South**

Ditch repair is required after the culvert was removed. Gravel, steep slopes, and contouring.

Steep slopes

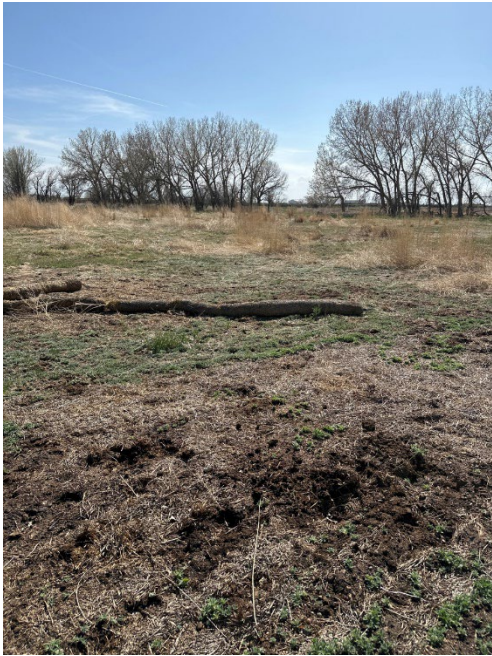
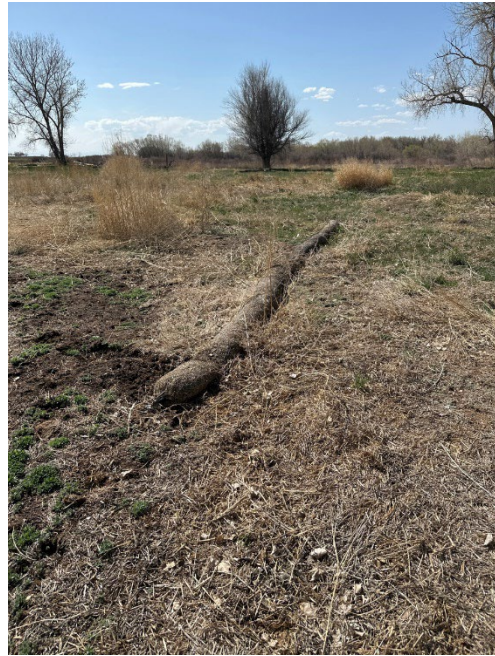
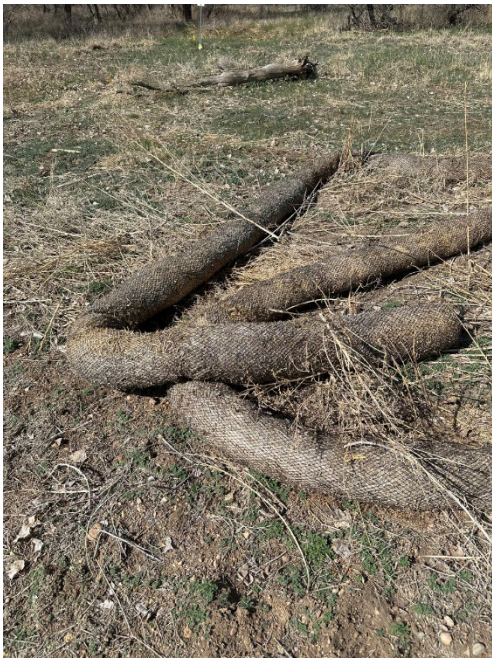
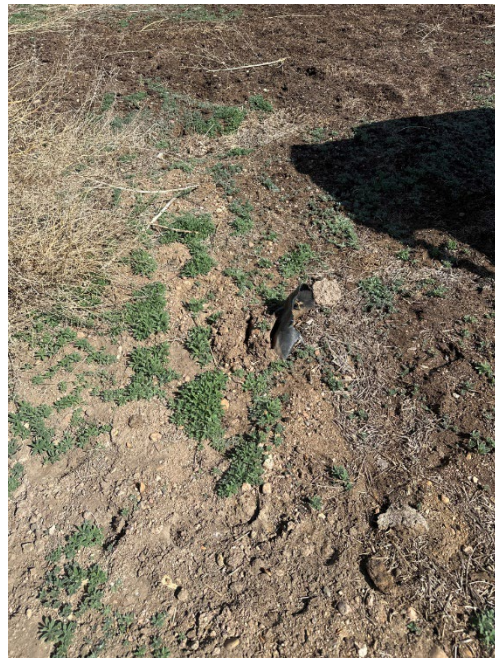
**Observation 11 – DEBRIS - South**

Silt waddles and trash

Silt waddles

Trash

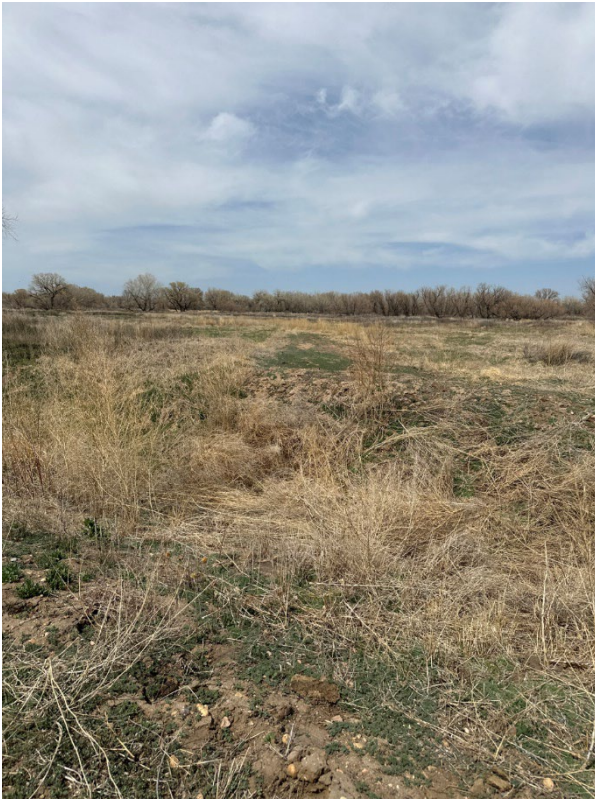
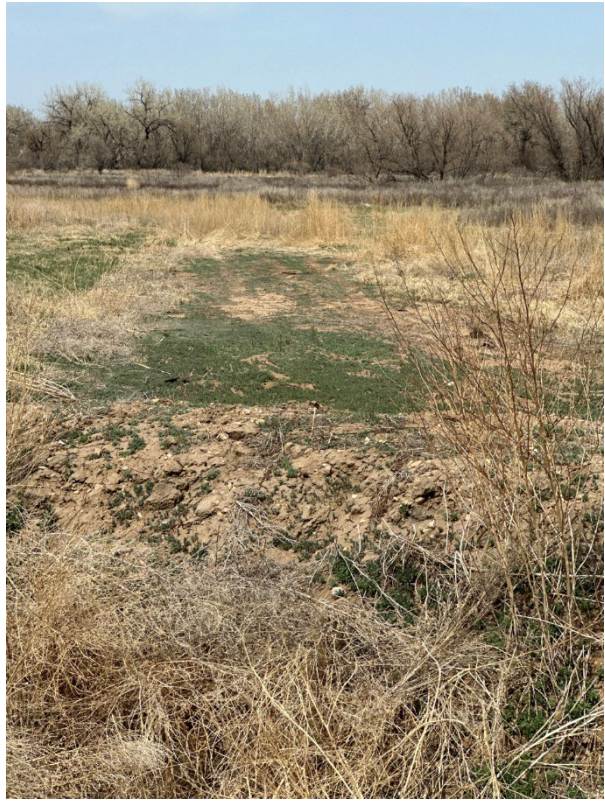
**Observation 24 – GULLY - South**

Ditch repair is required after the culvert was removed. Gravel, steep slopes, and contouring.

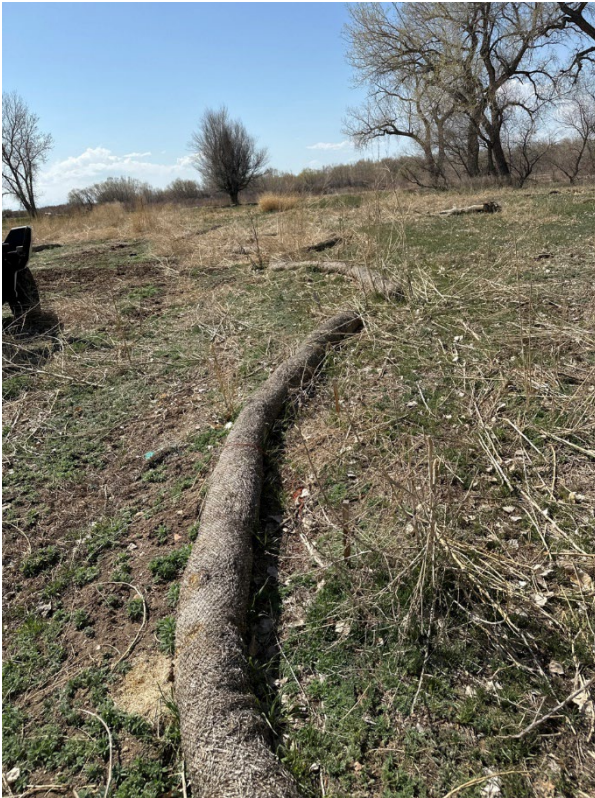
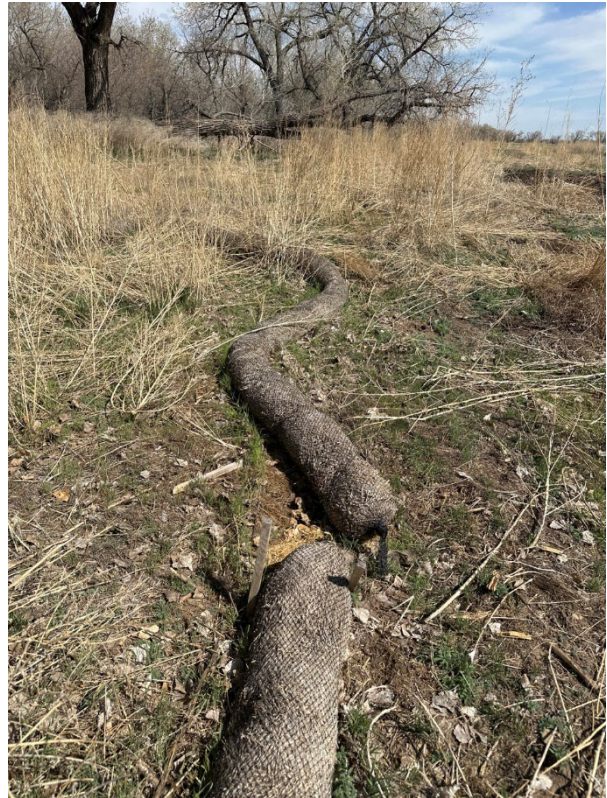
**Observation 25 – TANK BATTERY - South**

Silt and waddles

Silt and waddle

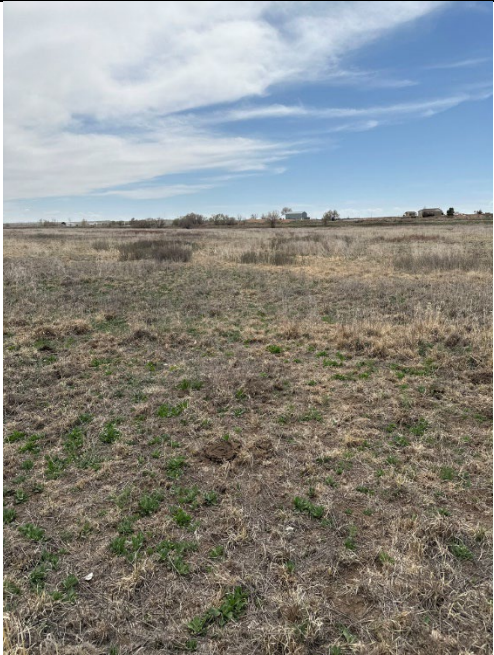
<p>Veg – West</p>	<p>Brome ssp.</p>

<p>Field Bindweed – <i>Convolvulus arvensis</i> – Colorado List C Noxious Weed</p>

Disc	Disc the site to a depth of 6.0-inches using a disk and harrow, field cultivator, vibrashank, or another alternative suitable to site conditions	
	Seed	CPW Mix	15 LBS/acre
	Straw	Spread certified weed free straw	2 Tons/acre
	Crimp	Crimp Straw	
<b>Monitoring</b>	Continuous	Site should be monitored post reclamation to ensure success	
<b>Weed Management</b>		Due to the seed bank of cheatgrass, thistle and kochia monthly monitoring is recommended with appropriate herbicide control
