ATTACHMENT B

SITE NAME: Dinner 6-5-14 WH							DATE: 3/13/2023	REM. PROJECT #: 26030	WEATHER: Sunny 50s	
SITE DIRECTIONS: CR35 and CR44 drive W .2 mi to location							CLIENT: PDC			
LEGALS AND LAT/LONG: SESE SEC 14 TWP 4N RNG 66W MERIDIAN 6 40.304978, -104.738474							TASMAN PERSONNEL: E.Wozniak			
SOIL TYPES: Well Graded Sand - SW							SURFACE GRADIENT: Northeast			
SOIL SAMPLING							FACILITY INFRASTRUCTURE			
Date/Time	Soil Sample ID	PID (ppm)	Visual	Olfactory	Photo?	Grab or Lab Sample?	EQUIPMENT		Quantity	
							Above Ground Storage Tank (AST)			
3/13/2023 12:15	WH01 @ 6'	0.1	No Staining	No Odor	Yes	Lab	Buried or Partially Buried Vessel			
3/13/2023 12:20	FLR01 @ 4'	0.2	No Staining	No Odor	Yes	Lab	Separator		1	
3/13/2023 12:19	WHS01-N @ 0-6"	0.1	No Staining	No Odor	Yes	Grab	Emission Control Device (ECD)			
3/13/2023 12:22	WHS01-W @ 0-6"	0.0	No Staining	No Odor	Yes	Grab	Dump Line			
3/13/2023 12:23	WHS01-S @ 0-6"	0.2	No Staining	No Odor	Yes	Grab	Wellhead		1

Photographic Log

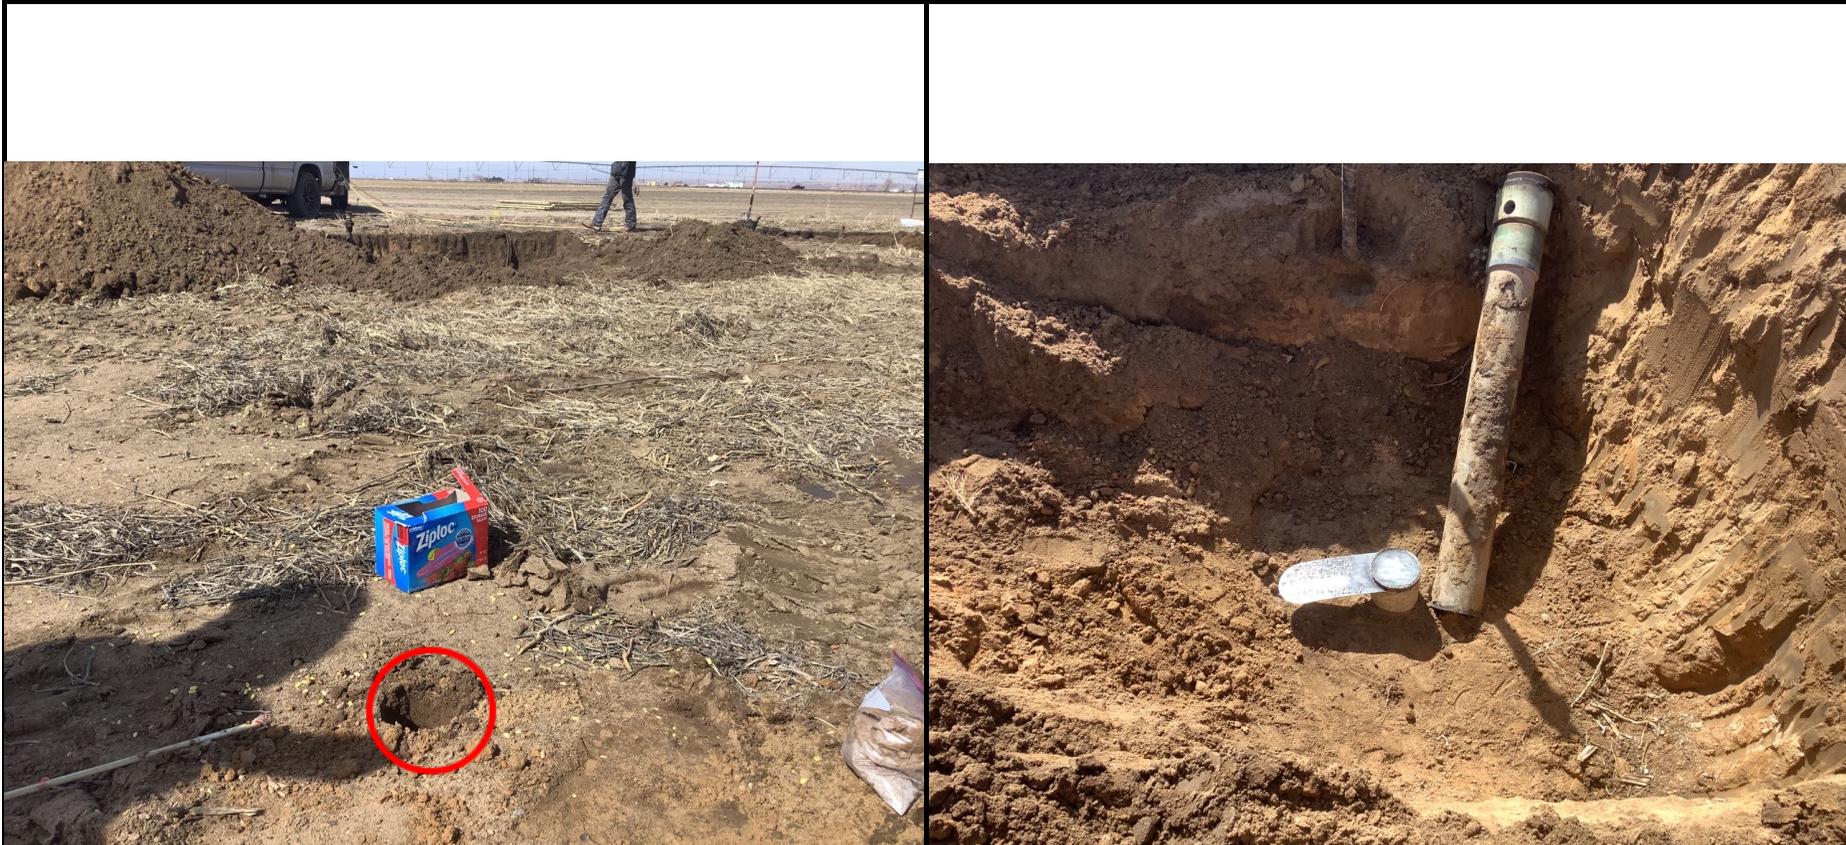
Equipment ID: <small>BKG01</small>		Equipment Type:		Equipment ID: <small>Cut and Capped wellhead</small>		Equipment Type:	
Material:	Volume:	Contents:		Material:	Volume:	Contents:	
Notes/Conditions:				Notes/Conditions:
