Inspection Photos

Loc: 470757

Operator: WESTERN OPERATING COMPANY

Inspection Date: 7/6/2023

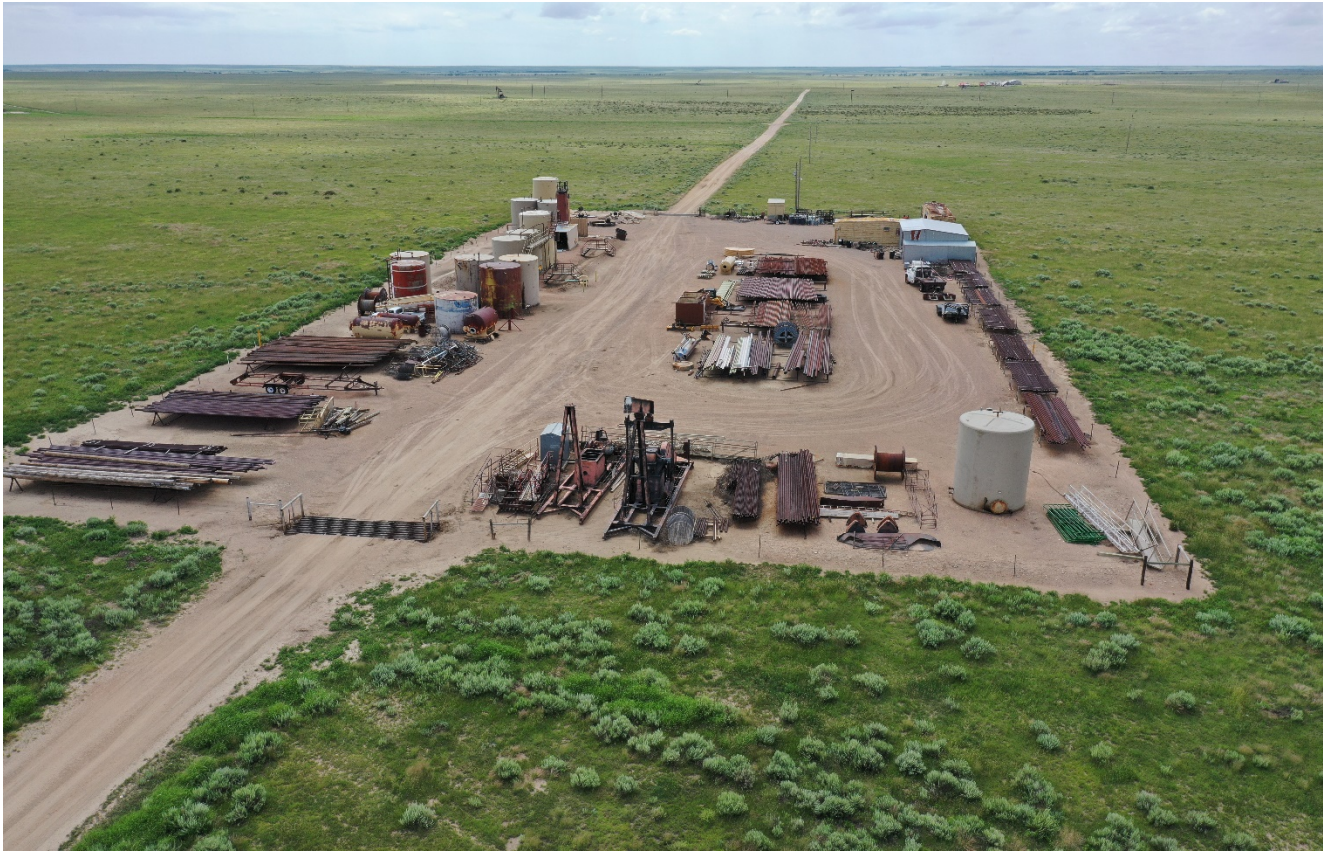
Photo 1. Drone aerial photo facing west toward the PYLES offsite tank battery and storage yard. The use of this location as a storage yard is prohibited per the rules. All unused equipment and supplies must be removed and interim reclamation must be performed.

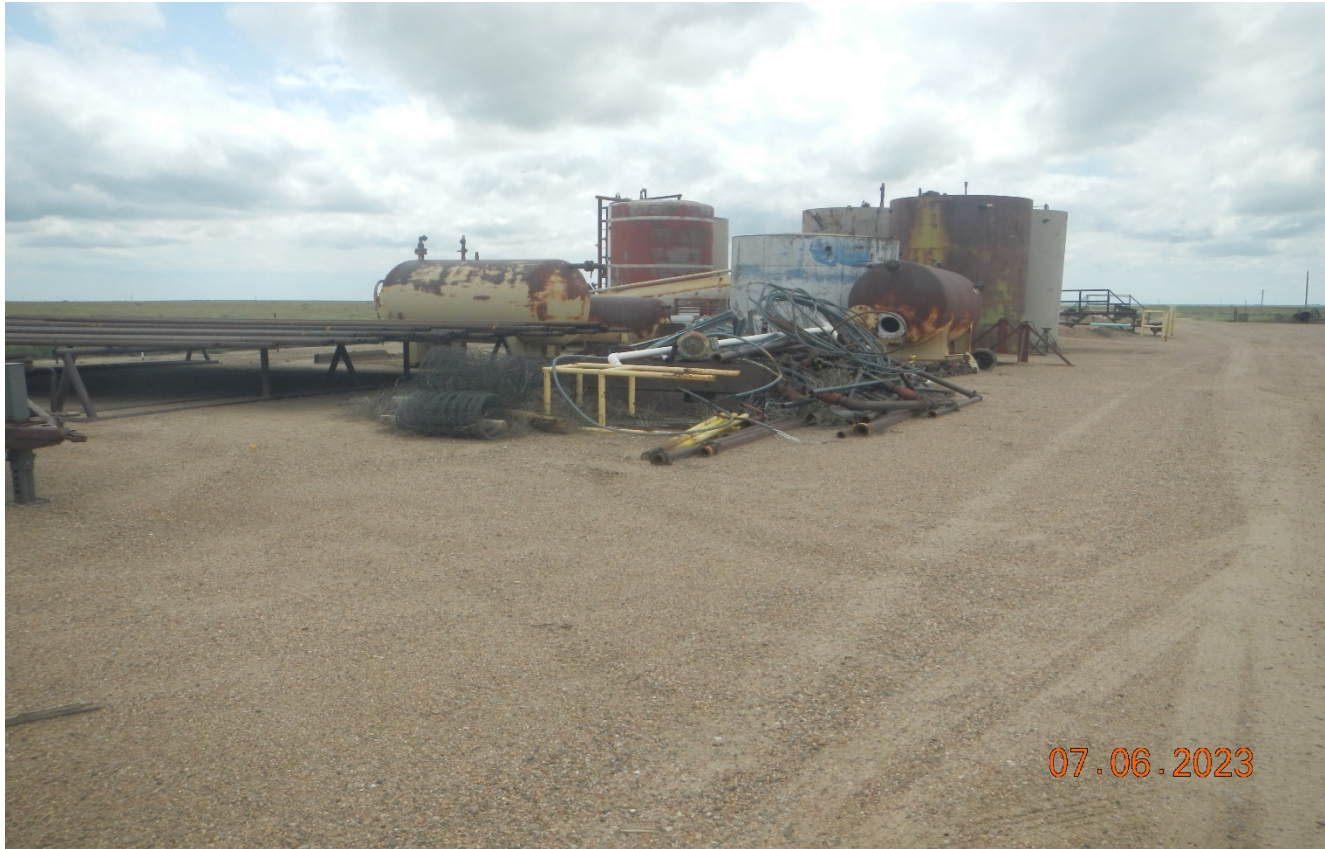
Photo 2. There is unused equipment being stored on location that needs to be removed. All equipment and supplies not necessary for use on this Oil and Gas Location is prohibited per Rule 606 and 1003.a.

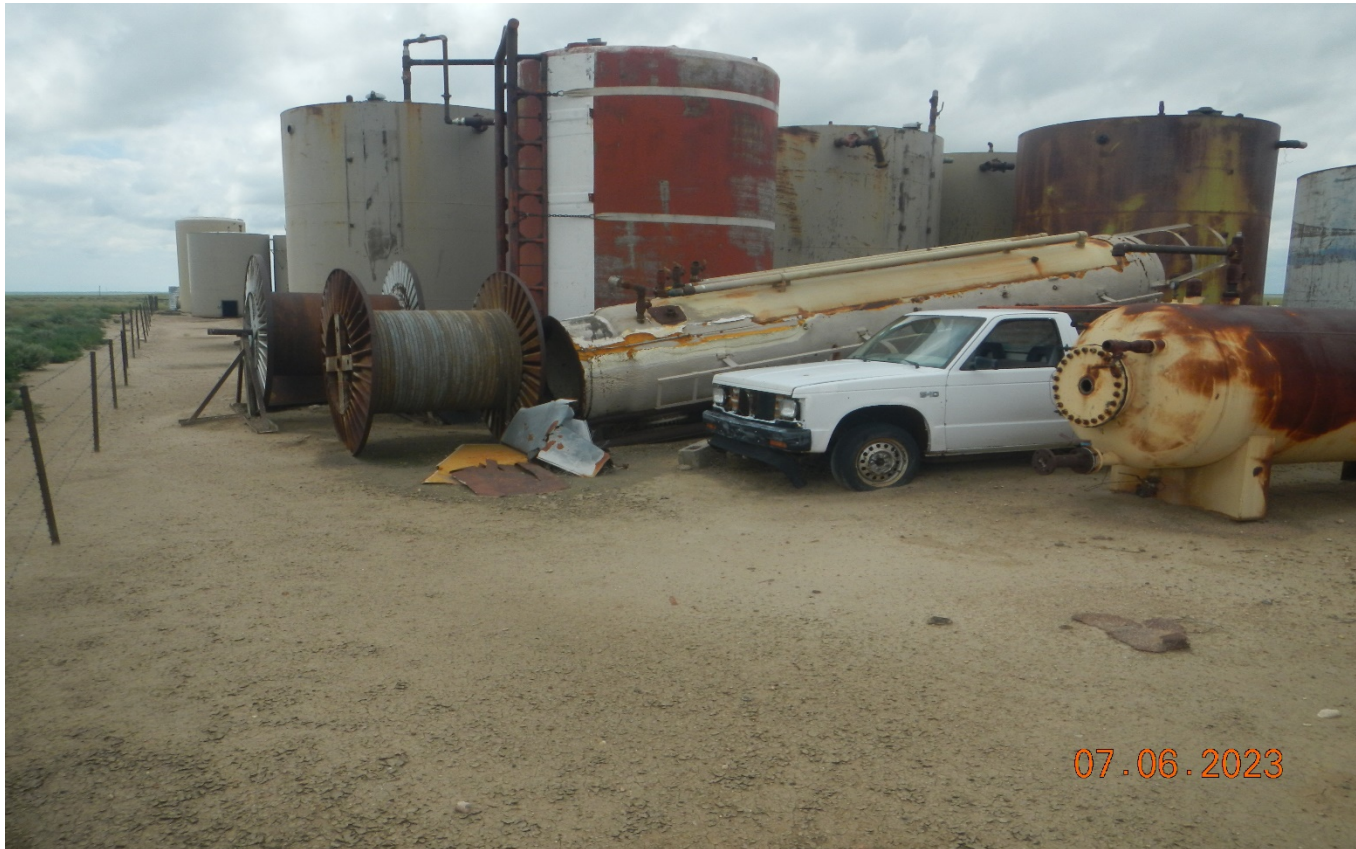
Photo 3. Facing west at the south side of the location. There is equipment and a vehicle that appears to have been sitting unused at this location for awhile.

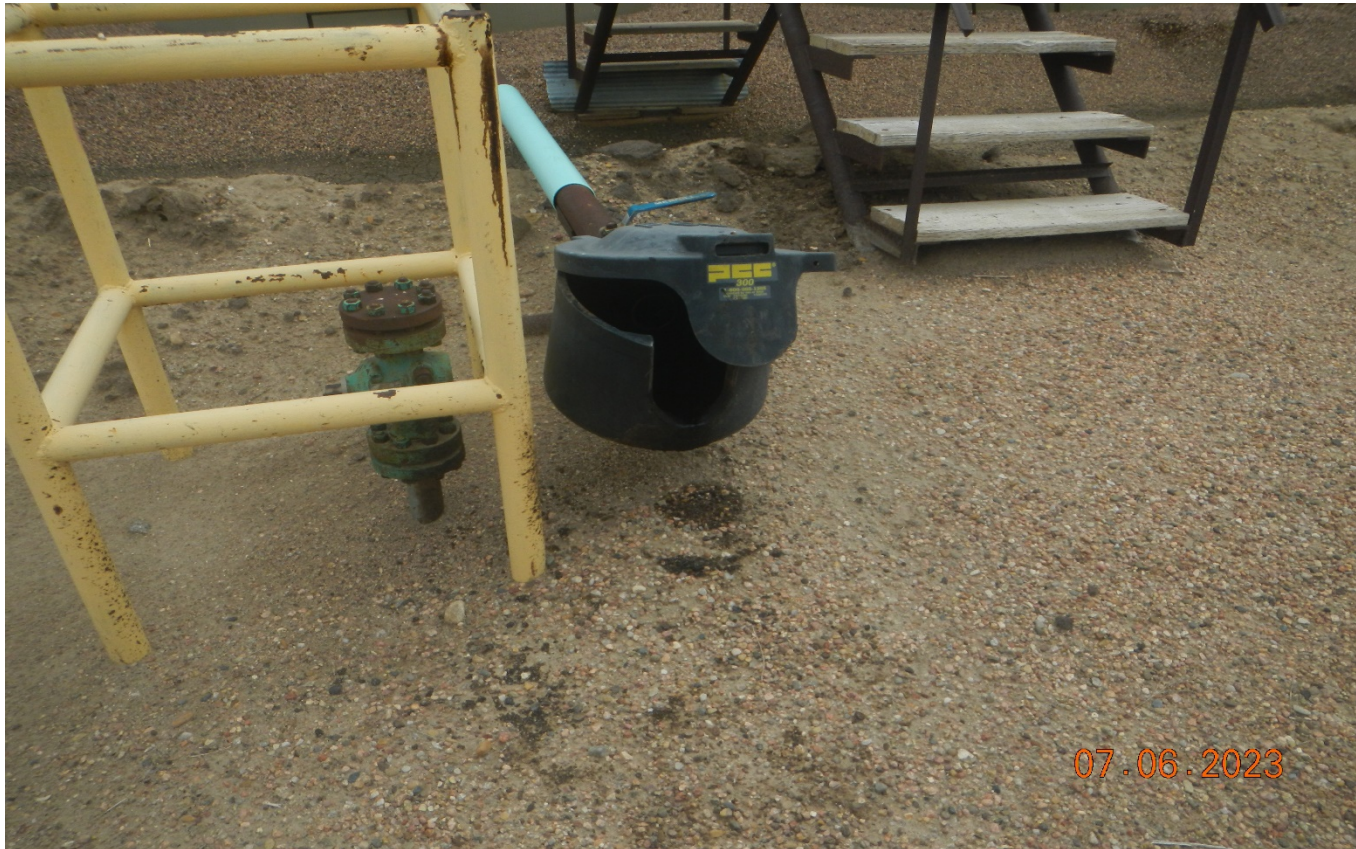
Photo 4. Facing toward the PYLES offsite tank battery at the location. There is still stained soil at the outlet and oil fluid inside the plastic containment.

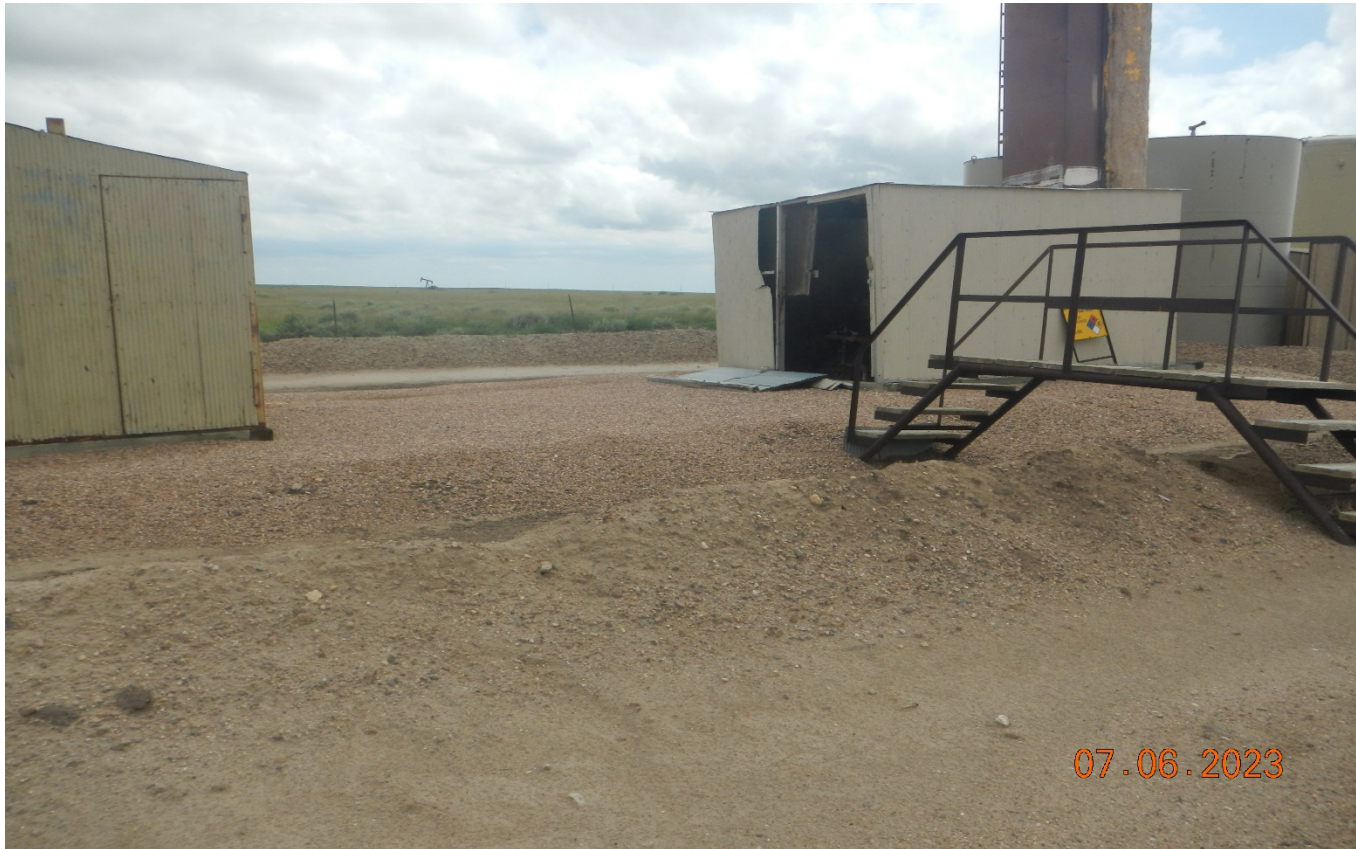
Photo 5. The shed inside the containment battery is not maintained with metal siding laying on the ground.

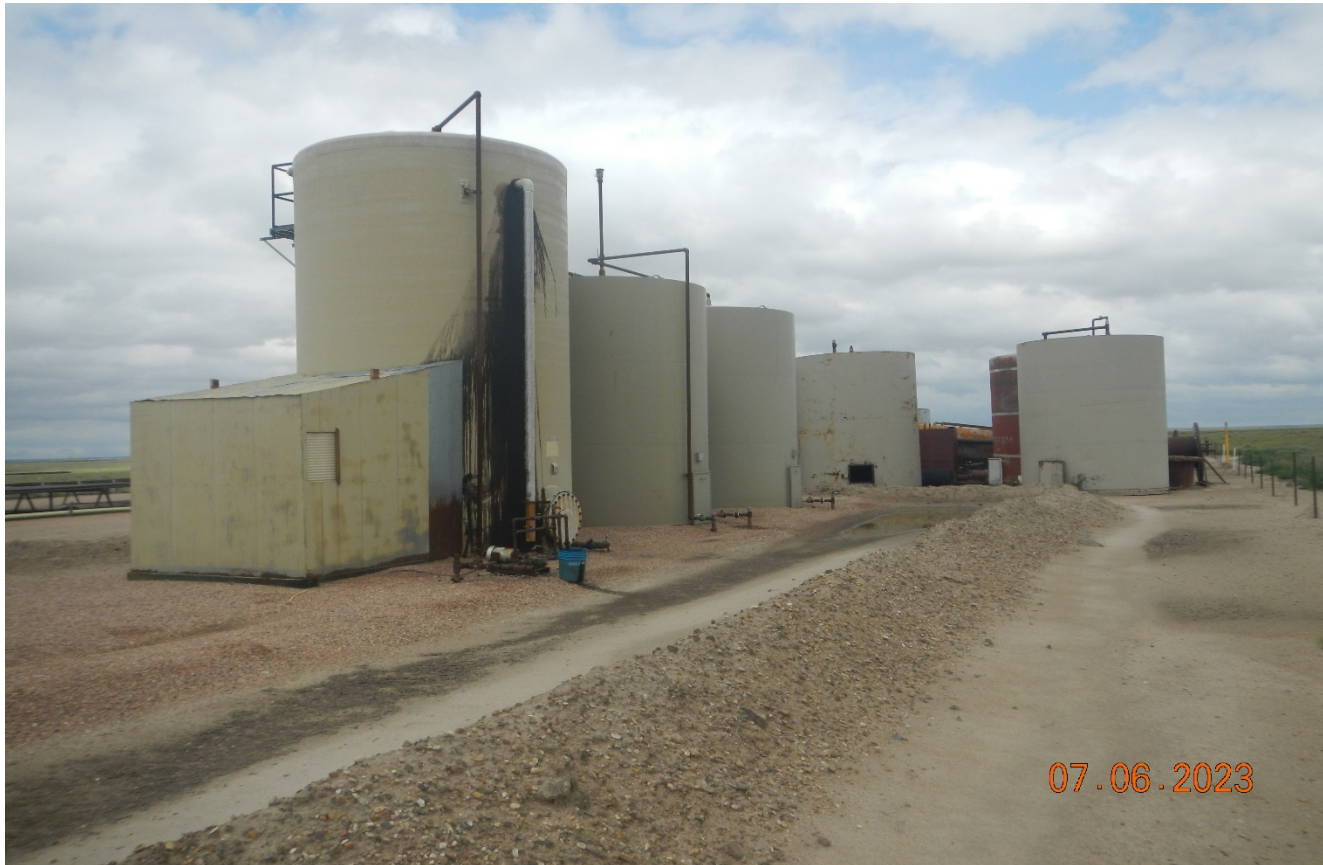
Photo 6. Facing at the back side of the tank battery. There was a spill from the tank which needs to be cleaned up. The blue bucket needs to be emptied and disposed of any oil.

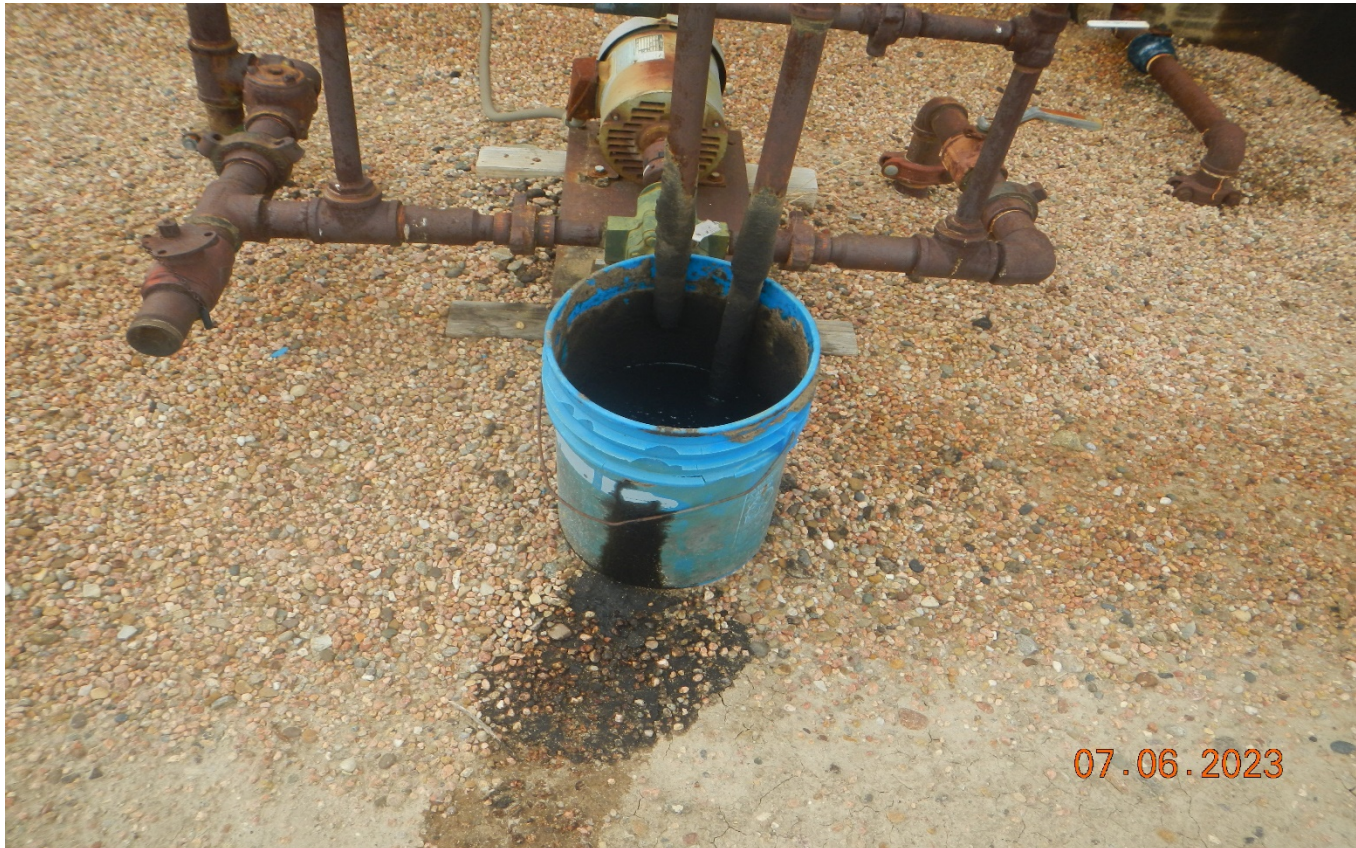
Photo 7. This bucket t the backside of the tank battery is full of oil which has spilled onto the ground.

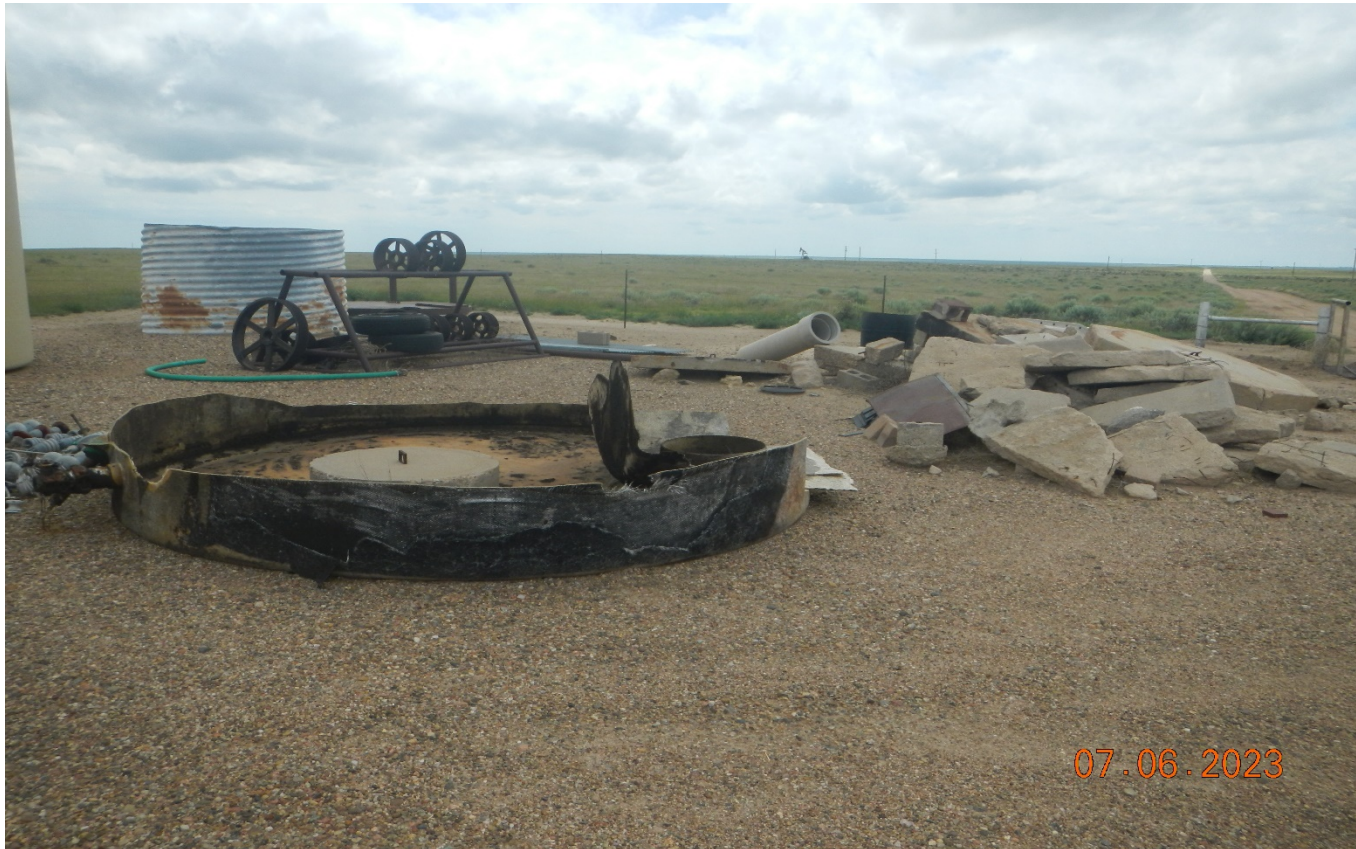
Photo 8. Facing toward the southwest side of the location. There is concrete debris and a broken bottom of a tank among other debris and equipment that must be removed per Rule 606 & 1003.a.

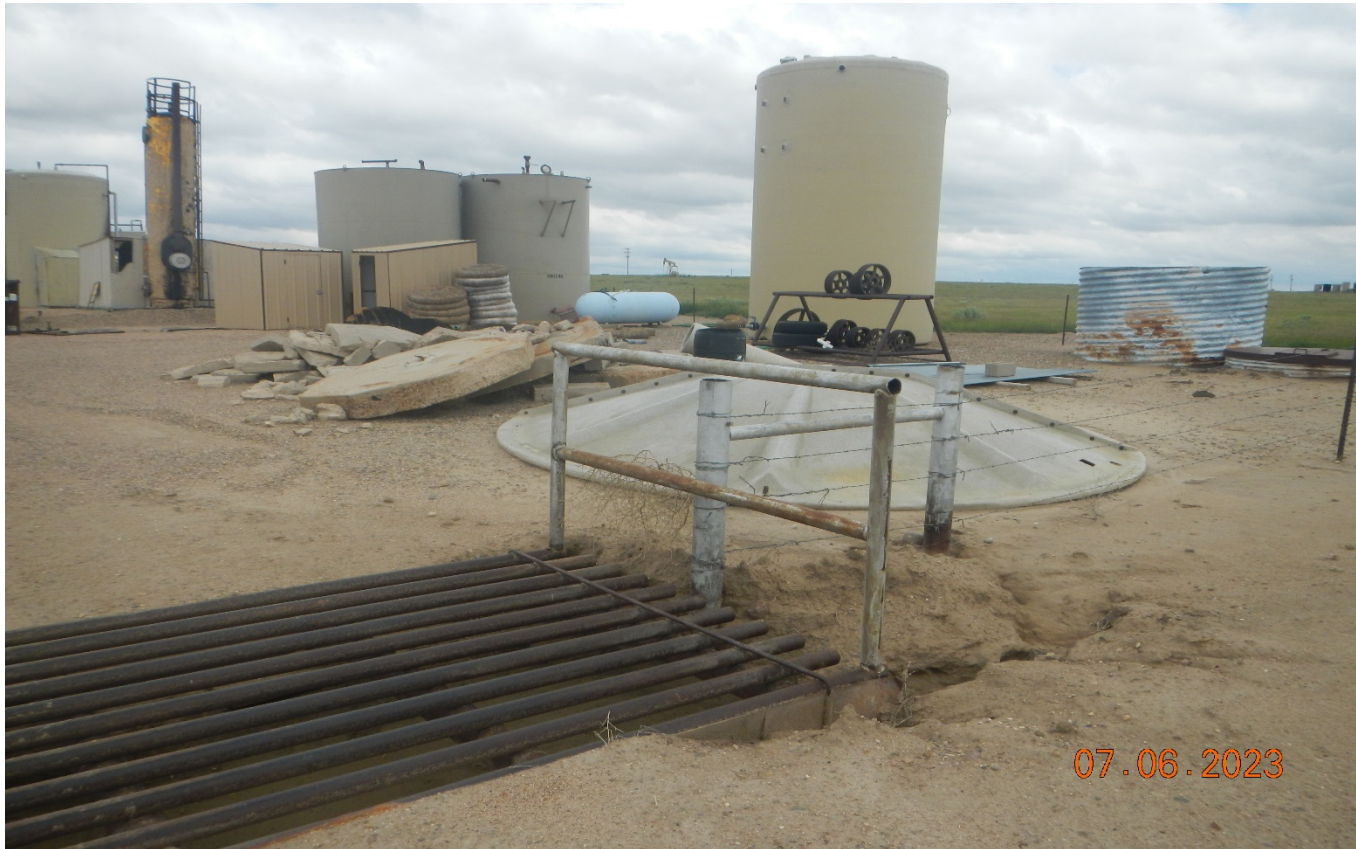
Photo 9. Facing southeast toward the PYLES offsite tank battery and storage yard. There is concrete debris and a broken bottom of a tank among other debris and equipment that must be removed per Rule 606 & 1003.a.

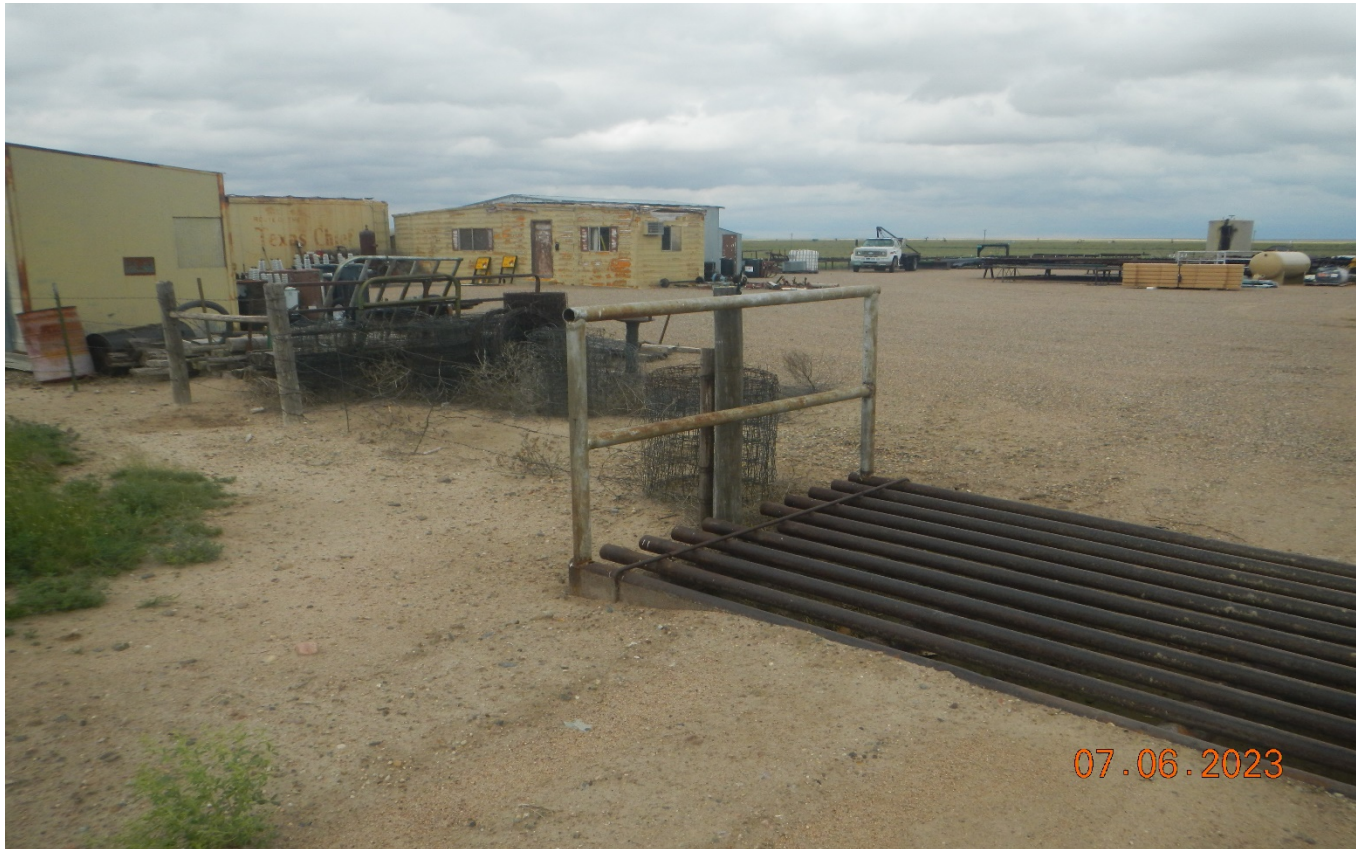
Photo 10. Facing northeast toward the PYLES offsite tank battery and storage yard.

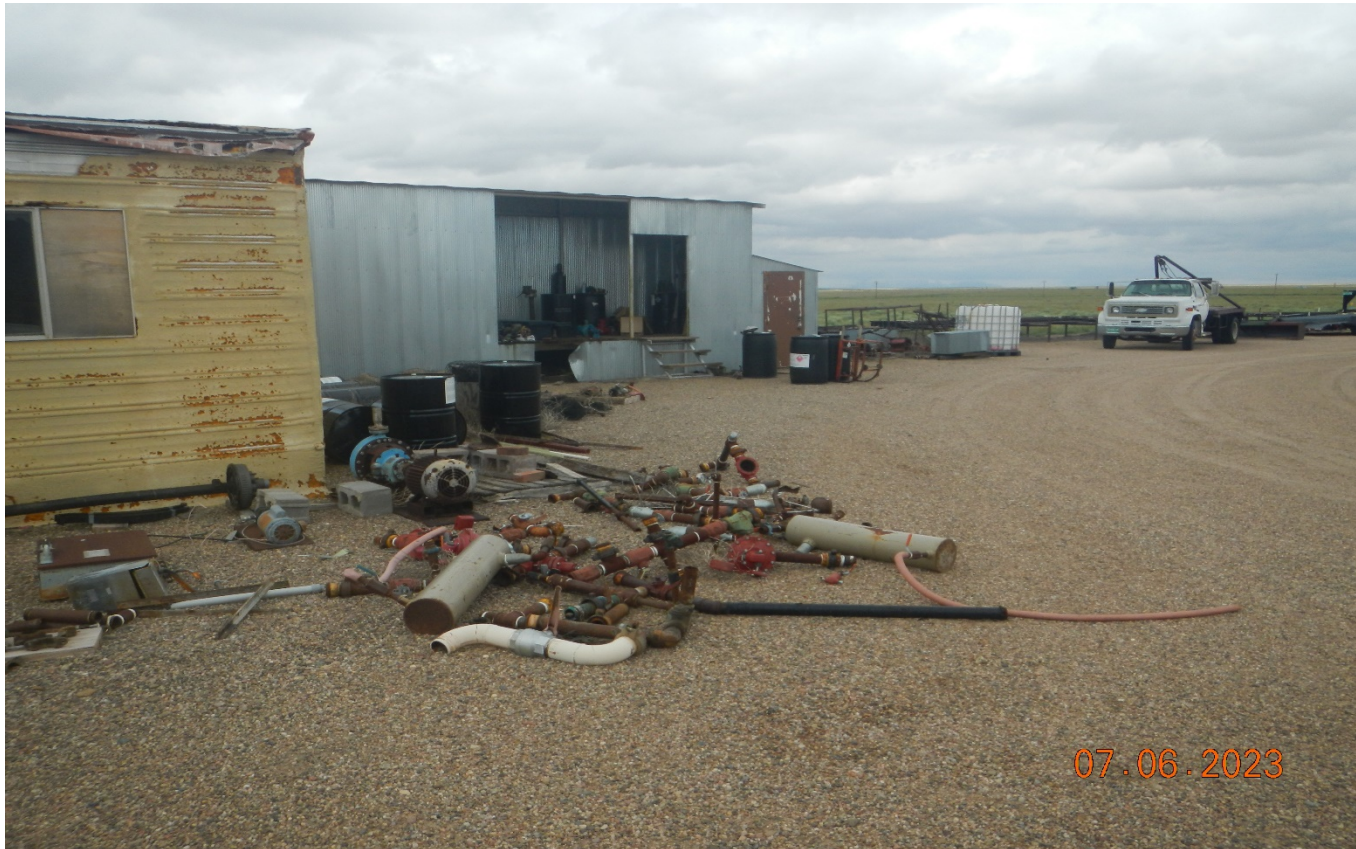
Photo 11. There is various parts and supplies being stored on location. All equipment and supplies not necessary for use on this Oil and Gas Location is prohibited per Rule 606 and 1003.a.

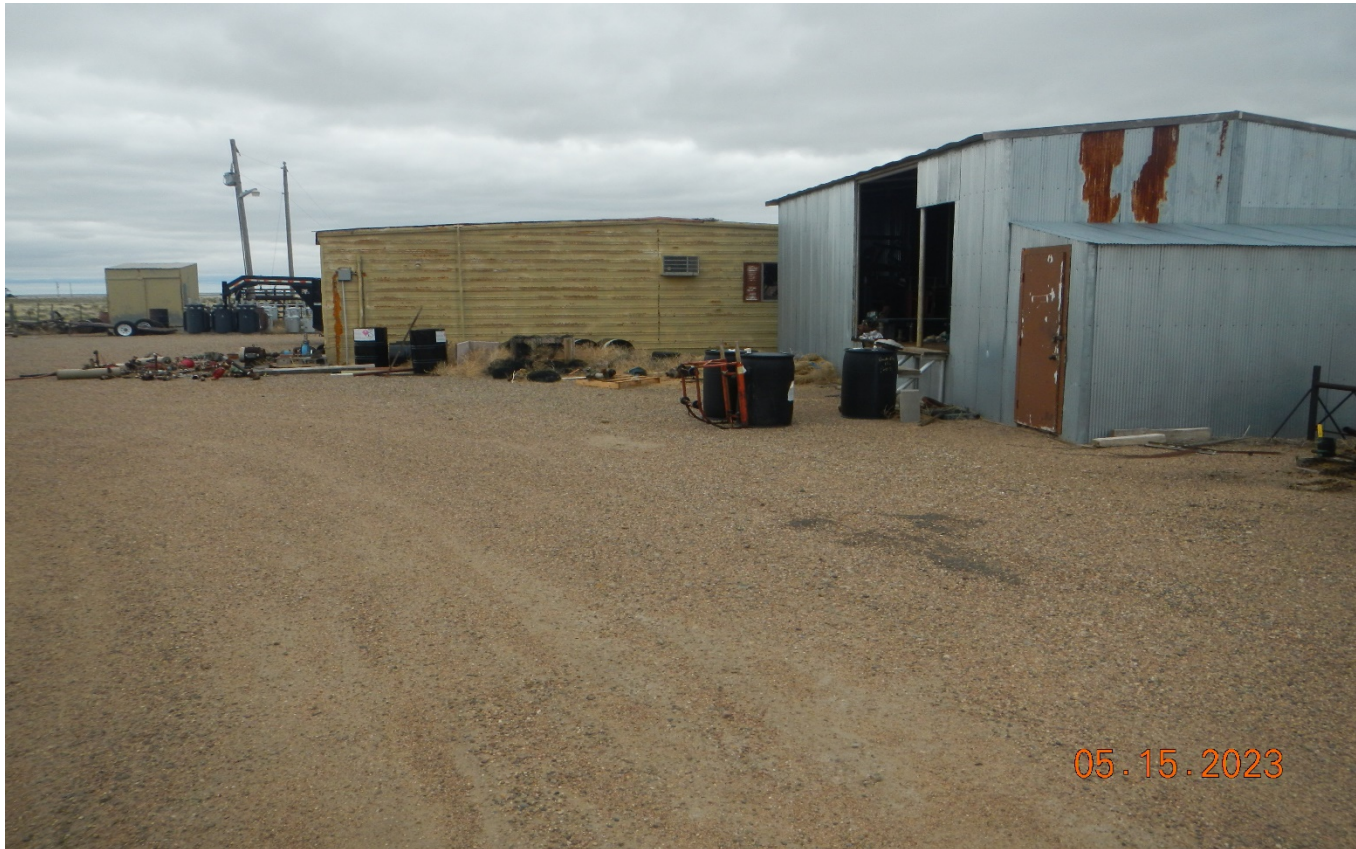
Photo 12. There are several chemical barrels on location with faded labeling and no secondary containment.

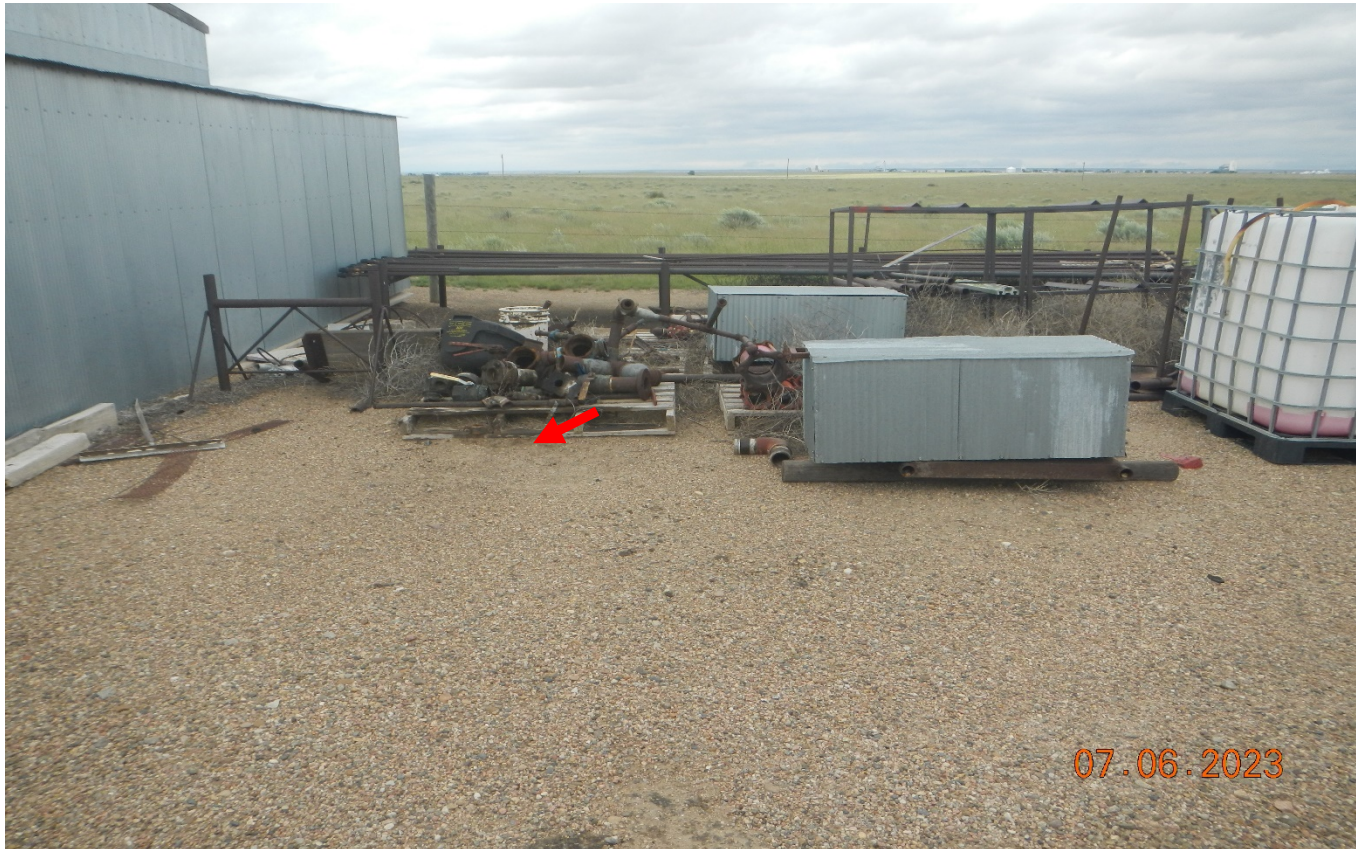
Photo 13. There are various parts and supplies in this area that need to be removed. The two buckets of oil have been removed however stain soils are still evident shown at red arrow.

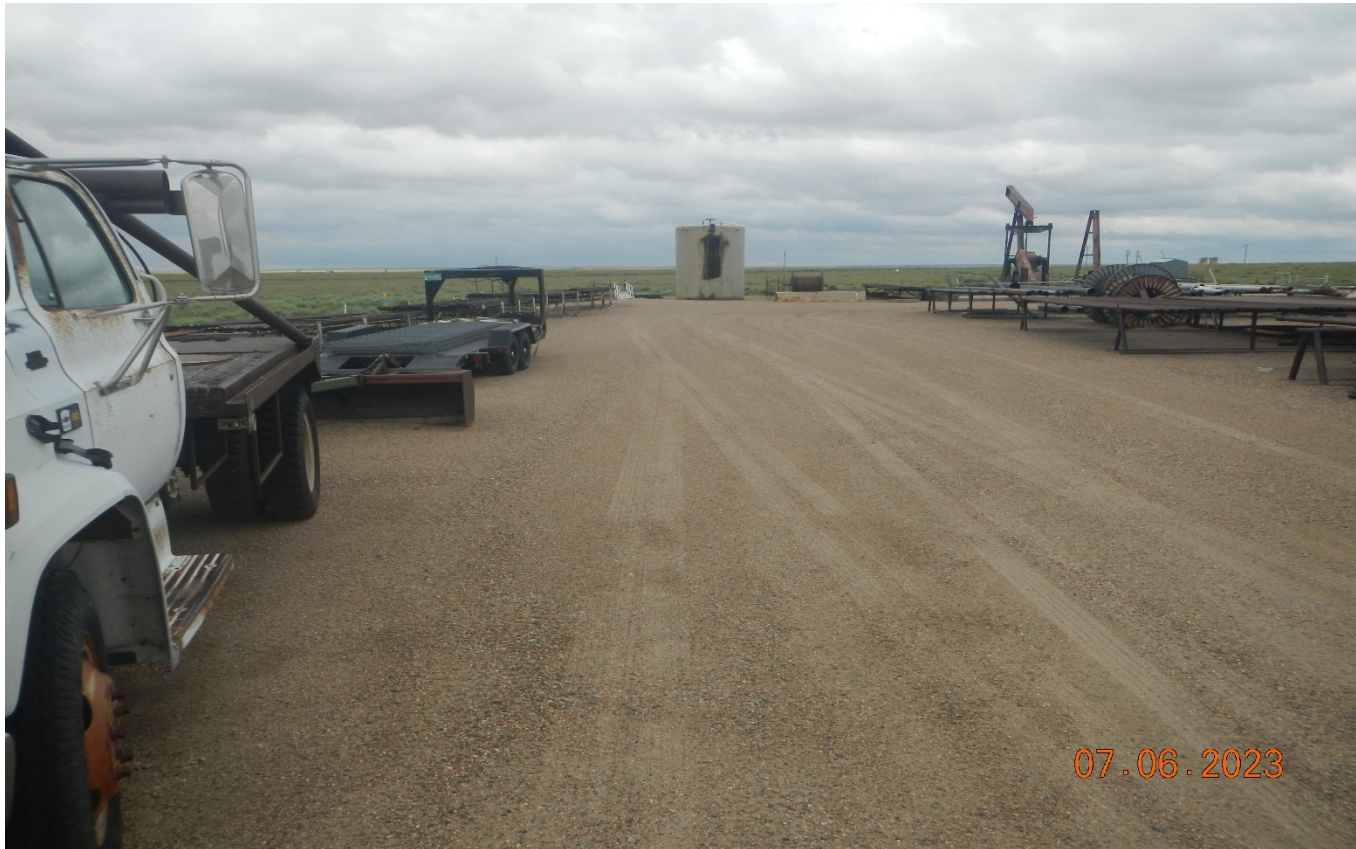
Photo 14. Facing east at the north side of the location. There is storage of unused drilling pipe, trailers, ect. All equipment and supplies not necessary for use on this Oil and Gas Location is prohibited per Rule 606 and 1003.a.

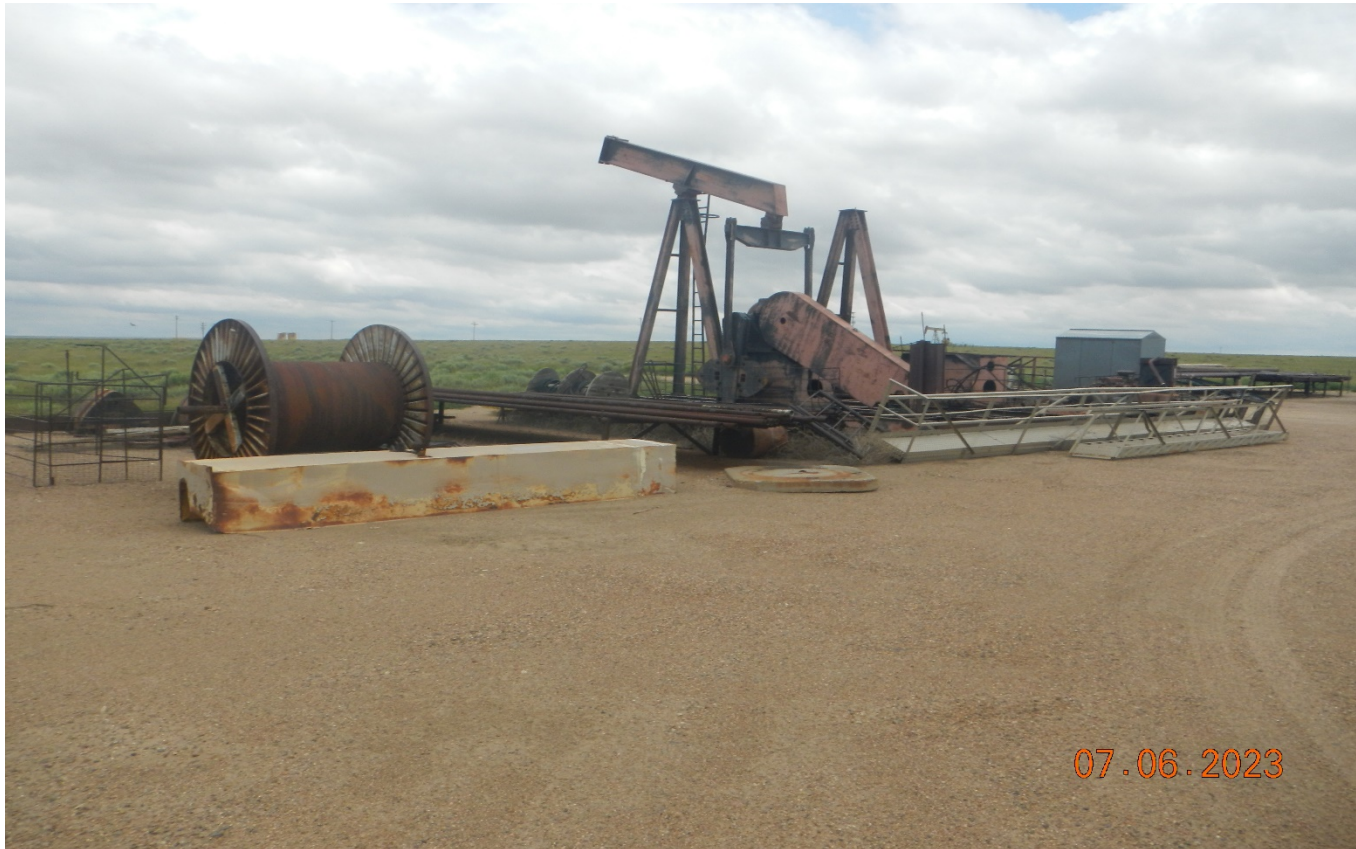
Photo 15. Facing toward the east side of the location. All equipment and supplies not necessary for use on this Oil and Gas Location is prohibited per Rule 606 and 1003.a.

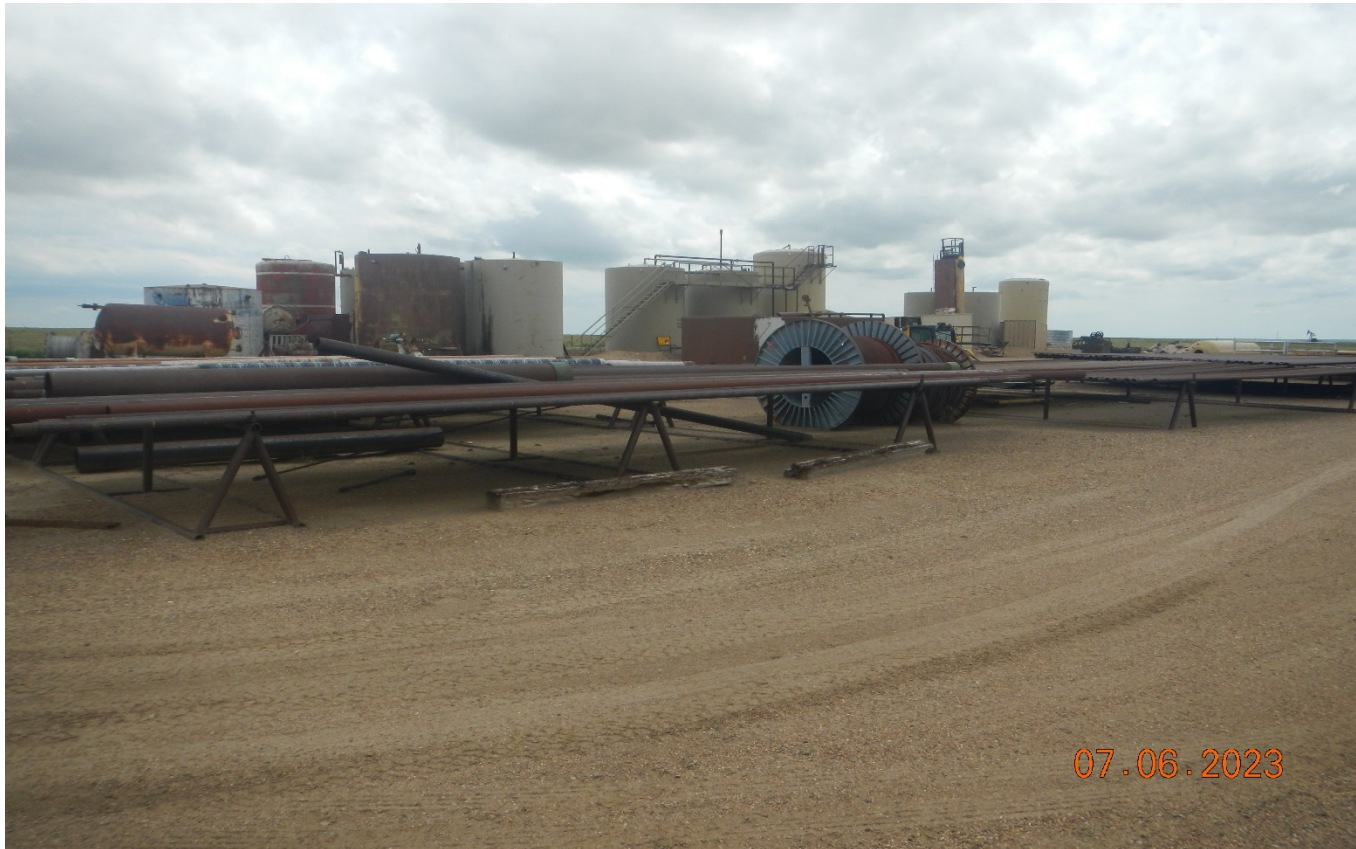
Photo 16. Facing southwest at the location PYLES offsite tank battery and storage yard. The use of this location as a storage yard is prohibited per the rules.
