**Operator: CIVITAS NORTH**  
**Location Name: Downtown Directional 1**  
**Loc ID: 432599**  
**Inspection: 694100119**

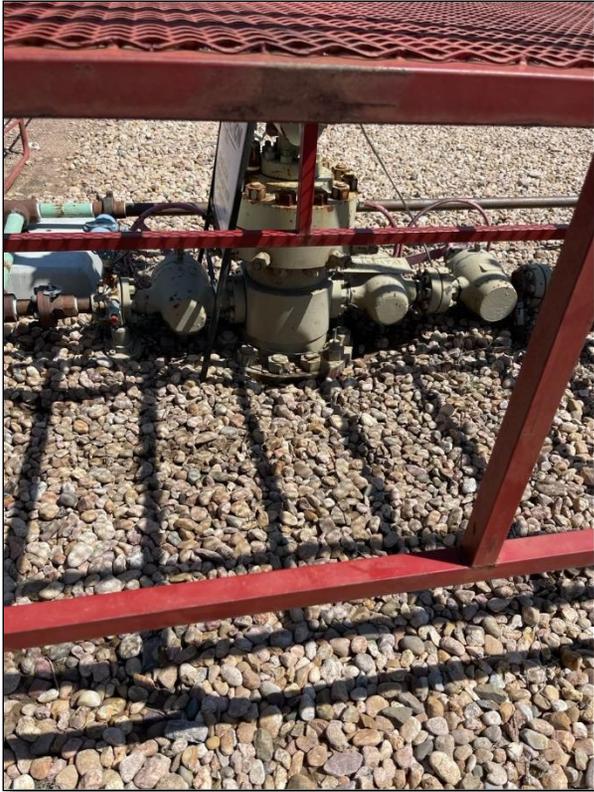
Exhibit A

**CA:** Oily stained soil. Please see photos - For localized stained soils or oily waste - "Properly dispose of oily waste in accordance with 905.e." For larger instances: "Properly dispose of oily waste in accordance with Rule 905.e and contact area COGCC EPS"

**CA Resolution:** Operator has reported and provided photo evidence that the identified stained soils have been properly addressed and disposed of to comply with Rule 905.e.

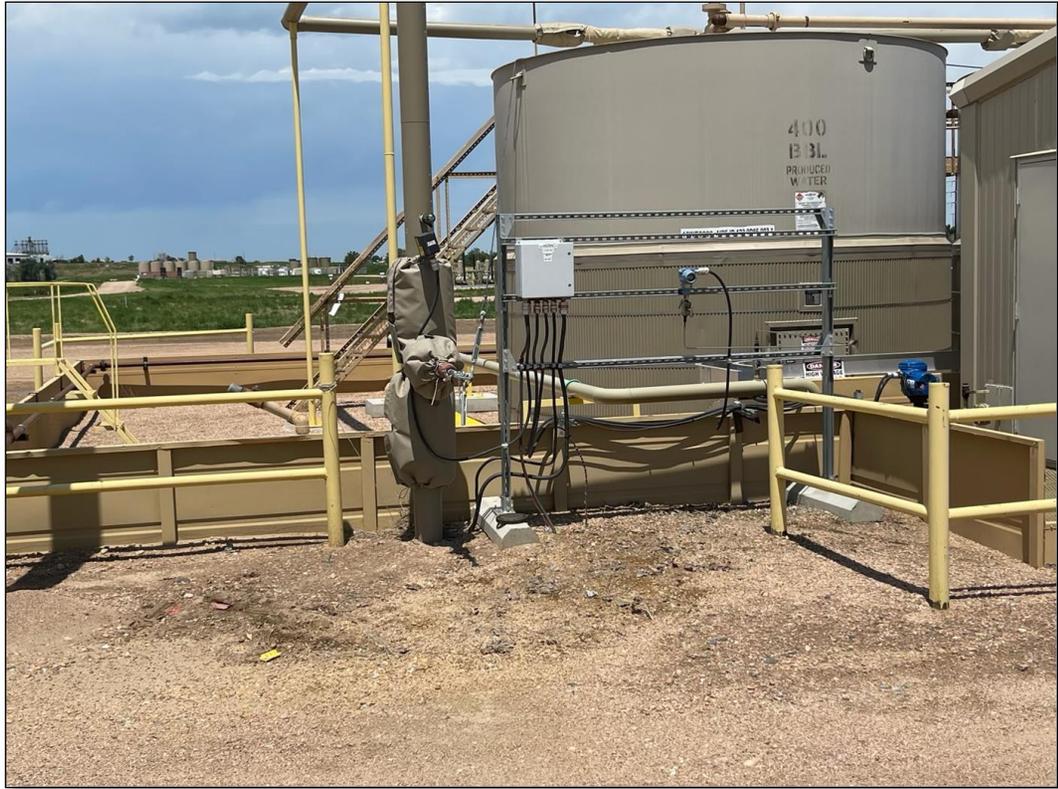
Exhibit B

**CA:** Weeds present. Please see photos. Weeds need to be removed. Statewide unnecessary equipment, weeds, waste, and trash requirements. Comply with Rule 606.

**CA Resolution:** Operator has reported that the weeds/debris identified on the location has been addressed and cleared appropriately to comply with Rule 606.
