Inspection Photos

API: 099-06255

Operator: BERRY* WALTER V DBA BERRY ENERGY INC

Inspection Date: 7/11/2023

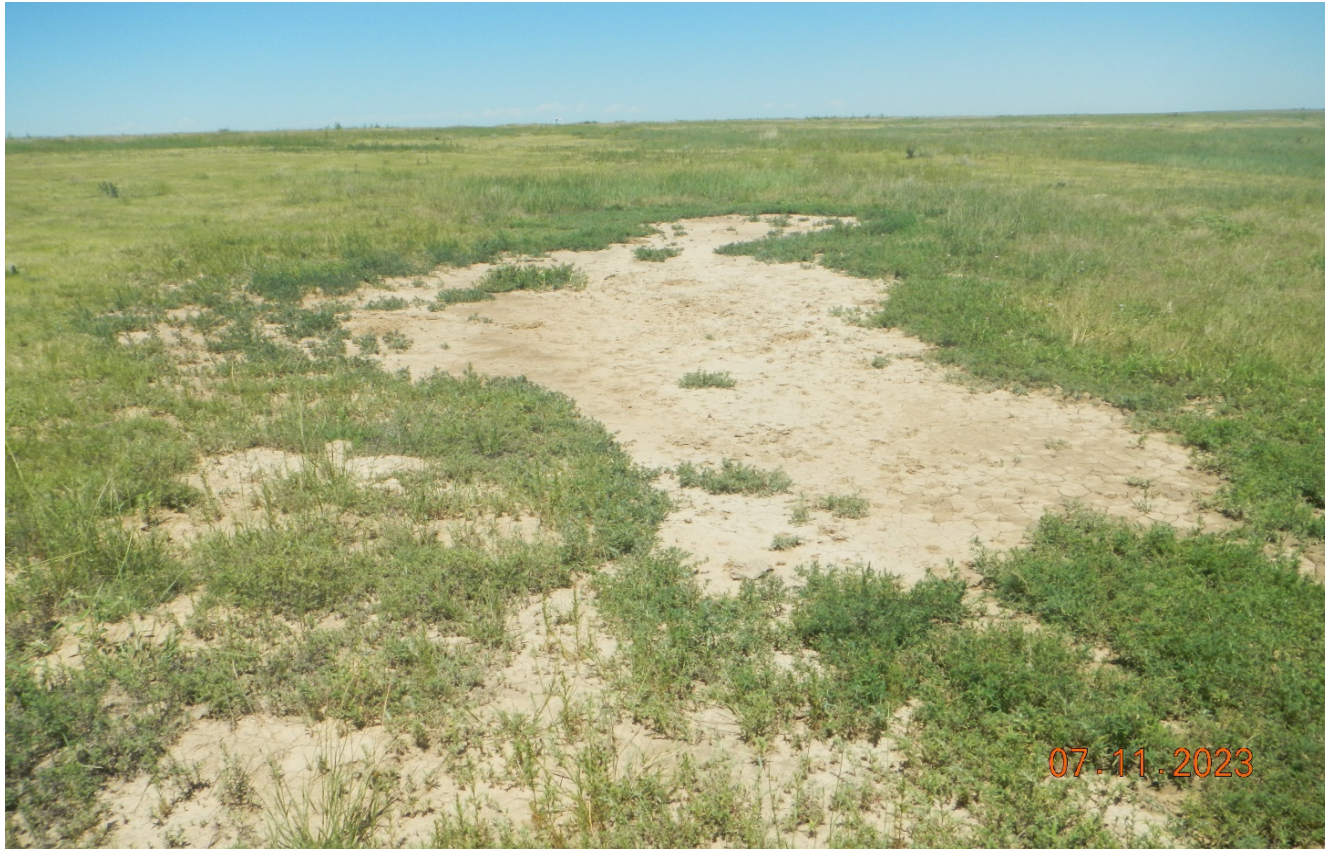
Photo 1. South side of the location facing northeast. This area does not have vegetation establishment which is approximately 100'x50'. This area likely has impacted soils from a possible spill.

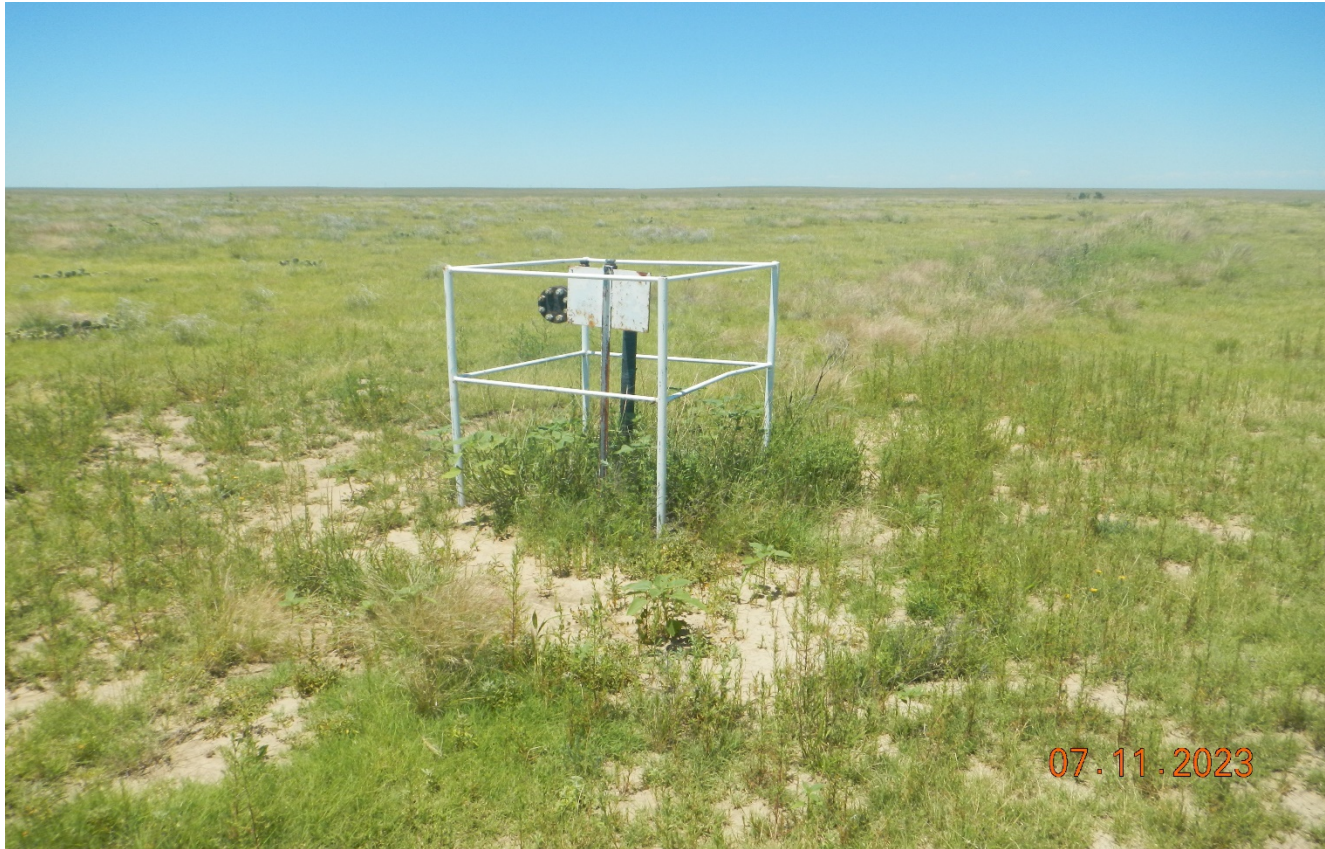
Photo 2. There is a pipe riser that remains at the north side of the location which has not been removed.

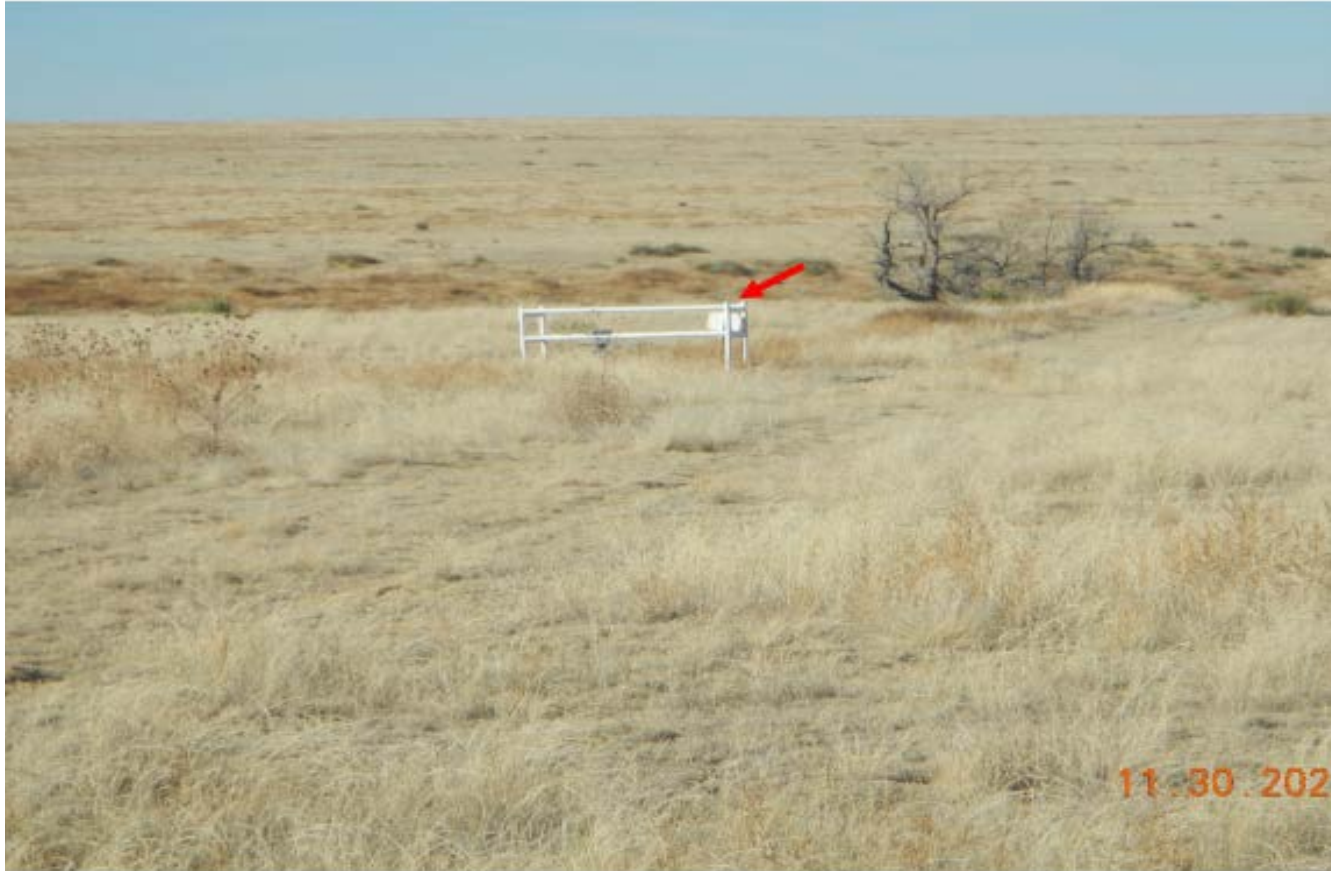
Photo 3. Photo from previous inspection. Facing northwest approximately 1400 ft. northwest of the location. There are two pipe risers associated with the well site that have not been removed. All equipment/risers must be removed. Lat/Long:37.78859,-102.44911.
