Inspection Photos

API: 099-06063

Operator: RENEGADE OIL & GAS COMPANY LLC

Inspection Date: 7/11/2023

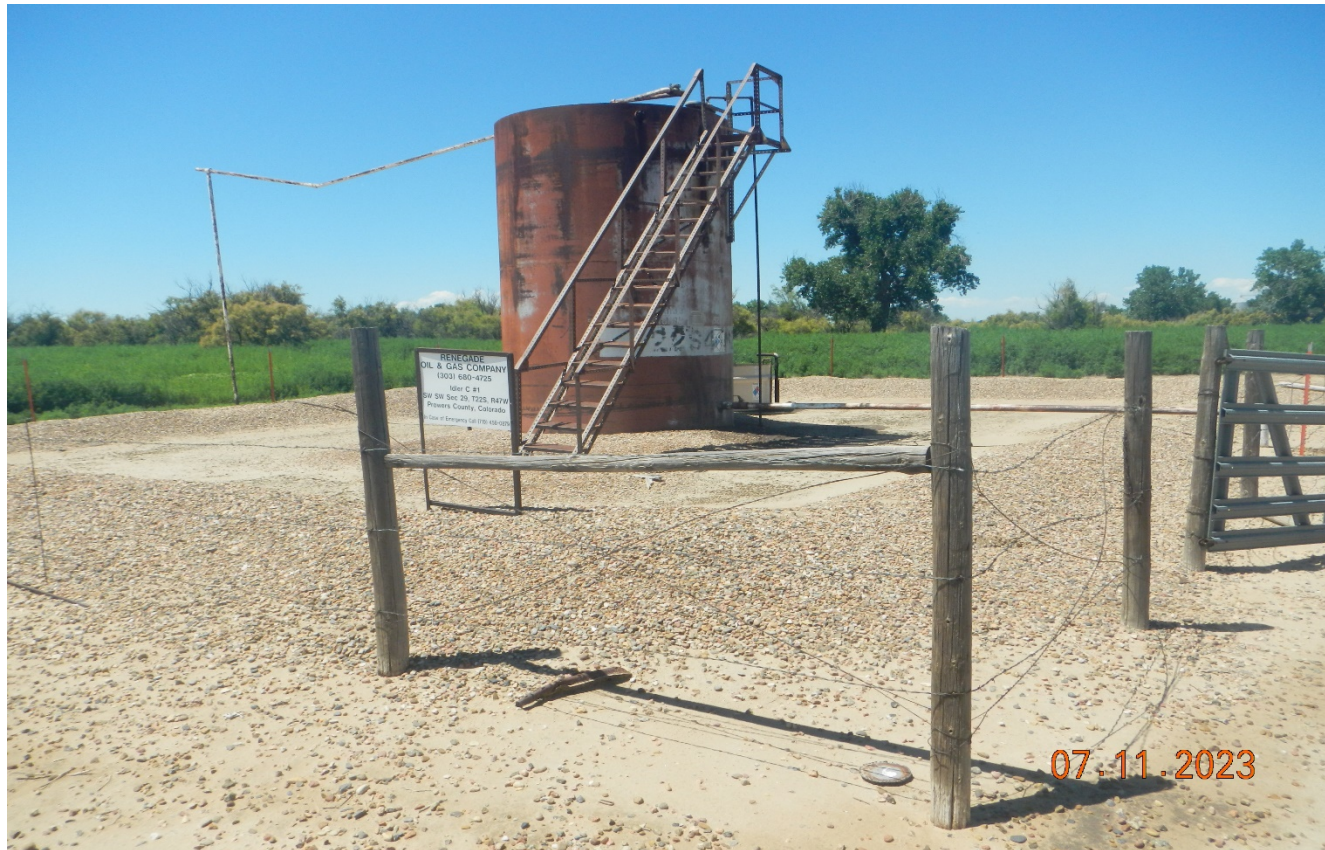
Photo 2. Sign is posted at the tank battery.

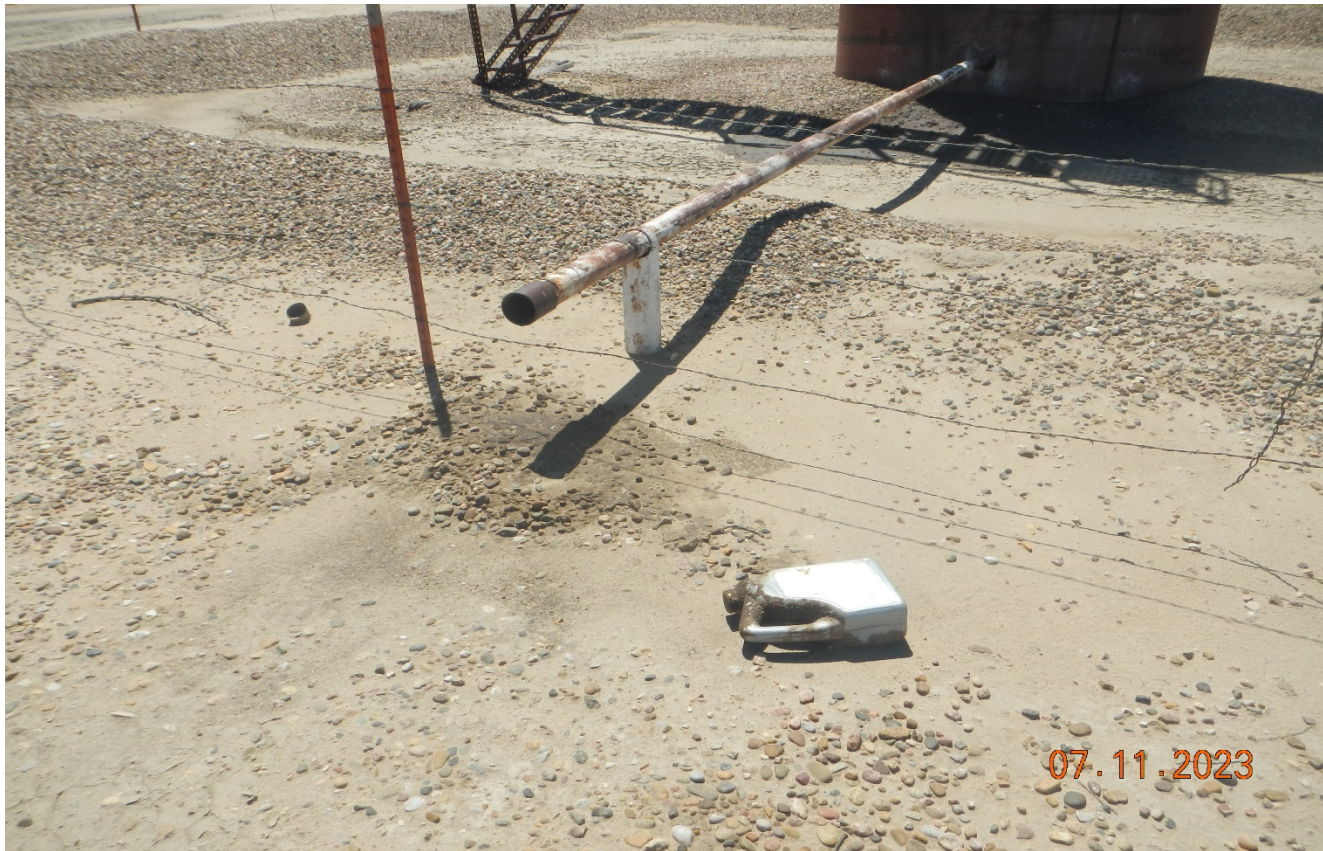
Photo 3. There is oil stained soils at the tank pipe outlet. There is a plastic oil container that needs to be removed and disposed.

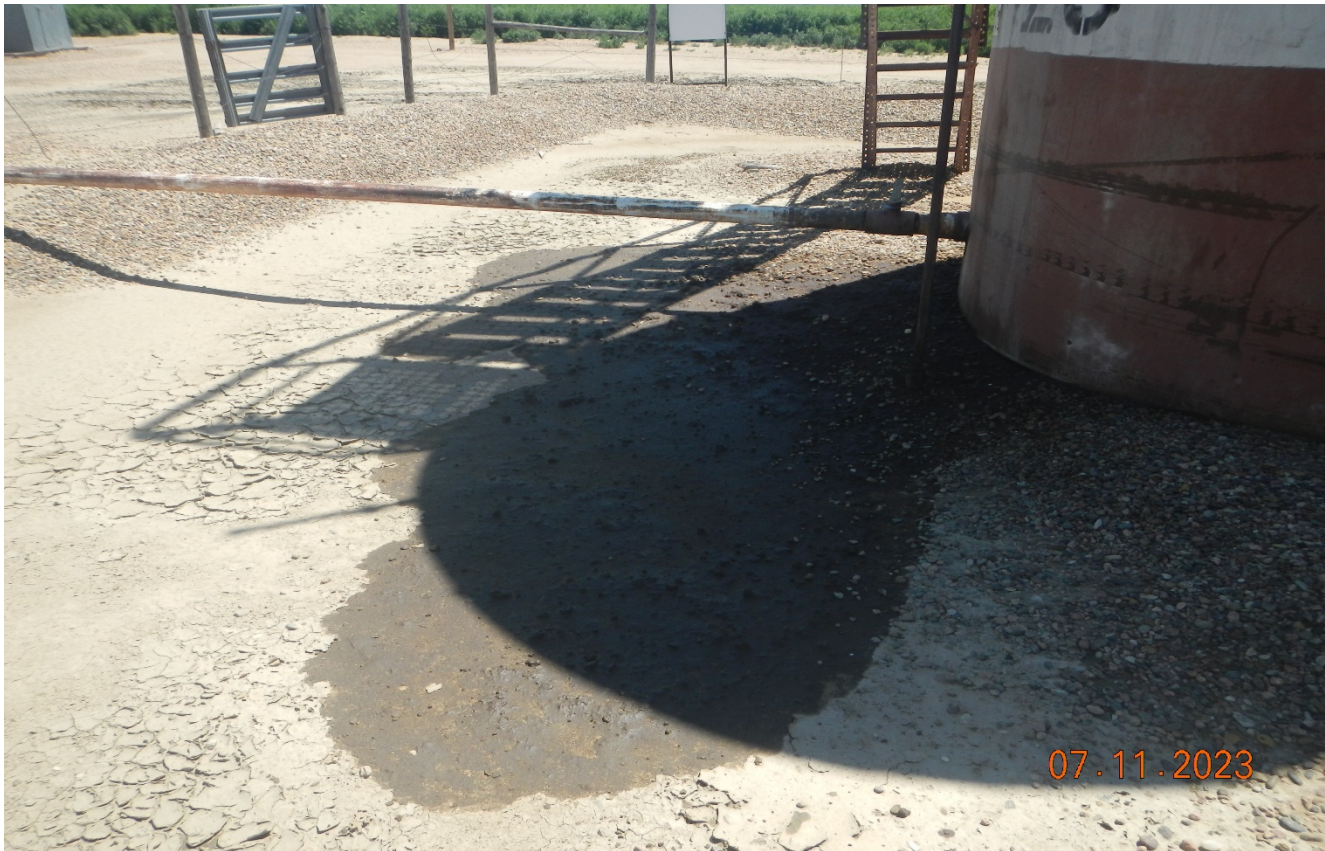
Photo 4. There is oil stained soil at the tank that needs to be cleaned up. It appears to have leaked out from the tank but no leak was observed at time of inspection.

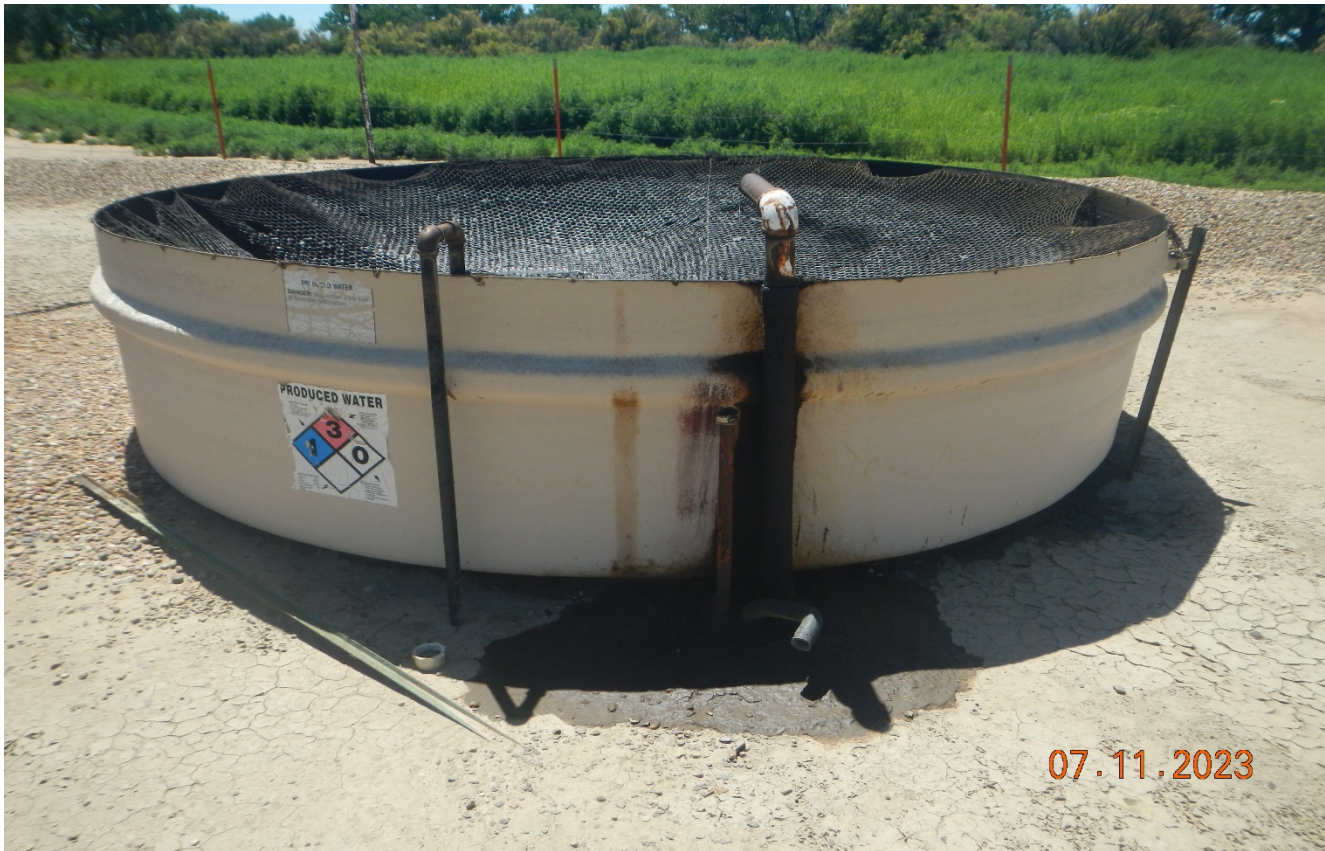
Photo 5. There is oil staining that overtopped the open top tank. There is oil inside the tank and the tank is mislabeled as produced water.

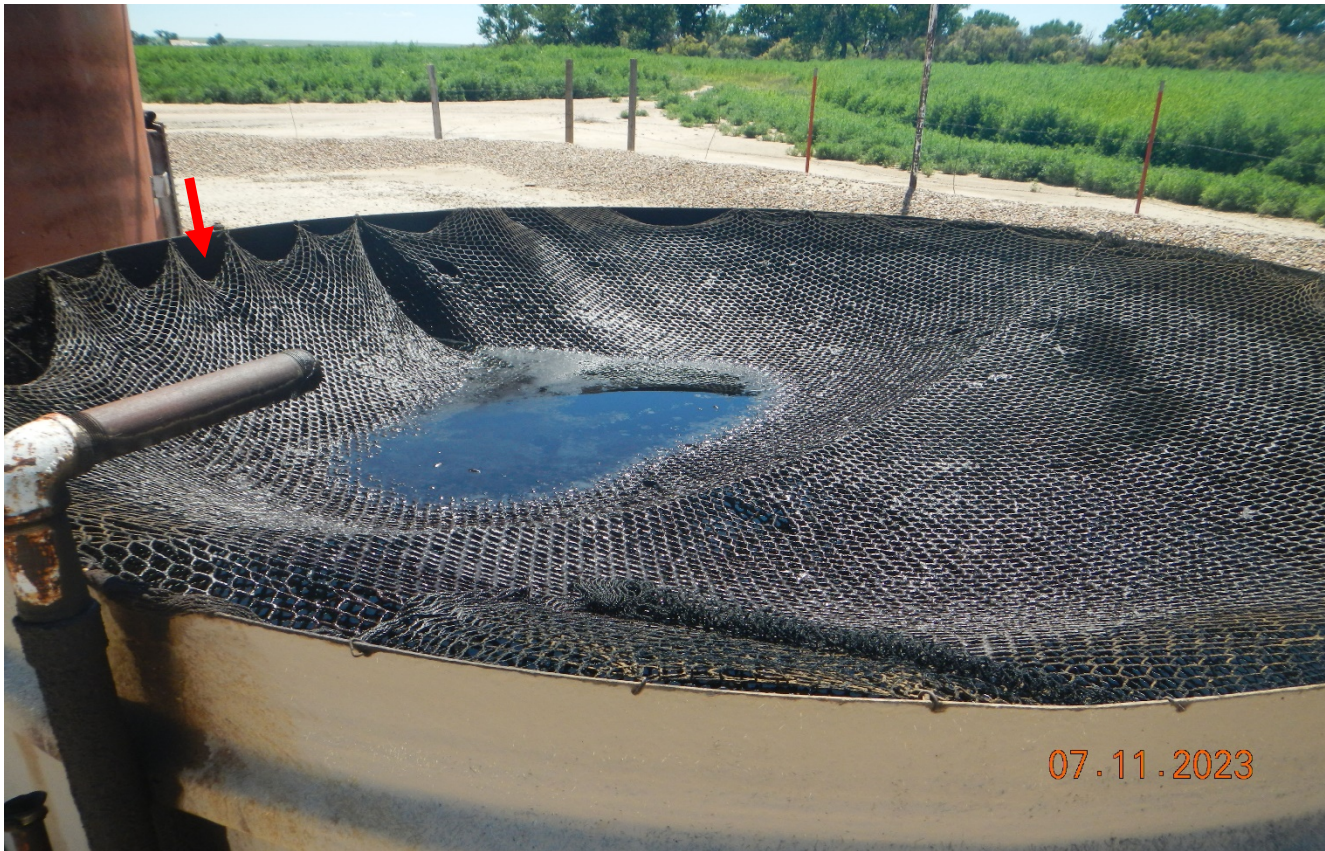
Photo 6. The netting on the open top tank is insufficient to prevent wildlife entry. There are openings at red arrow and oil level is over the netting.
