Inspection Photos

Operator: LARAMIE ENERGY LLC #10433

Location Number: 335647

Garfield County, CO

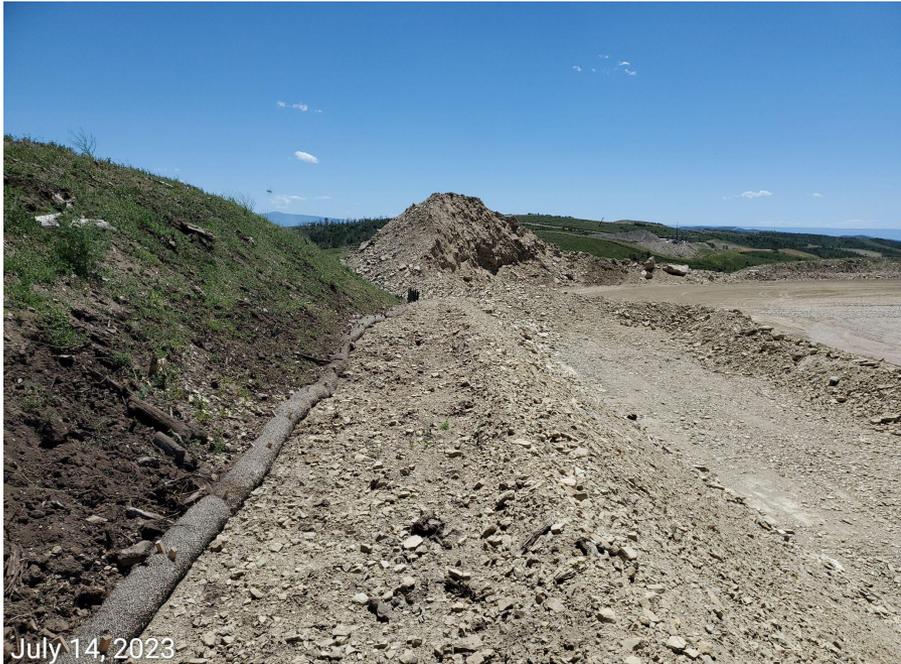
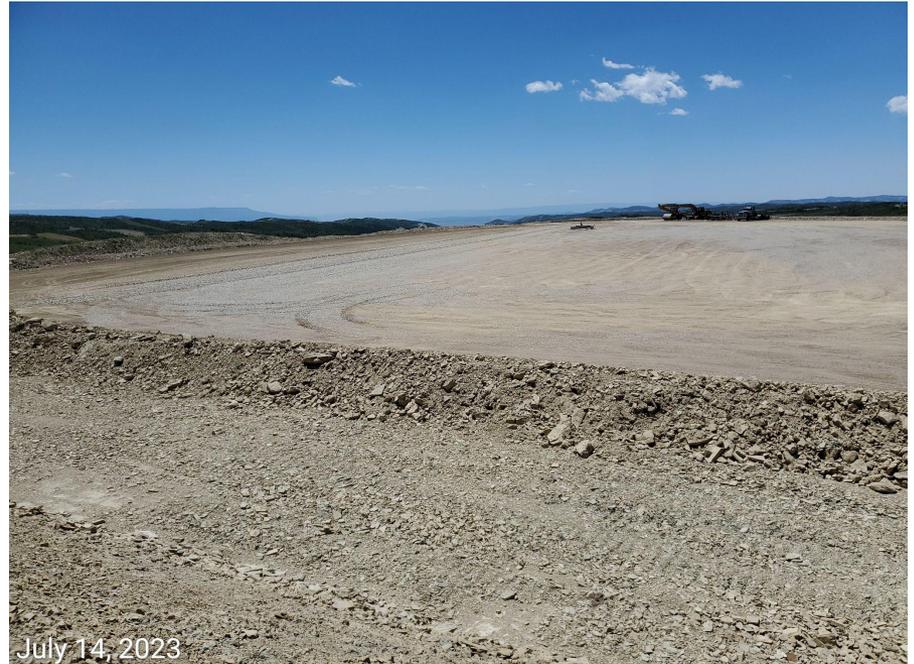
Photo 1: Photos 1-2 taken from the northeast end of the pad. Photos provide an overview of the Location from southeast, southwest, west to northwest.

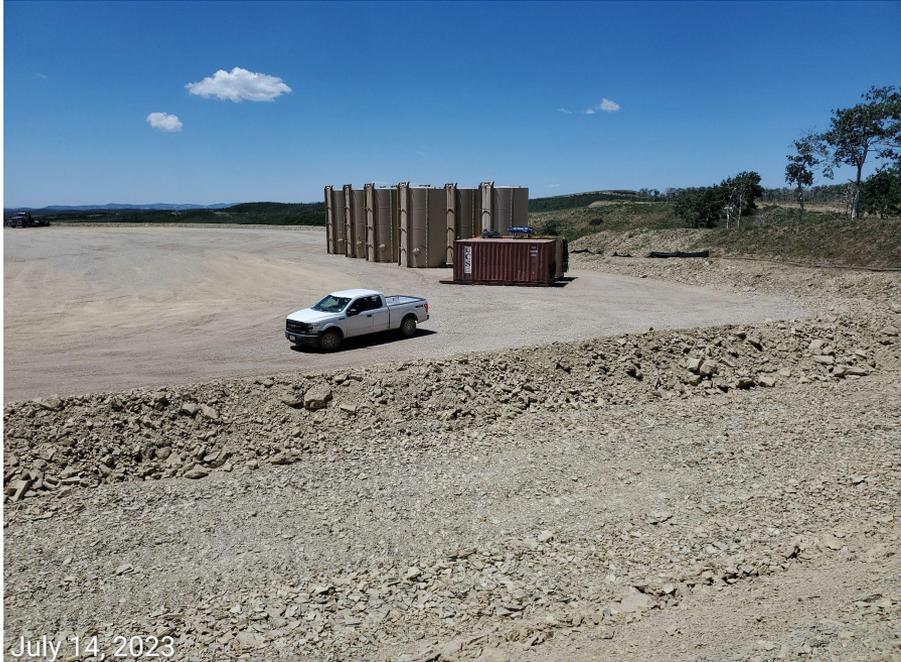
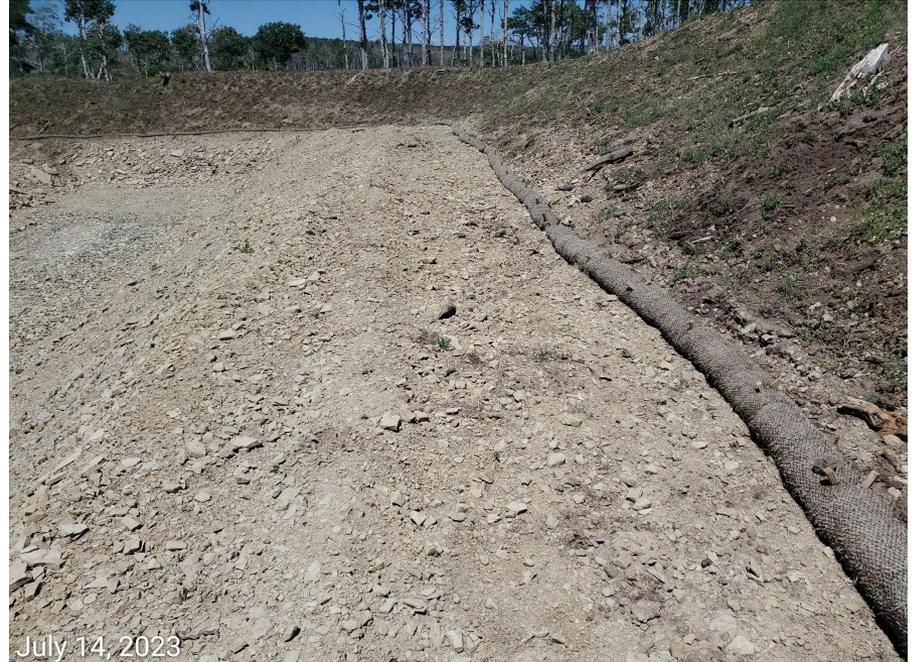
Photo 2: see comments under photo 1.

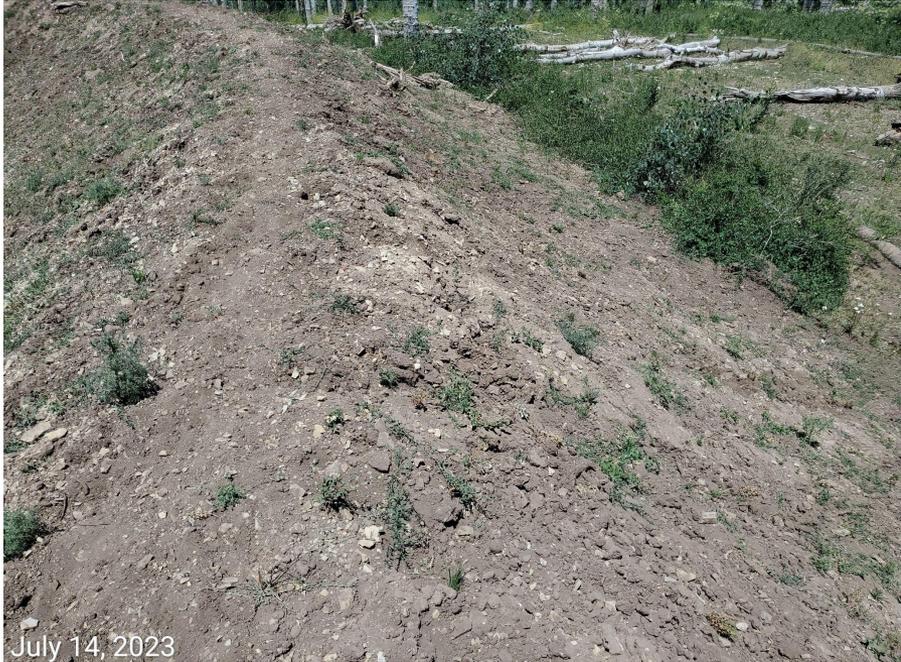
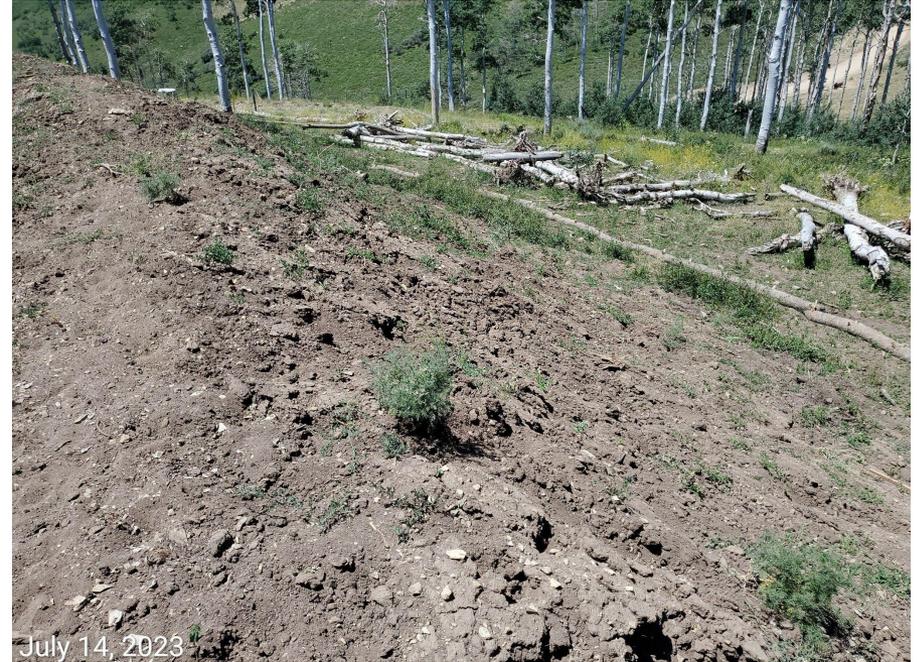
Photo 3: Photos 3-4 taken from the topsoil stockpiles on the Location. Photos examples showing BMPs to protect the topsoil from erosion, degradation and weed establishment remain missing or insufficient. Soils predominantly bare and at risk to erosion. Vegetation observed on topsoil stockpiles Undesirable Plant Species such as amaranth, various introduced mustard species, prostrate knotweed, etc...

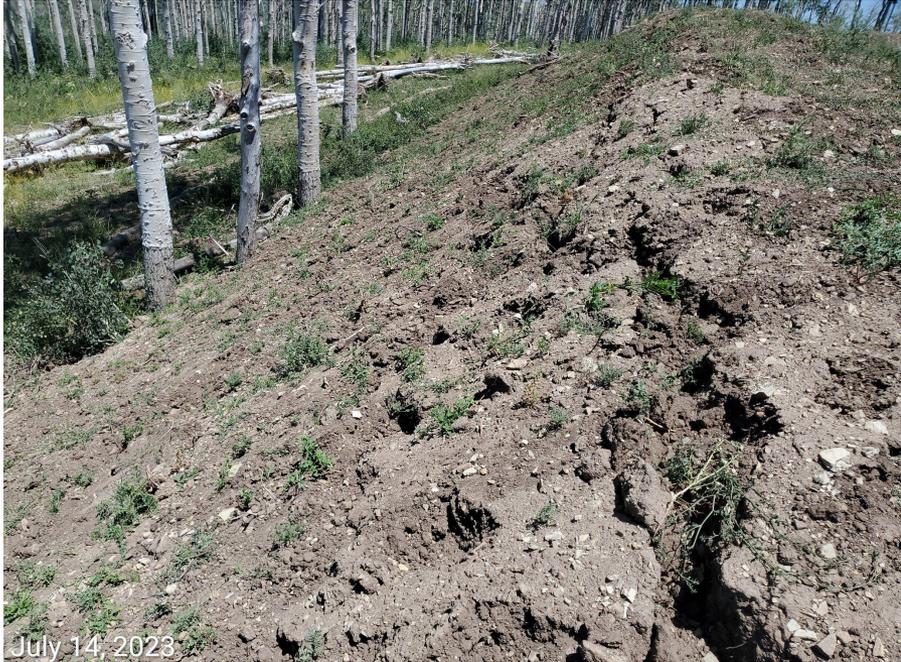
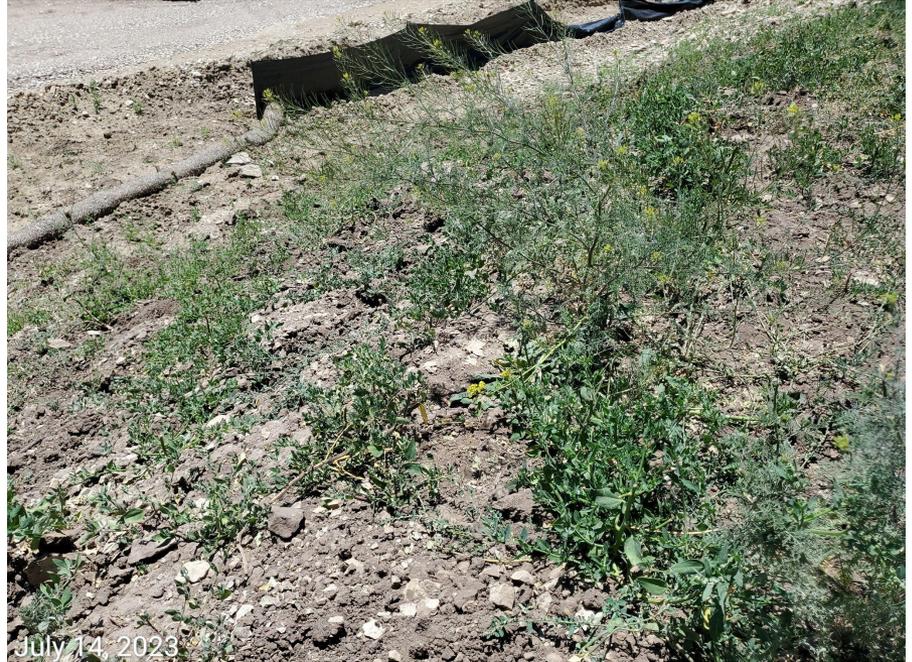
Photo 4: See comments under photo 3.

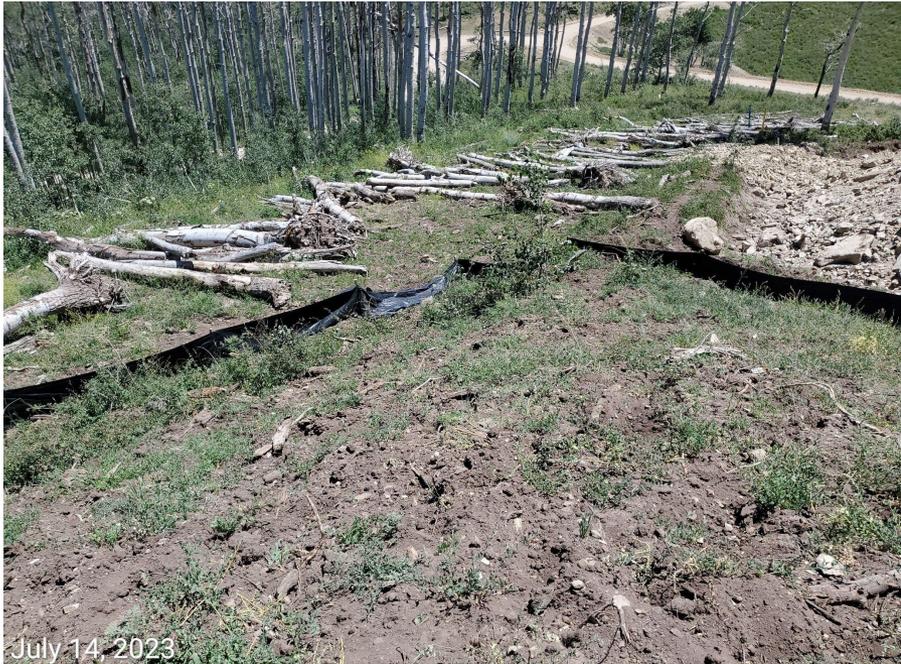
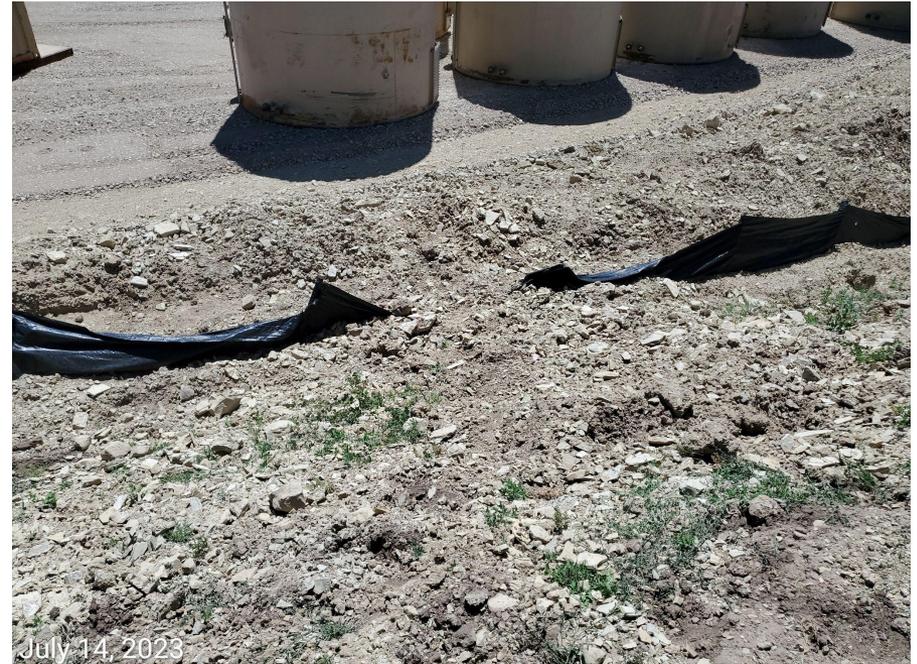
Photo 5: Photos 5-6 examples showing silt fence installed on the Location have not been maintained in proper functioning condition. Photos also show BMPs to ensure topsoil remains segregated from the fille slope/subsoils are inadequate on the Location.

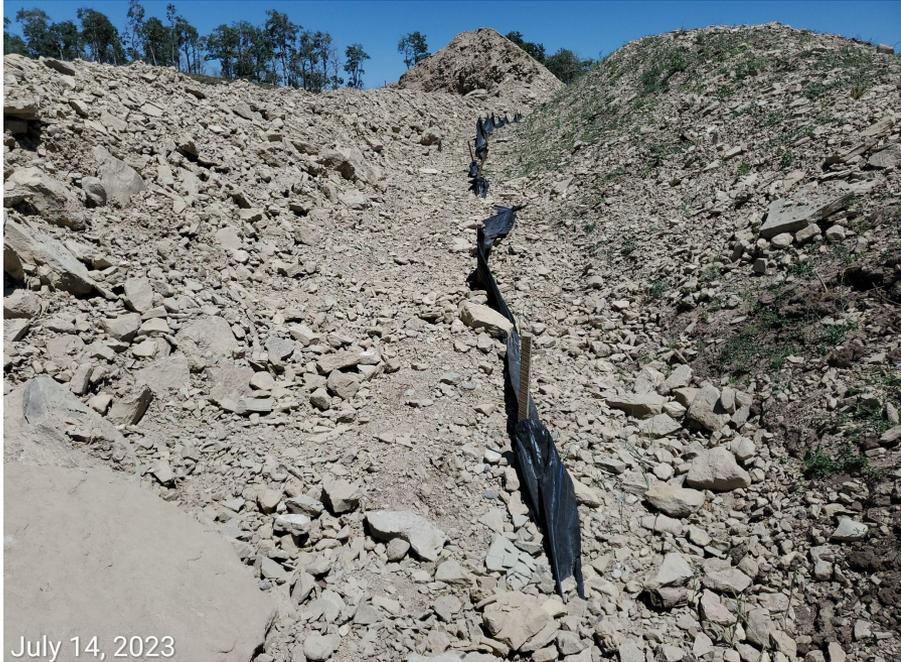
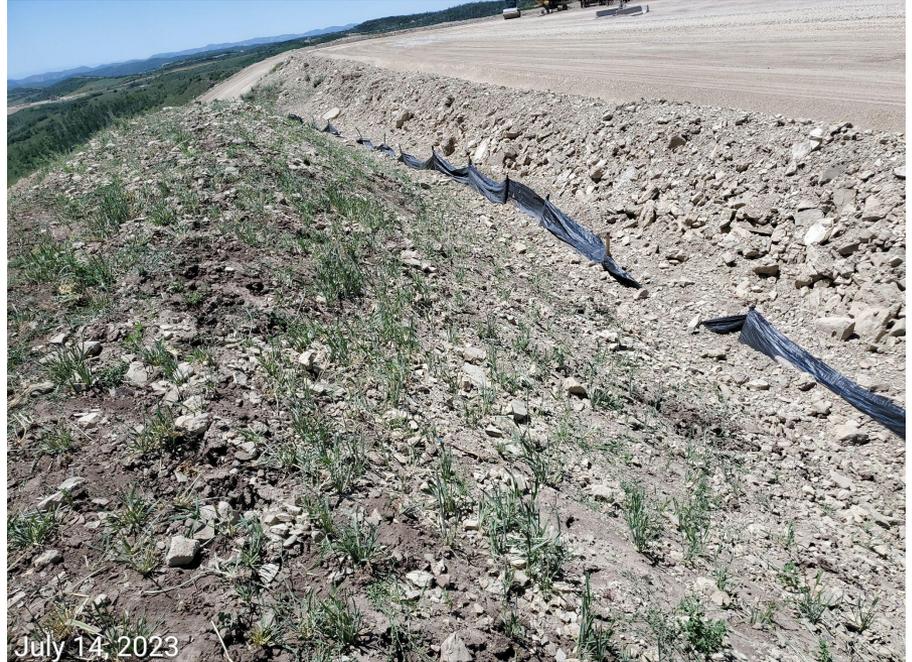
Photo 6: See comments under photo 5.

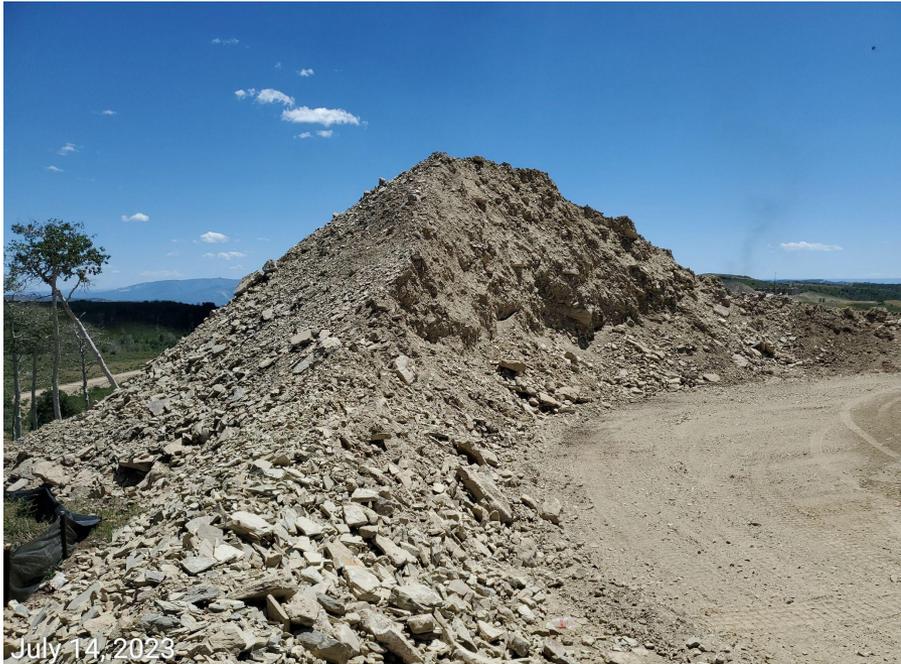
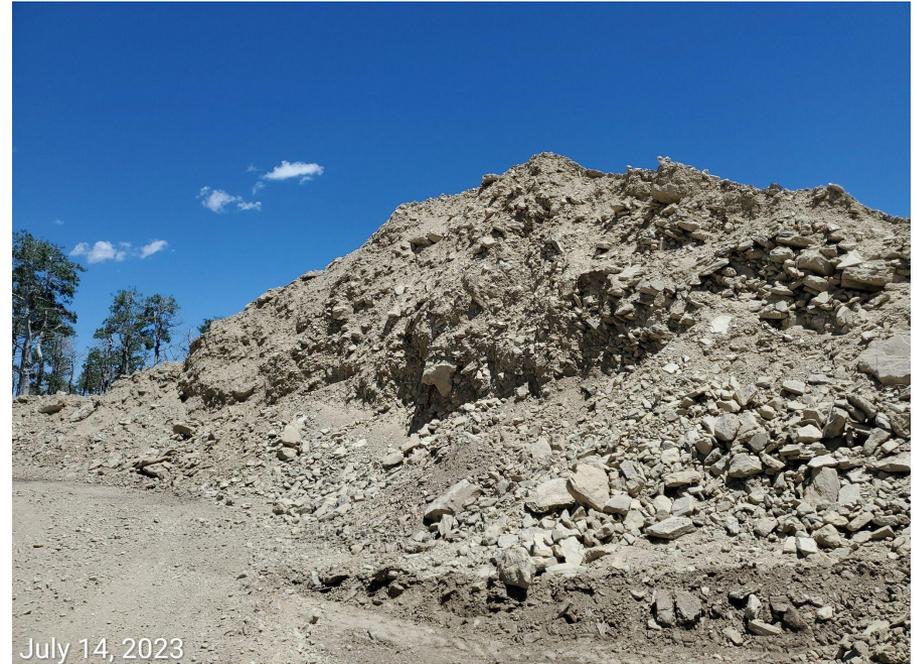
Photo 7: Photos 7-8 taken from the northeast corner of the pad. Photo shows unstabilized soil stockpile. Stockpile lacks stabilization, or adequate BMPs to minimize erosion/degradation. Potential safety issues also exist due to the unstabilized steep slopes above the pad.

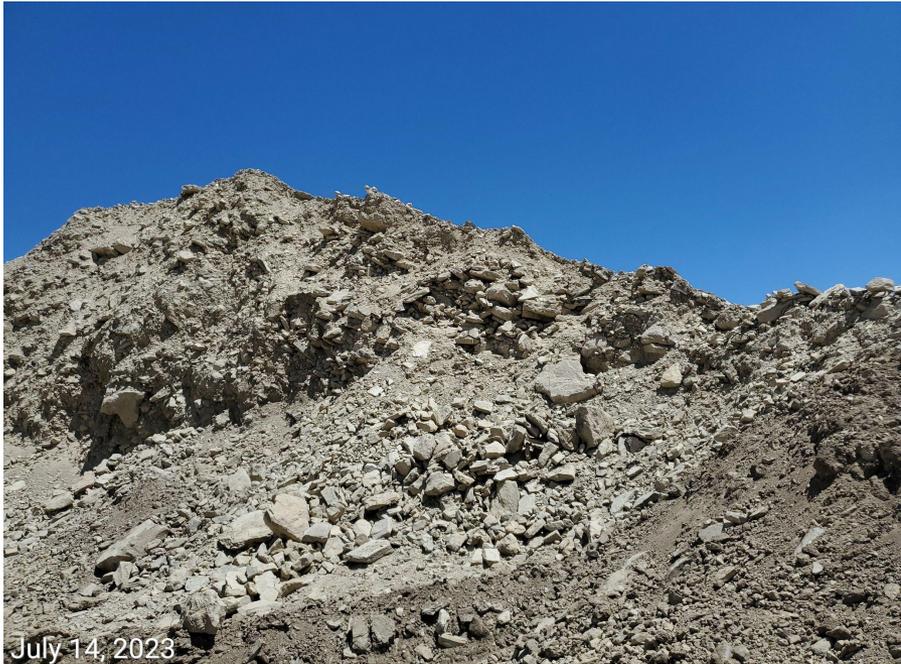
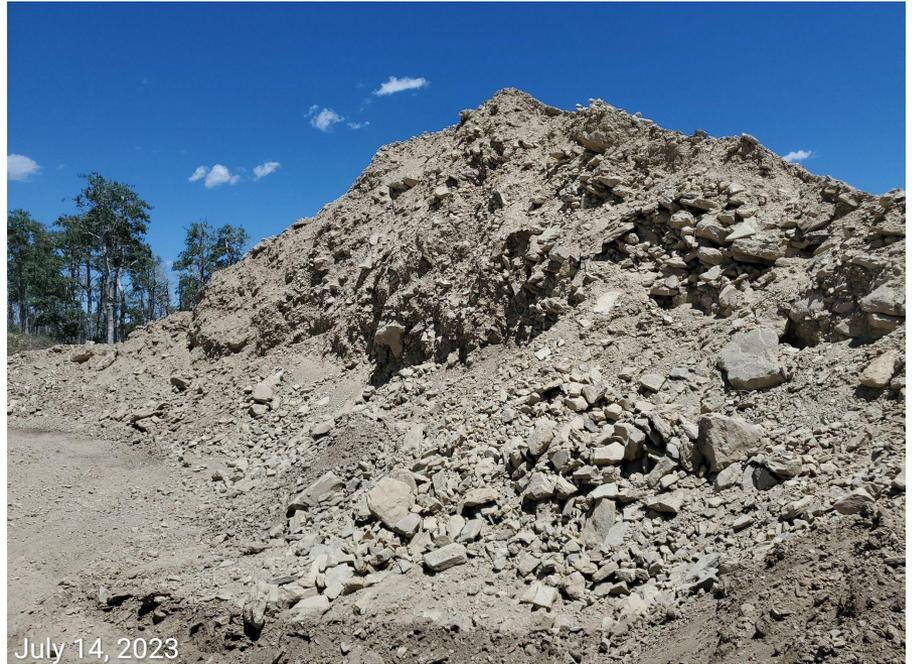
Photo 8: See comments under photo 7.

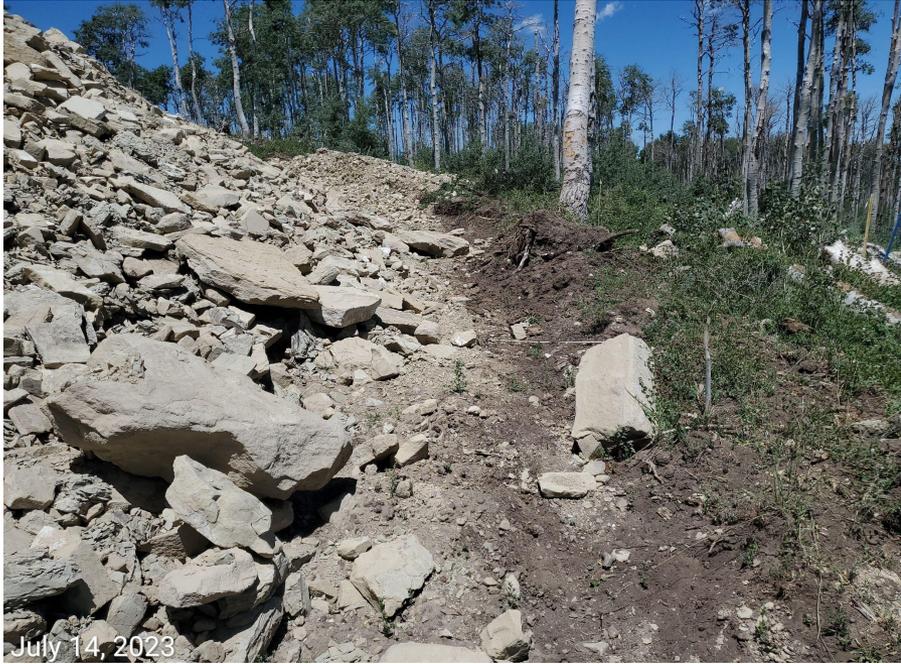
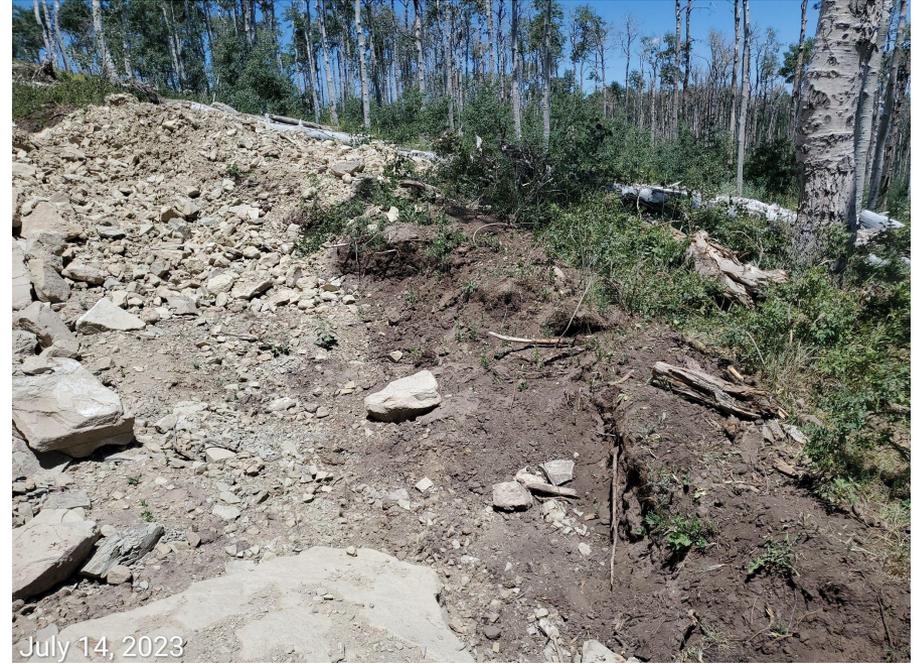
Photo 9: Photos taken from the outside perimeter of the stockpile on the east end of the Location. Operator appear to have constructed a ditch utilizing topsoil material. Photos also show stockpile lacks stabilization. Photo right shows material has eroded from the stockpile, filling in the ditch and traveling off-site.

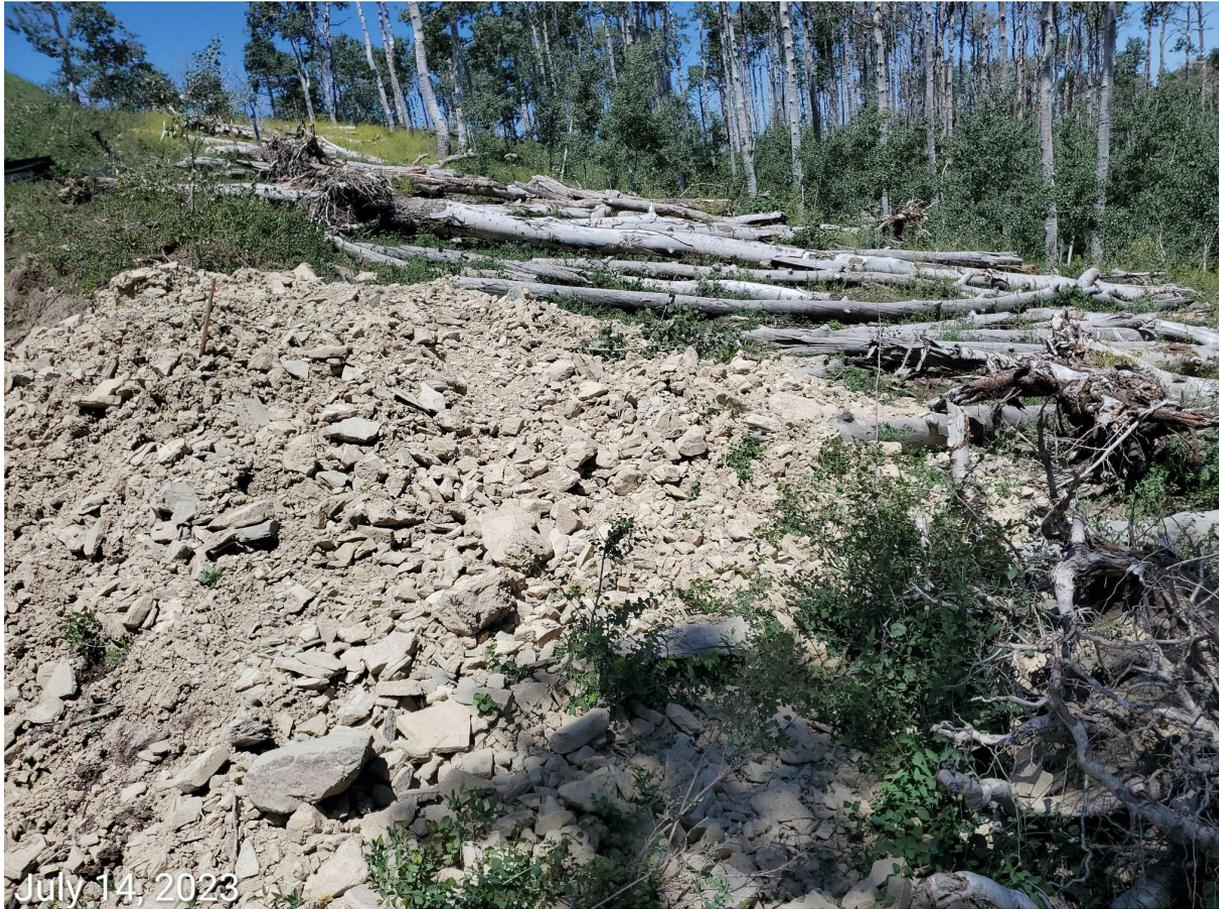
Photo 10: Continued from photo 9; subsoil material has migrated over the perimeter BMP, and offsite.

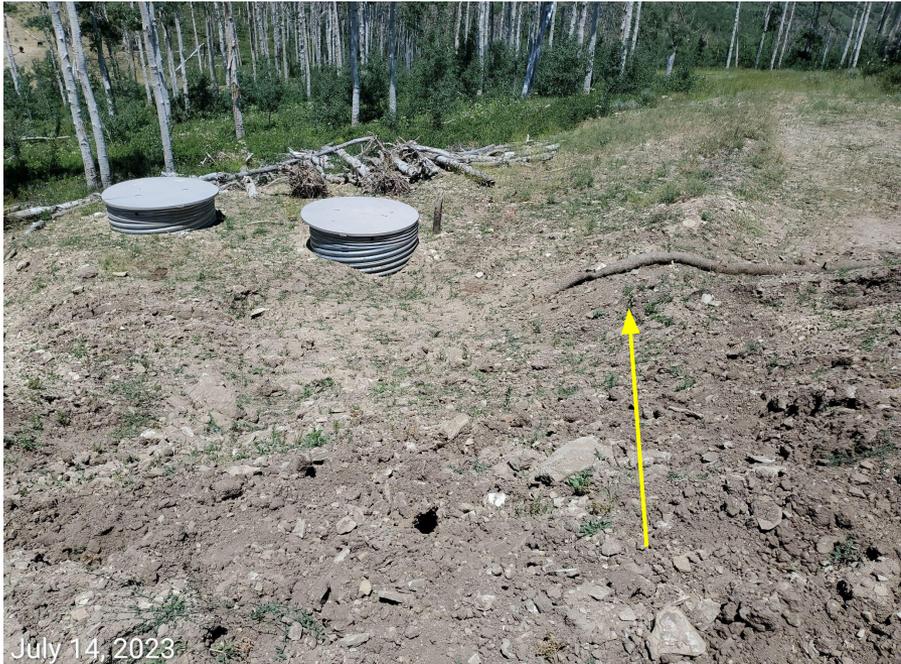
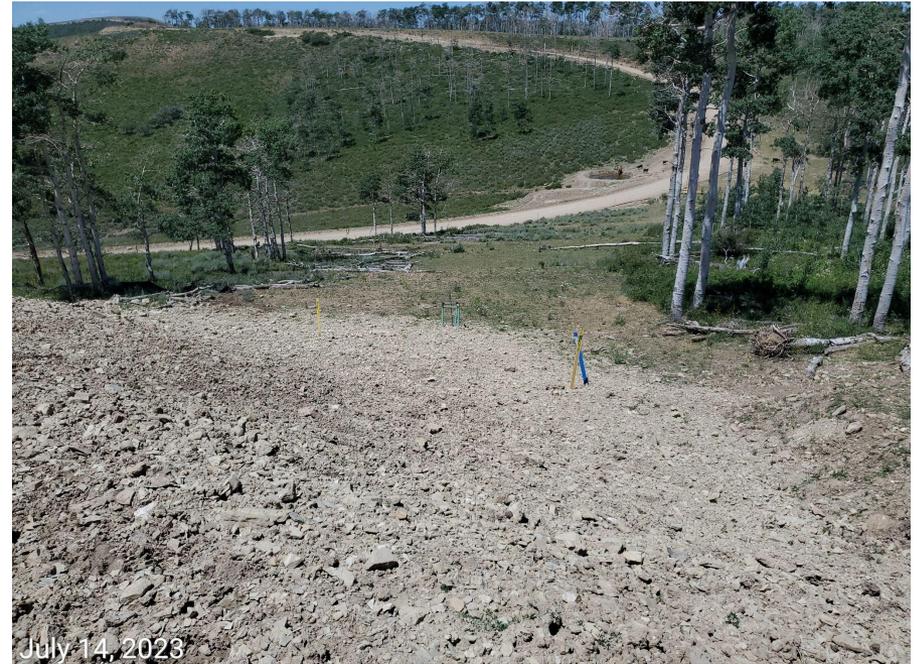
Photo 11: Photos taken from the north end of the Location. Photos show perimeter stormwater BMPs to minimize erosion, degradation and sediment transport remain missing or insufficient.

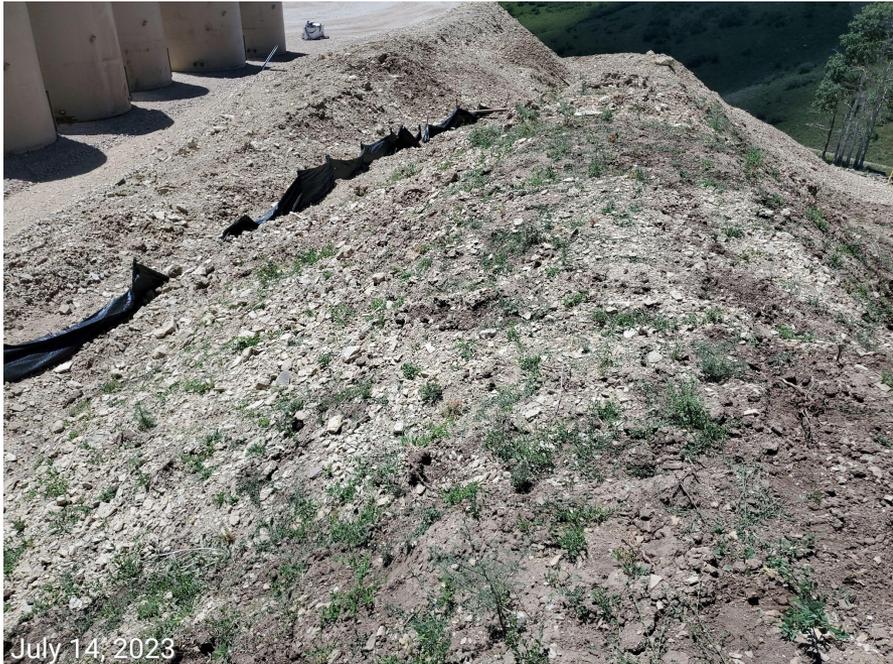
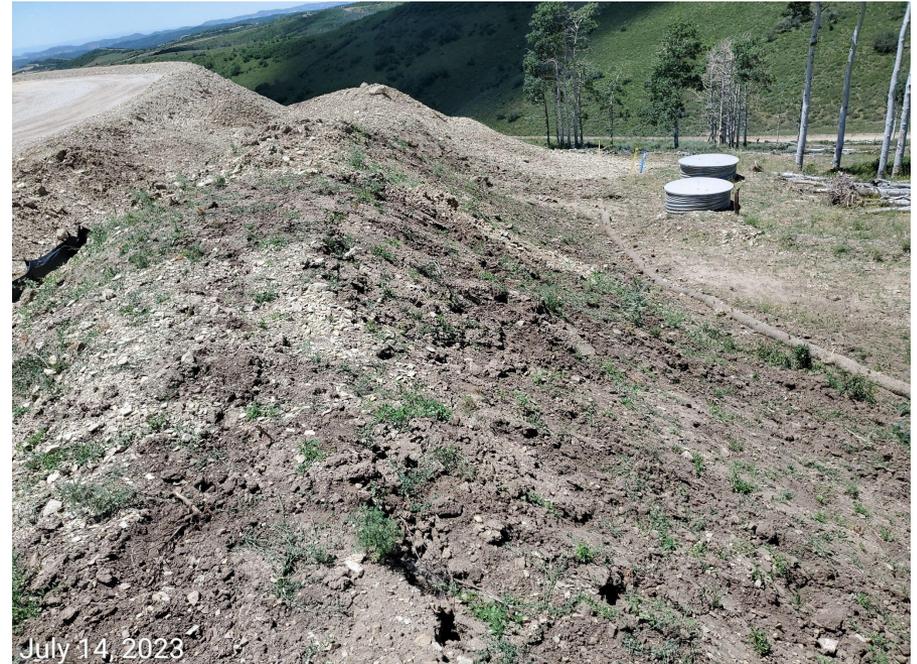
Photo 12: Photos 12-15 taken from the topsoil stockpiles on the Location. Photos examples showing Operator placed subsoils/fill material on top of the topsoil stockpiles on the Location.

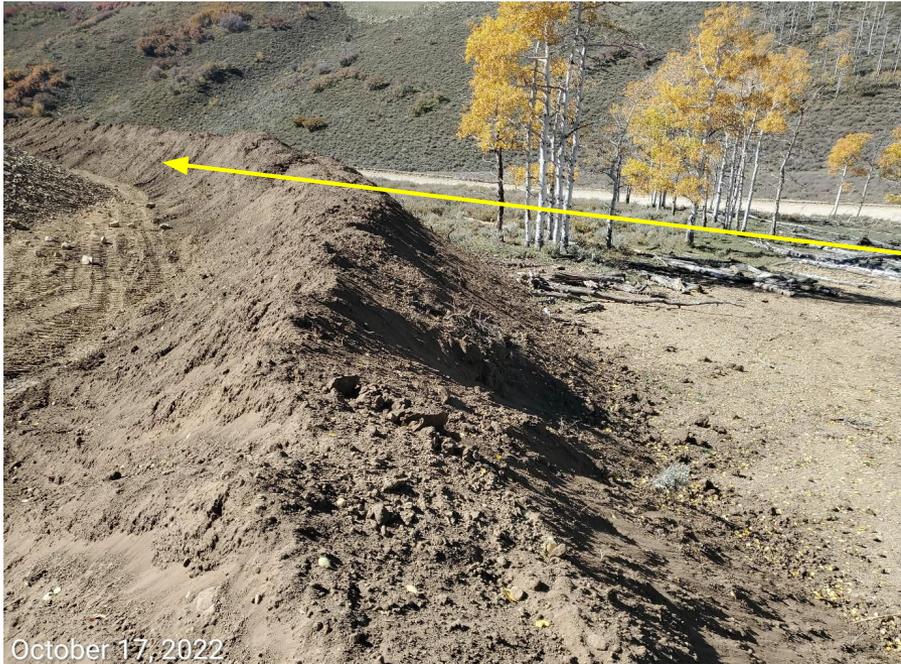
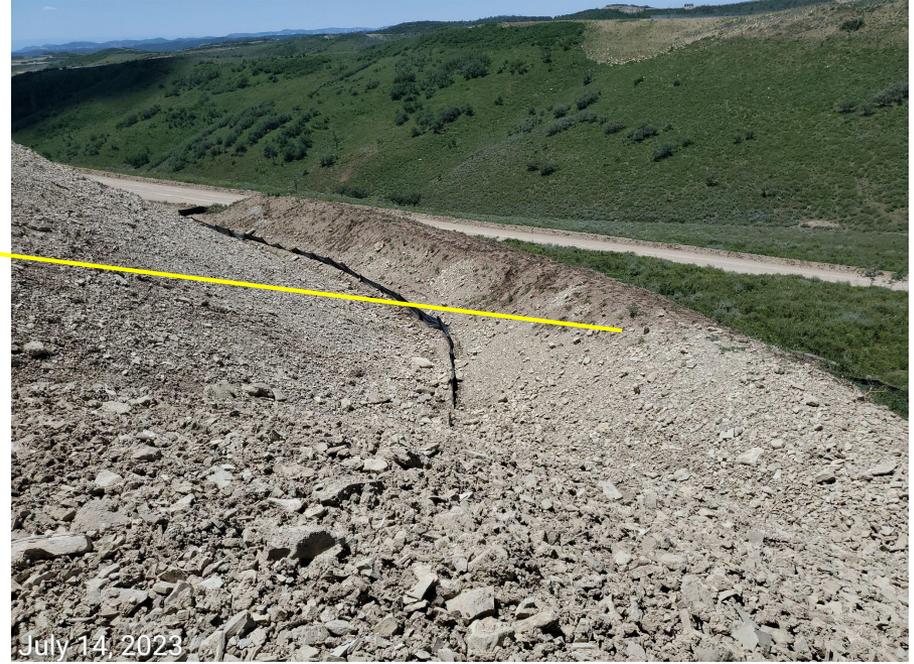
Photo 13: Photo left shows the topsoil stockpile on the northwest end of the Location as observed during the 10/17/2022 inspection. Photo right shows that the majority of the topsoil stockpile has been buried beneath fill/subsoil material; areas of the topsoil stockpile below arrow in the right photo (foreground of photo left) have been completely covered.

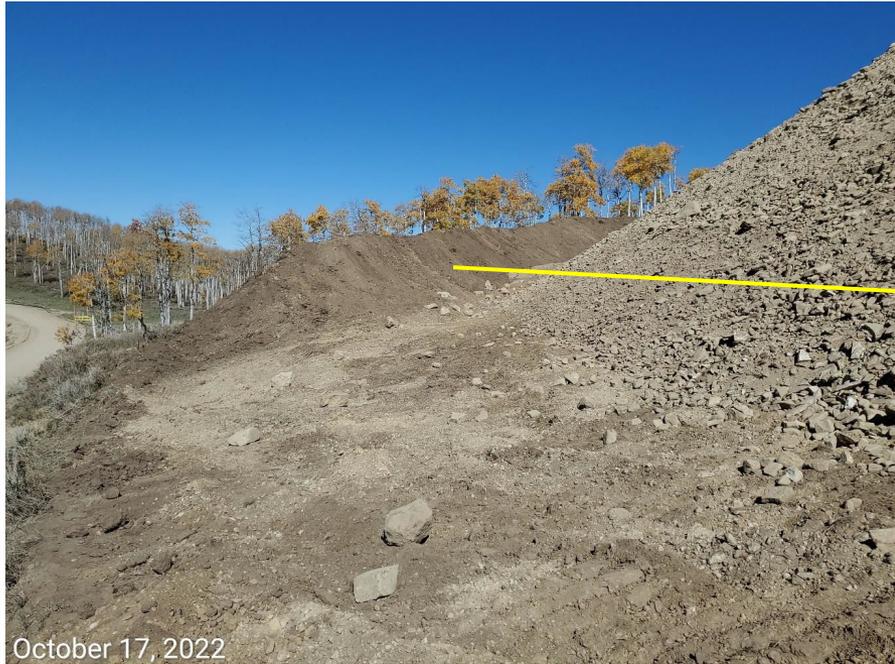
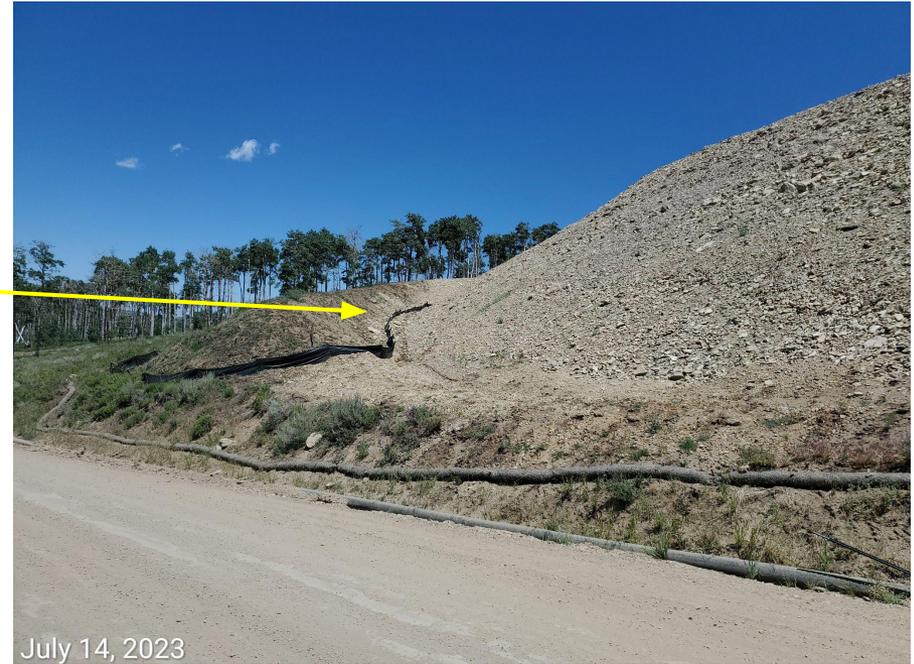
Photo 14: Photo left shows the topsoil stockpile on the northwest end of the Location as observed during the 10/17/2022 inspection. Photo right shows large areas of the topsoil stockpile have been covered by fill/subsoil material.

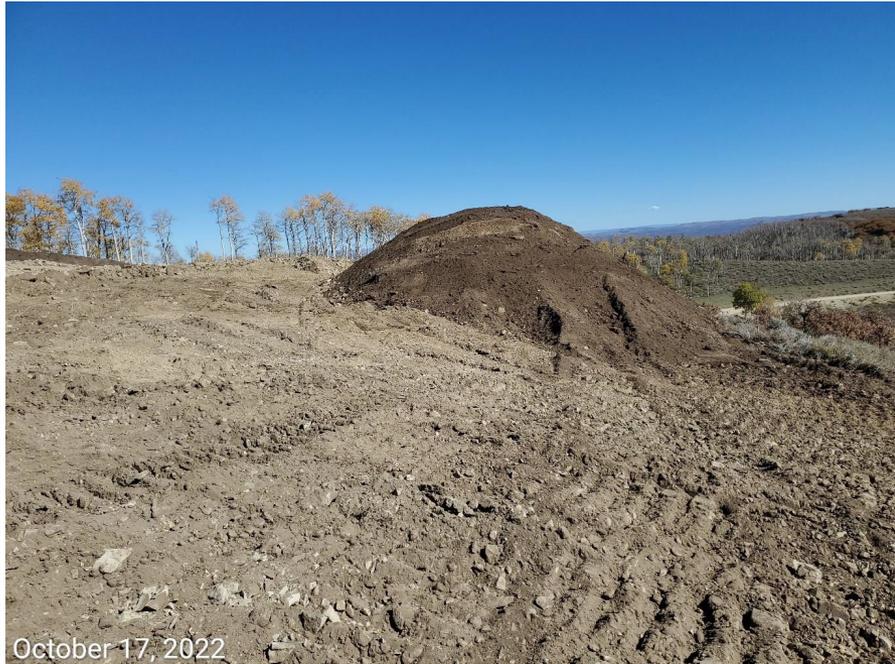
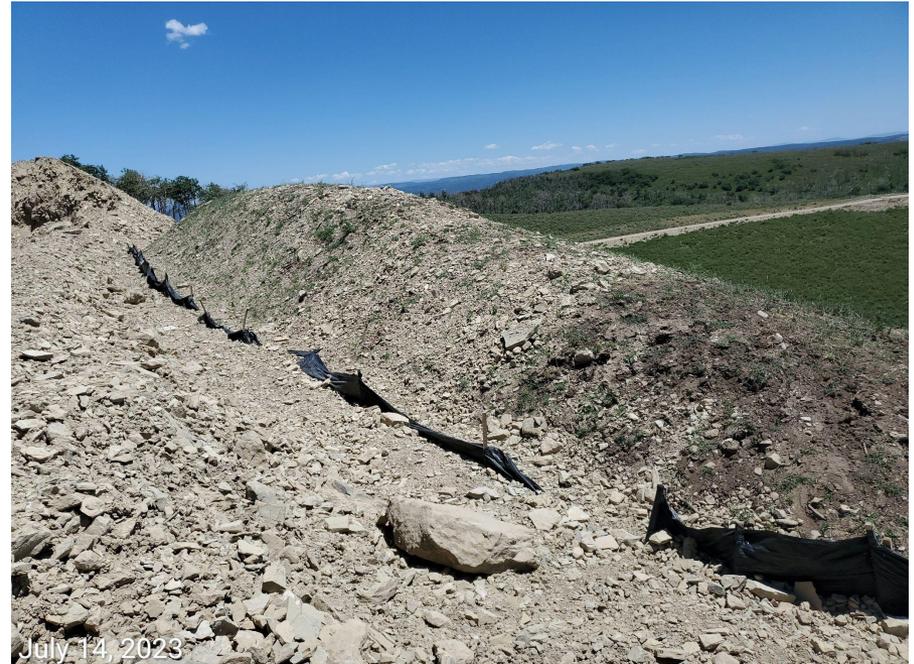
Photo 15: Photo left shows the topsoil stockpile on the south end of the Location as observed during the 10/17/2022 inspection. Photo right shows large areas of the topsoil stockpile have been covered by fill/subsoil material.

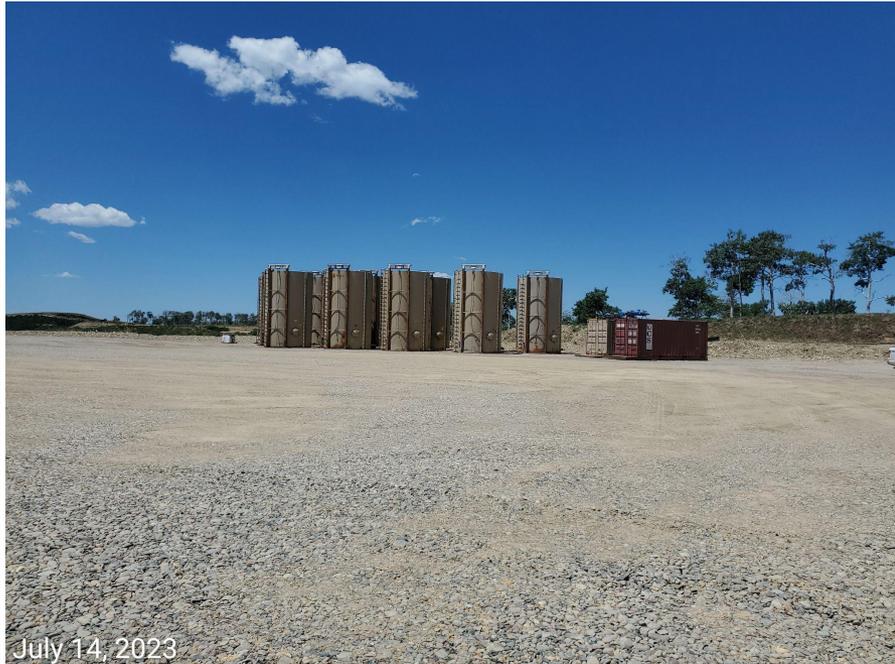
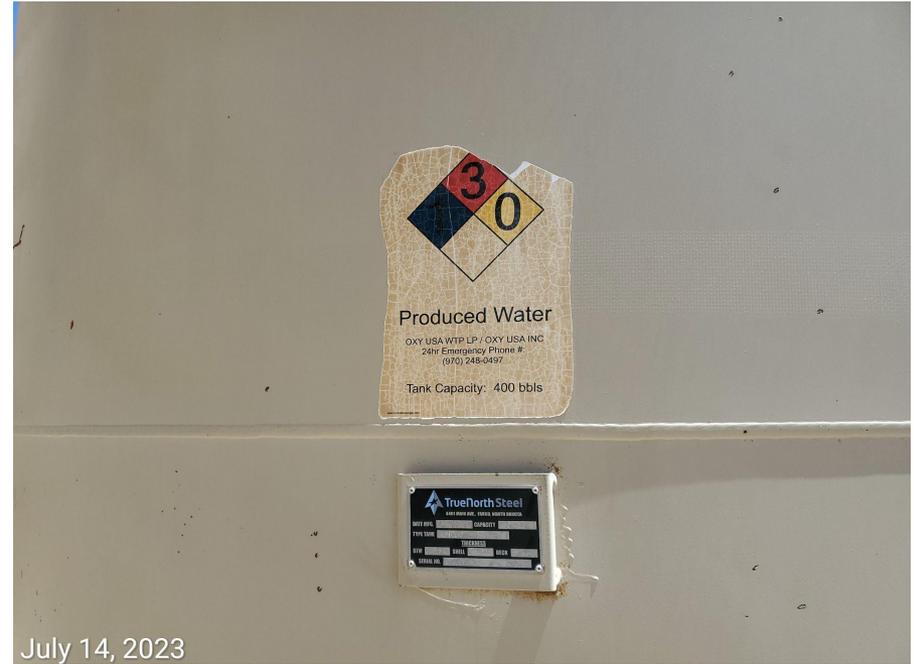
Photo 16: Photo shows tanks stored on the north end of the Location. Photo right an example showing labels on the tank are missing, or not per 605.h requirements.

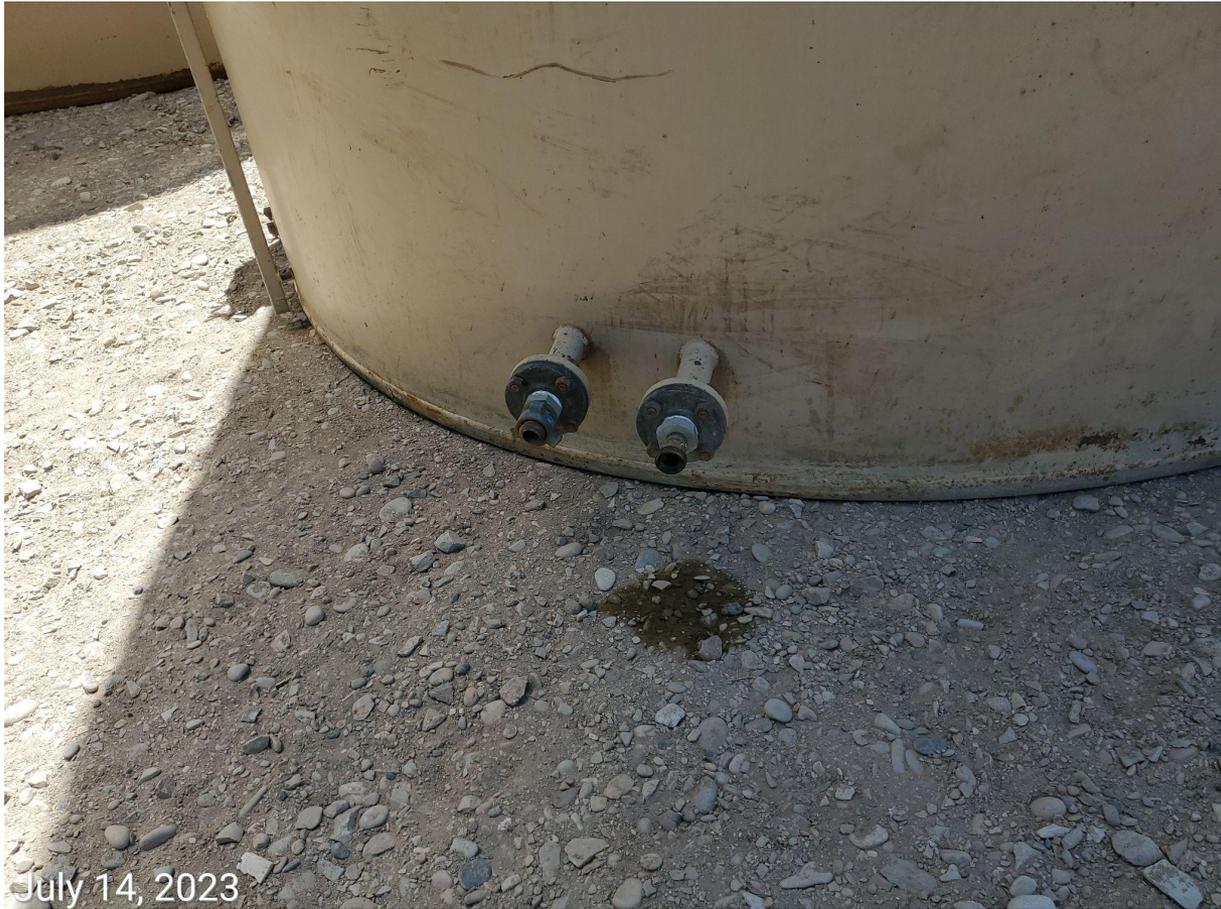
Photo 17: Stained soils observed at tanks.
