MGP ENTERPRISE A-4 RECLAMATION PLAN

COGCC Location ID:
386457

0234949.00
Prepared For
**BP America
Production Company**

June 2023

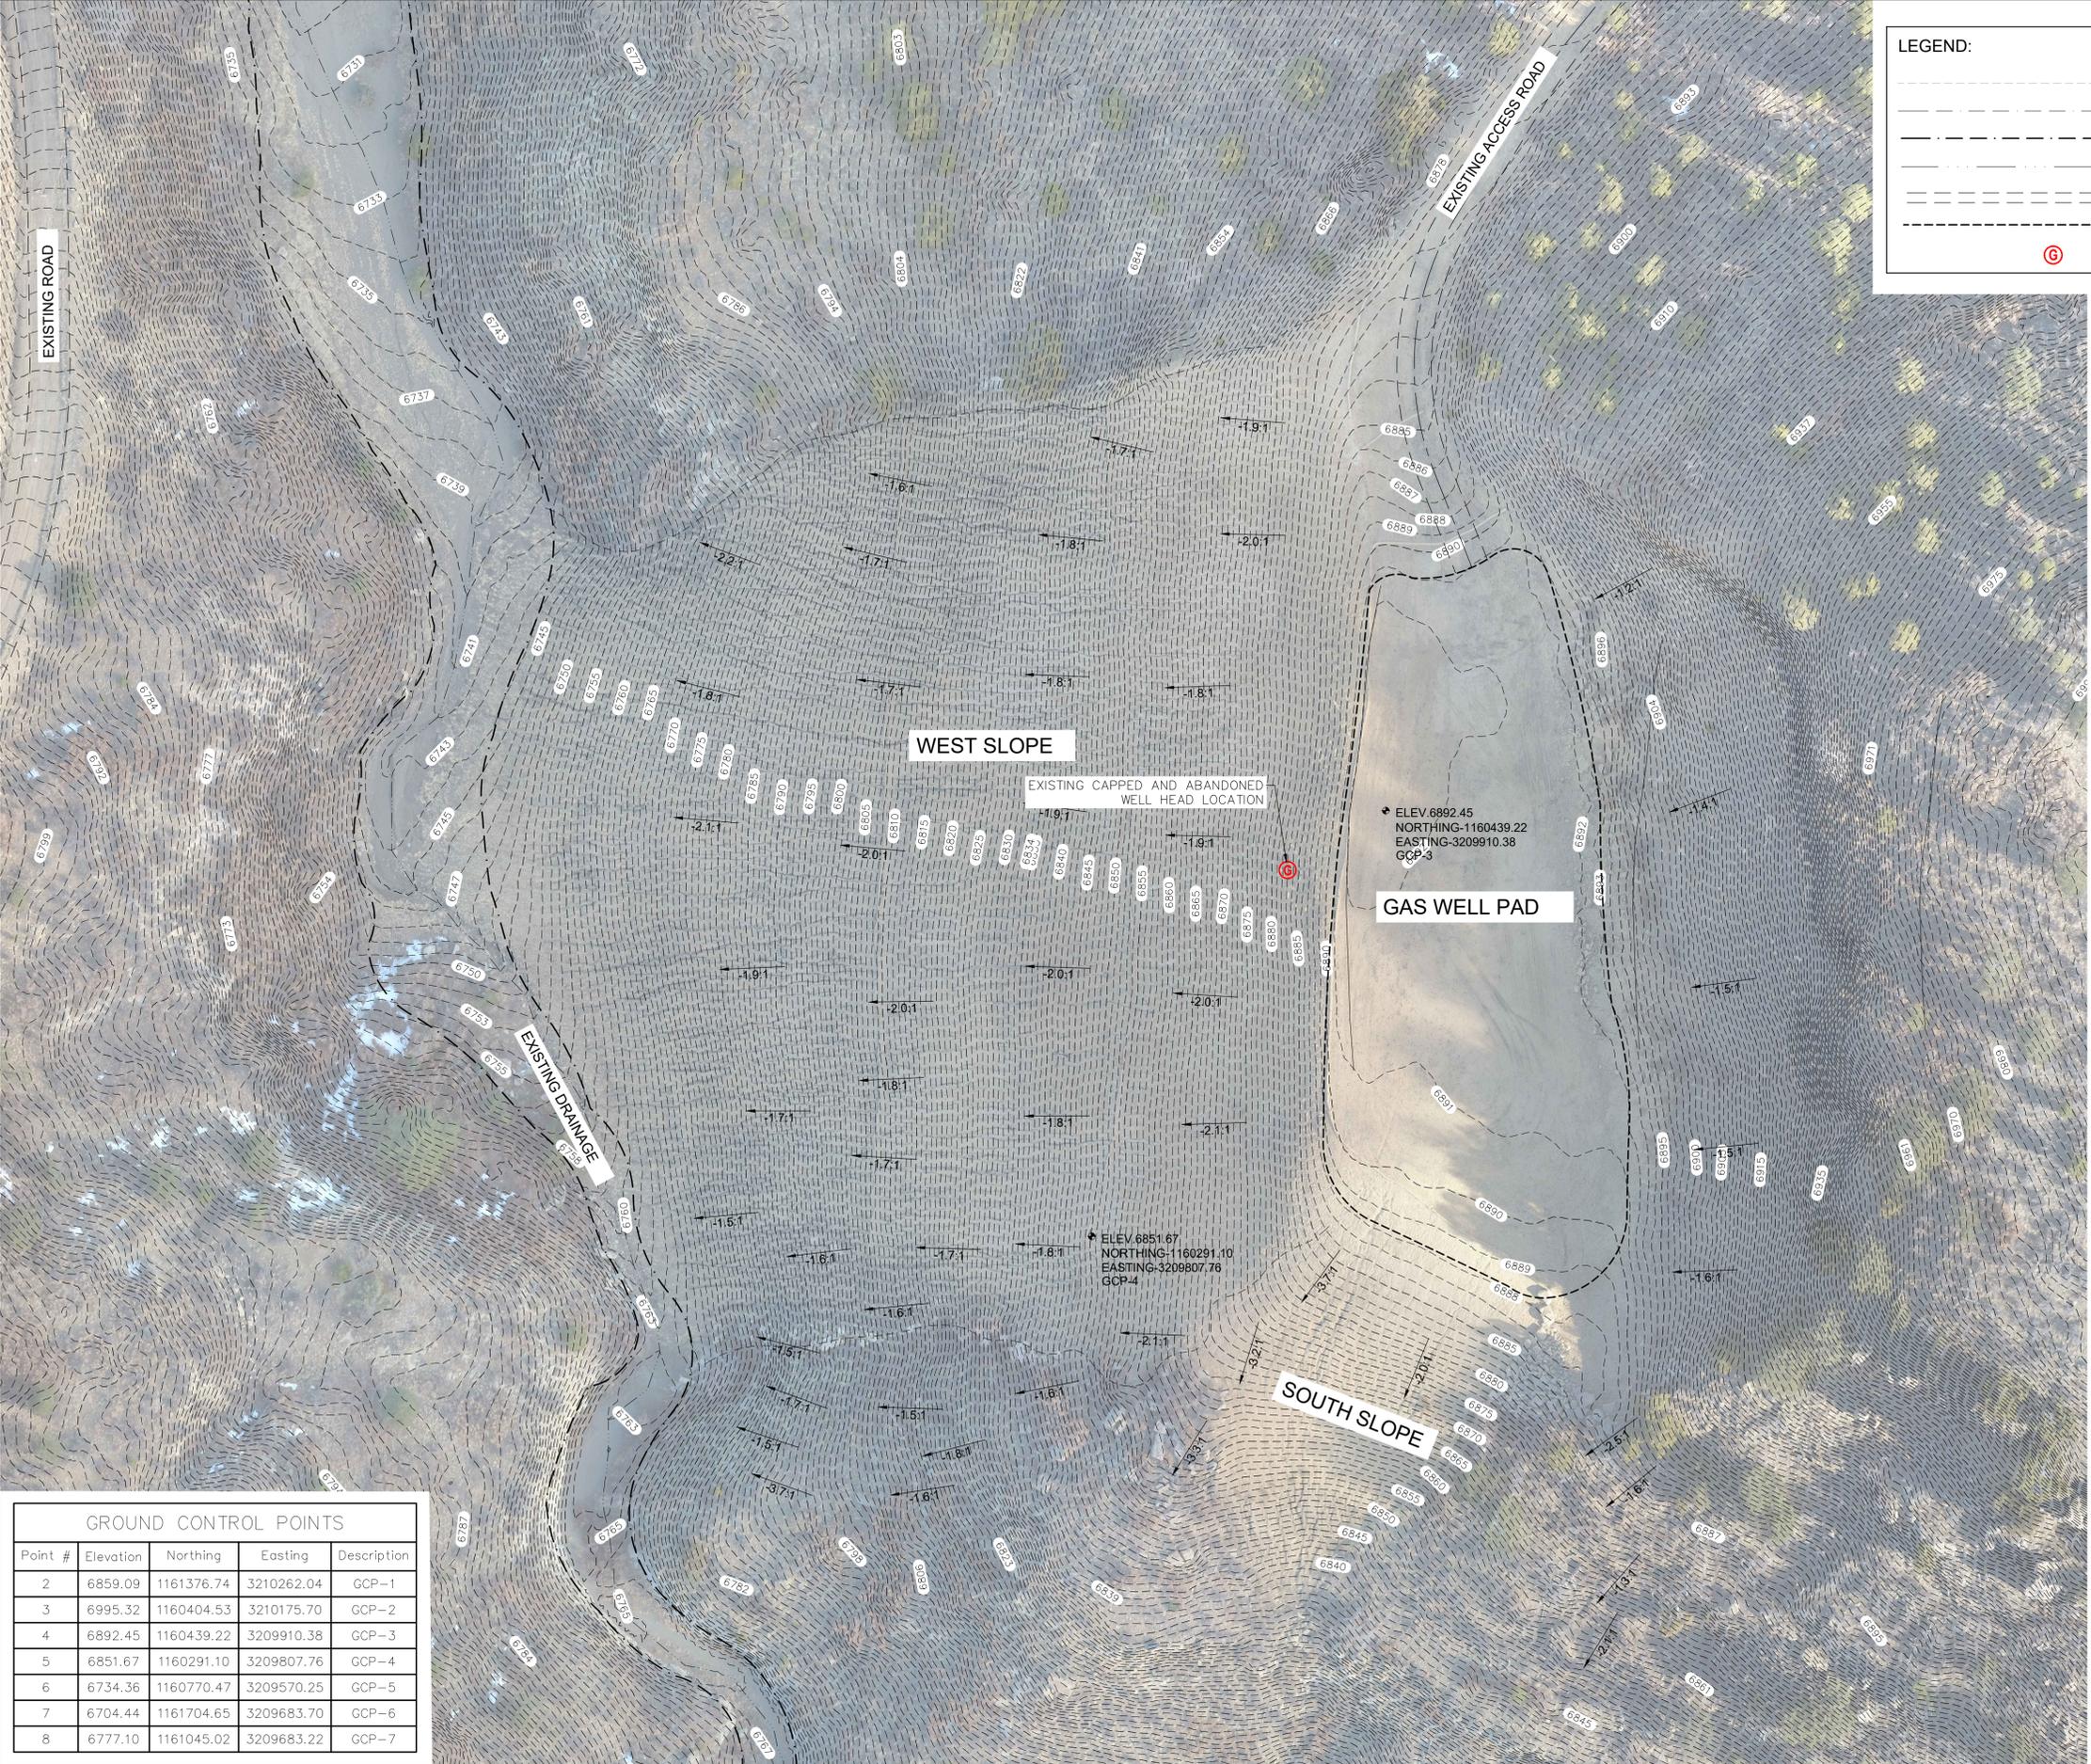
EXISTING CONDITIONS

EXISTING AND PROPOSED PROJECT ELEVATIONS ARE BASED ON AN ASSUMED LOCAL SITE DATUM. ELEVATIONS ARE BASED ON A GROUND CONTROL POINT LOCATED AT 1161045.02 N, 3209683.22 E (PLASTIC GCP-7). THE BENCHMARK HAS AN ELEVATION 6777.10 FEET ABOVE MEAN SEA LEVEL (NAD 1983 (CONUS) USING GEIOD18 (CONUS)). BEARINGS AND NORTH ORIENTATION SHOWN HEREON ARE BASED UPON THE COLORADO SOUTH 0503 STATE PLANE COORDINATE SYSTEM. CONTRACTOR SHALL VERIFY BENCHMARKS AND RE-SET CONTROL AS NECESSARY PRIOR TO START OF CONSTRUCTION.

GROUND CONTROL POINTS ARE BLACK PLASTIC ANCHORING SPIKES.

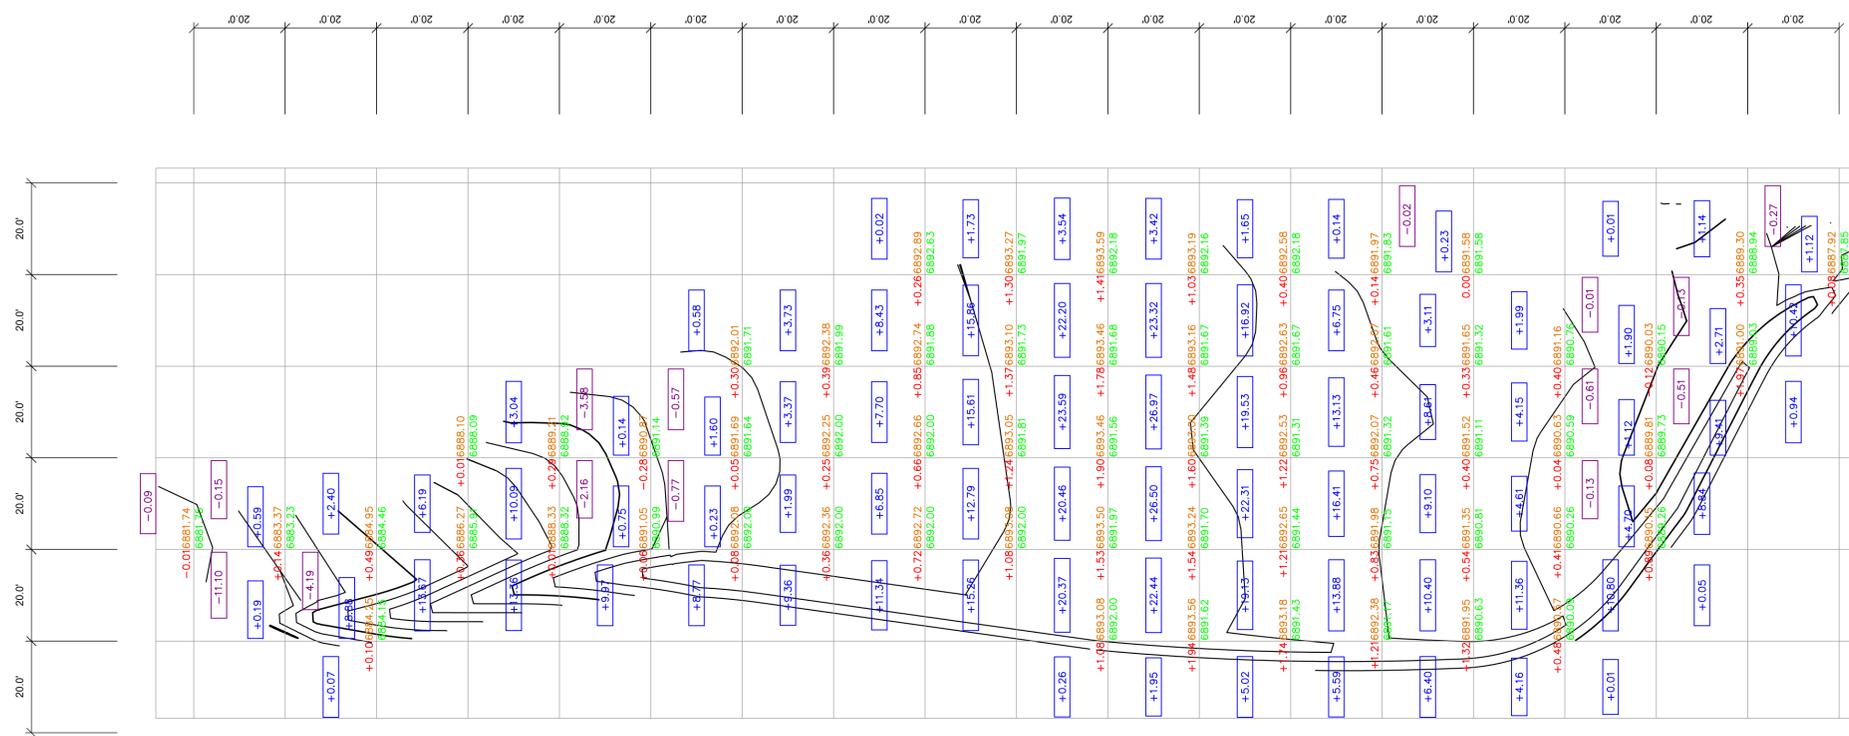
Cut/Fill Summary

Name	Cut Factor	Fill Factor	2d Area	Cut	Fill	Net
VOL-EG TO FG	1.000	1.000	22990 Sq. Ft.	35 Cu. Yd.	648 Cu. Yd.	612 Cu. Yd.<Fill>
Totals			22990 Sq. Ft.	35 Cu. Yd.	648 Cu. Yd.	612 Cu. Yd.<Fill>

0.1	11.2	4.2	0.0	0.0	5.7	1.3	0.0	0.0	0.0	0.0	0.0	0.0	0.0	0.0	0.0	0.8	0.6	0.3	0.0	Cut	
0.0	0.8	11.4	19.9	26.5	10.9	11.2	18.5	34.3	61.3	90.4	104.6	84.6	55.9	37.8	26.3	18.5	22.2	12.5	0.0	0.0	Fill

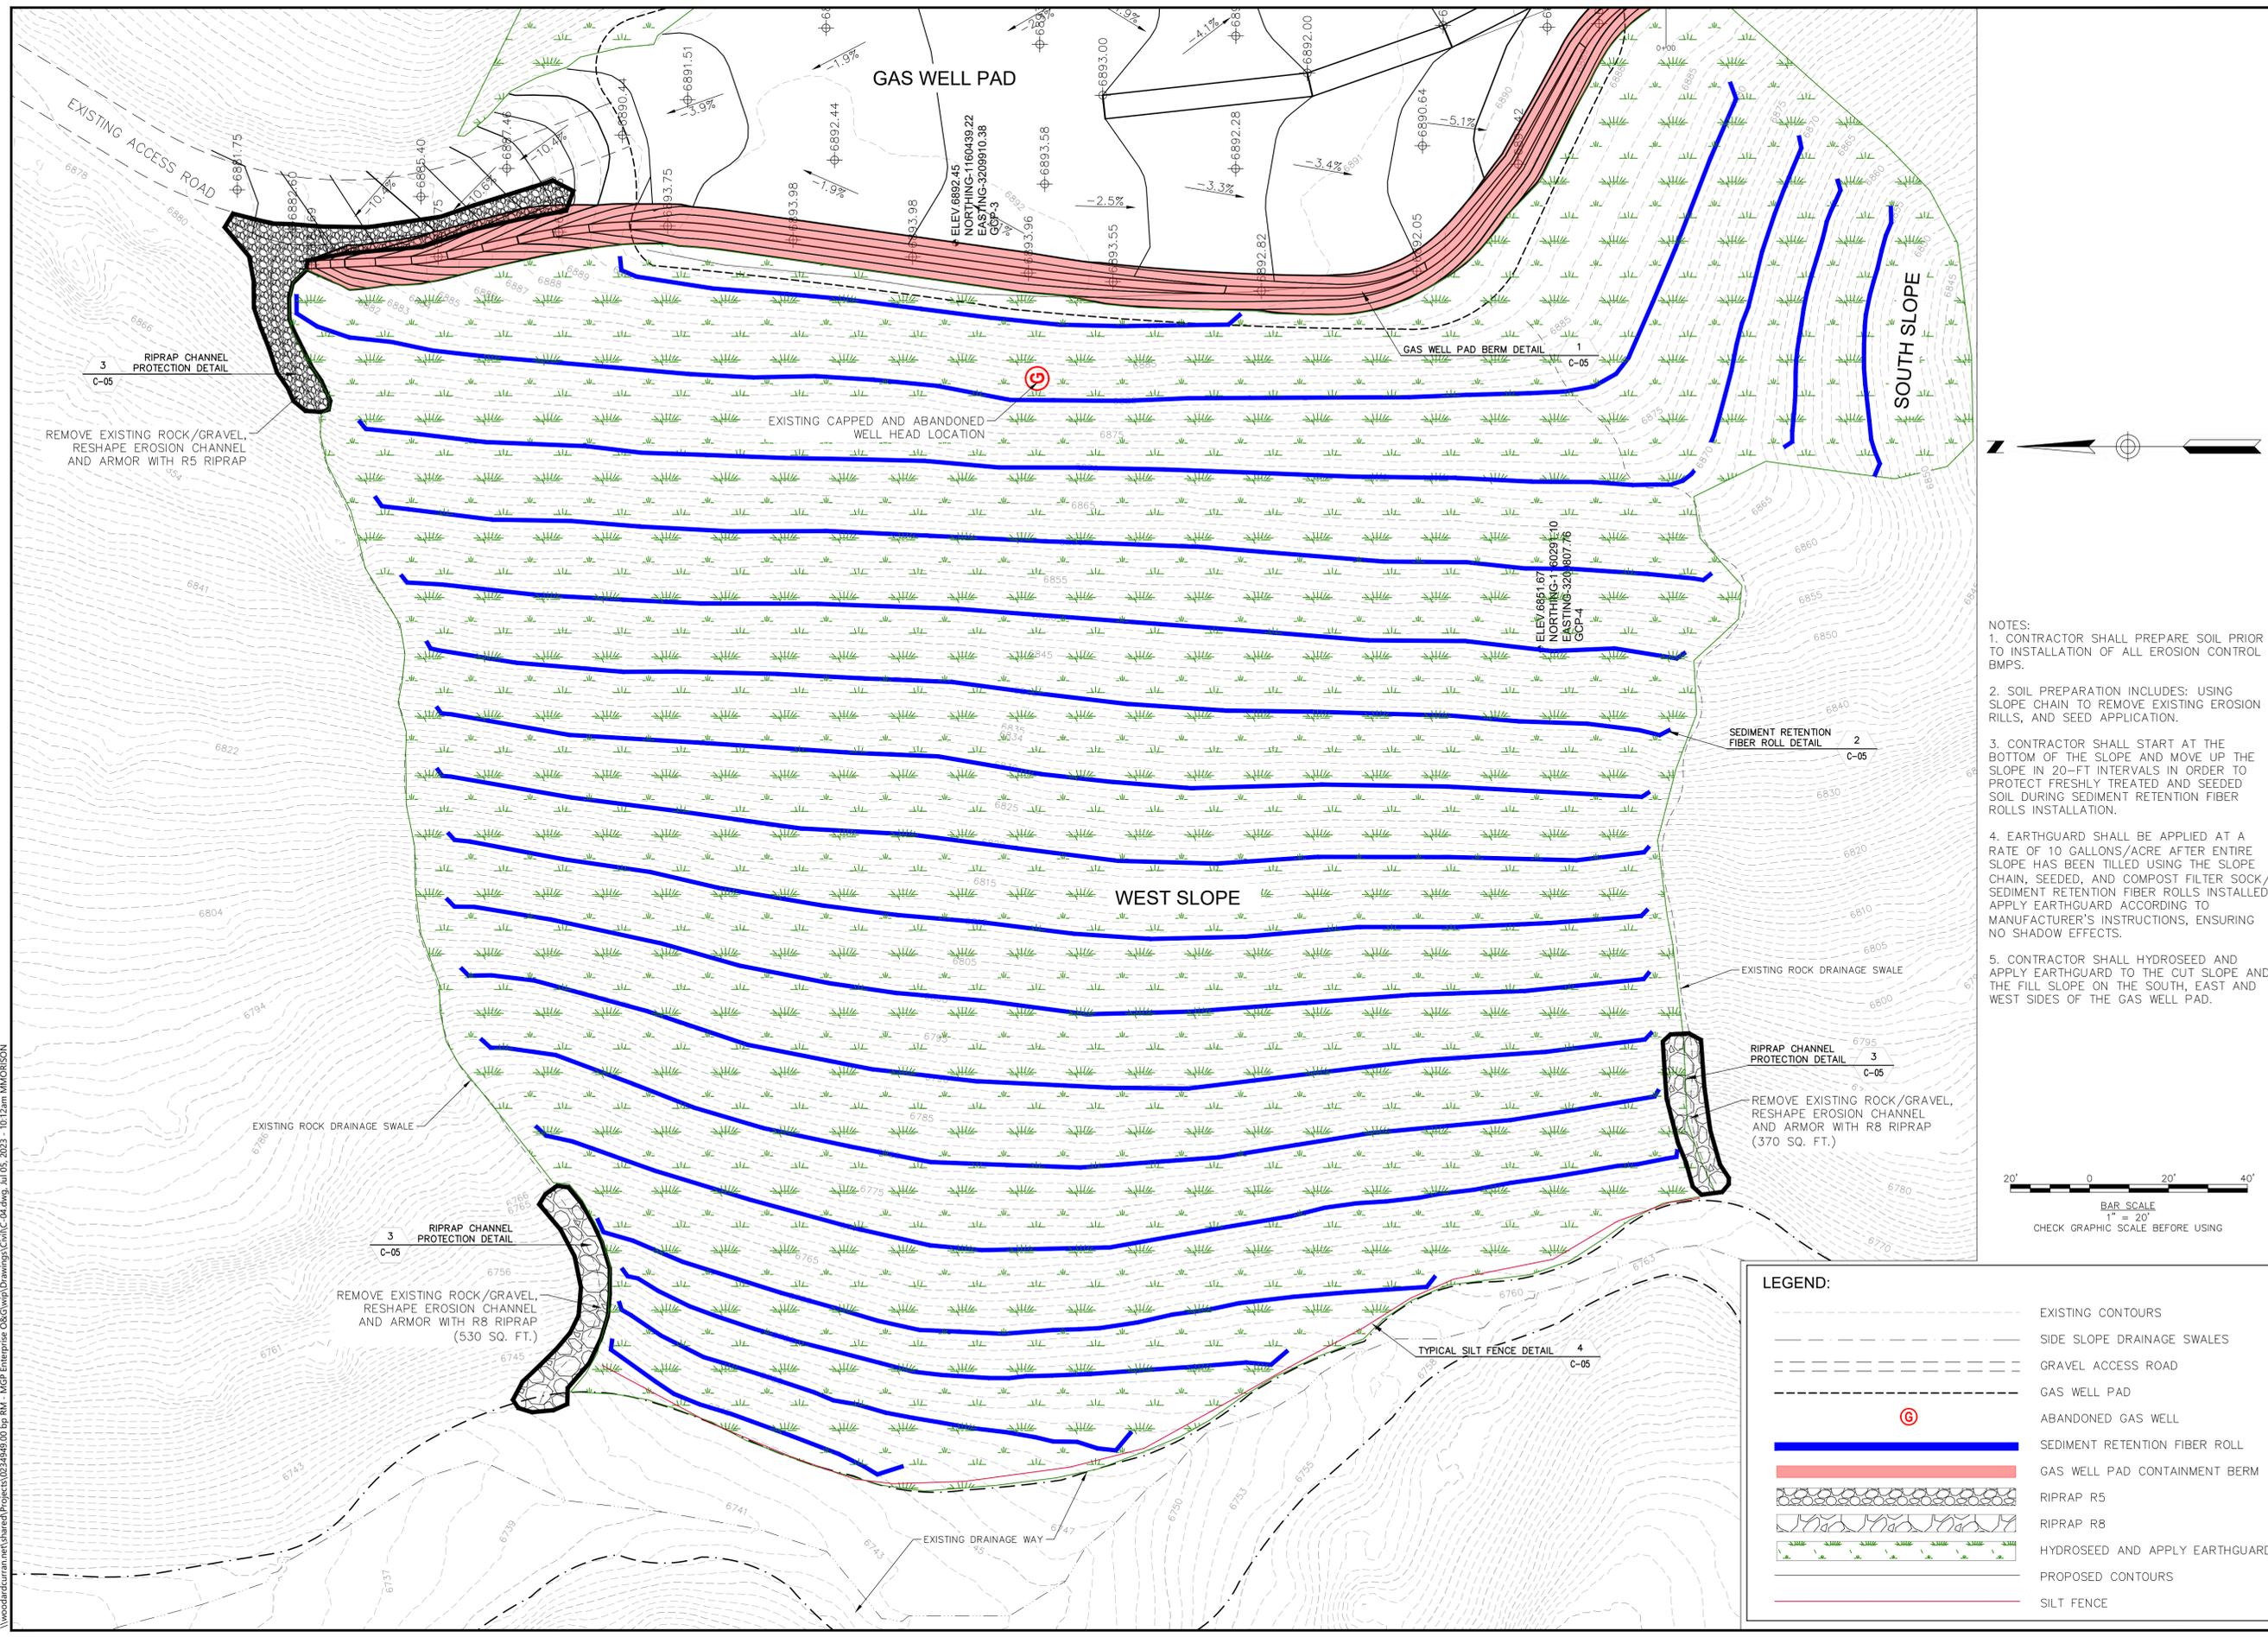
DRAWING NO:
C-04
SHEET: 7 OF 8

DRAWING TITLE:
CIVIL
EROSION CONTROL PLAN

- NOTES:
- CONTRACTOR SHALL PREPARE SOIL PRIOR TO INSTALLATION OF ALL EROSION CONTROL BMPs.
 - SOIL PREPARATION INCLUDES: USING SLOPE CHAIN TO REMOVE EXISTING EROSION RILLS, AND SEED APPLICATION.
 - CONTRACTOR SHALL START AT THE BOTTOM OF THE SLOPE AND MOVE UP THE SLOPE IN 20-FT INTERVALS IN ORDER TO PROTECT FRESHLY TREATED AND SEEDED SOIL DURING SEDIMENT RETENTION FIBER ROLLS INSTALLATION.
 - EARTHGUARD SHALL BE APPLIED AT A RATE OF 10 GALLONS/ACRE AFTER ENTIRE SLOPE HAS BEEN TILLED USING THE SLOPE CHAIN, SEEDED, AND COMPOST FILTER SOCK/ SEDIMENT RETENTION FIBER ROLLS INSTALLED. APPLY EARTHGUARD ACCORDING TO MANUFACTURER'S INSTRUCTIONS, ENSURING NO SHADOW EFFECTS.
 - CONTRACTOR SHALL HYDROSEED AND APPLY EARTHGUARD TO THE CUT SLOPE AND THE FILL SLOPE ON THE SOUTH, EAST AND WEST SIDES OF THE GAS WELL PAD.

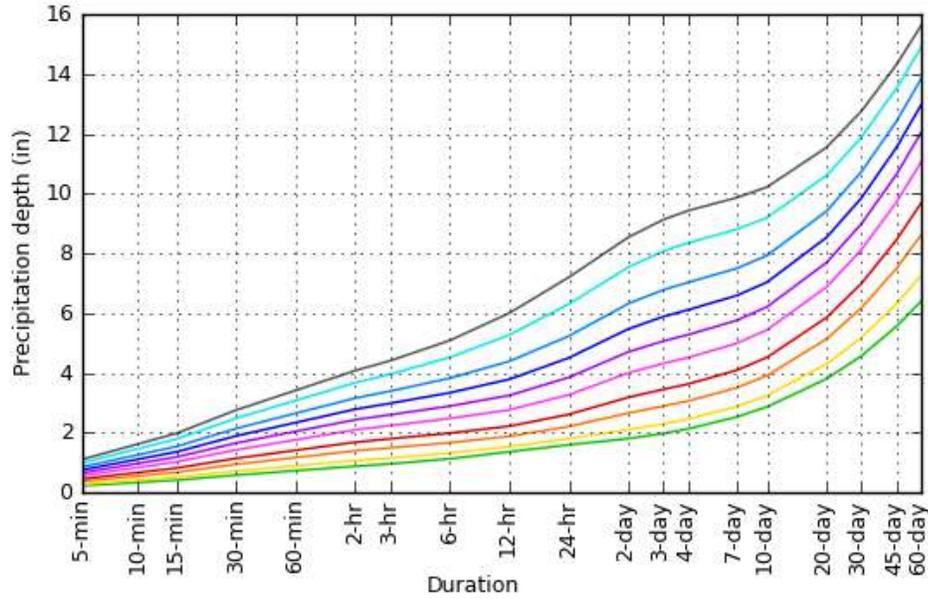
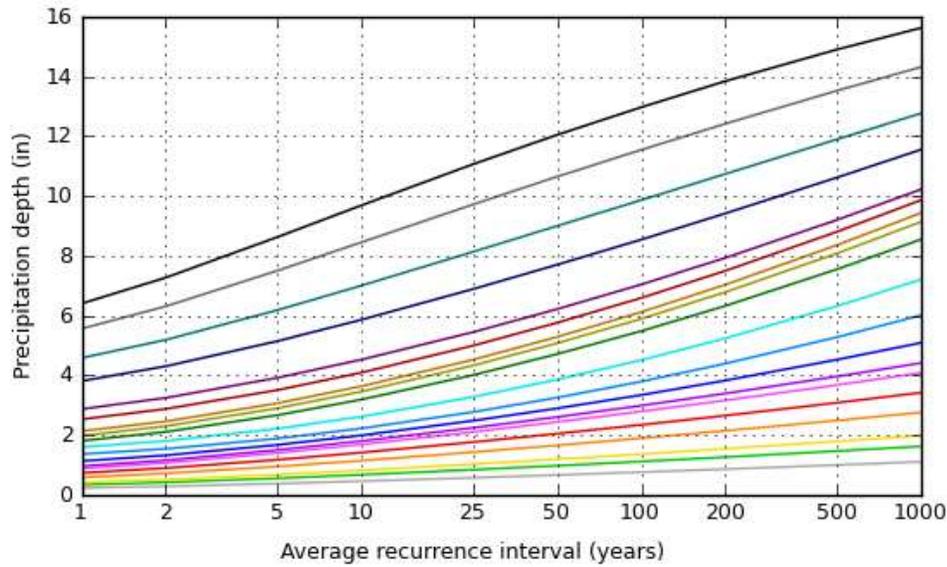
PDS-based depth-duration-frequency (DDF) curves

Latitude: 37.1050°, Longitude: -104.7802°

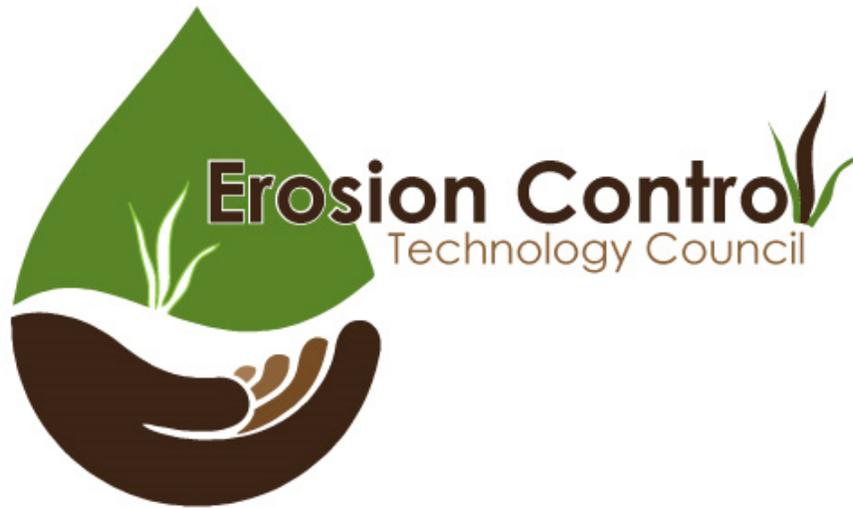
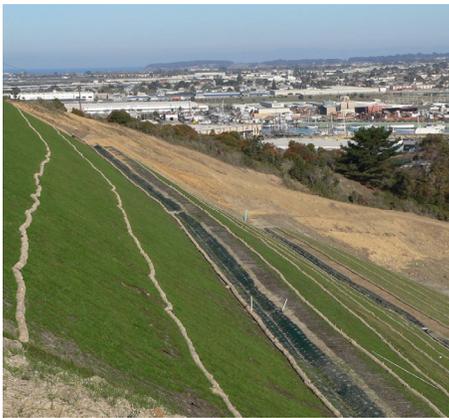
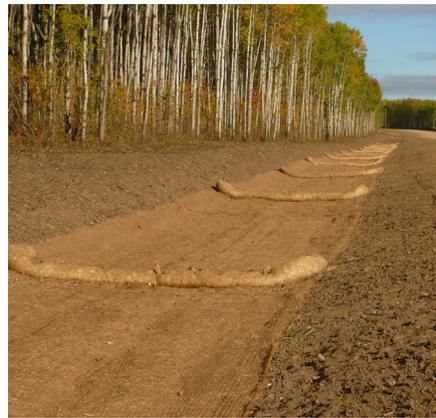
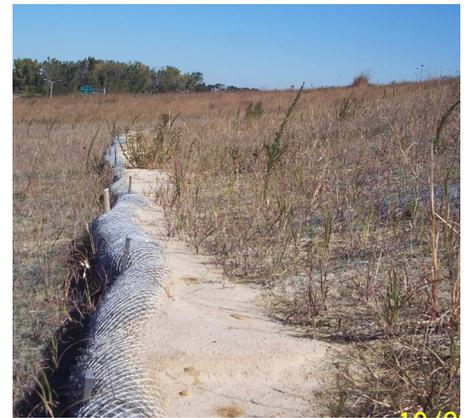
Sediment Retention Fiber Roll (SRFR) General Usage and Installation Guidelines

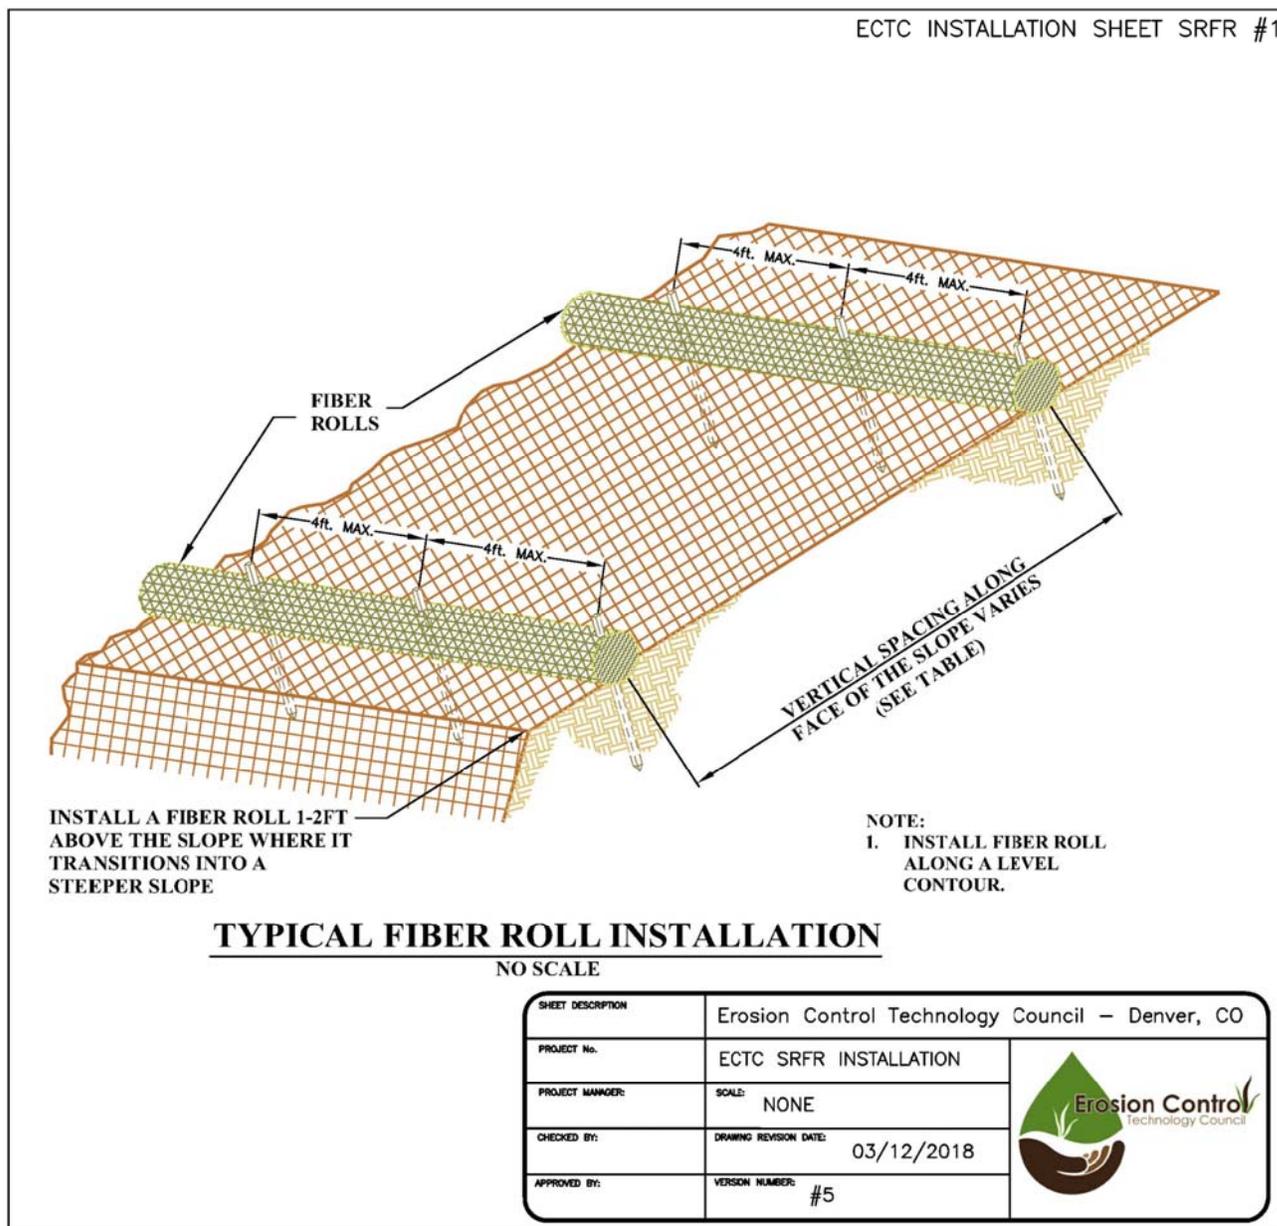
NOTES:

1. Install fiber roll along a level contour.
2. Some SRFRs are anchored on the down gradient side through the netting only as compared to through the center of the SRFR as shown on this detail. (See netting only stake detail – ECTC SRFR installation sheet 5)

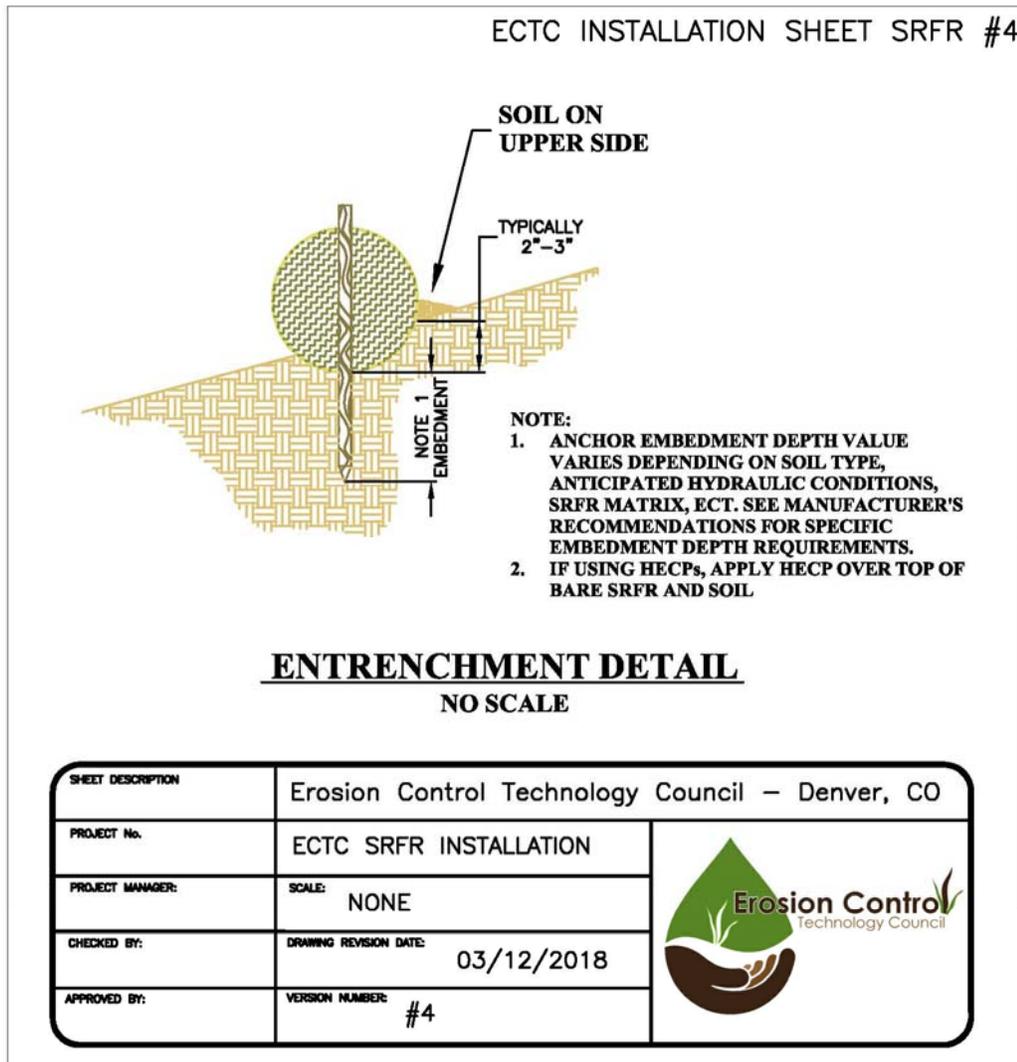
Figure 4. Stake through the middle of the SRFR.

Figures 4, 5 & 6 Entrenchment and Staking Details.

Step Six: Secure the SRFR with stakes or pins along the length of the unit. Stakes should be driven in vertically, perpendicular to a horizontal

ground plane (see **Figures 4, 5 and 6**, “Entrenchment and Staking Details”). Driving stakes perpendicular to a sloped ground surface may compromise the stability of the SRFR.

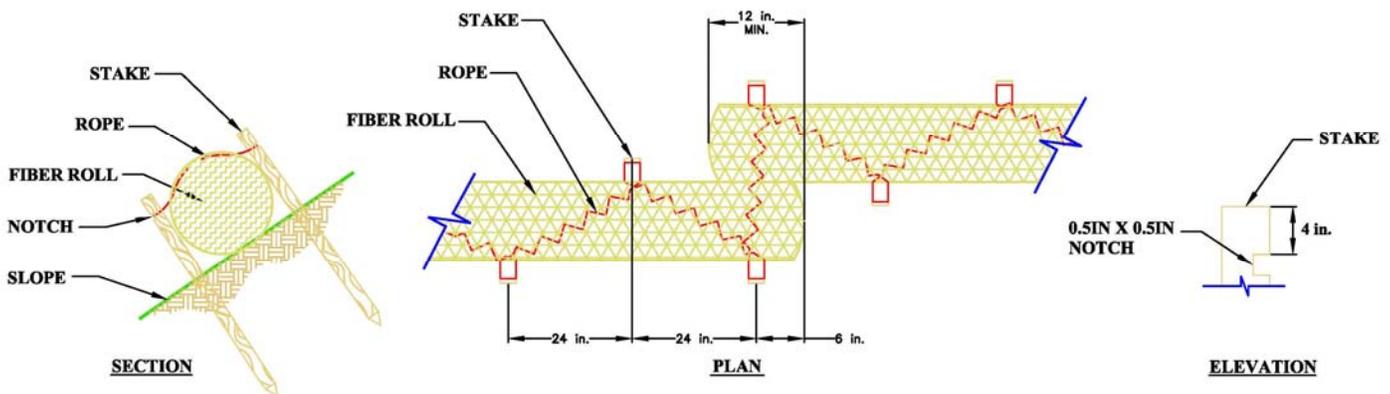
LASHED SRFR INSTALLATION DETAIL
NO SCALE

- NOTE:**
- TEMPORARY FIBER ROLL SPACING VARIES DEPENDING UPON SLOPE INCLINATION.
 - ROPE SHALL BE A MINIMUM OF 1/2" THICK.

fiber roll tightly to the slope. If metal stakes are used the rope may be laced and knotted at the bend at the top of the metal stakes. Secure ends of each SRFR. See **Figure 7** for schematics of Stake Lacing.

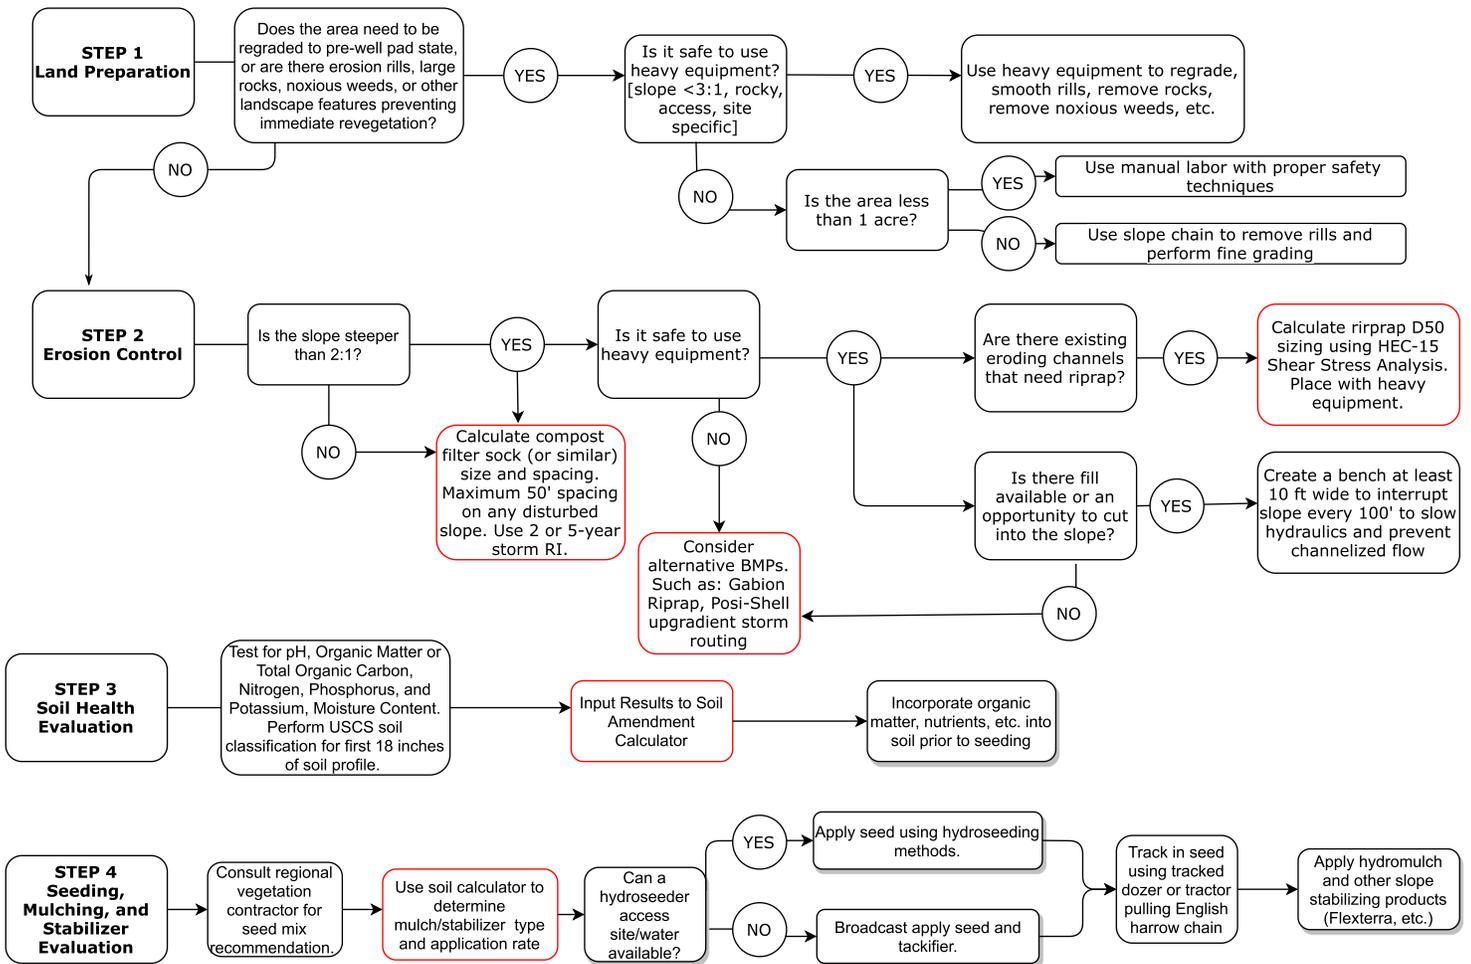
Decision Flow Chart for Well Pad Reclamation

MONITOR 2-3 GROWING SEASONS FOR EROSION & VEGETATION ESTABLISHMENT
