# Final Reclamation and Stormwater Inspection

Operator: NOBLE ENERGY INC - 100322

Location ID: 327020

Inspection Photos  
Location Name: Lilli Unit 6-3  
Location ID: 327020

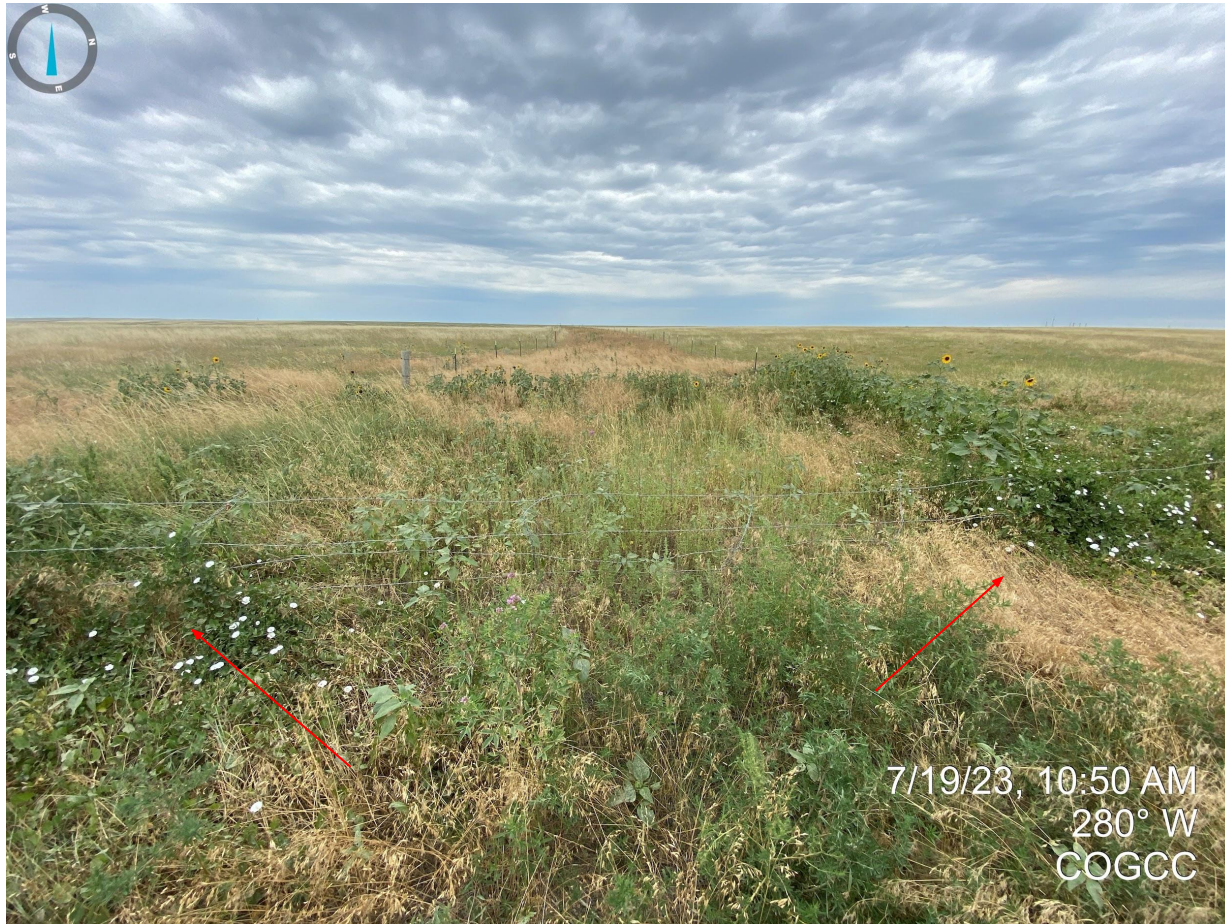
**Photo 1.** Taken at the entrance, off the county road. Undesirable vegetation (e.g. russian thistle, field bindweed, downy brome) were observed to be growing throughout the reclaimed location. Additional management of undesirable species is required in order to meet Rule 1004 standards.

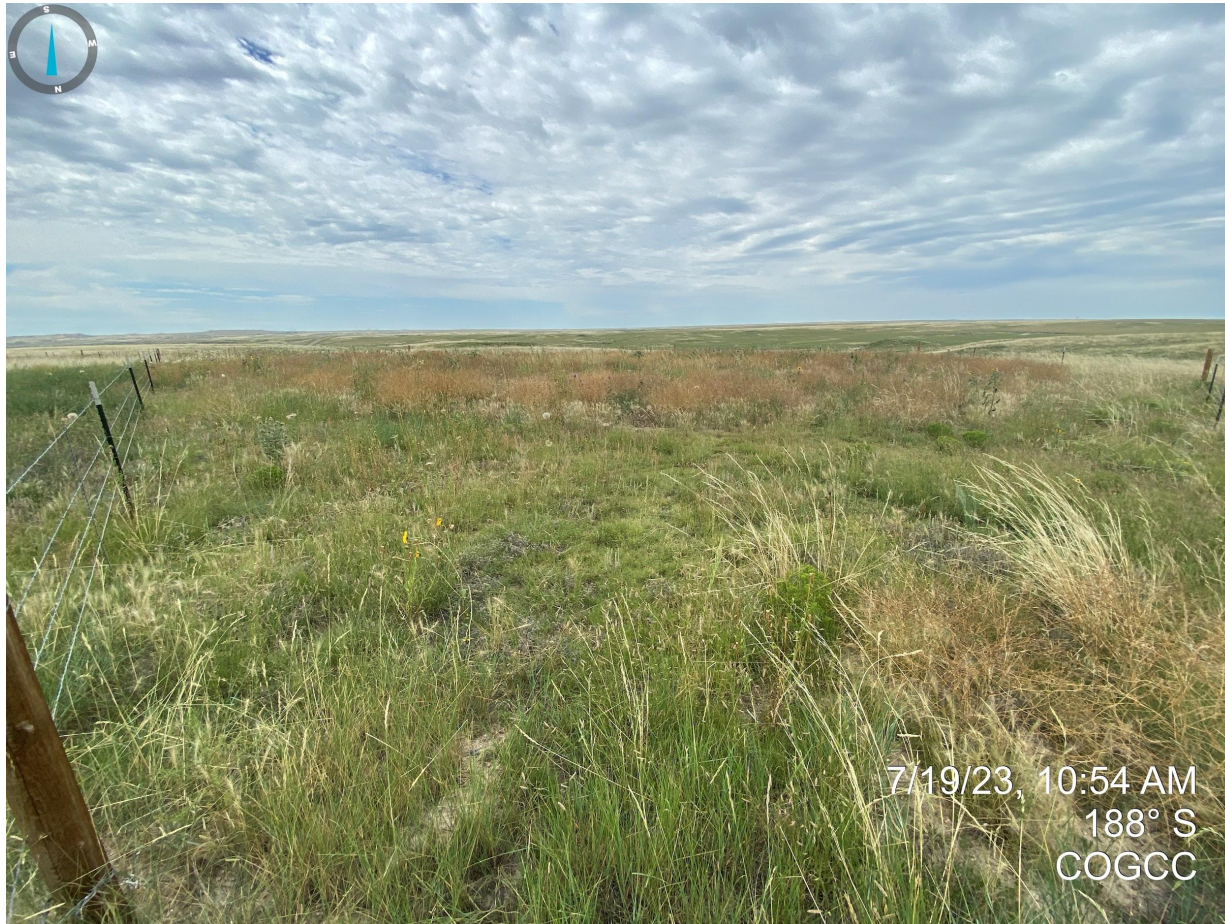
**Photo 2.** Portions of the reclaimed location appear to be progressing towards Rule 1004 standards with evidence of desirable perennial species (blue grama, buffalo grass, etc). Additional reclamation activities are required to manage undesirable species within the reclaimed area.

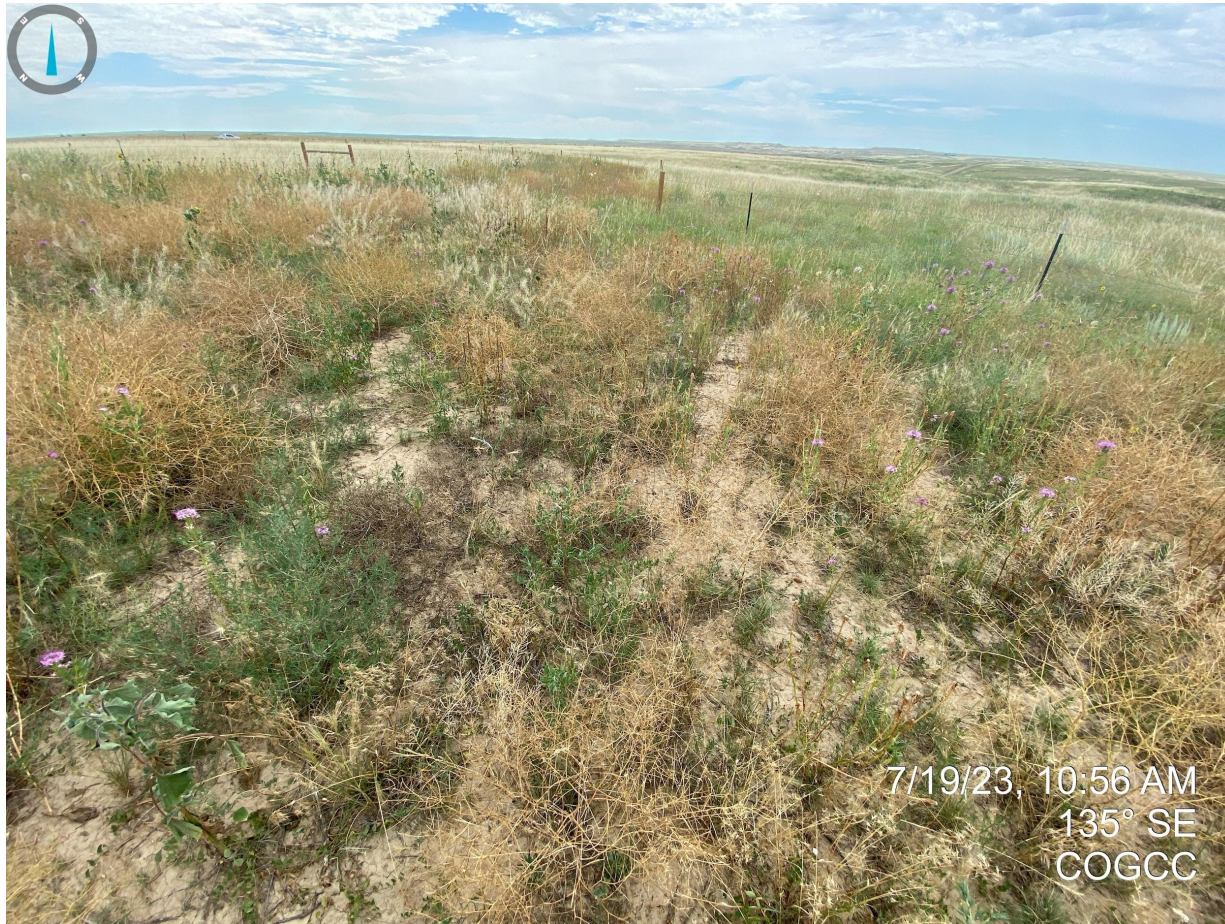
**Photo 3.** Center portions of the reclaimed area are experiencing exposed/bare soil.

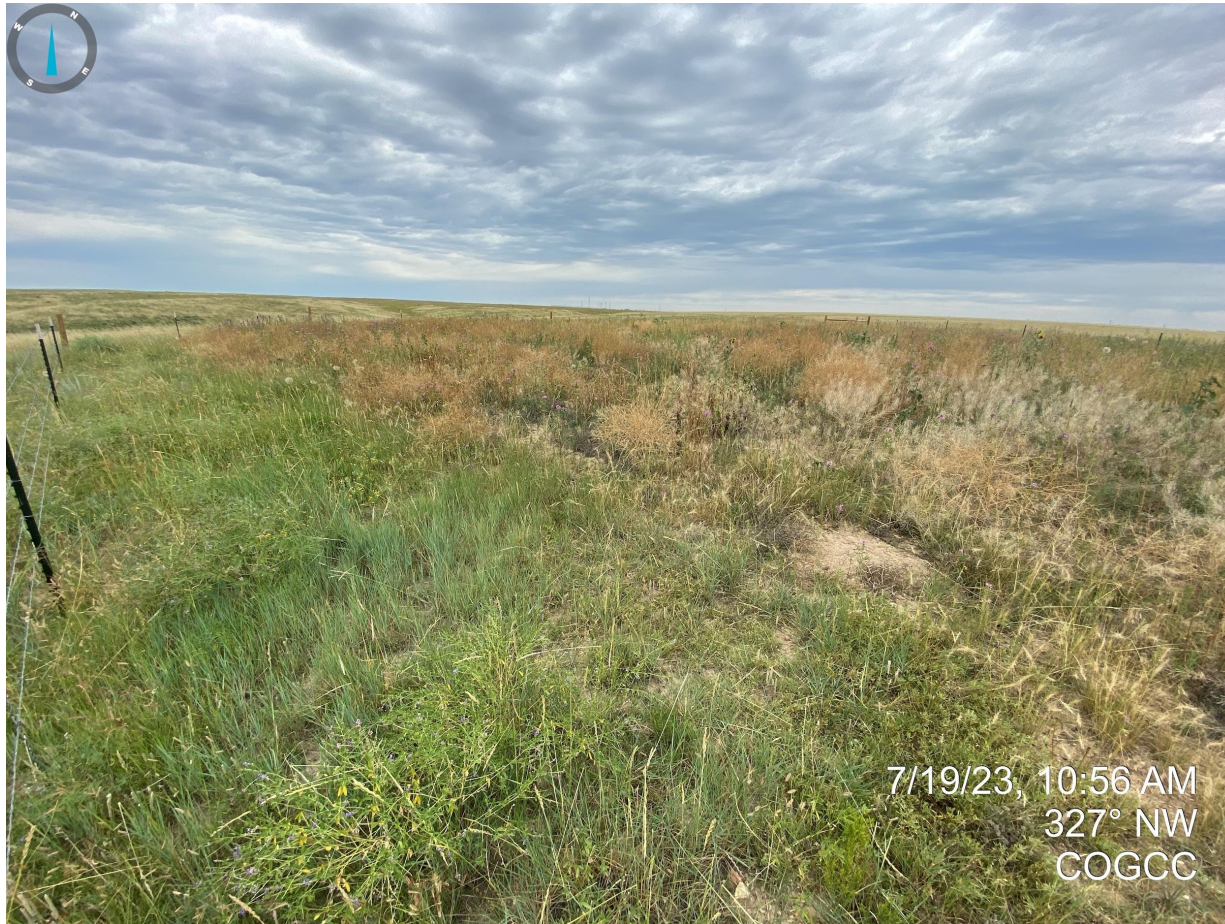
**Photo 4.** Taken from the southern portion of the location; see comments in Photos 2 & 3.

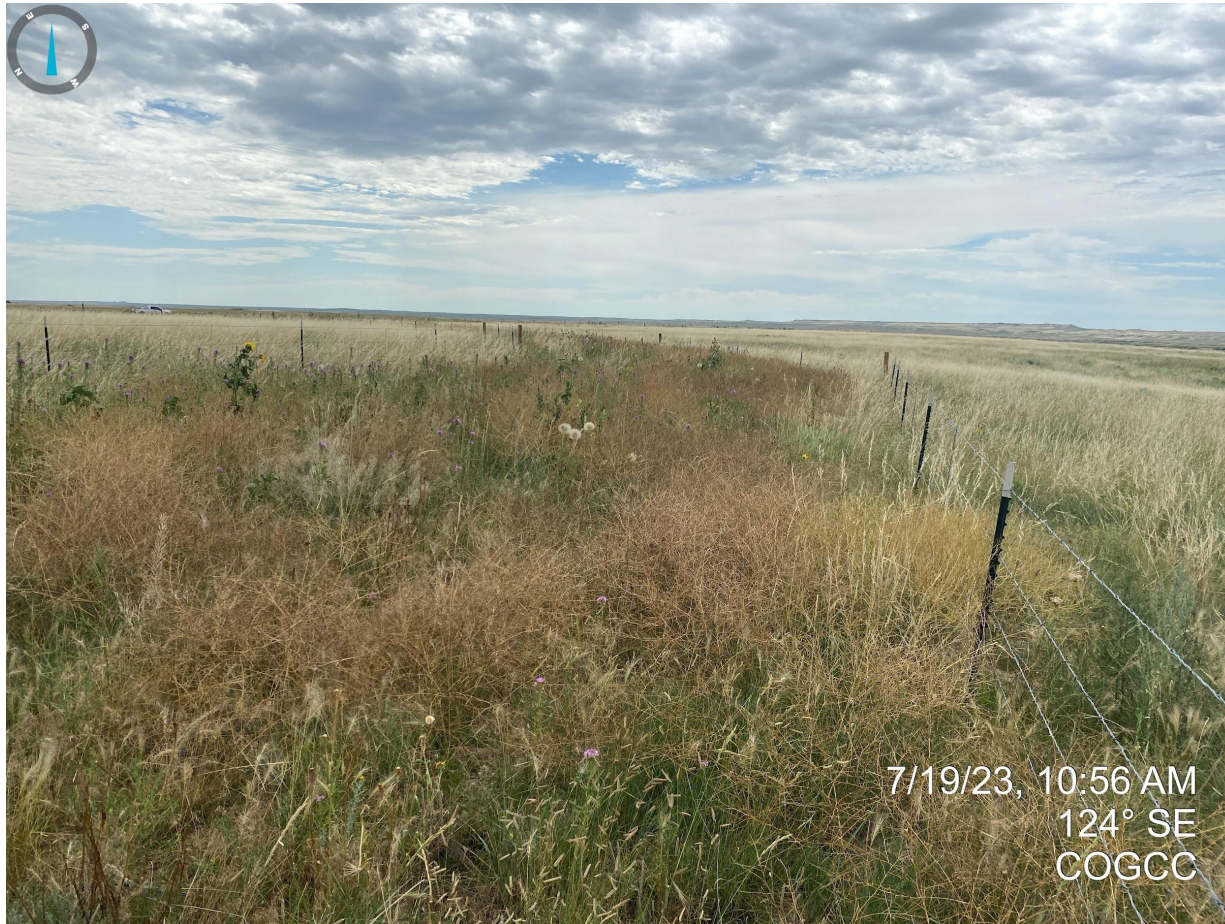
**Photo 5.** Taken from the location facing southeast towards the access road. Weedy debris and undesirable species observed throughout the access road.
