Final Reclamation and Stormwater Inspection

Operator: NOBLE ENERGY INC - 100322

Location ID: 327017

Inspection Photos
Location Name: Lill Unit 14-3
Location ID: 327017

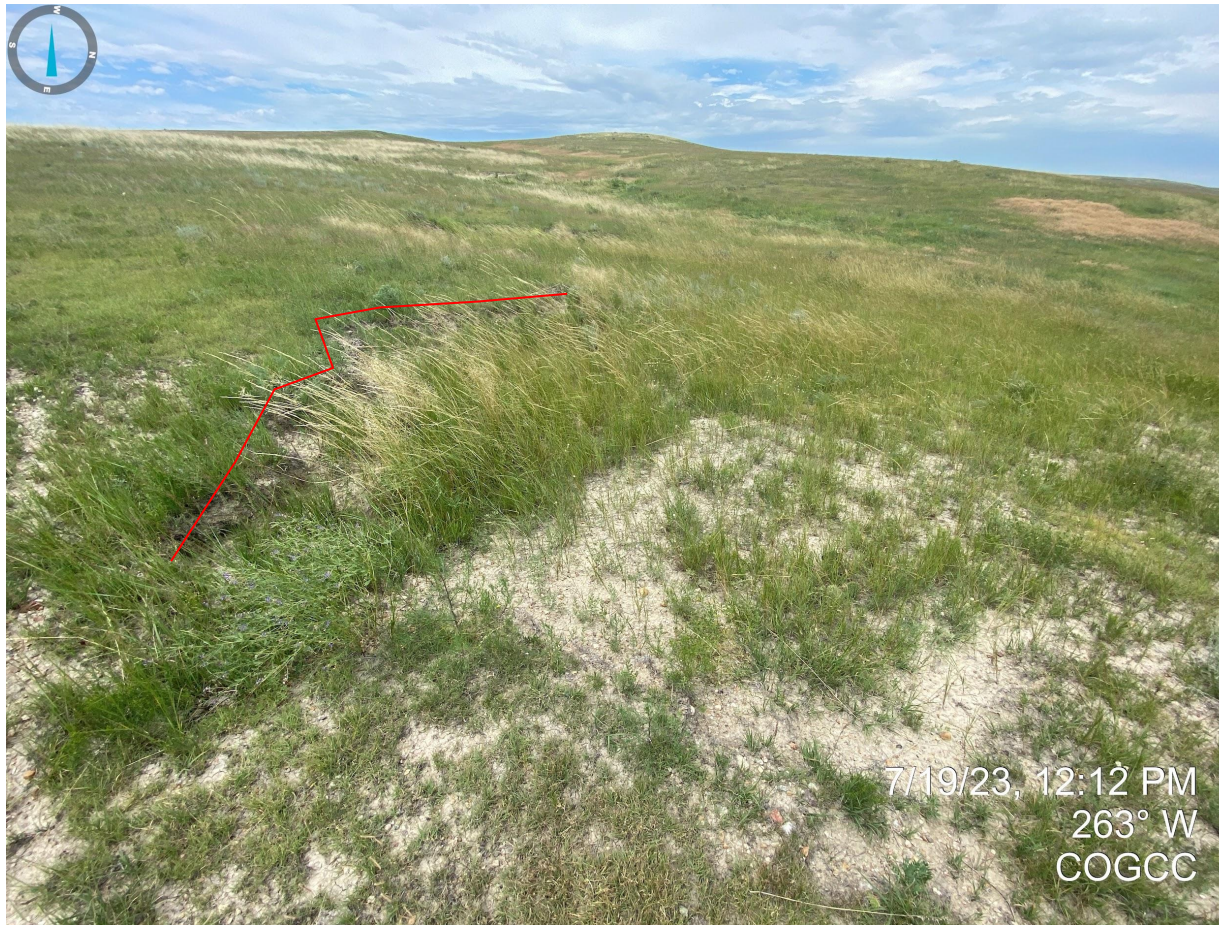
Photo 1. Taken from the former access road, facing west. Photo illustrates that cut banks (red line) have not been recontoured and bare/exposed soils are evident. Additional reclamation work will need to be performed in order to stabilize the exposed soils.

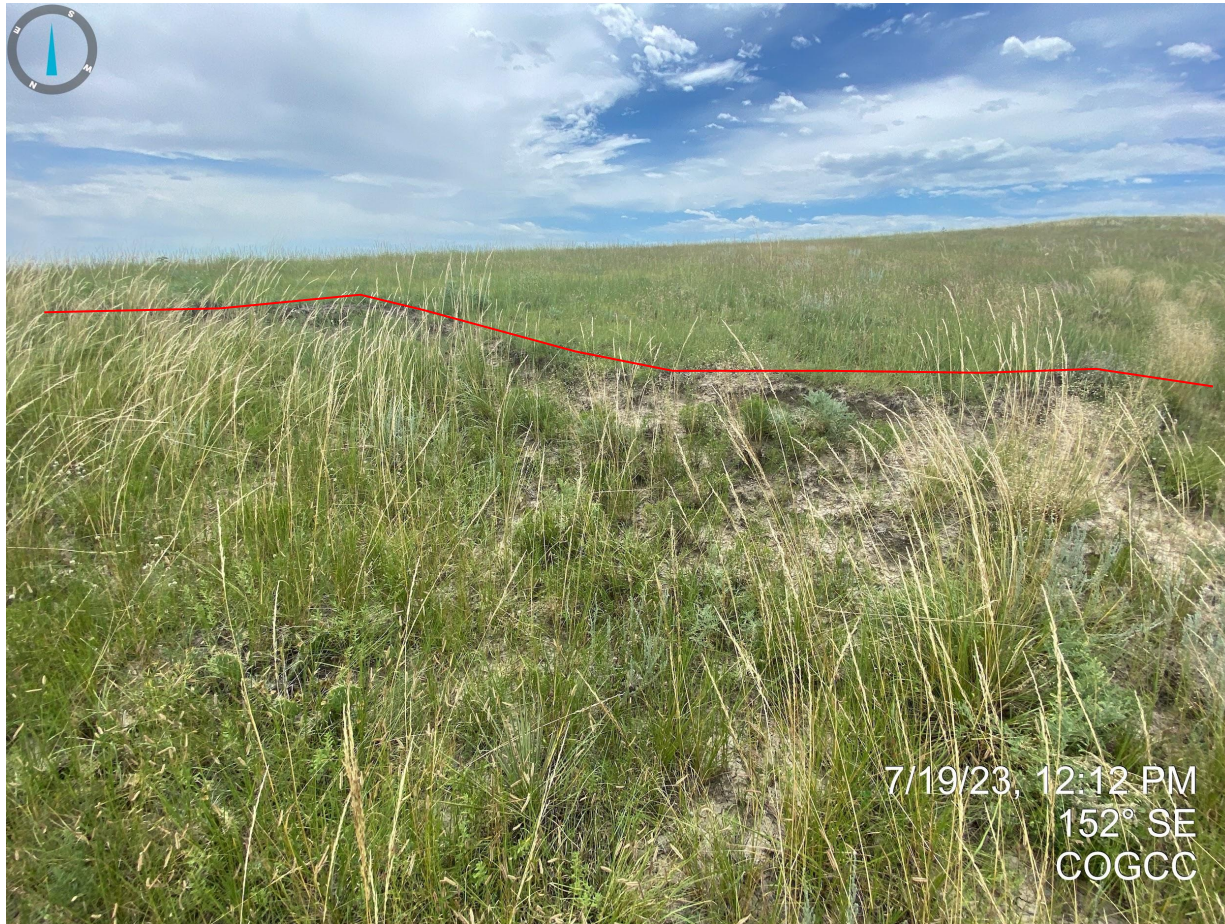
Photo 2. Facing southeast; see comments in Photo 1.

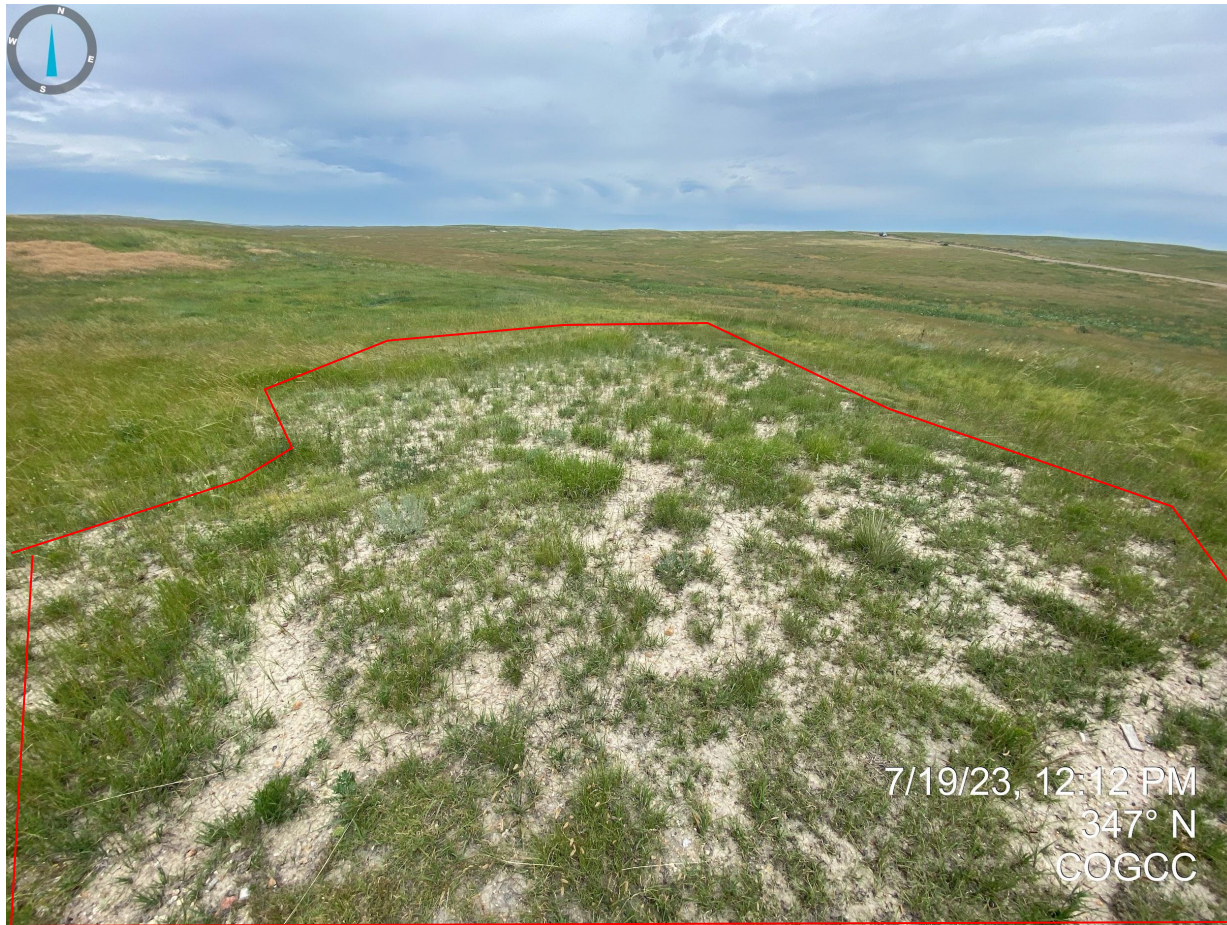
Photo 3. Facing north from cut bank area; see comments in Photo 1.

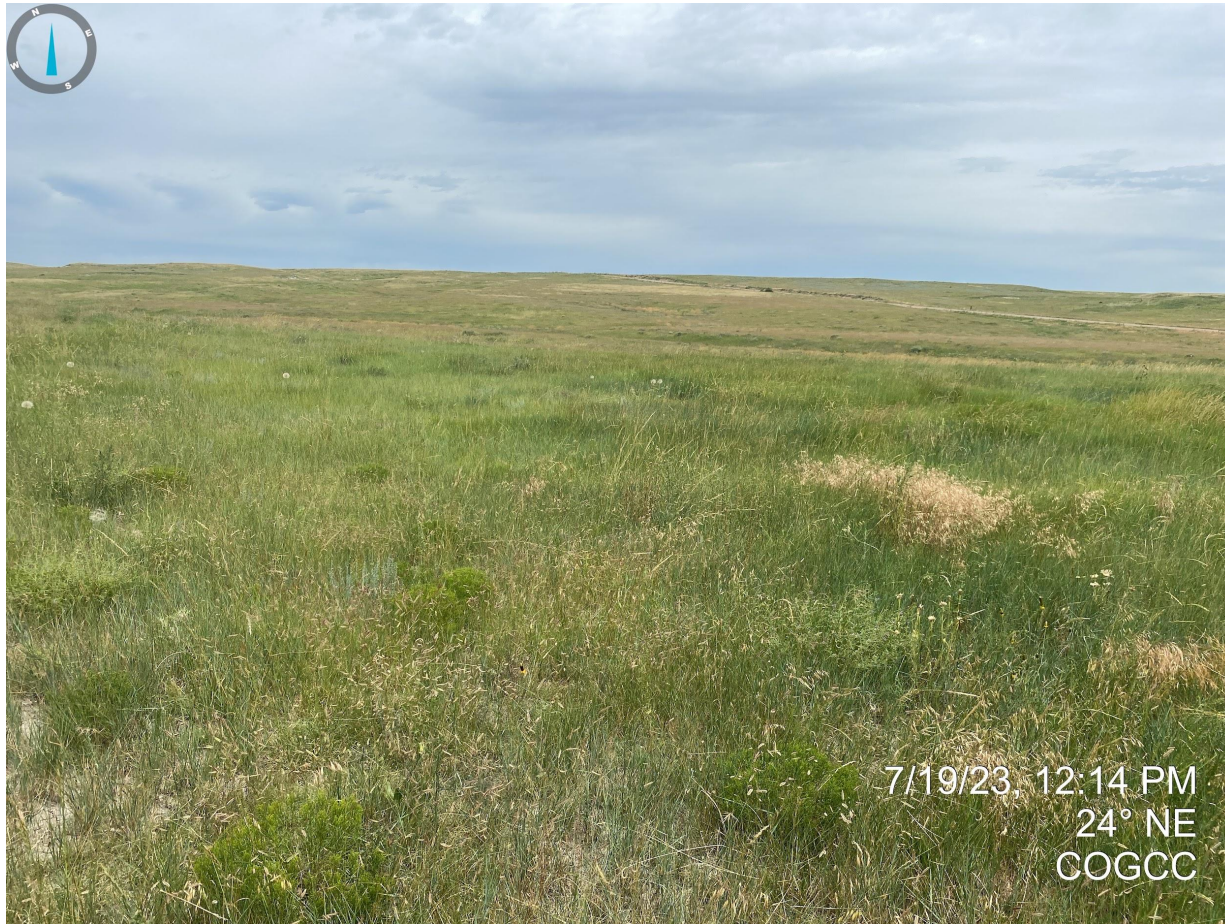
Photo 4. Facing northeast from the former well location. The reclaimed portions of the location appear to be progressing towards Rule 1004 standards with evidence of desirable perennial species observed.
