Operator: BONANZA CREEK ENERGY OPERATING COMPANY LLC

Location Name: Antelope P-17 PAD

Loc ID: 428964

Inspection: 696305112

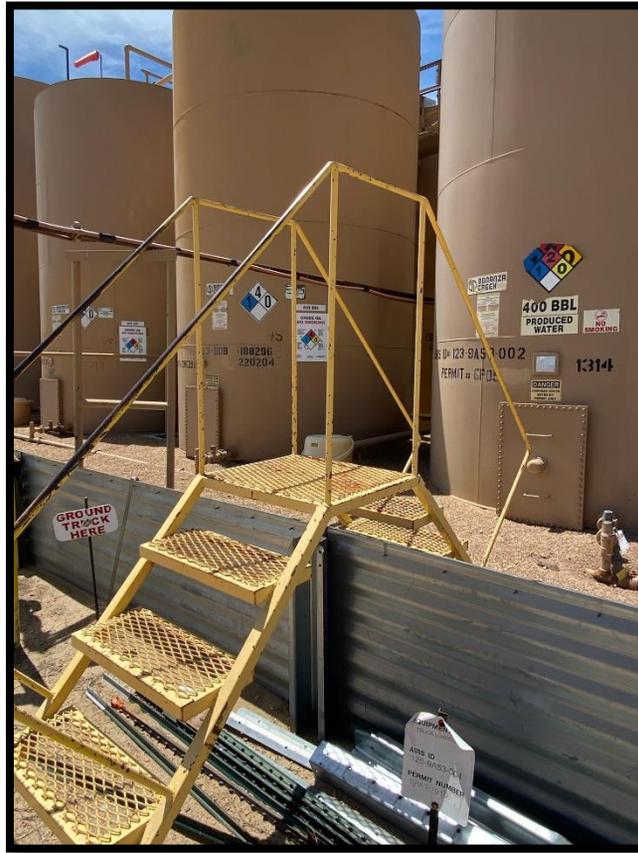
Exhibit A

CA: East 400 BBL Crude Oil Tanks - Content and Capacity Labels have faded; see photos. Install sign to comply with Rule 605.h.

CA: Unused Production Equipment/Parts on East Side of Location; see photos. Comply with Rule 606.

CA: Locate Line Flags on Location; see photos. Comply with Rule 606.

CA Resolution: Operator has provided photo evidence and noted the two Crude Oil Tanks have new capacity/content labels installed to comply with Rule 605.h.

CA Resolution: Operator has reported that there is active maintenance going on at this facility and this equipment will be reinstalled on the tank battery when completed.

CA Resolution: Operator has requested that the current locate line flags remain in place as there is additional digging is likely to be needed. Field will be sure to remove these flags when maintenance has been completed to comply with Rule 606.

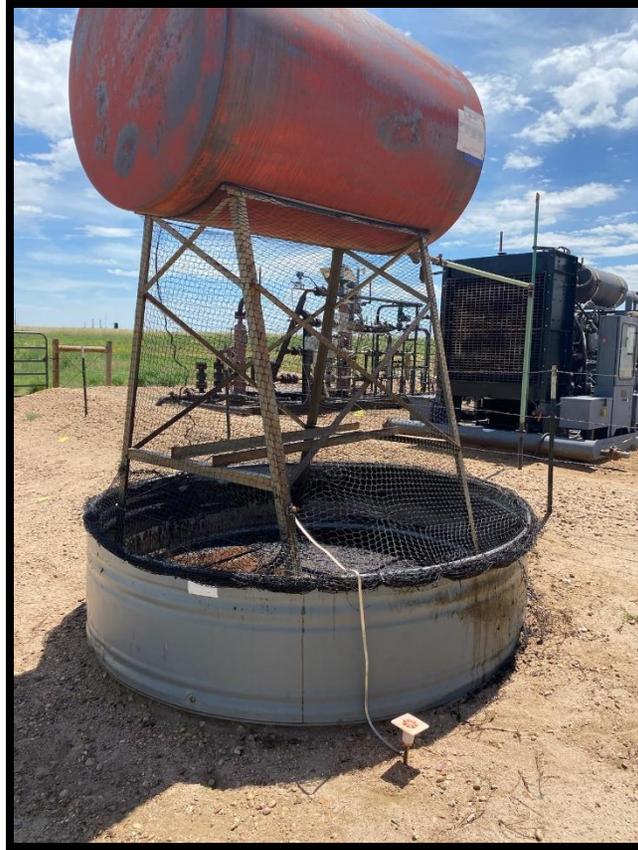
Exhibit A

CA: Day Tank Netting is in disrepair. See photos. Install or repair wildlife protection equipment. Prevent any unauthorized discharge (specify condition if it is E&P waste, improper disposal, trash, etc.) Per Rule 902.b

CA Resolution: Operator has provided photo evidence and noted wildlife protective netting has been appropriately replaced to comply with Rule 902.b, and any surrounding debris has been cleared and removed.
