**Operator: BONANZA CREEK ENERGY OPERATING COMPANY LLC**

**Location Name: Antelope J-20 Pad**

**Loc ID: 430128**

**Inspection: 696305122**

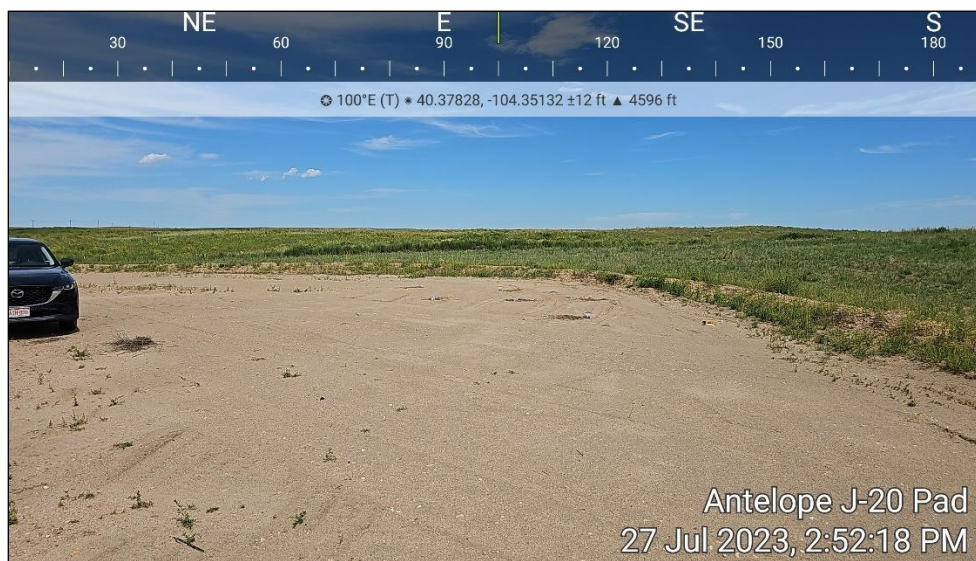
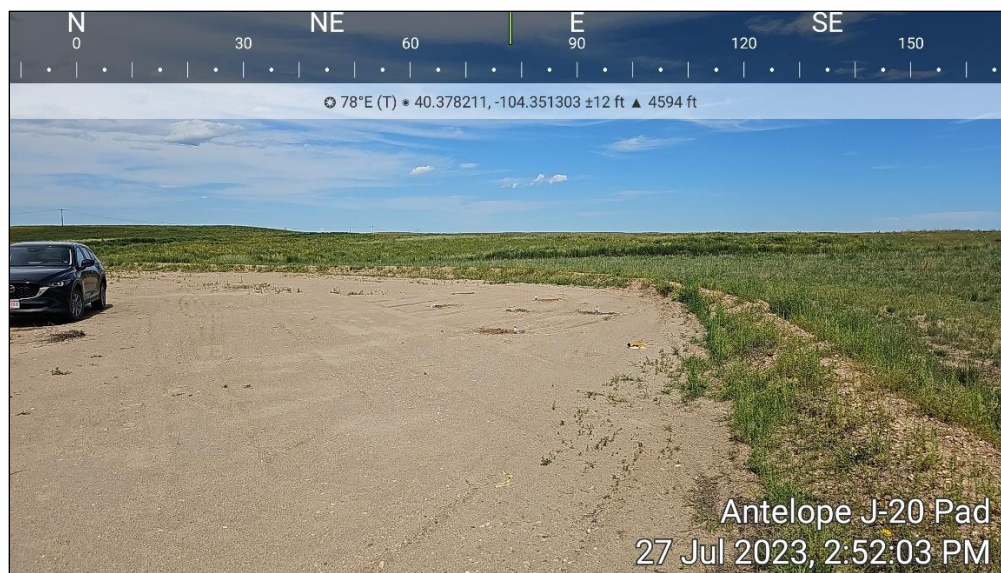
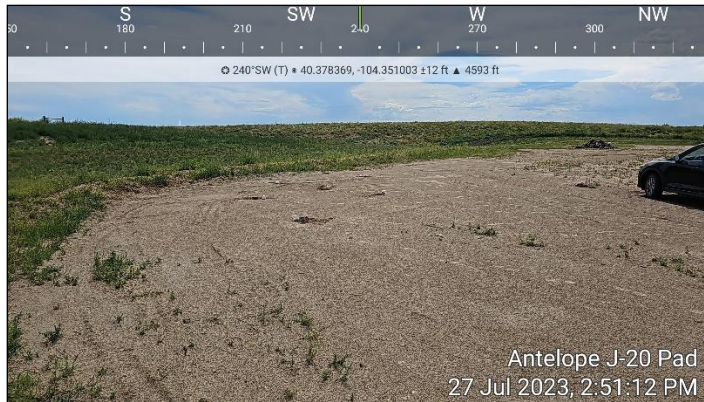
**CA:** What appears to be Frac Sand or some type of Solid on South side of Location; see photos. Pollution: Violation to water quality standards and classifications. Comply with reporting requirements in 906 and notify EPS within 24-hrs. Comply with 912 Series Rules.

**CA Resolution:** Environmental Specialist reviewed the location and reported that the area has been appropriately cleared of frac sand and cleaned to now comply with Rules 906 and 912. Reported readings from PID were between 26-335ppm.

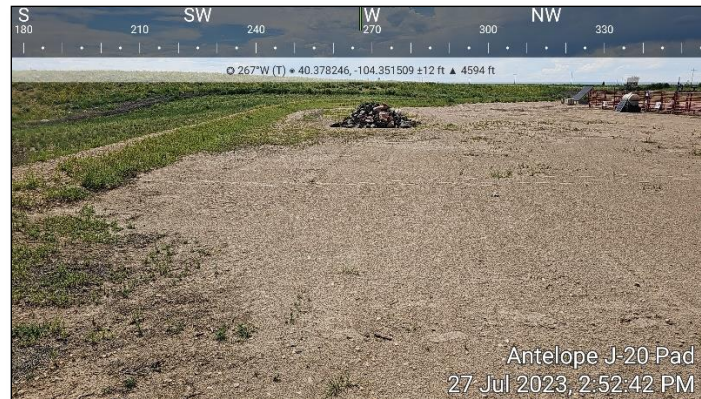
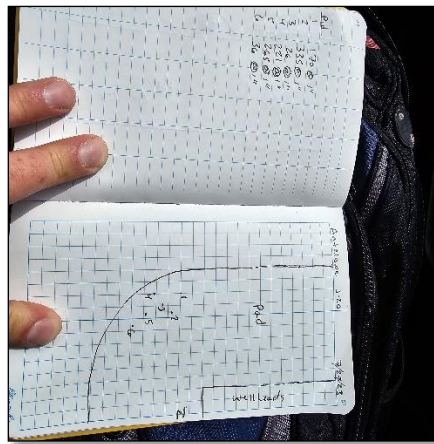
**CA:** SE Corner - Solid Waste - What appears to be Solids Waste from Hydrovac Truck; see photos. Pollution: Violation to water quality standards and classifications. Comply with reporting requirements in 906 and notify EPS within 24-hrs. Comply with 912 Series Rules.

**CA Resolution:** Environmental Specialist reviewed the location and reported that waste from the Hydrovac has been appropriately cleared and cleaned from the site to comply with Rules 906 and 912. Reported readings from PID were between 26-335ppm.
