# Final Reclamation Inspection

Operator: PDC ENERGY INC - 69175

Location ID: 331416

Inspection Photos  
Location Name: Fickel 41-21  
Location ID: 331416

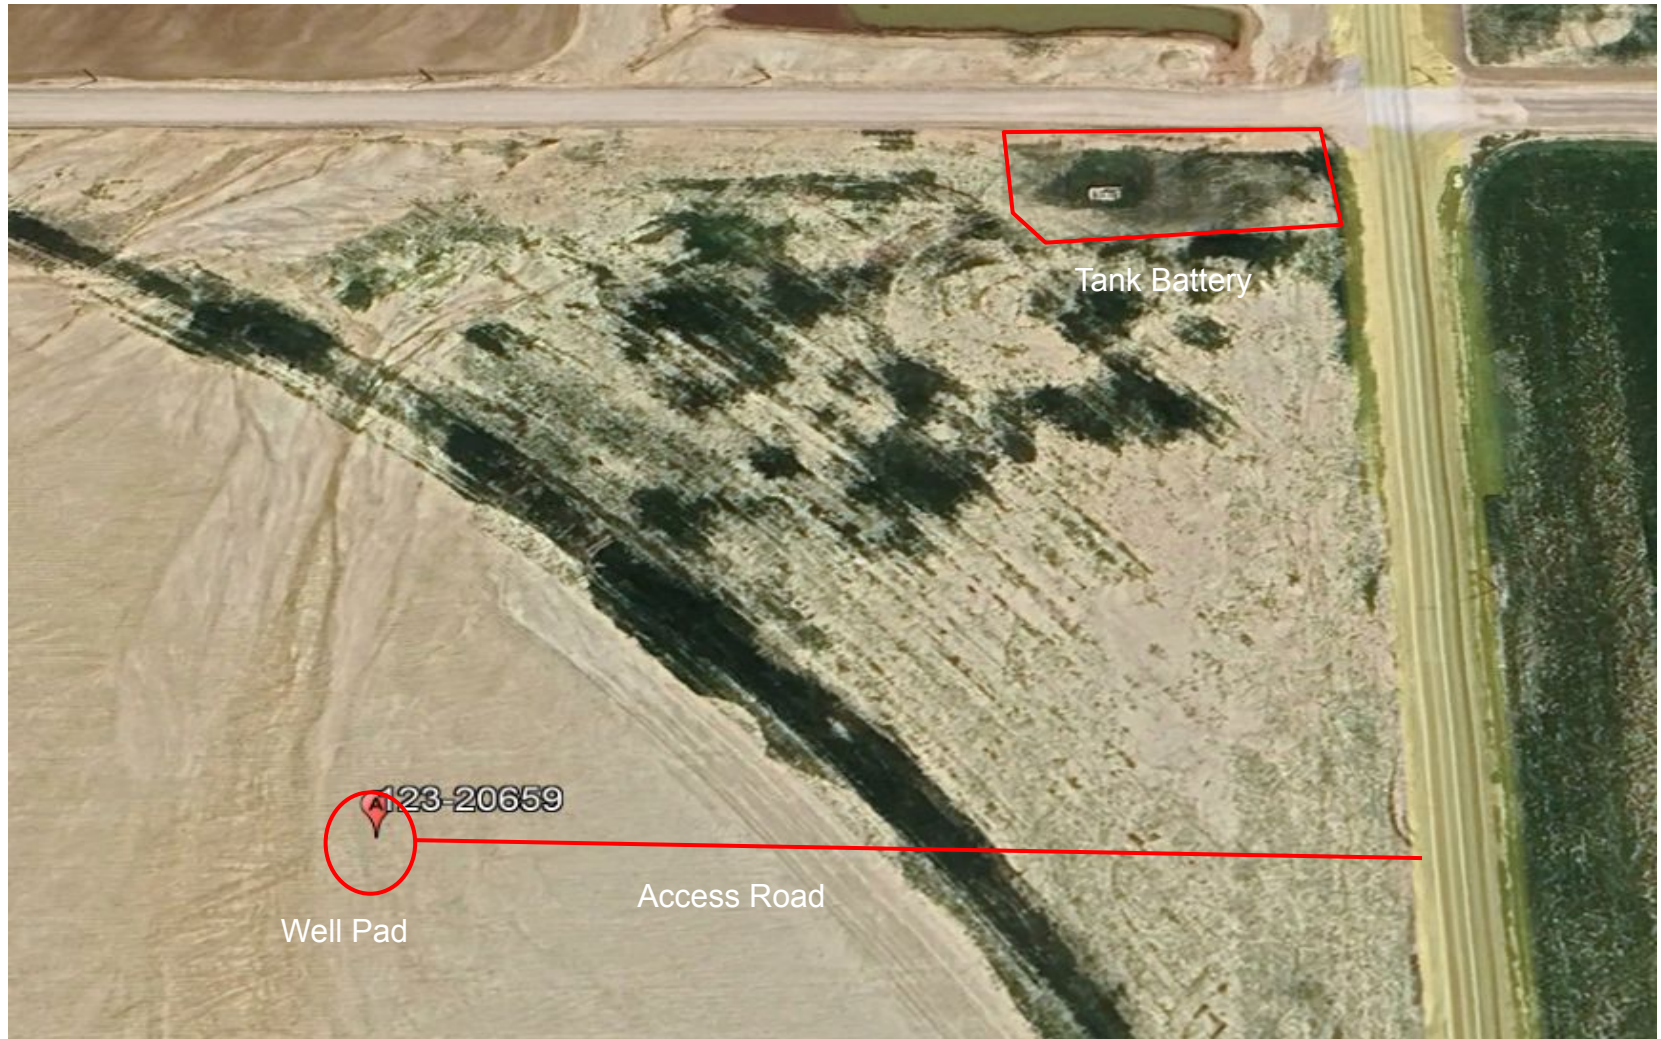
**Photo 1.** 2023 aerial imagery of the well pad, access road and tank battery (north is up).

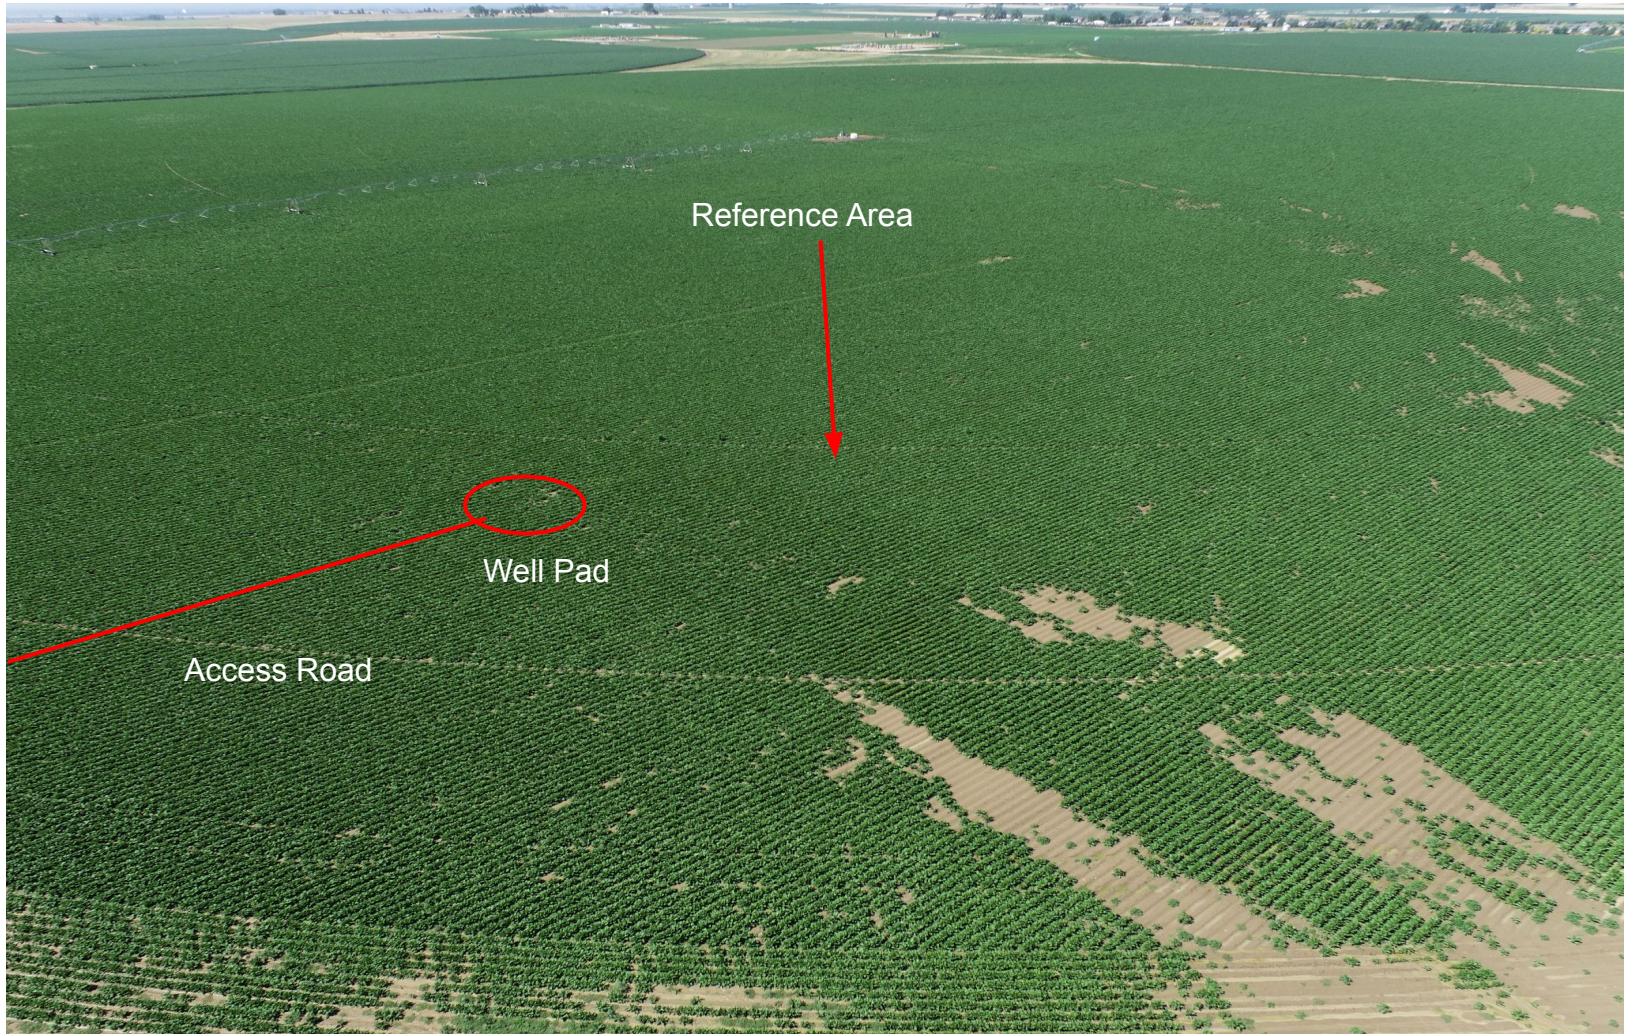
**Photo 2.** Overview photo of the access road and well pad taken from the northern edge facing southern using a drone. Photo shows that the well pad and access road appear consistent with adjacent reference area.

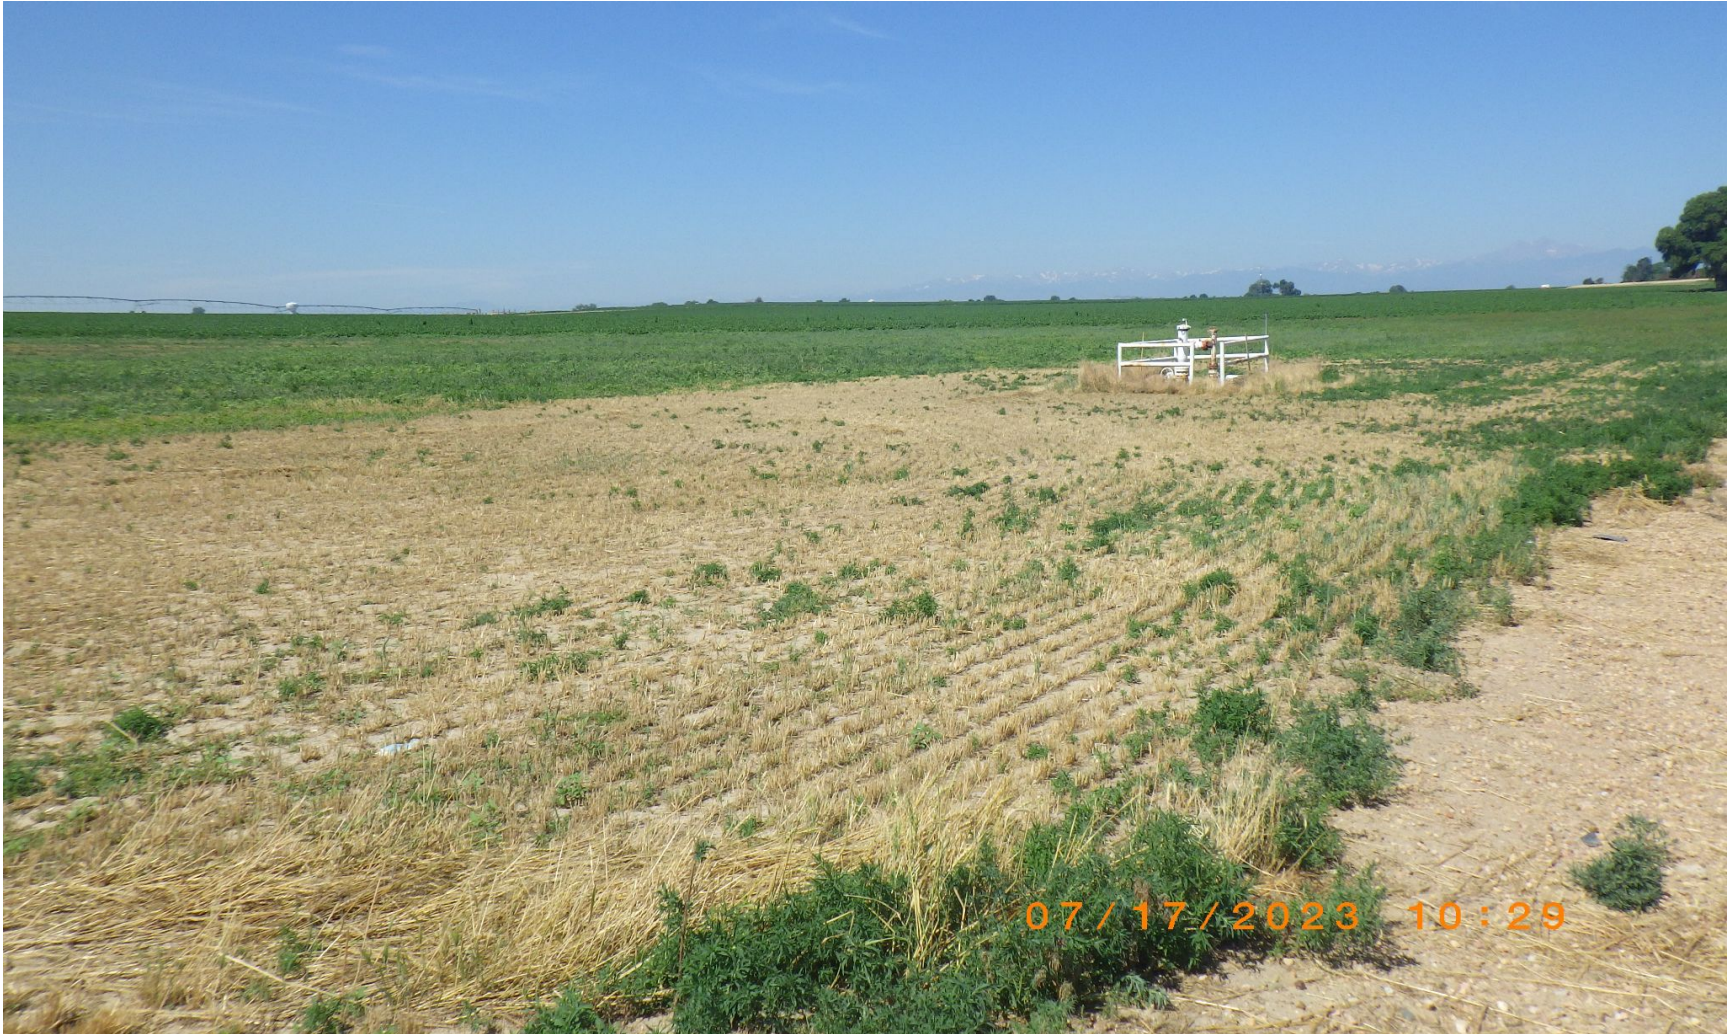
**Photo 3.** Overview photo of the tank battery taken at ground level from the northern edge facing southwest.

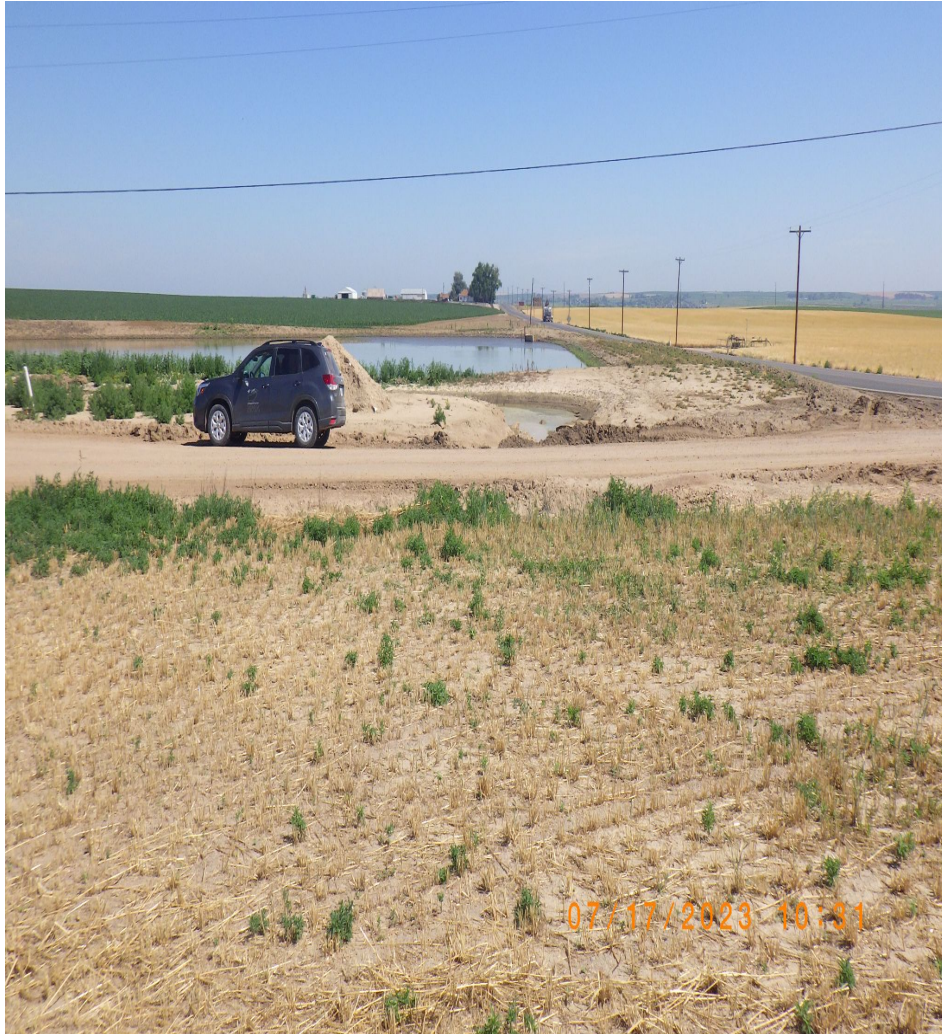
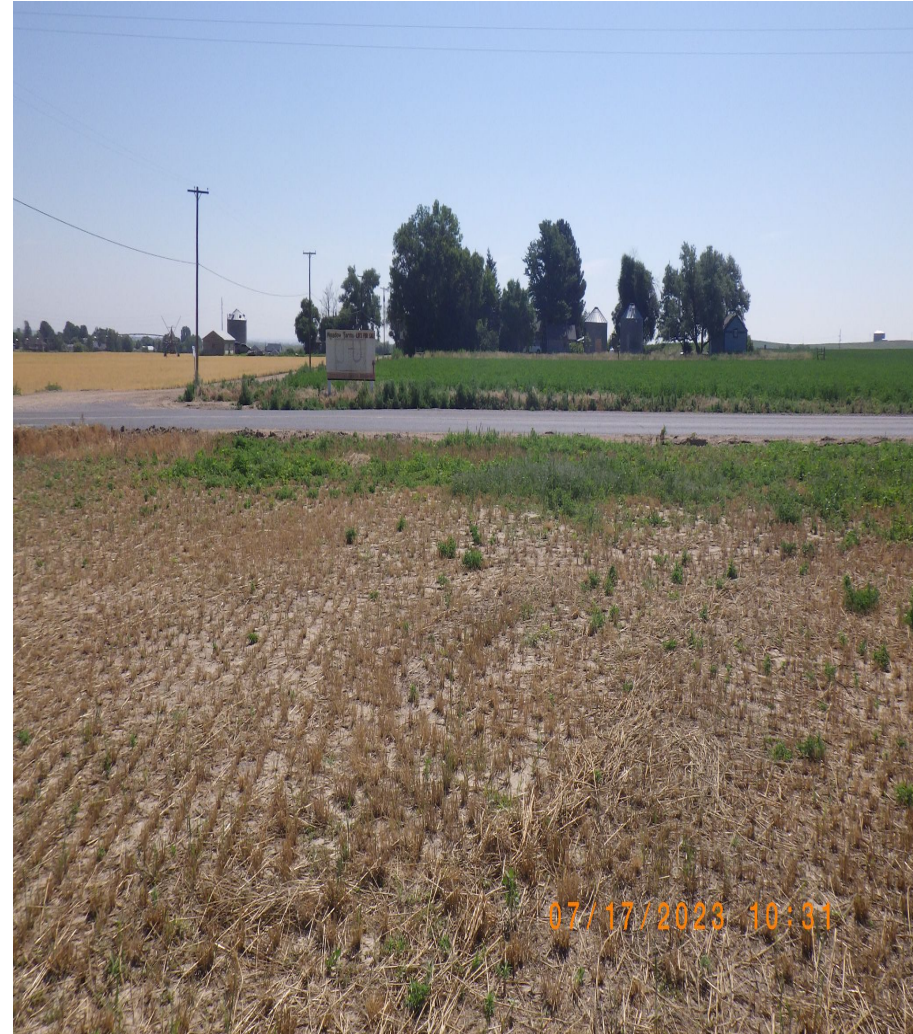
**Photo 4.** Cardinal photos taken from the middle of the tank battery.  
Left photo facing north, right photo facing east.

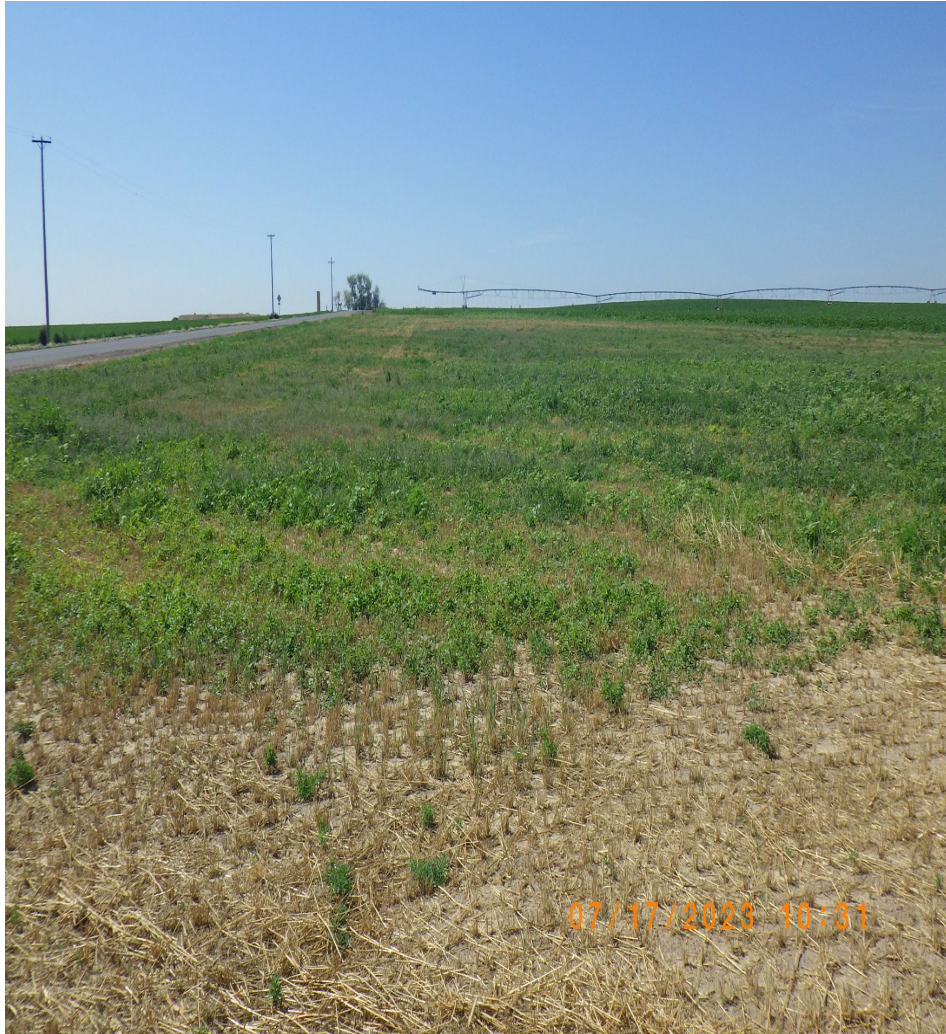
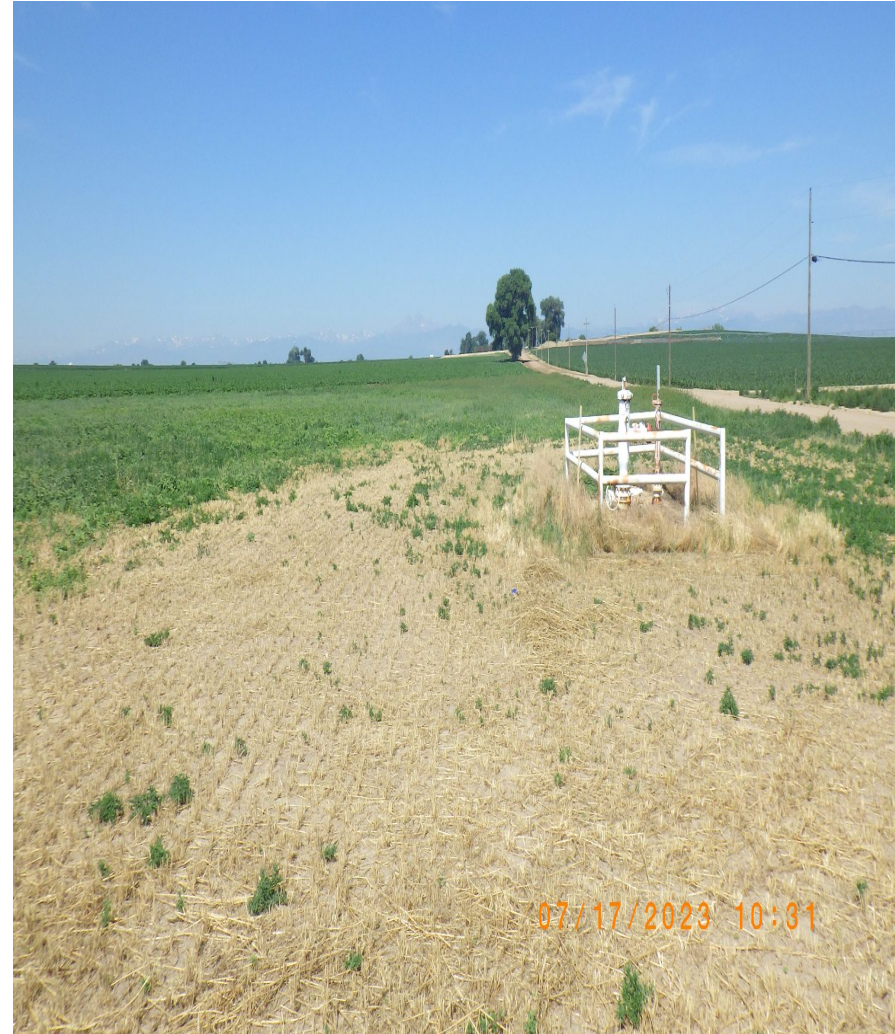
**Photo 5.** Cardinal photos taken from the middle of the tank battery. Left photo facing south, right photo facing west. Photo shows that the operator failed to remove risers at the location.

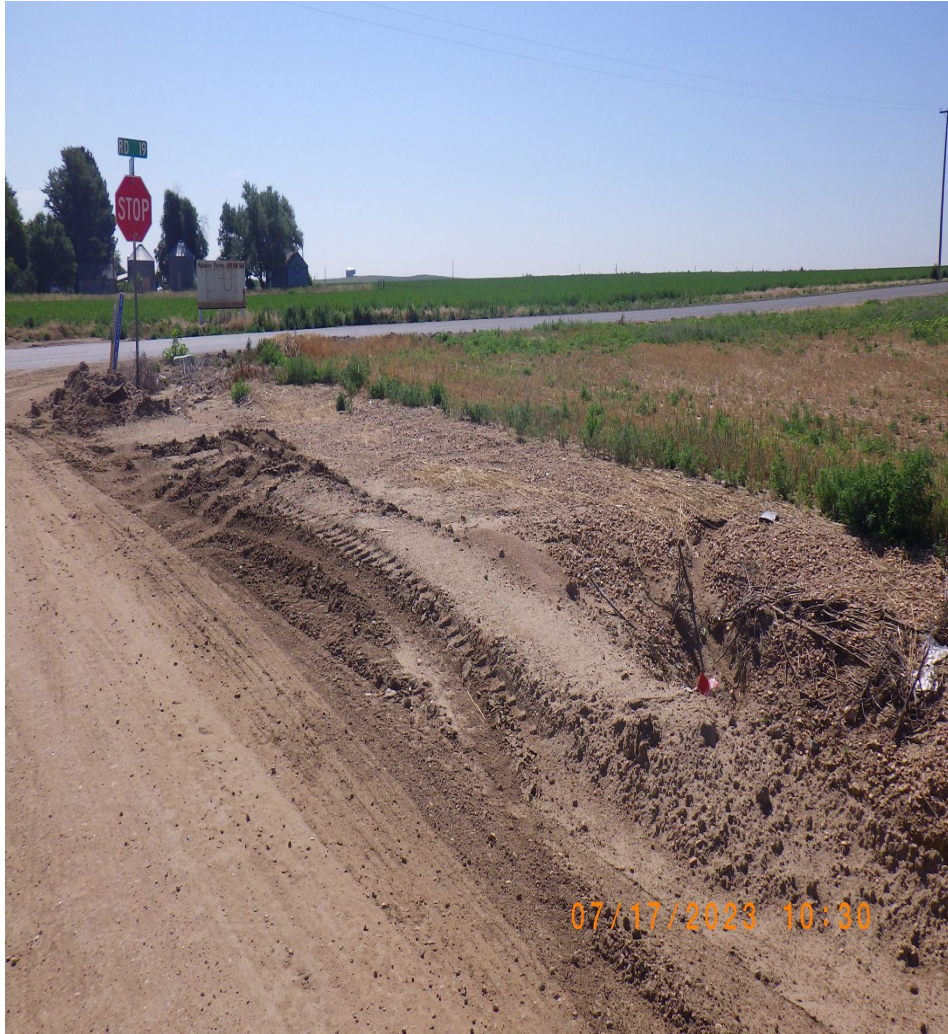
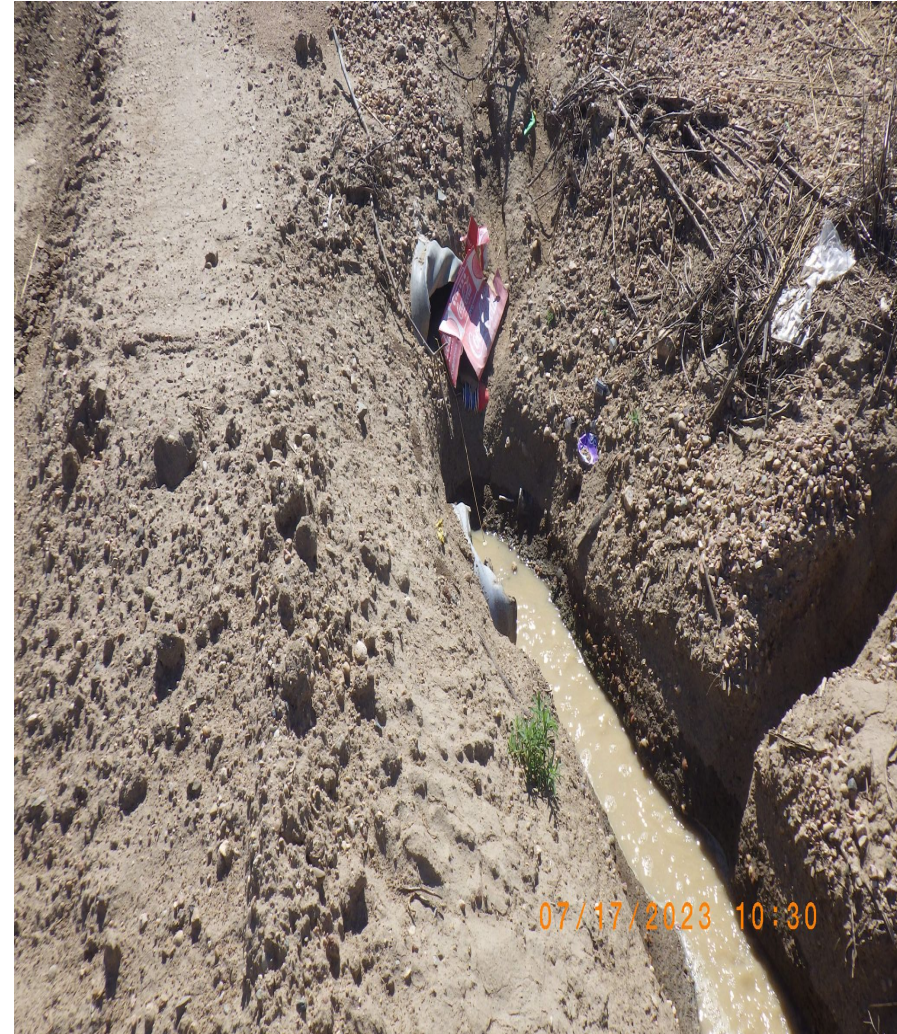
**Photo 6.** Photos of the tank battery access point and culvert. Photo shows that the operator failed to reclaim the access point and remove culverts.

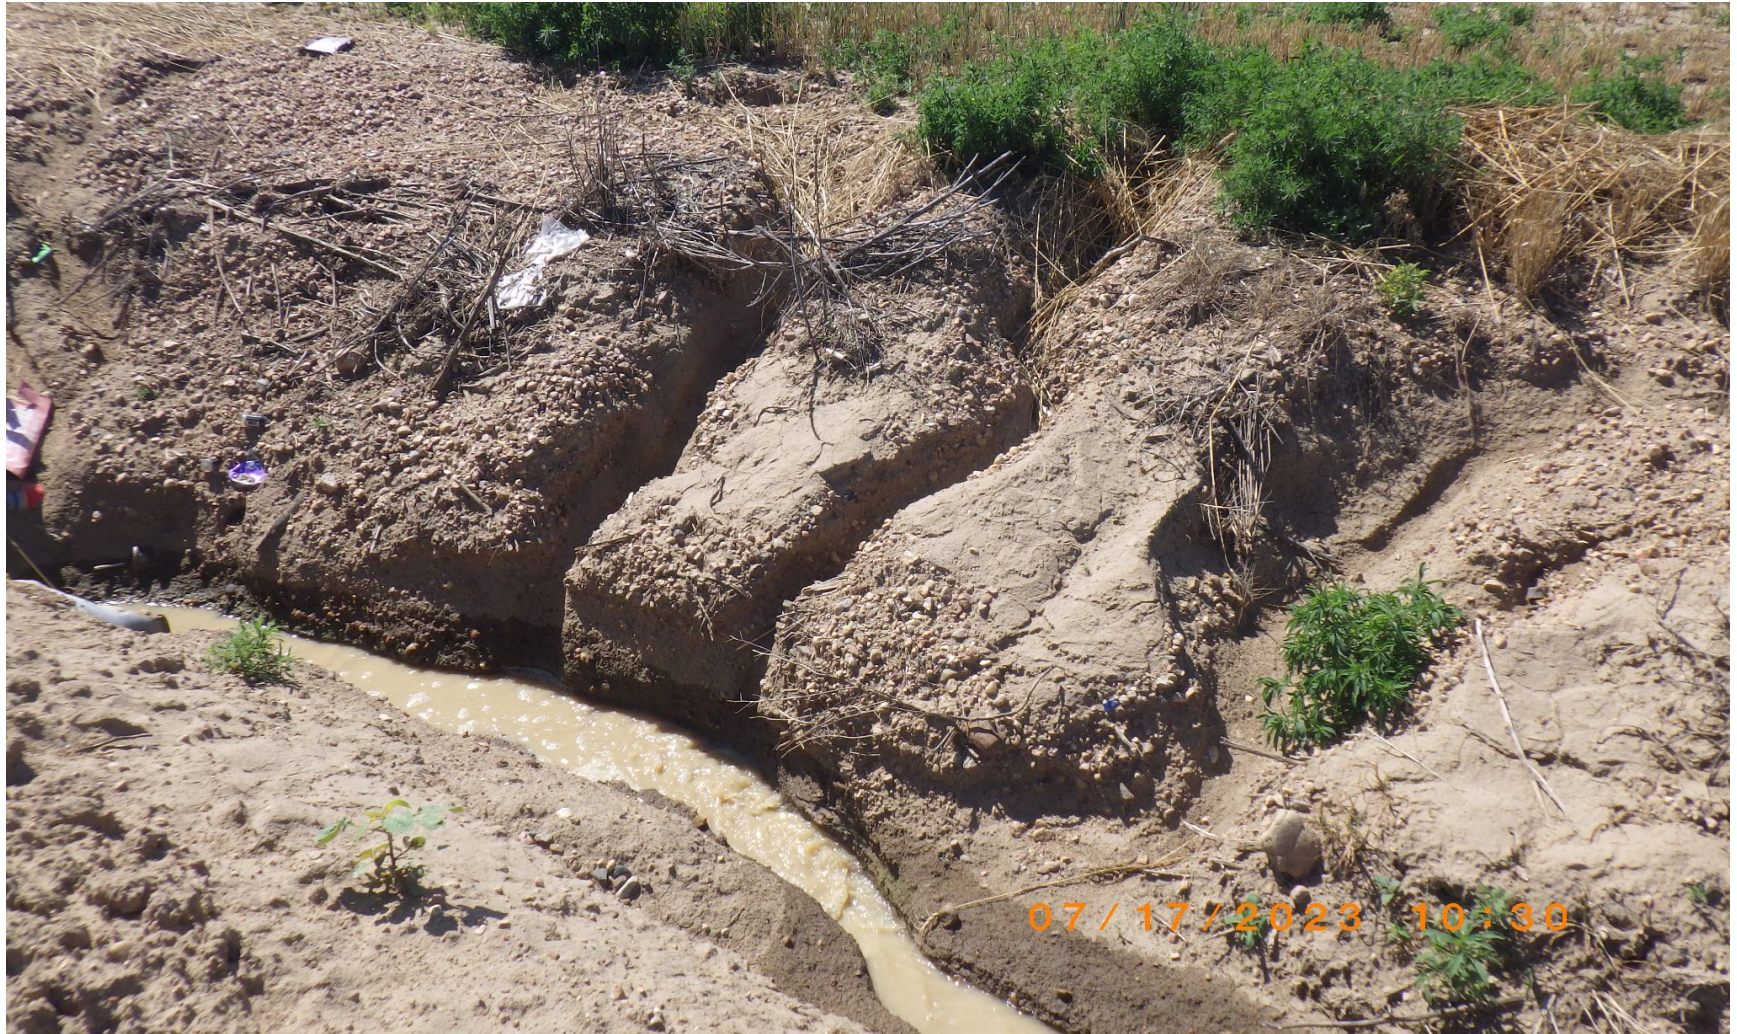
**Photo 7.** Stormwater erosion observed along the northern edge of the tank battery.
