Operator: BONANZA CREEK ENERGY OPERATING COMPANY LLC

Location Name: Antelope J-19 PAD

Loc ID: 430139

Inspection: 696305114

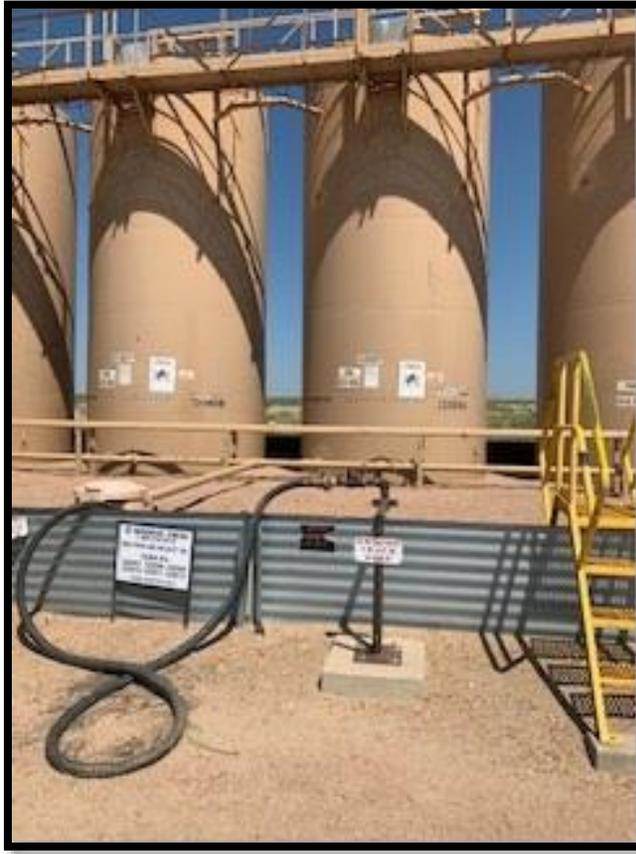
Exhibit A

CA: Tanks 2205080 and 220509 NFPA Labels have faded no longer visible; see photos. Install sign to comply with Rule 605.h.

CA Resolution: Operator has provided photo evidence and noted that NFPA Labels have been installed to comply with Rule 605.h.

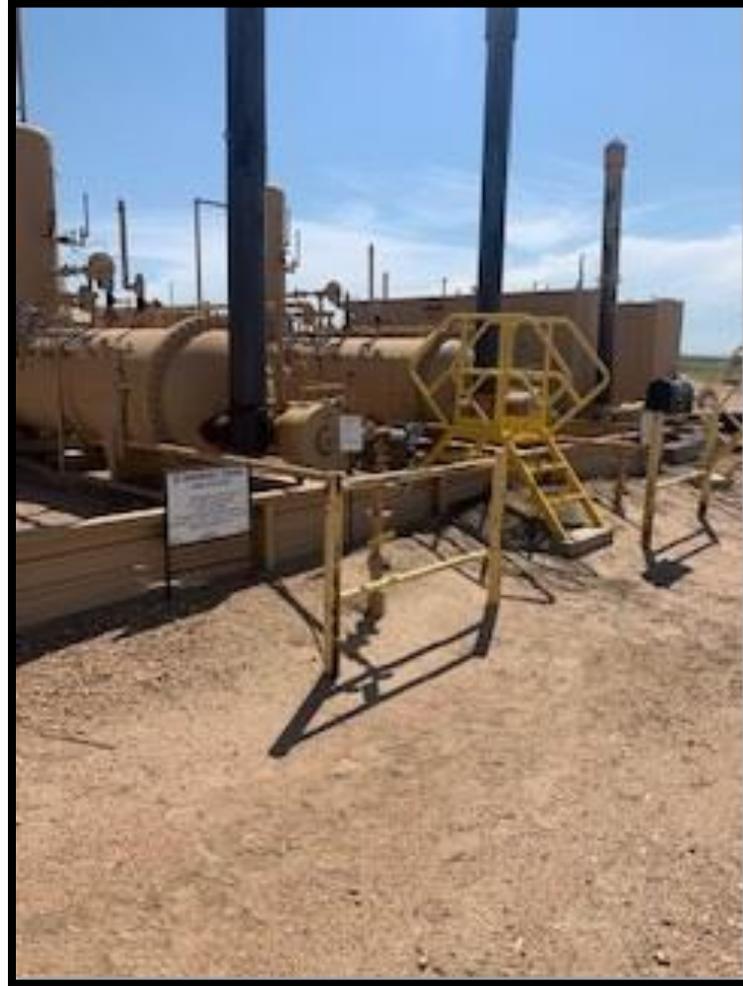
Exhibit B

CA: Tumbleweed Debris at Separators. Comply with Rule 606.

CA Resolution: Operator has reported that the identified tumbleweeds have been cleared from location to comply with Rule 606.

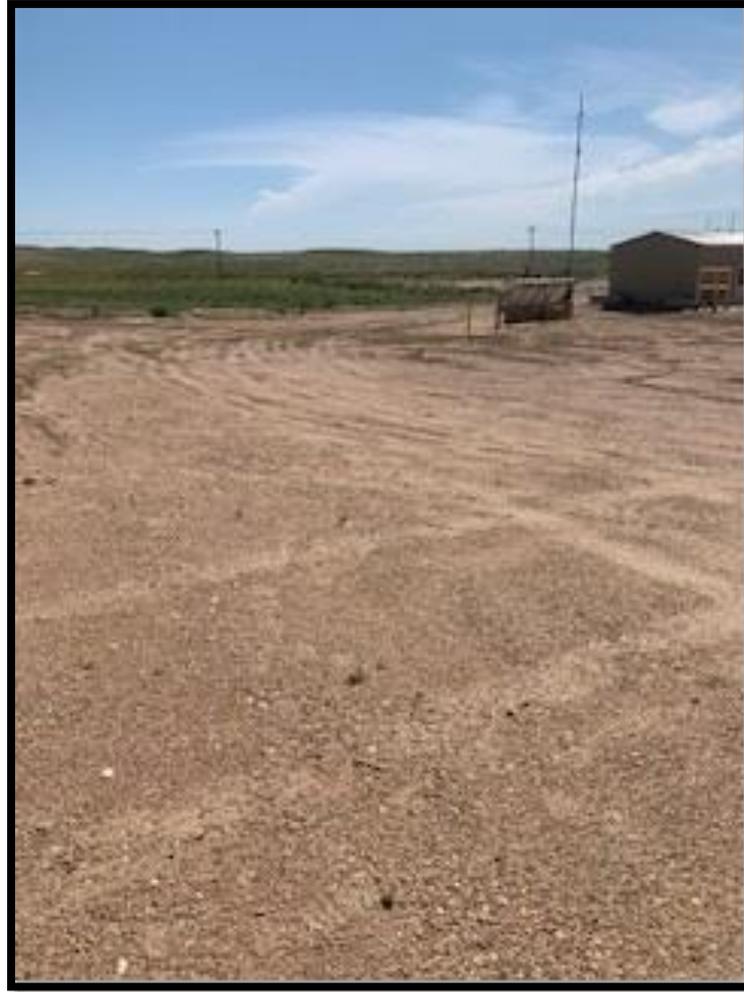
Exhibit A

CA: Out of date Locate Flags on location in varies spots; see photos. Comply with Rule 606.

CA Resolution: Field has reported that most of the locate flags have been removed; however, a few will need to remain on the East side of the tanks while there is active work being done to the water line. Field will be sure to remove these flags when maintenance has been completed to comply with Rule 606.

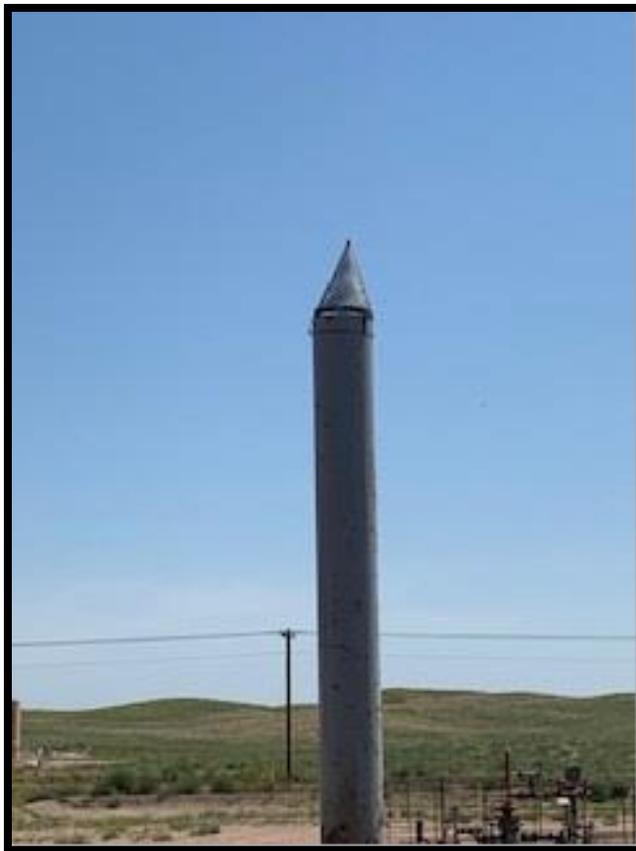
Exhibit A

CA: Line Heater missing Bird Protector; see photos. Install or repair wildlife protection equipment. Prevent any unauthorized discharge (specify condition if it is E&P waste, improper disposal, trash, etc.) Per Rule 902.b.

CA Resolution: Operator has provided photo evidence and noted wildlife protective netting has been appropriately installed to comply with Rule 902.b.
