# Inspection Photos

API: 071-09013

Operator: WAPITI OPERATING LLC

Inspection Date: 7/31/2023

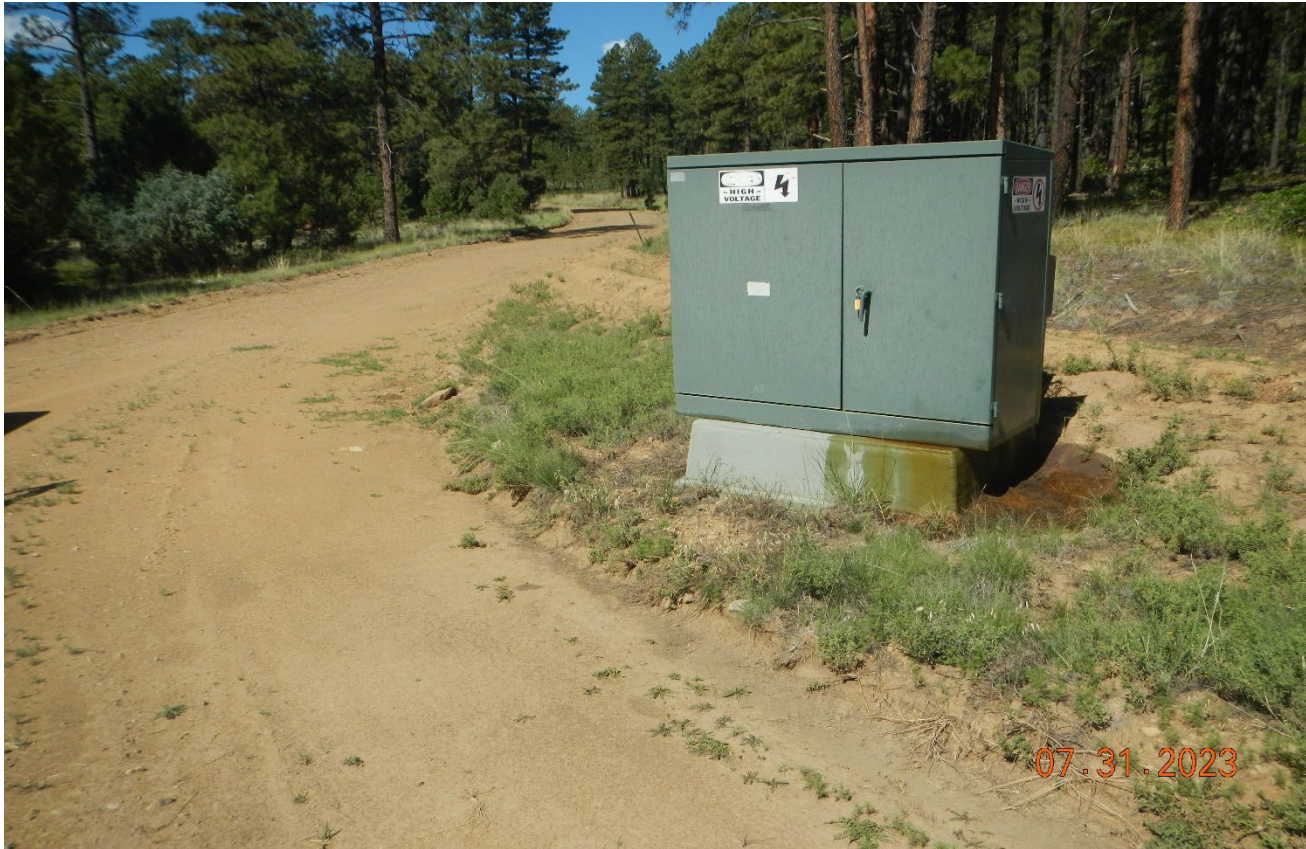
**Photo 1.** Facing northeast along the access road at Latitude: 37.00784 Longitude: -104.858674. This electric utility is leaking oil that needs to be repaired and cleaned up.

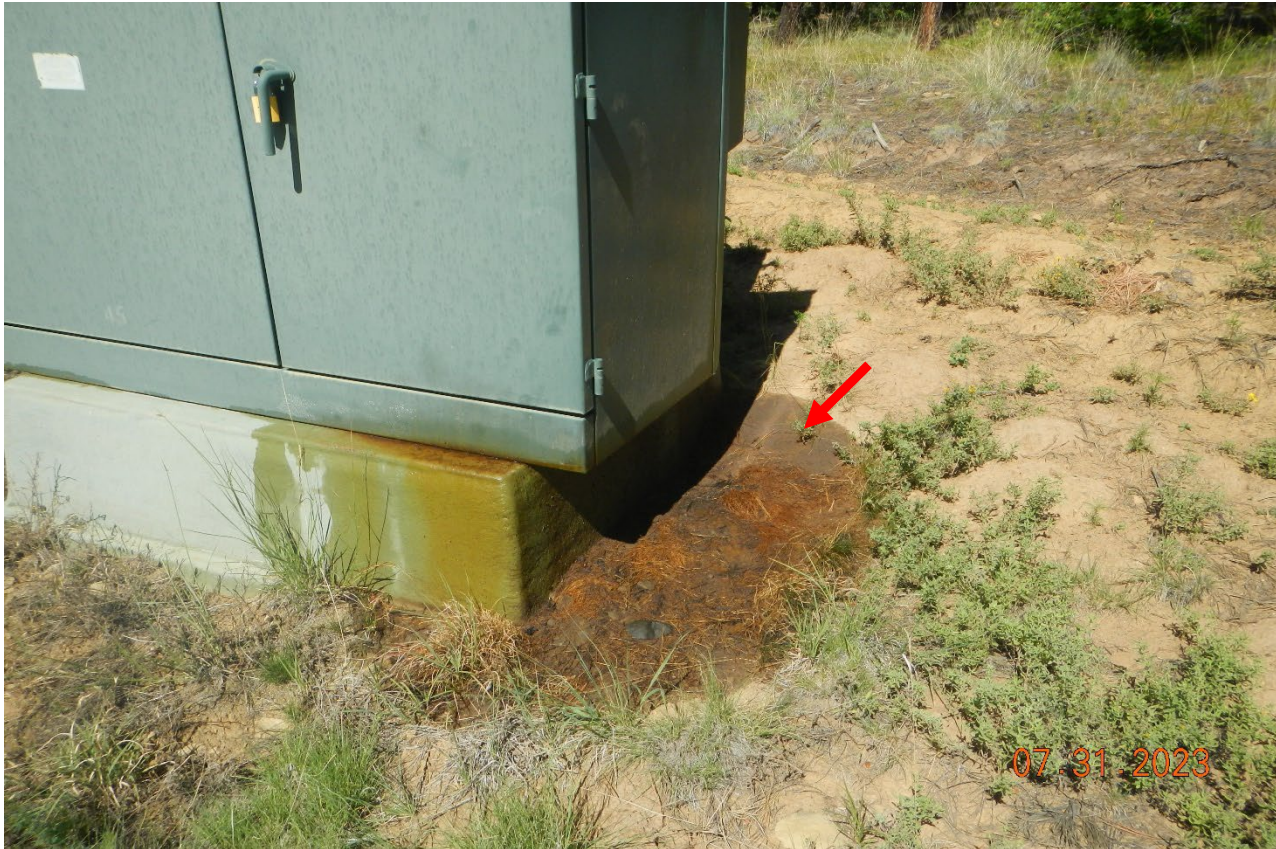
**Photo 2.** There is oil stained soils at the electric utility that needs to be cleaned up.

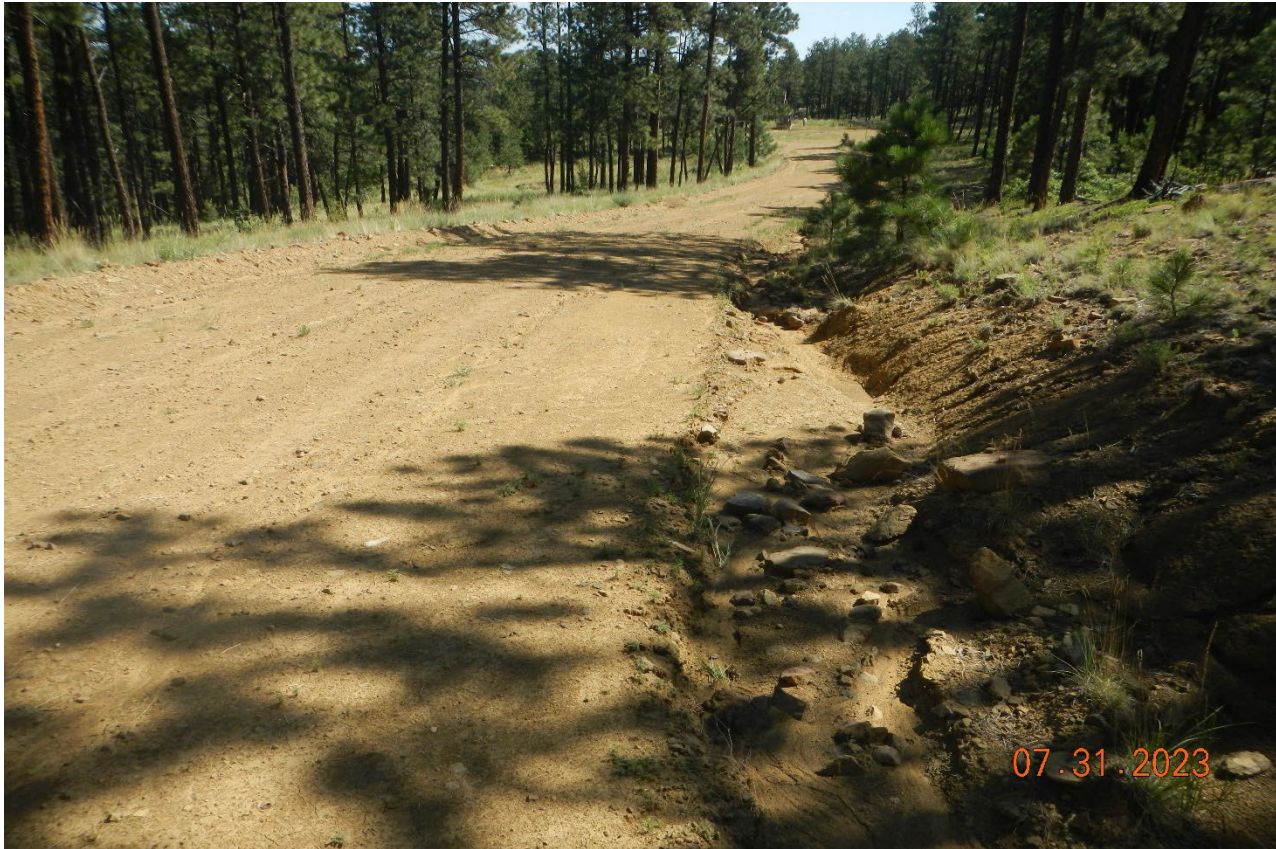
**Photo 3.** Facing northeast along the access road. There is erosion along the roadside which needs BMP's to control erosion.
