Attachment B

TANK BATTERY DECOMMISSIONING FORM

SITE NAME: McLeod 29-41 Tank Battery							DATE: 3/21/2022	REM. PROJECT #: 21589	WEATHER: 30's Windy		
SITE DIRECTIONS: CR42/29, 0.5 mi S, W into							CLIENT: PDC - Paul Ruiz				
LEGALS AND LAT/LONG: 40.282597, -104.795100							TASMAN PERSONNEL: Jesse Marcus				
SOIL TYPES: Silty Sand - SM							SURFACE GRADIENT: South				
SOIL SAMPLING							FACILITY INFRASTRUCTURE				
Date/Time	Soil Sample ID	PID (ppm)	Visual	Olfactory	Photo?	Grab or Lab Sample?	EQUIPMENT		Quantity		
							Above Ground Storage Tank (AST)		1		
3/21/2022 11:54	AST01@0-6"	0.9	No Staining	No Odor	Yes	Lab	Buried or Partially Buried Vessel		1		
3/21/2022 12:00	ECD01@0-6"	0.0	No Staining	No Odor	Yes	Grab	Separator		1		
3/21/2022 13:35	SEP01-FL@4'	0.0	No Staining	No Odor	Yes	Lab	Emission Control Device (ECD)		1		
3/21/2022 13:36	SEP01-DL@4'	0.0	No Staining	No Odor	Yes	Lab	Dump Line		1		
3/21/2022 16:10	PWV01-B@8'	243.6	HC Staining	HC Odor	Yes	Lab	Wellhead

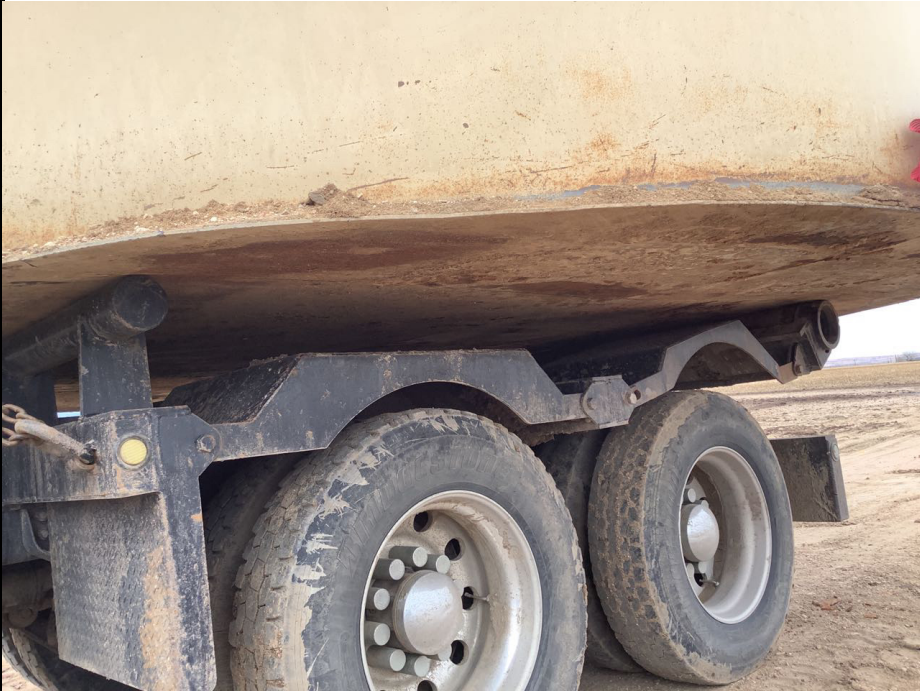
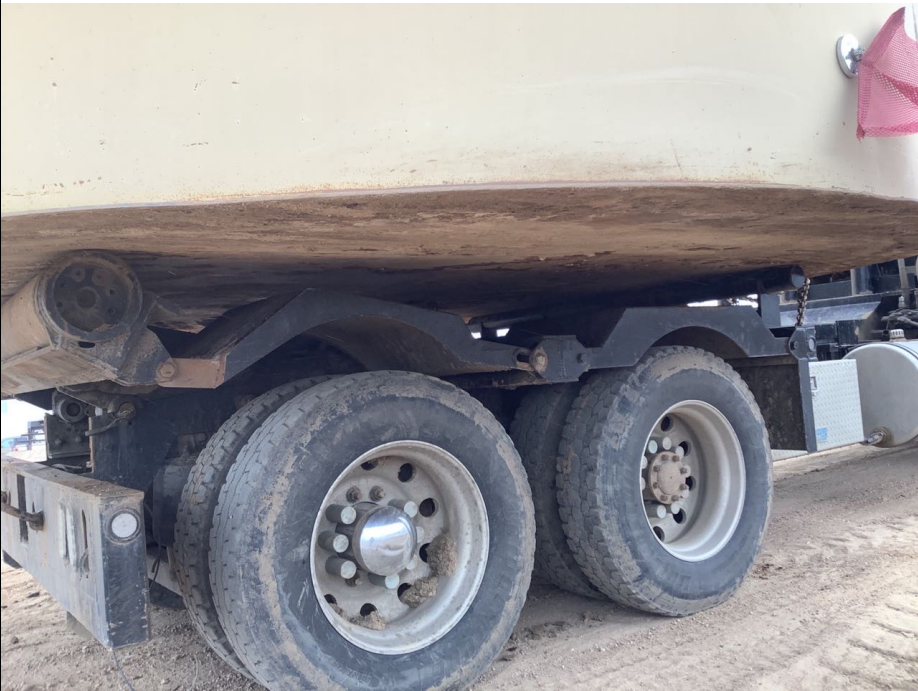
Equipment ID:		Equipment Type:		Equipment ID:	
Material:	Volume:	Contents:	Material:	Volume:	Contents:
Notes/Conditions: Bottom of AST01			Notes/Conditions: Bottom of AST01

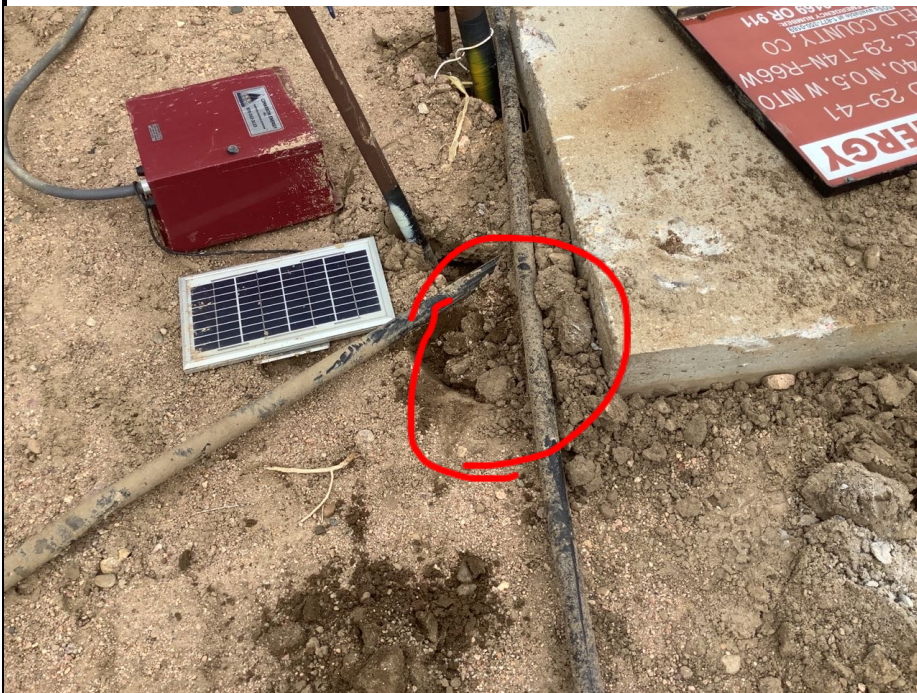
Equipment ID: ECD01		Equipment Type:		Equipment ID: SEP01-FL		Equipment Type:	
Material:	Volume:	Contents:		Material:	Volume:	Contents:	
Notes/Conditions:				Notes/Conditions:

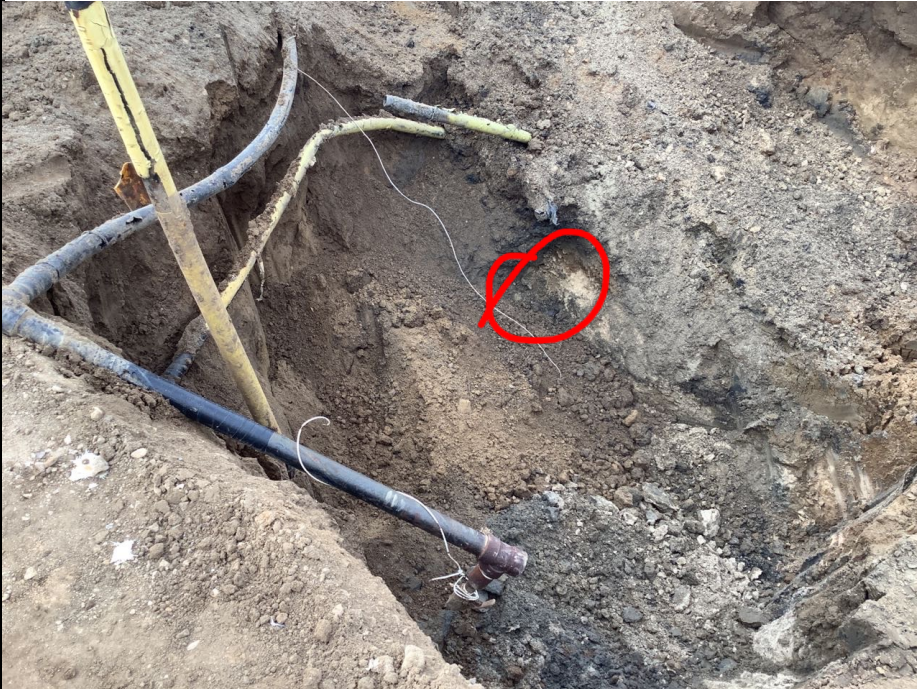
Equipment ID:		Equipment Type:		Equipment ID:		Equipment Type:					
Material:		Volume:		Contents:		Material:		Volume:		Contents:	
Notes/Conditions: PWW01-W@5'						Notes/Conditions: PWW01-S@5'

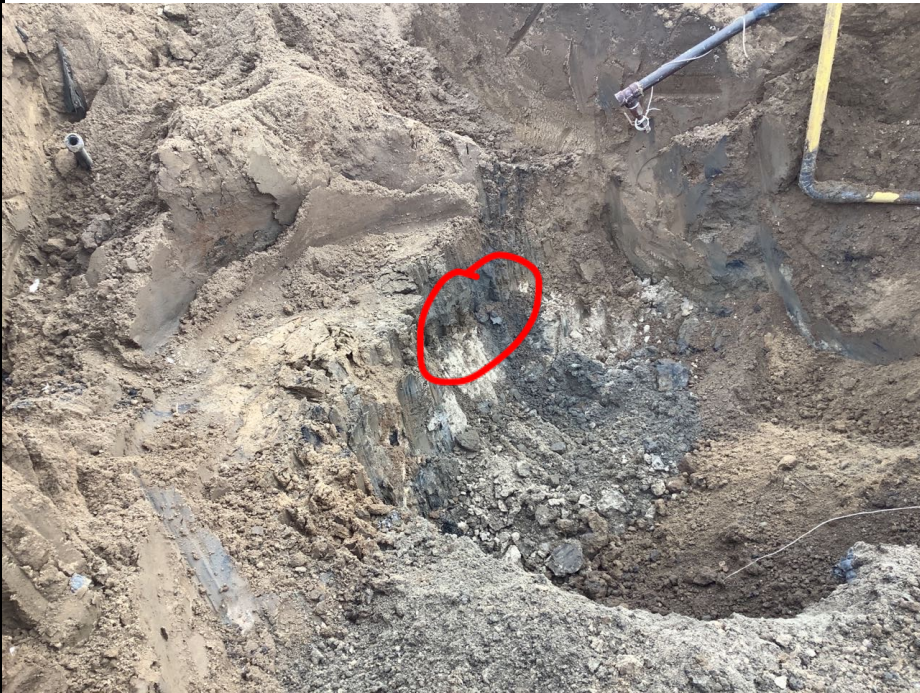
Equipment ID:		Equipment Type:		Equipment ID:		Equipment Type:					
Material:		Volume:		Contents:		Material:		Volume:		Contents:	
Notes/Conditions: PWV01-E@5'						Notes/Conditions:

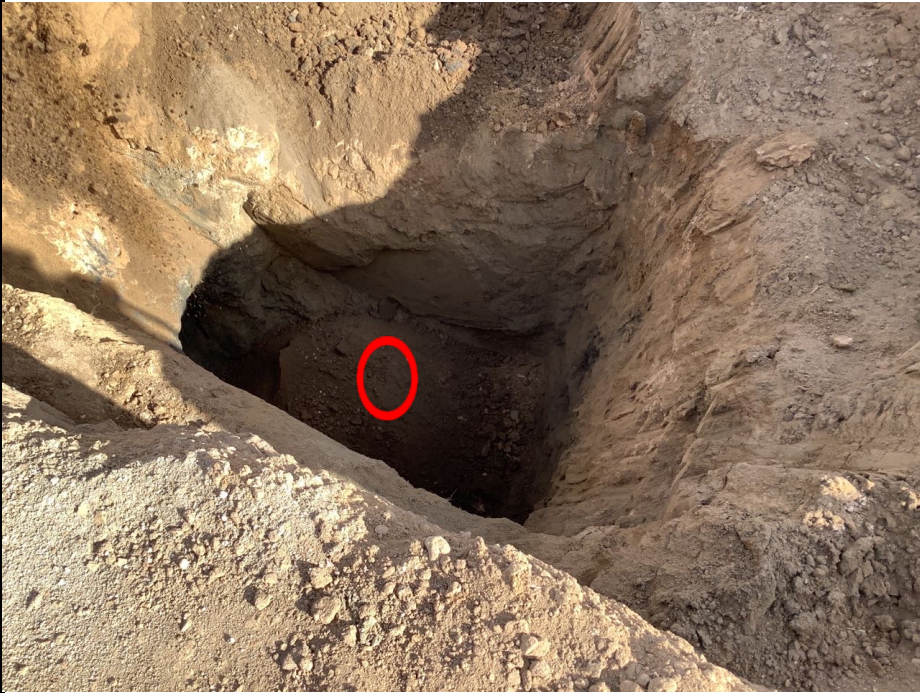
Equipment ID:		Equipment Type:		Equipment ID:		Equipment Type:					
Material:		Volume:		Contents:		Material:		Volume:		Contents:	
Notes/Conditions: SS01 (14')						Notes/Conditions: GS01 (10')

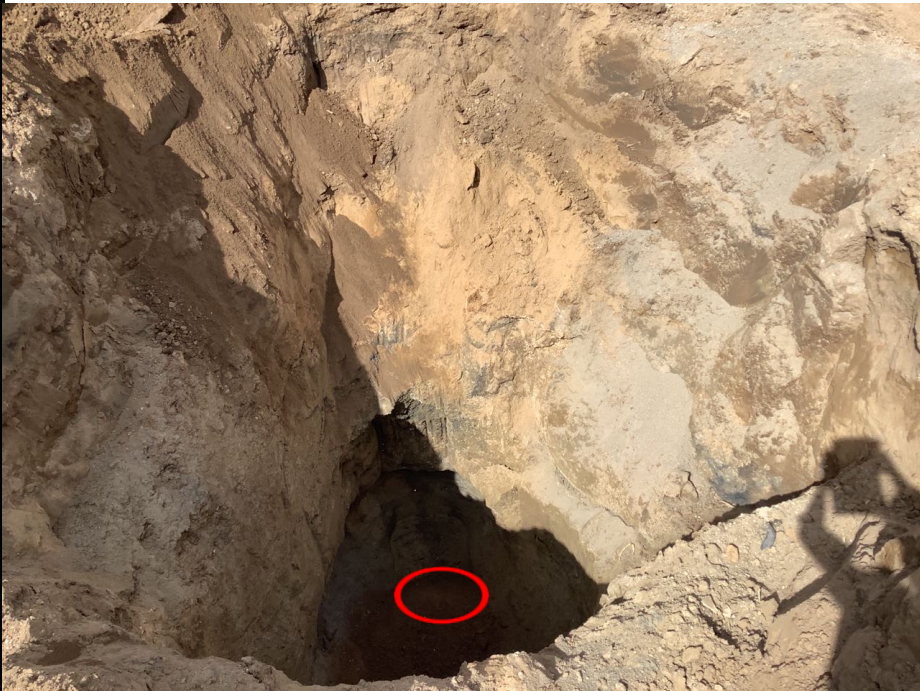
Equipment ID:		Equipment Type:		Equipment ID:		Equipment Type:					
Material:		Volume:		Contents:		Material:		Volume:		Contents:	
Notes/Conditions: SS02 (16')						Notes/Conditions:

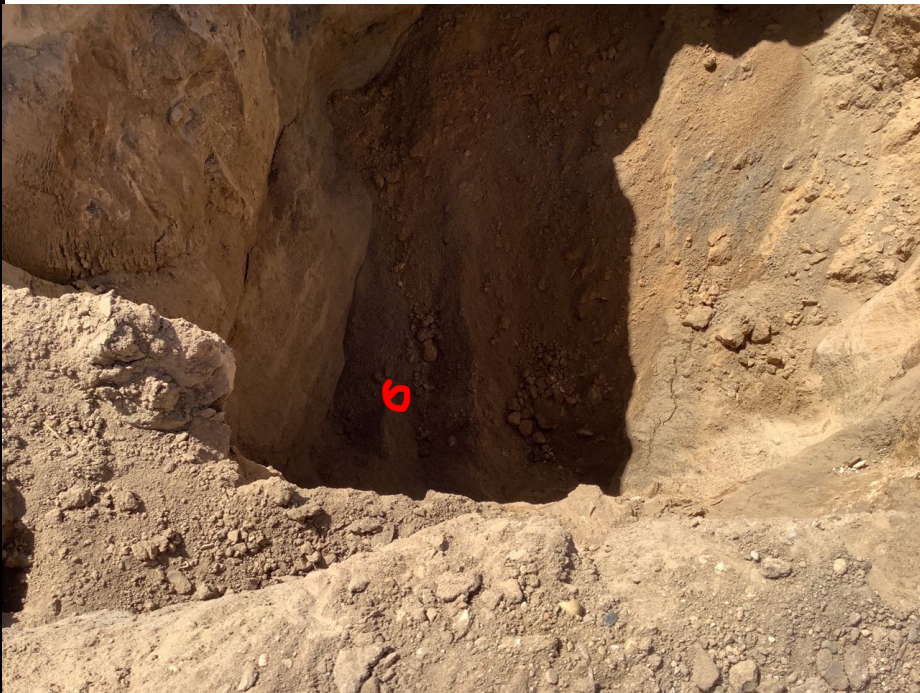
Equipment ID:SS03		Equipment Type:		Equipment ID:SS04		Equipment Type:	
Material:	Volume:	Contents:		Material:	Volume:	Contents:	
Notes/Conditions:				Notes/Conditions:

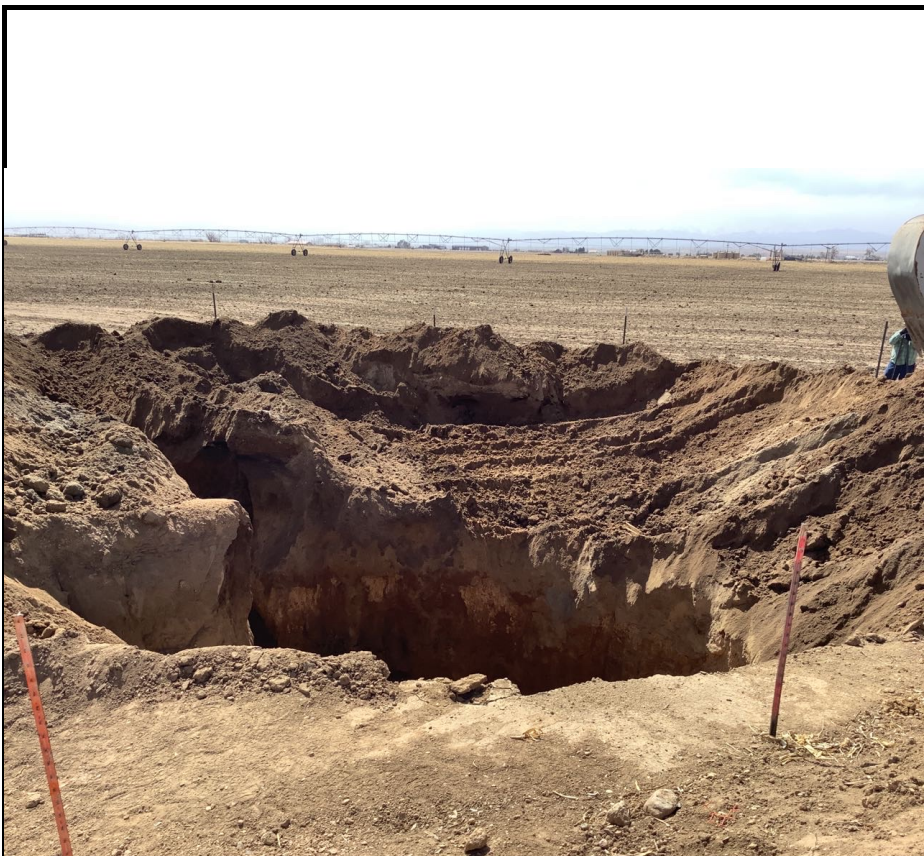
Equipment ID:		Equipment Type:		Equipment ID:		Equipment Type:					
Material:		Volume:		Contents:		Material:		Volume:		Contents:	
Notes/Conditions: Excavation overview						Notes/Conditions:
