Inspection Photos

8/4/2023

Operator: LARAMIE ENERGY LLC #10433

Location Number: 383264

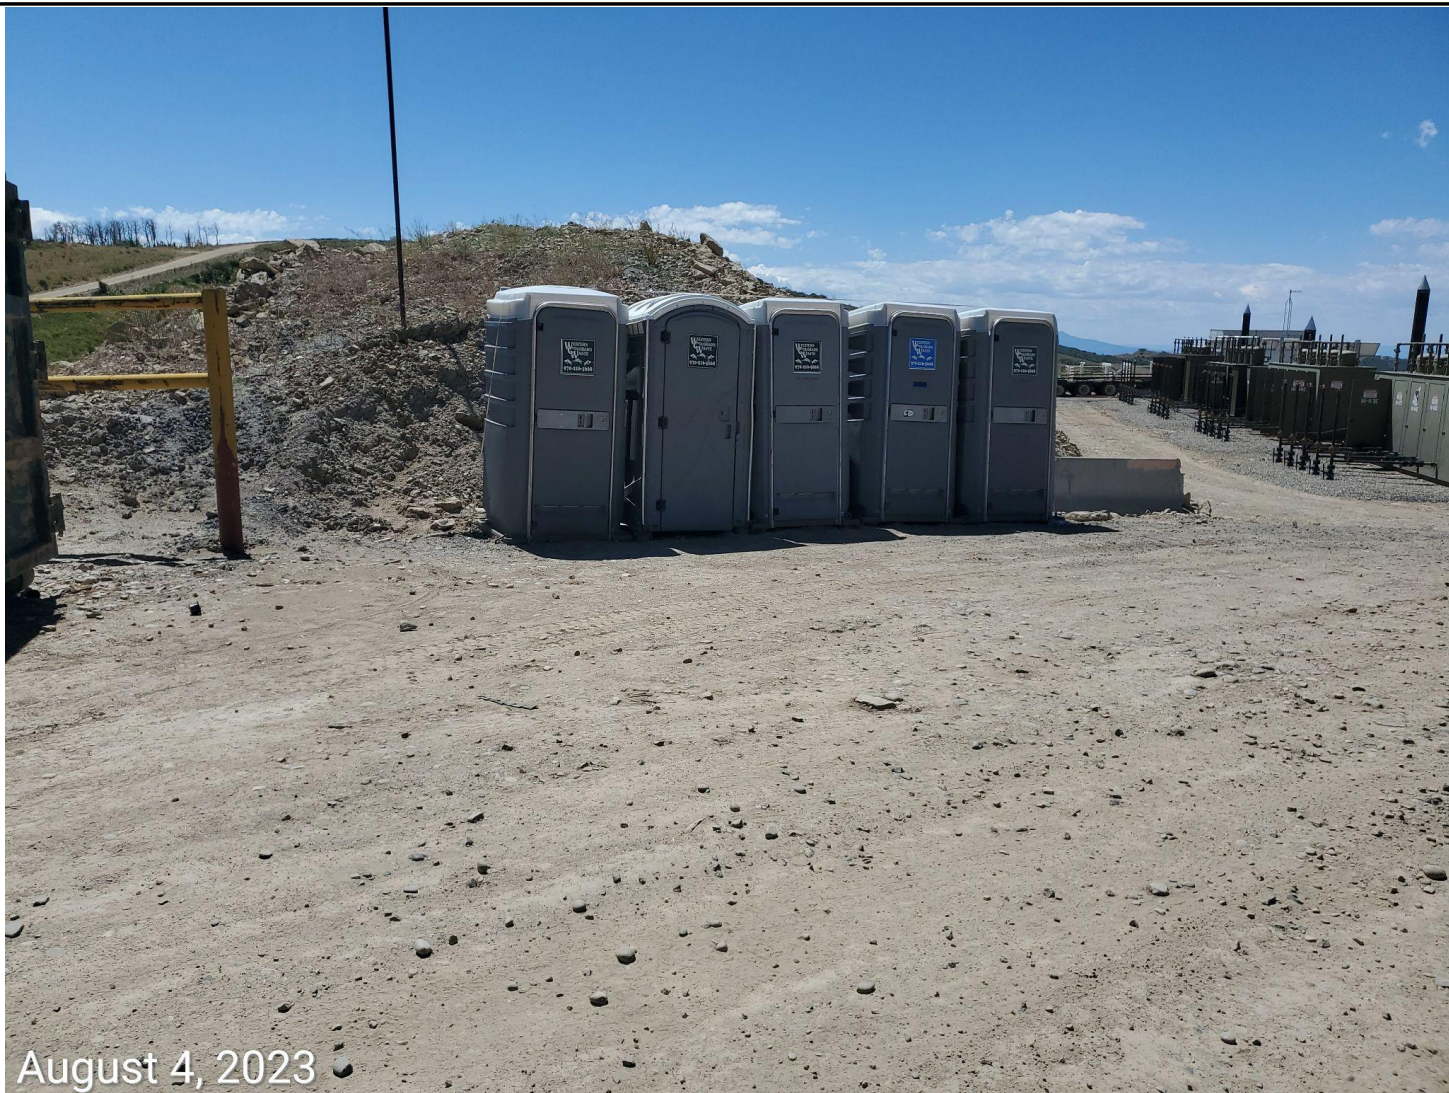
August 4, 2023

Photo 1: Photo shows Porta-johns have been secured to prevent a spill.

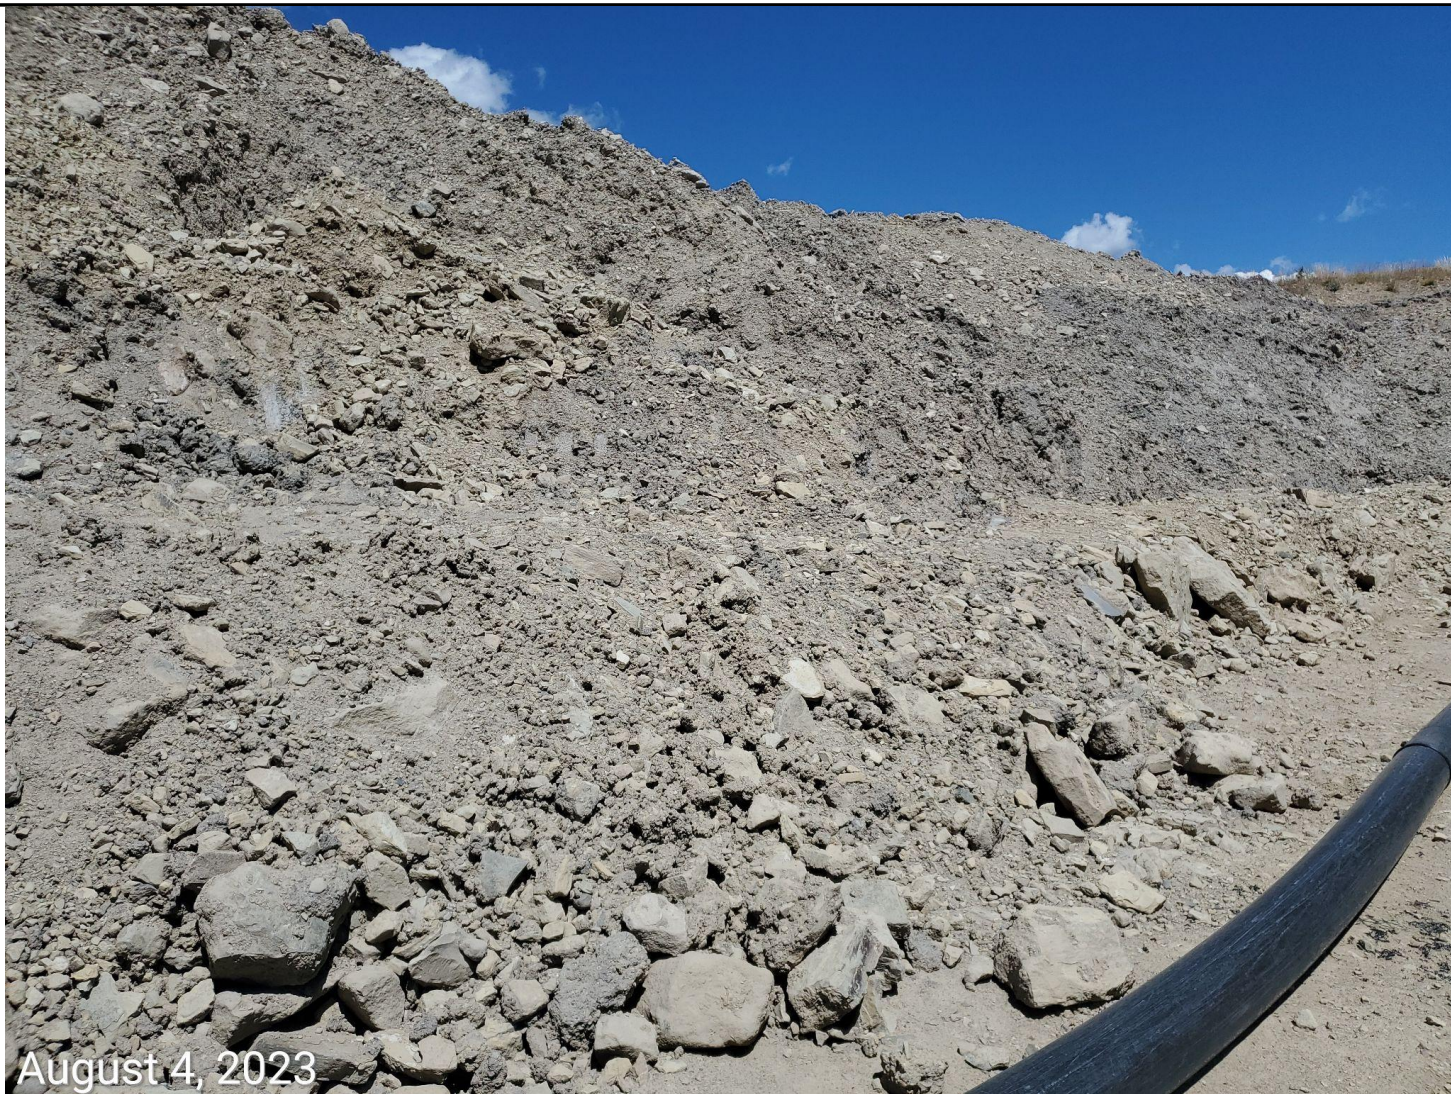
August 4, 2023

Photo 2: Photo shows Operator has installed a berm at the toe of the drill cuttings stockpiled on the north end of the Location. Berm has been installed in a manner that is inadequate to contain/prevent a spill. BMP also largely unconsolidated material.

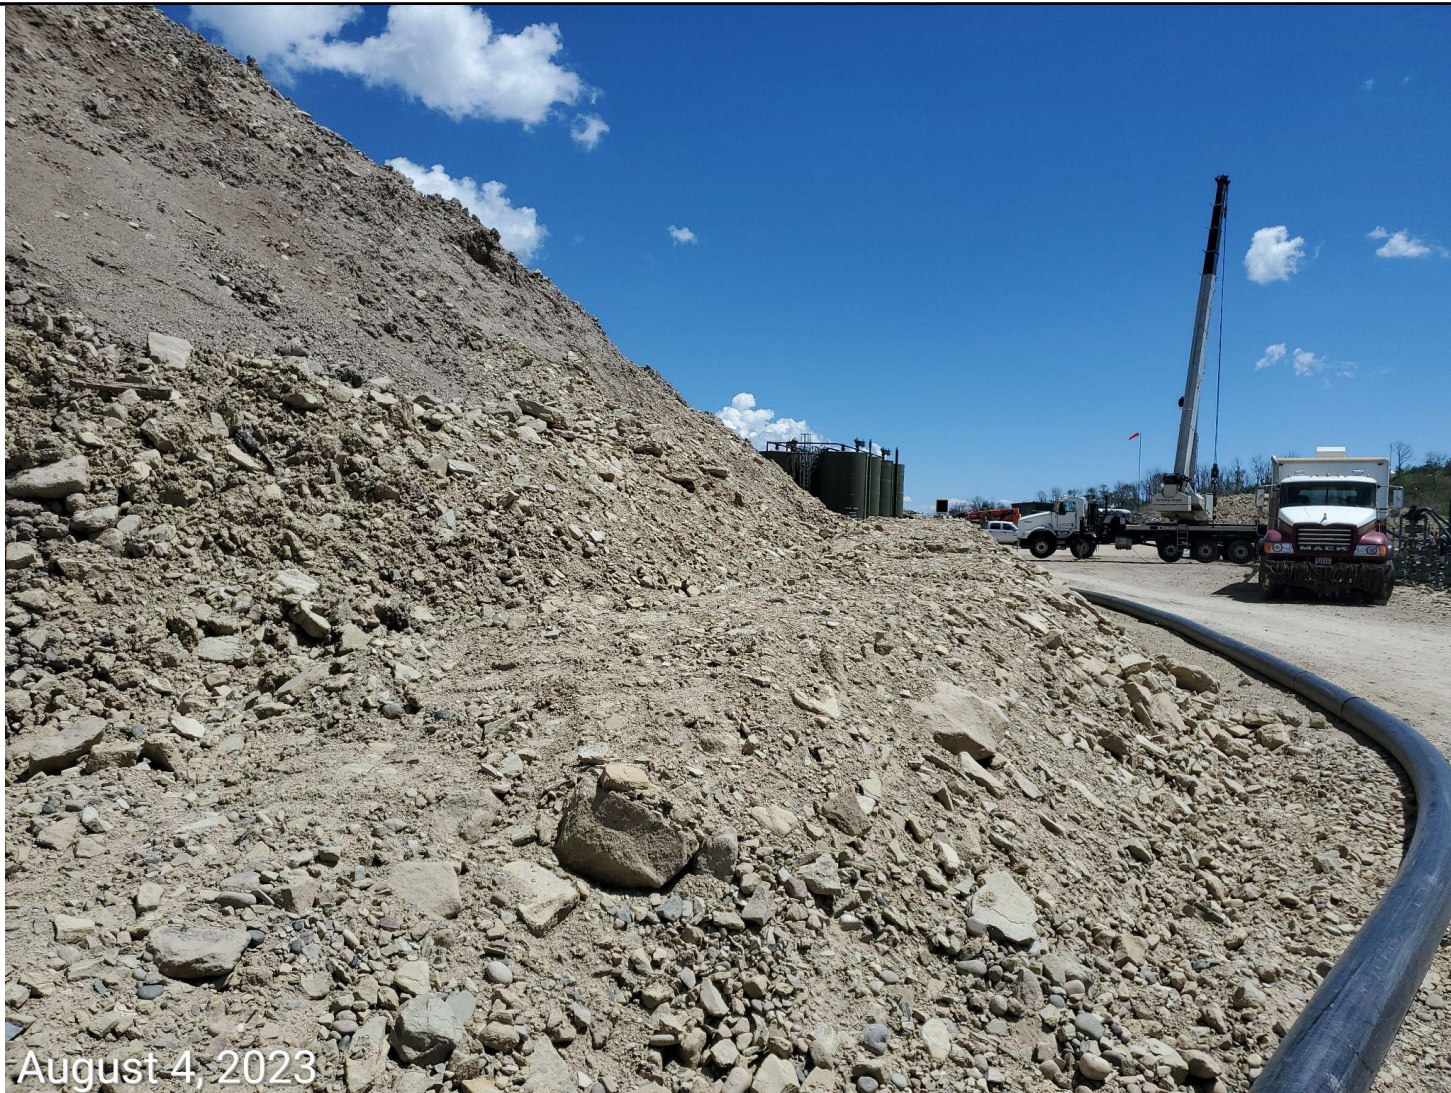
August 4, 2023

Photo 3: Photo shows Operator has installed a berm at the toe of the drill cuttings stockpiled on the north end of the Location. Berm has been installed in a manner that is inadequate to contain/prevent a spill. BMP also largely unconsolidated material.

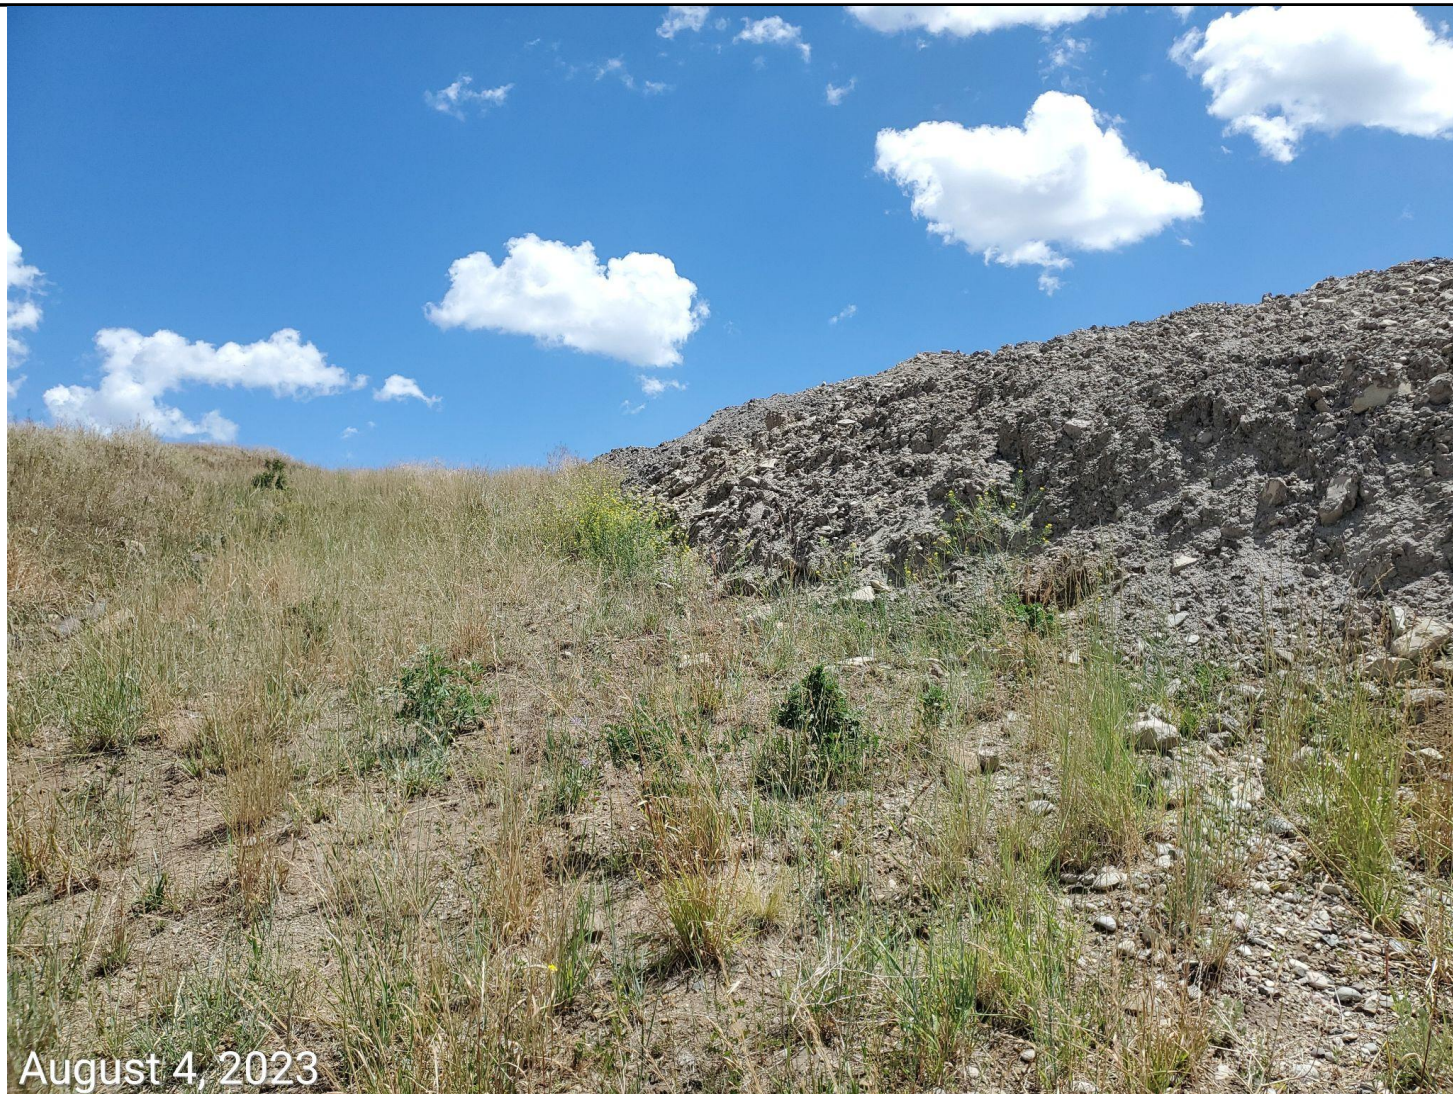
August 4, 2023

Photo 4: Photo taken from the north end of the Location, just north of the Location's cutslope. Photo shows Operator has pushed cutting material beyond the working pad surface and cutslope.

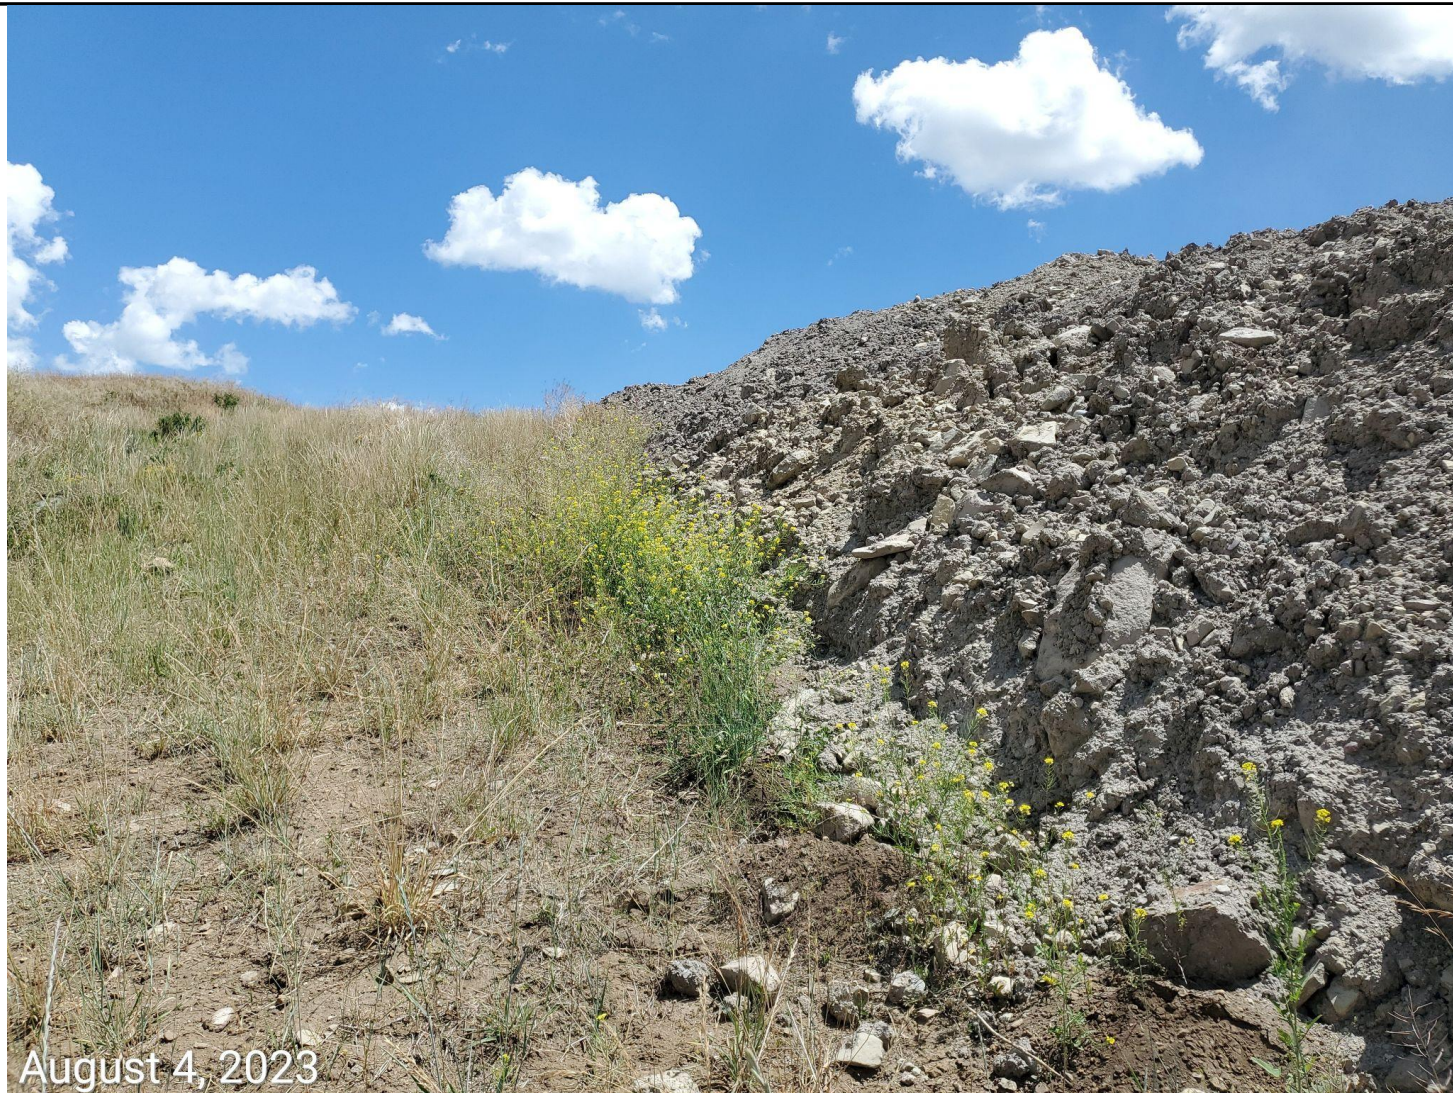
Photo 5: Photo taken from the north end of the Location, just north of the Location's cutslope. Photo shows Operator has pushed cutting material beyond the working pad surface and cutslope.

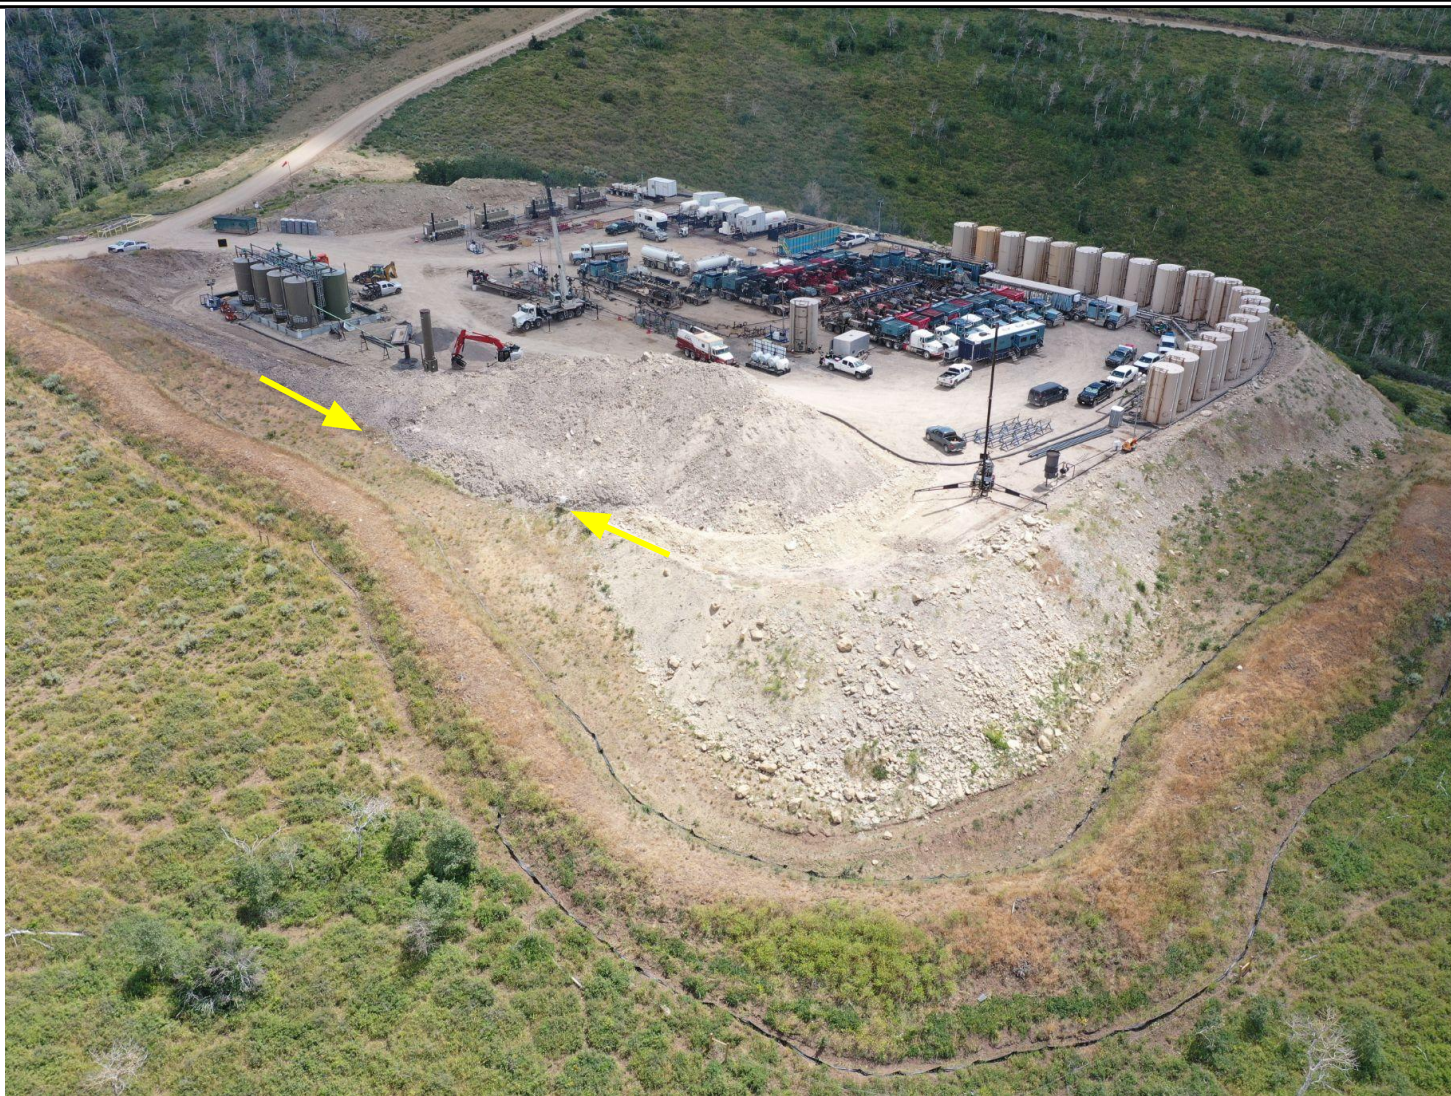
Photo 6: Drone imagery of the Location. Photo shows Operator has pushed cutting material beyond the working pad surface and cutslope (arrow).

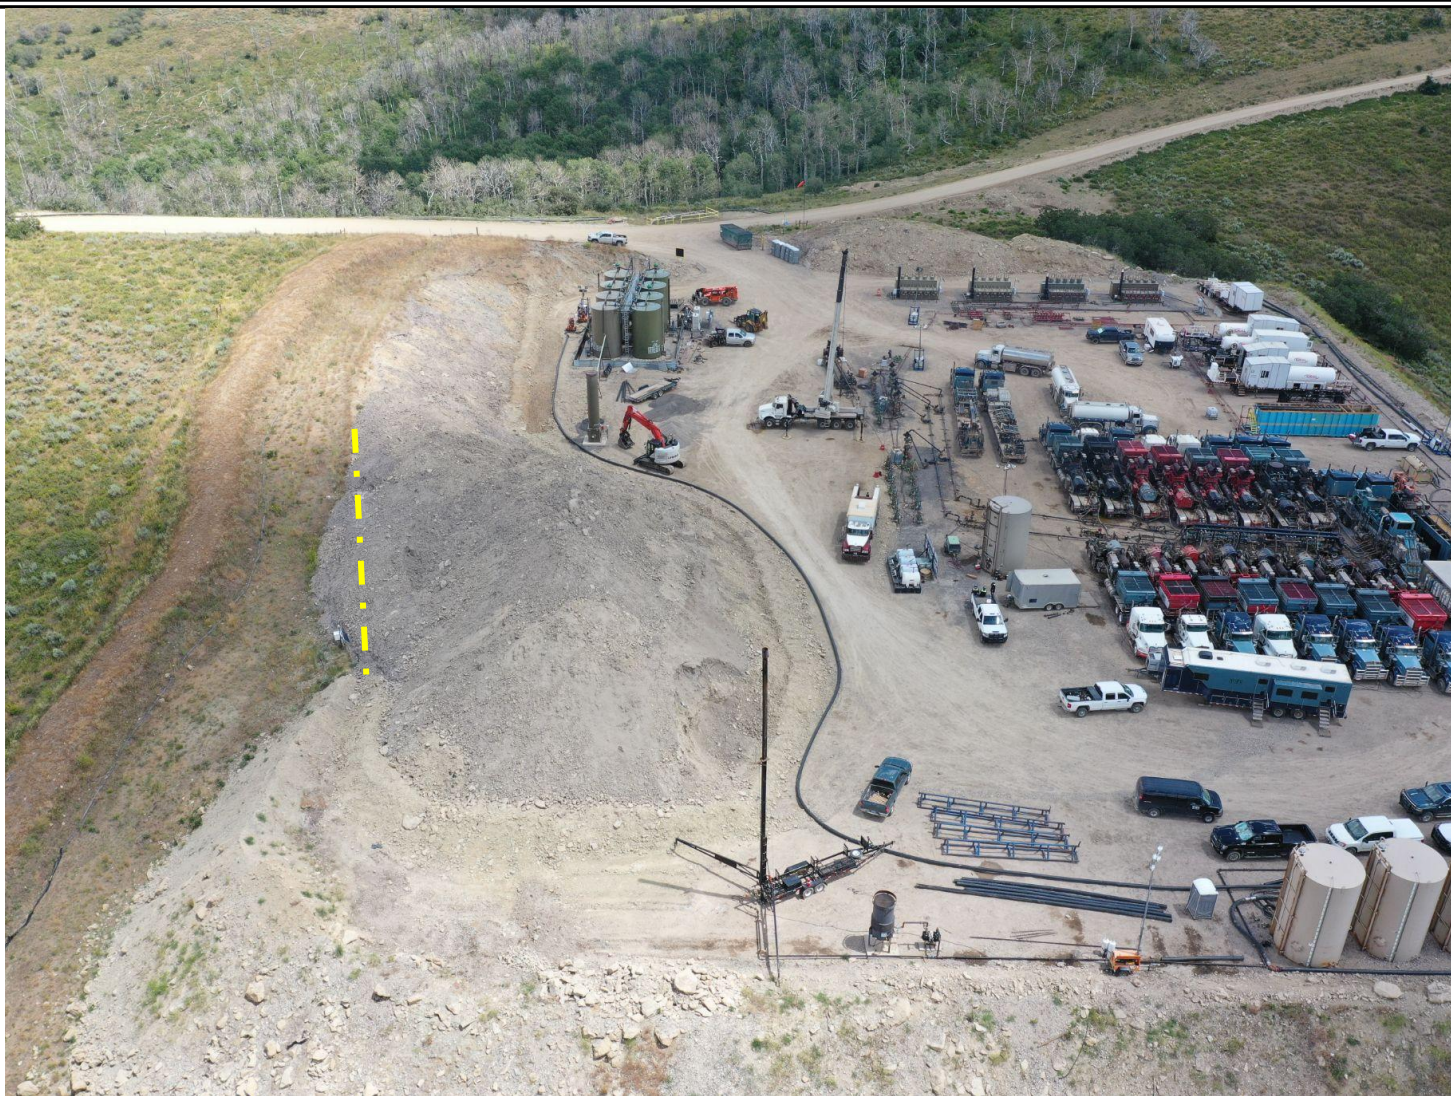
Photo 7: Drone imagery of the Location. Photo shows Operator has pushed cutting material beyond the working pad surface and cutslope (dotted line).

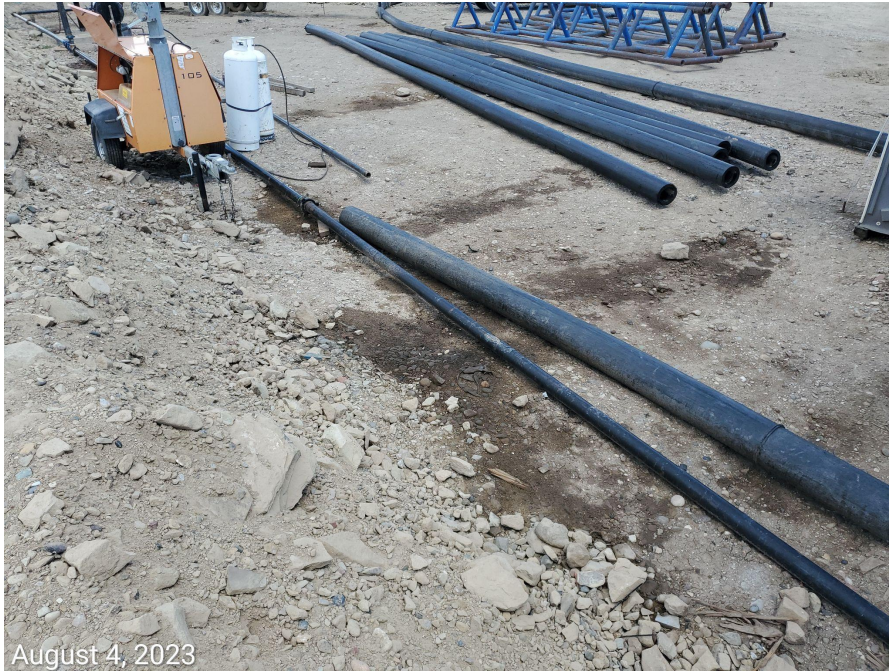
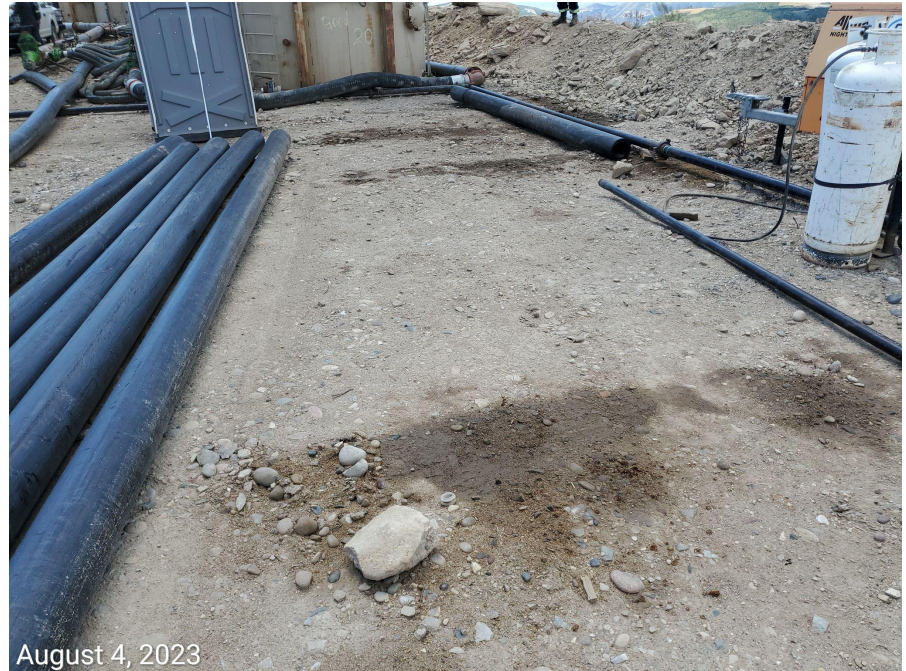
Photo 8: Photos example showing stained soils on the west end of the Location.

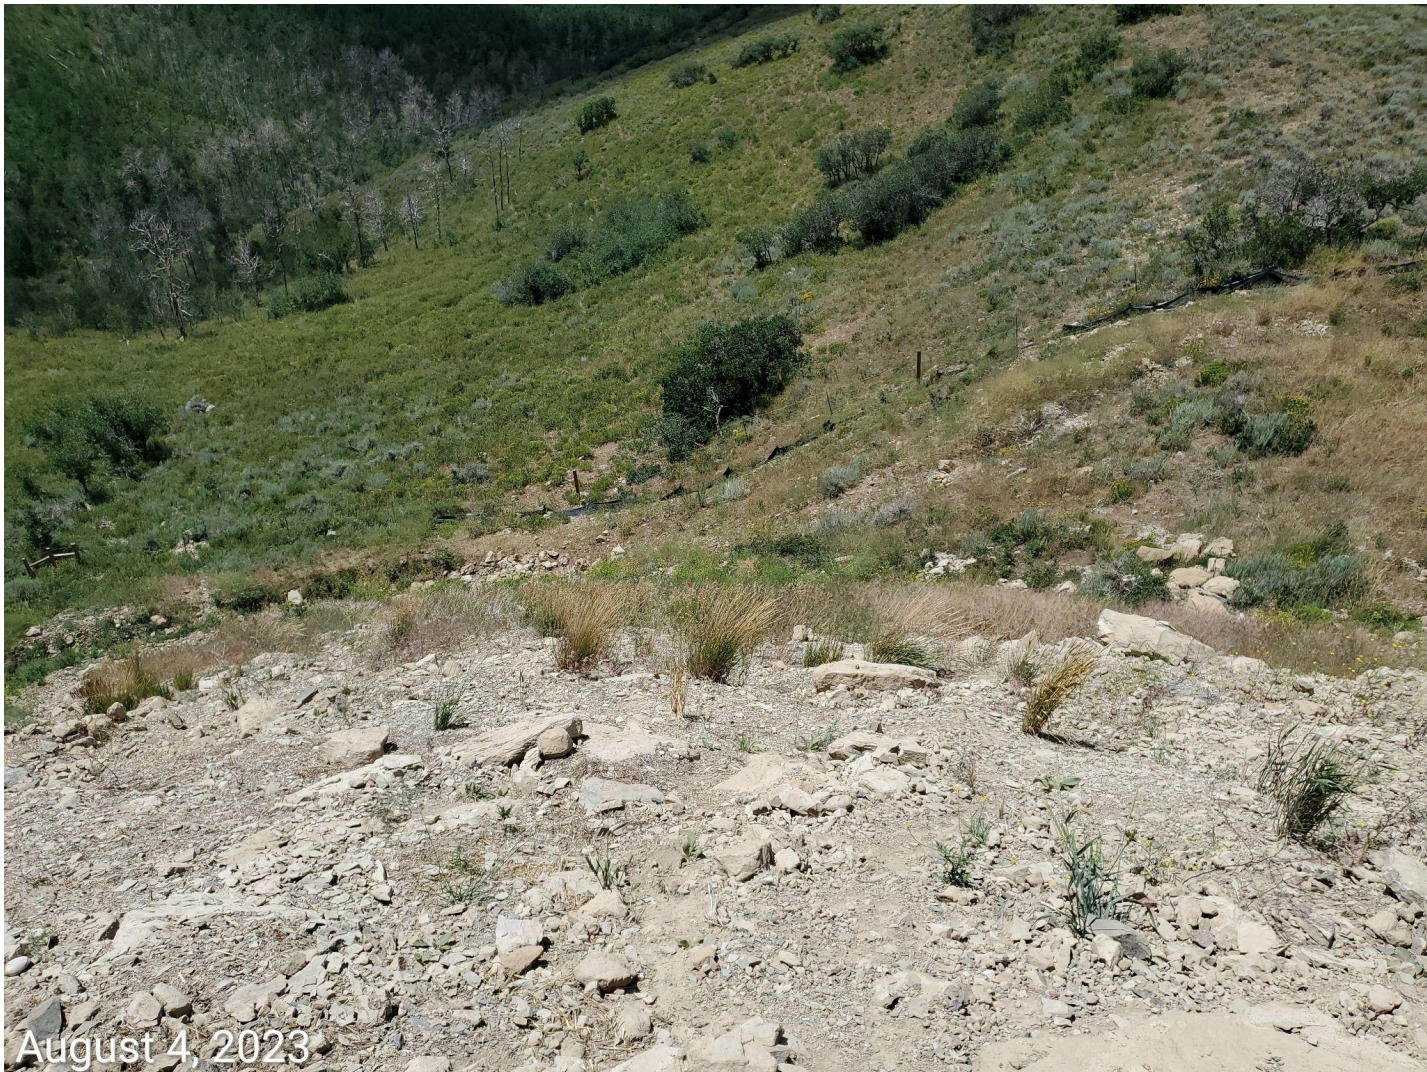
Photo 9: Photo example showing silt fence on the Location has not been maintained in accordance with good engineering practices.

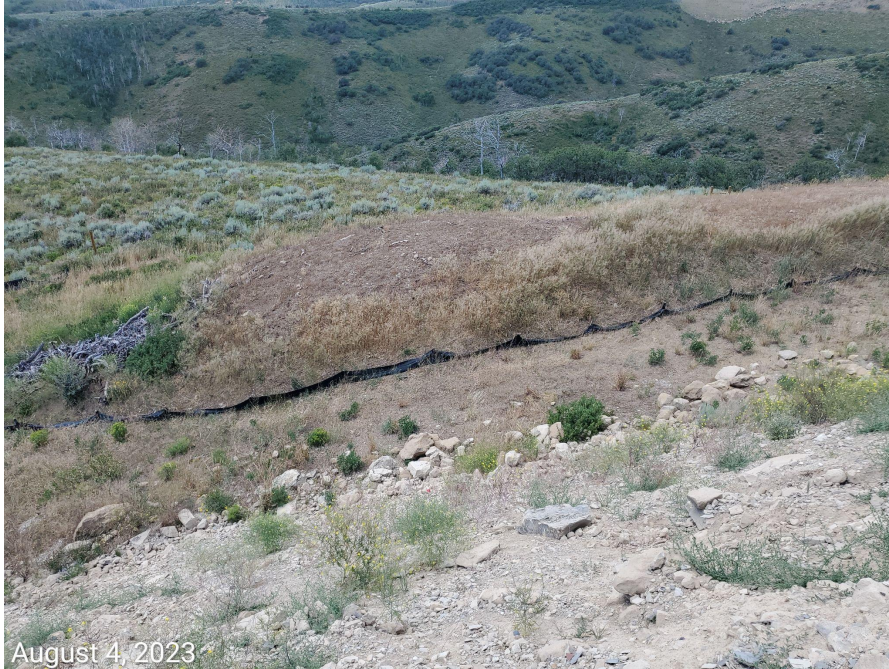
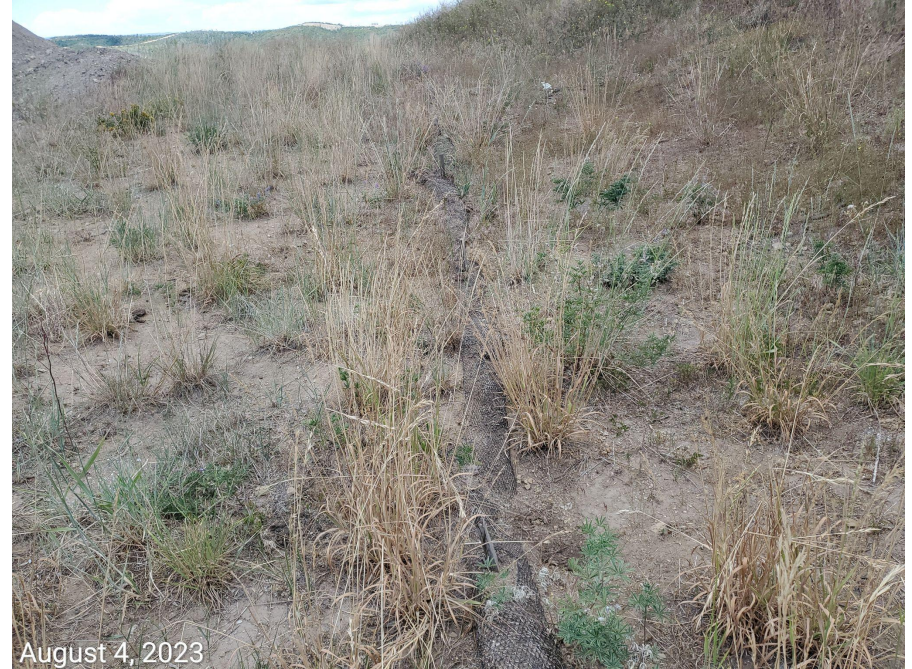
Photo 10: Photos example showing silt fence and erosion logs on the Location has not been maintained in accordance with good engineering practices.

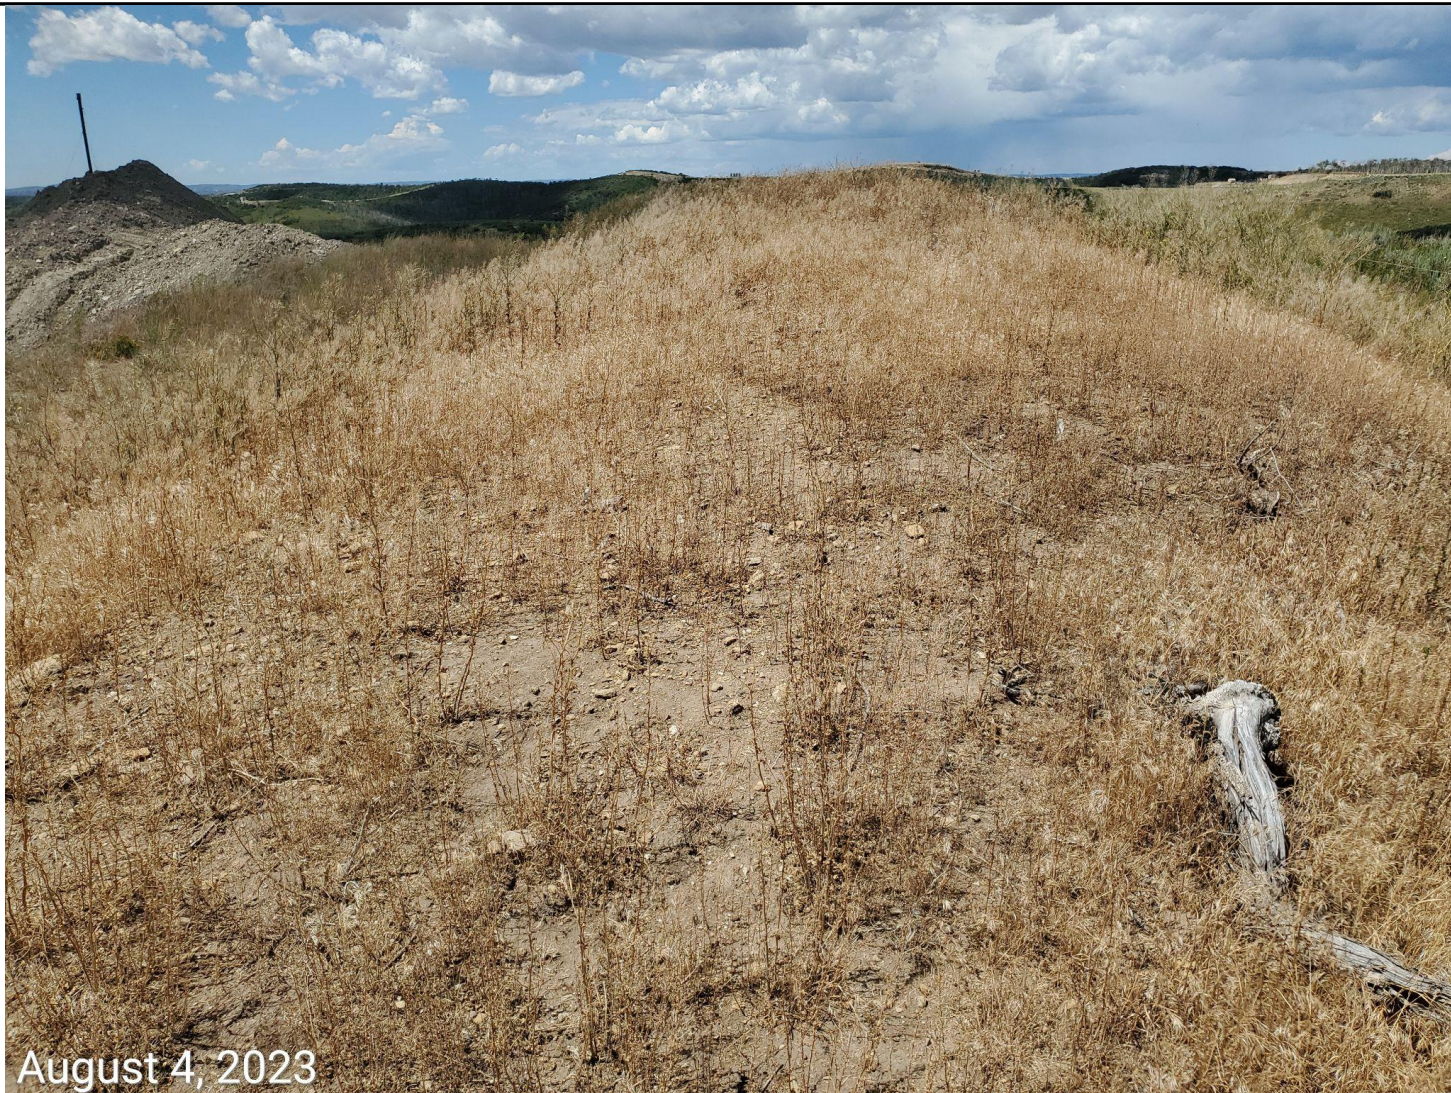
August 4, 2023

Photo 11: Photo taken from the topsoil stockpile on the north end of the Location. Photo shows BMPs to prevent weed establishment on the topsoil stockpiles are inadequate.

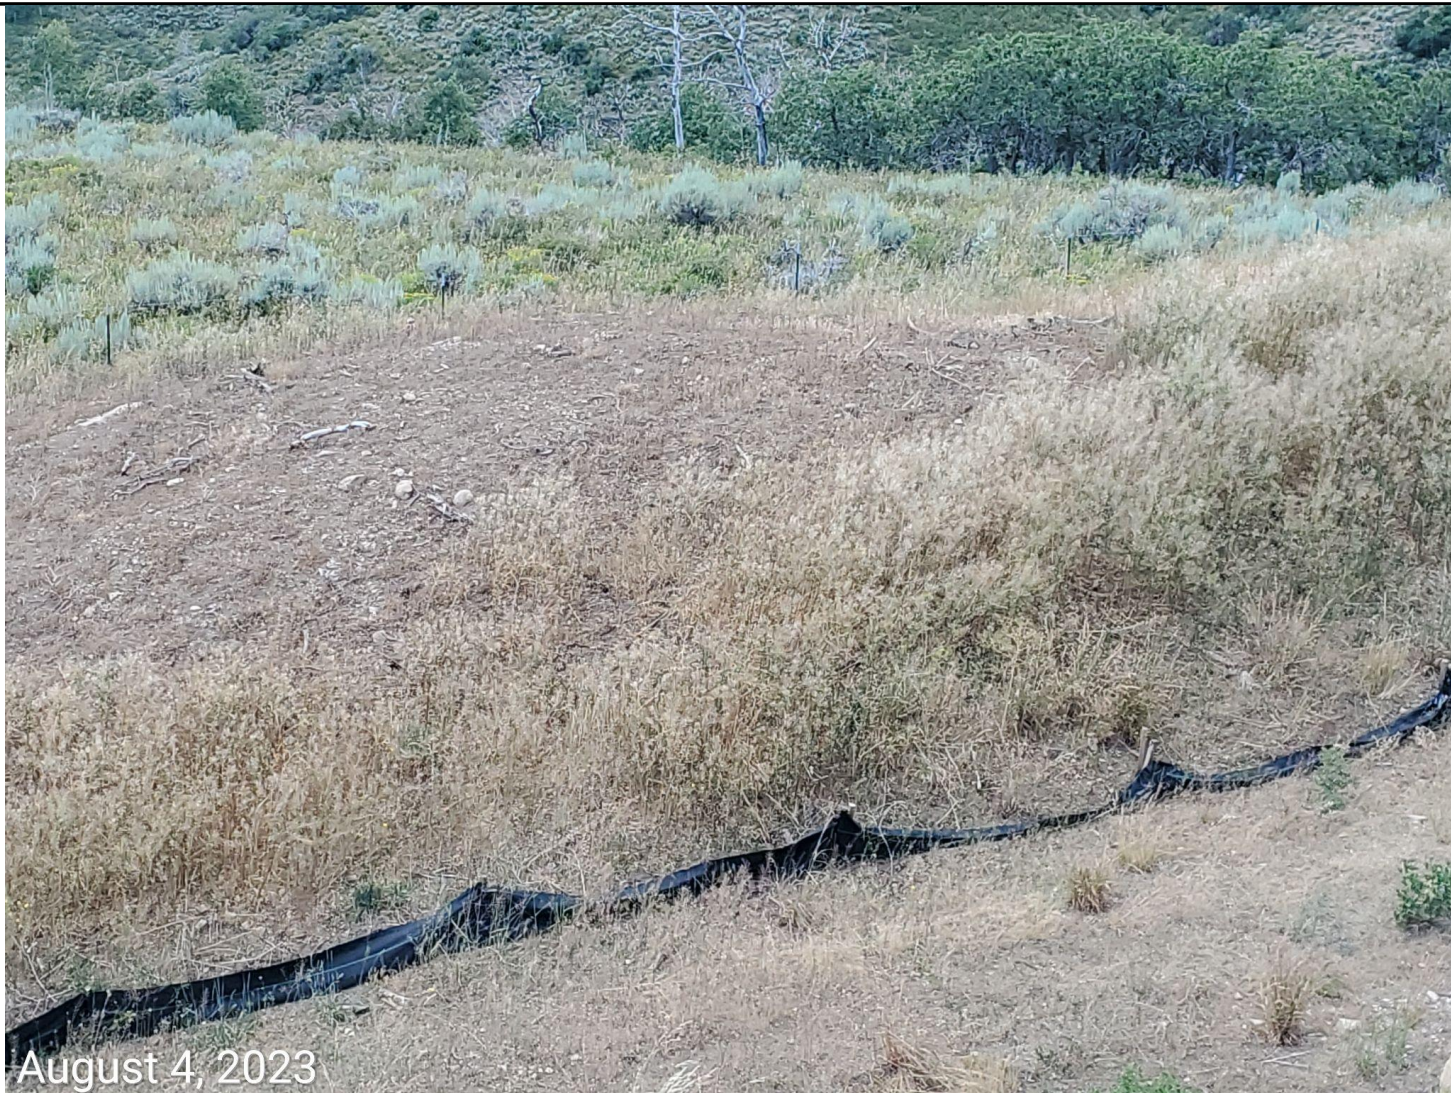
August 4, 2023

Photo 12: Photo shows topsoil stockpile on the west end of the Location. Photo shows BMPs to prevent weed establishment on the topsoil stockpiles are inadequate.
