# Interim Reclamation and Stormwater Inspection

Operator: UPLAND EXPLORATION LLC- #10701

Location ID: 462919

Inspection Photos  
Location Name: Little Lady 21/South Well Pad  
Location ID: 462919

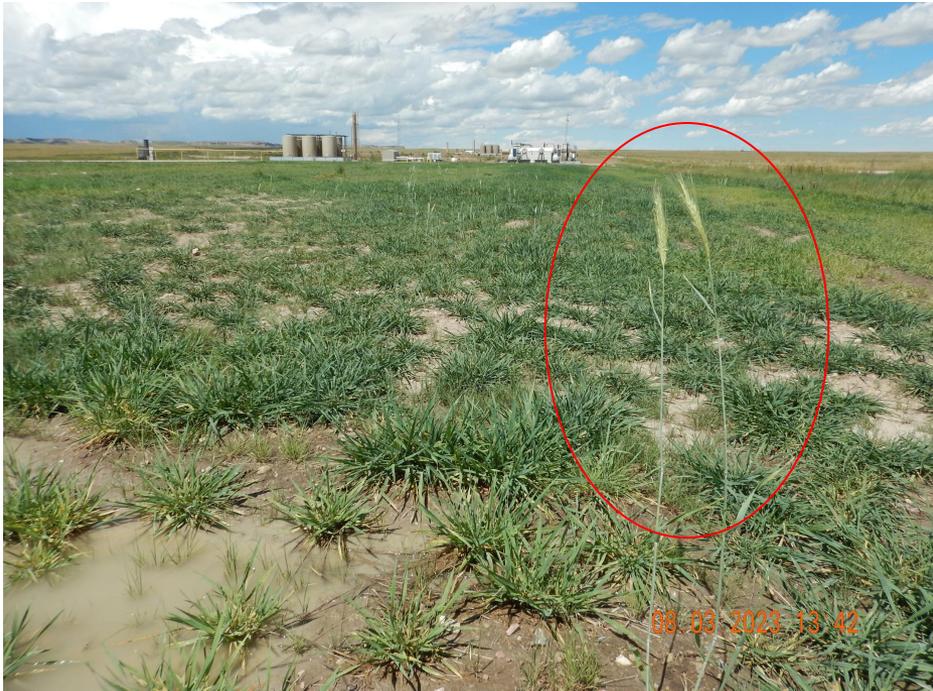
**Photo 1.** Photo taken from the southeastern location, facing North. Photo illustrates much of the vegetative growth to be an introduced grass species, which was falsely reported to Staff.

Red circle is highlighting an undesirable, introduced invasive plant species, Cereal rye. Cereal rye was observed throughout portions of the interim reclamation area.

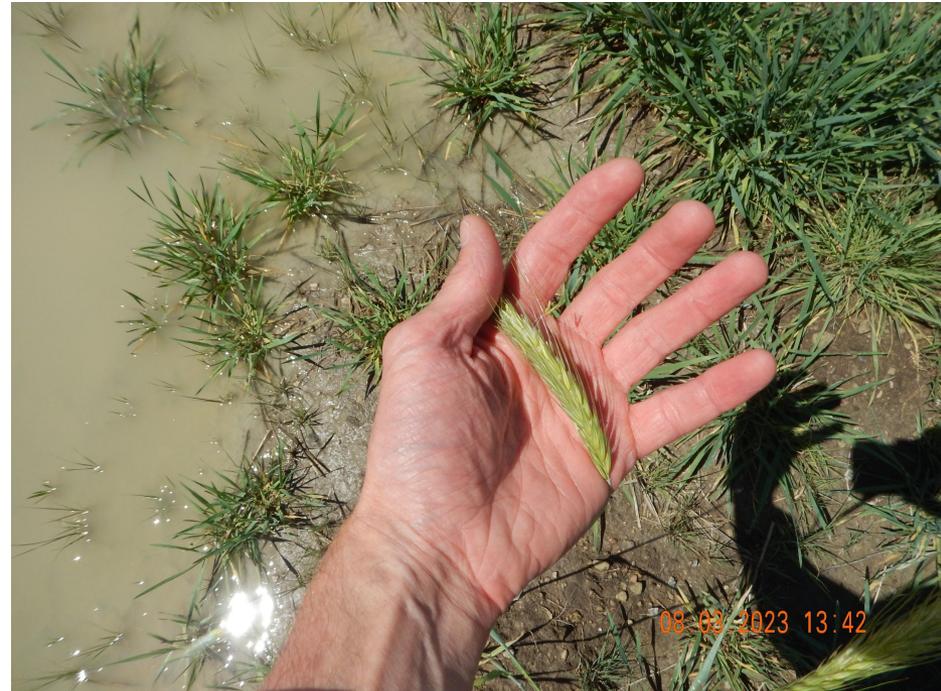
**Photo 2.** Close up photo taken of Cereal rye.

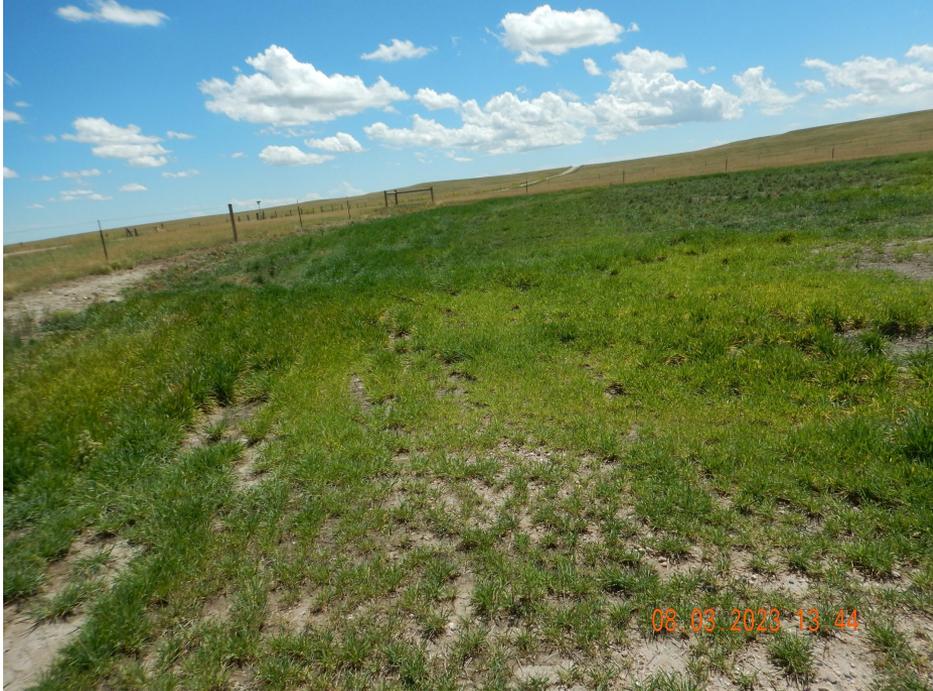
**Photo 3.** Photo taken from the southeastern location, facing South. See comments under Photo 1.

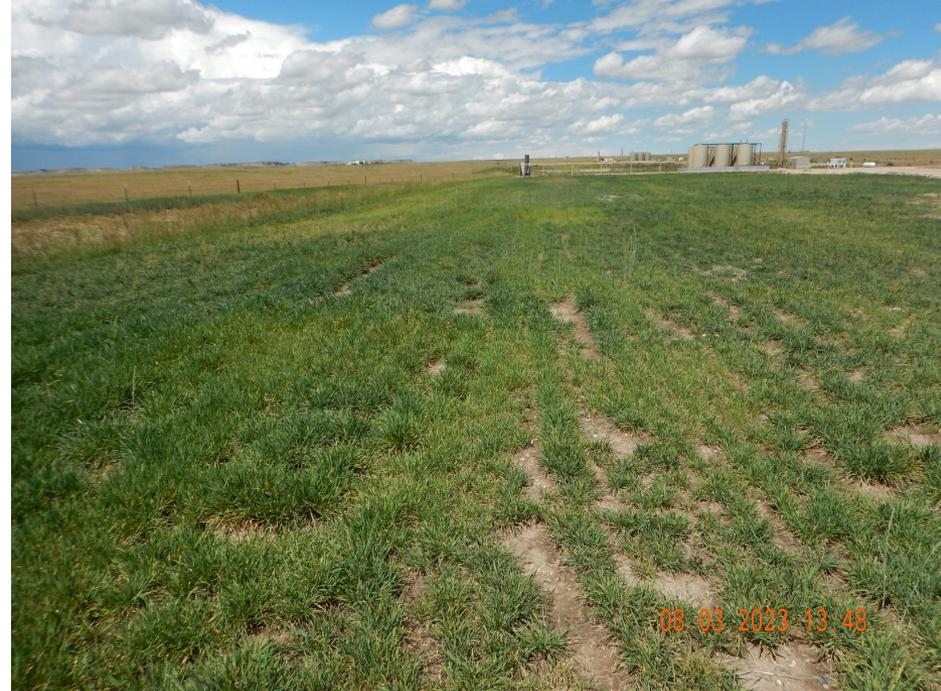
**Photo 4.** Photo taken from the southwestern location, facing North. See comments under Photo 1.

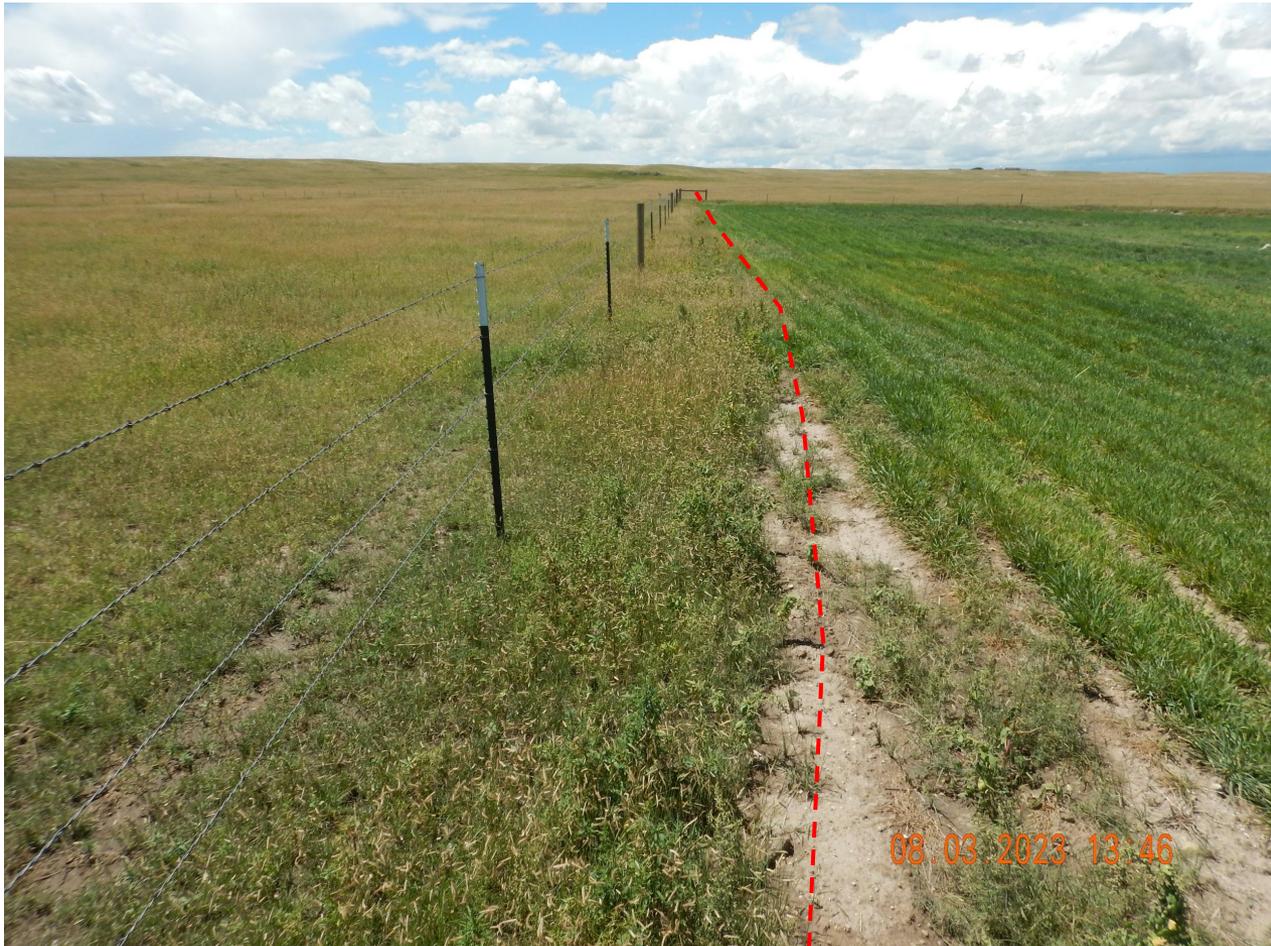
**Photo 5.** Photo taken from the southern interim reclamation area, facing West. Photo illustrates reference vegetation to the left of the red-dashed line and the introduced grass species to the right, which is not reflective of reference areas.

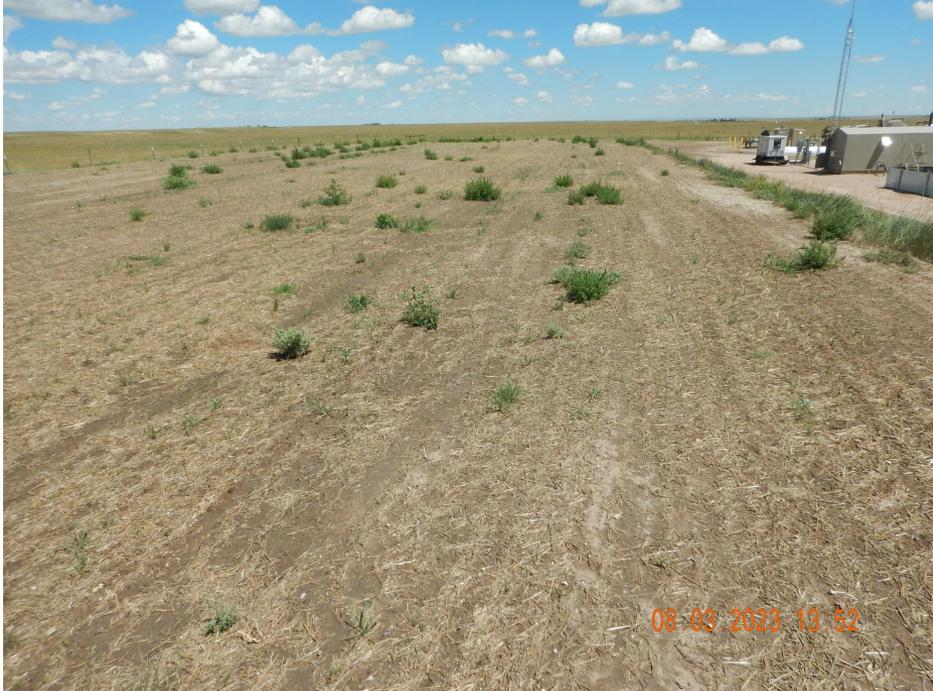
**Photo 6.** Photo taken from the topsoil stockpile, facing East. It is hard to demonstrate in this photo but there is desirable germination.

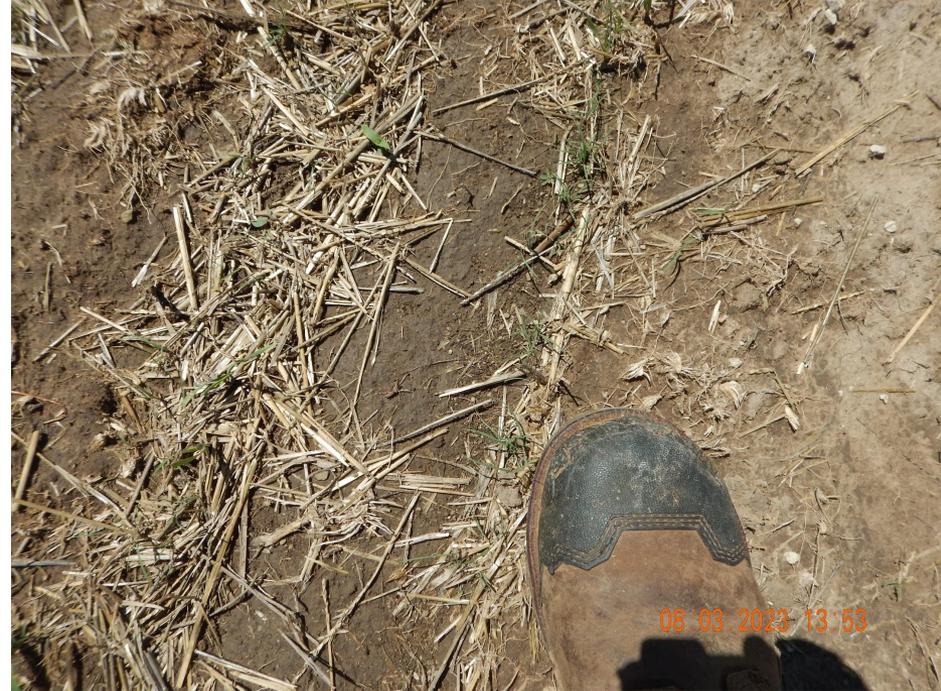
**Photo 7.** Close up photo taken from the topsoil stockpile illustrating desirable germination of what appears to be native grass.

Note- there is some undesirable weed establishment that will have to be controlled at a future date.
