Inspection Photos

Operator: NONSUCH NATURAL GAS INC

Location Number: 324169

Garfield County, CO

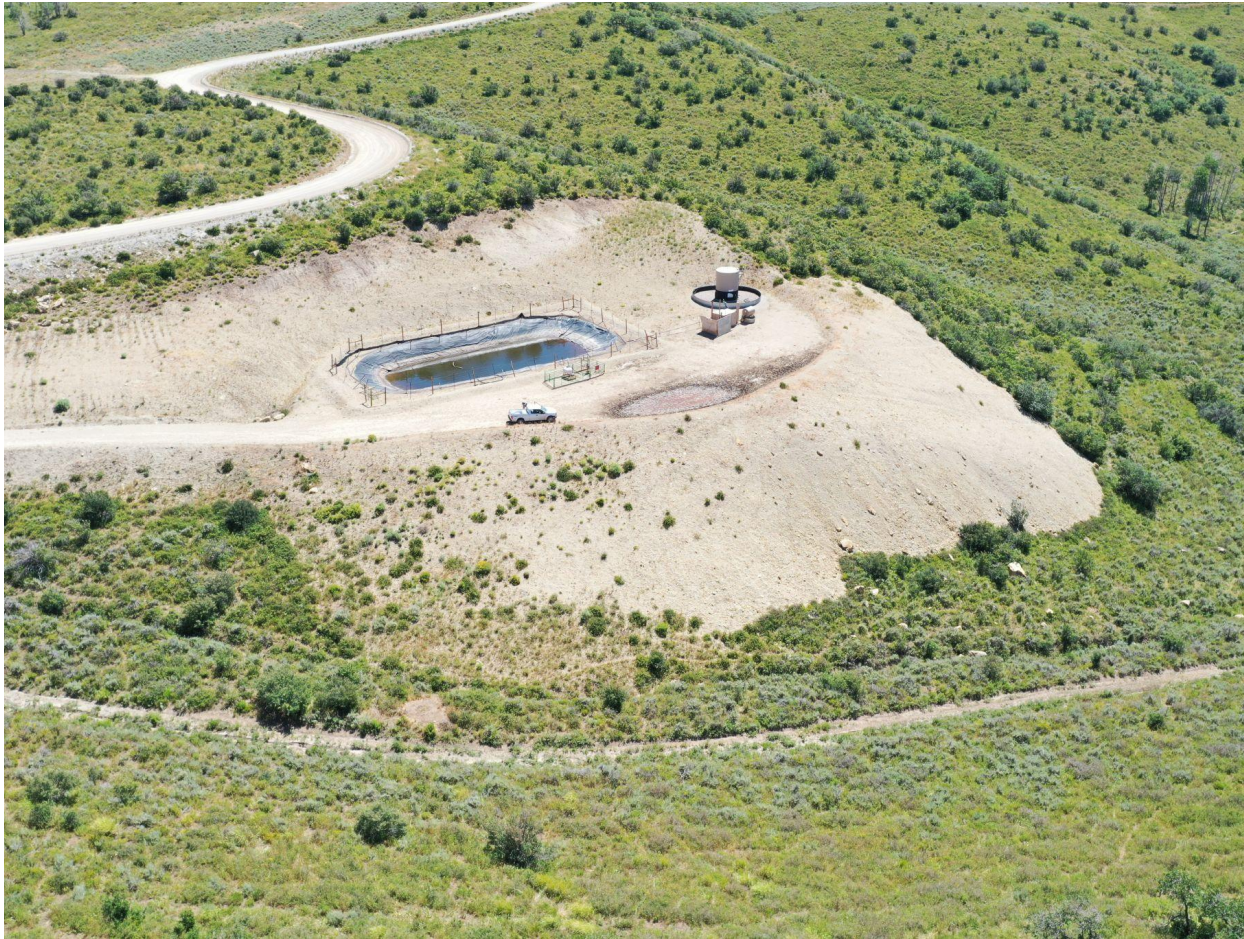
Photo 1: Photo taken with a sUAS. Photo shows overview of the Location; reclamation not progressing towards 1003 standards.

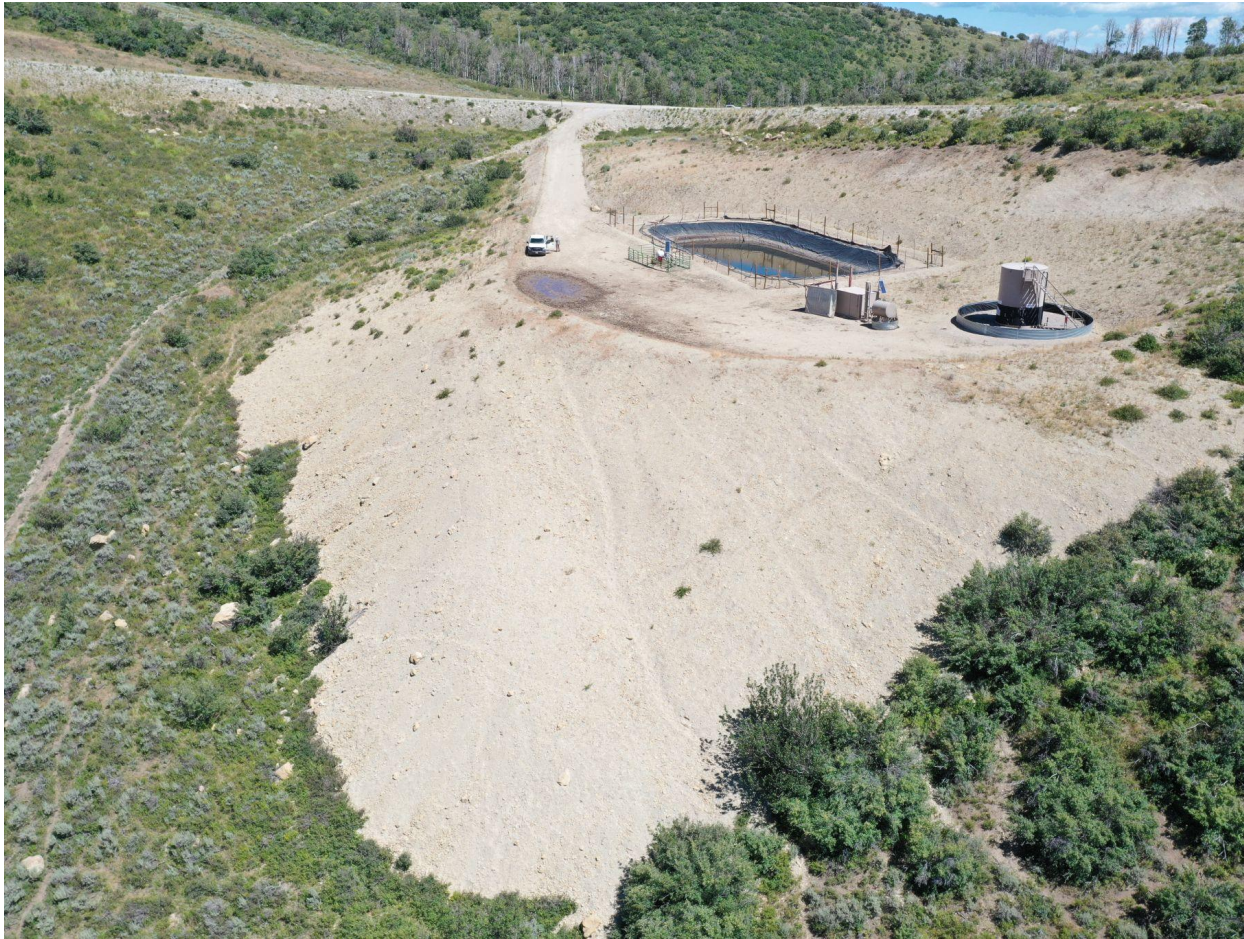
Photo 2: Photo taken with a sUAS. Photo shows overview of the Location; reclamation not progressing towards 1003 standards.

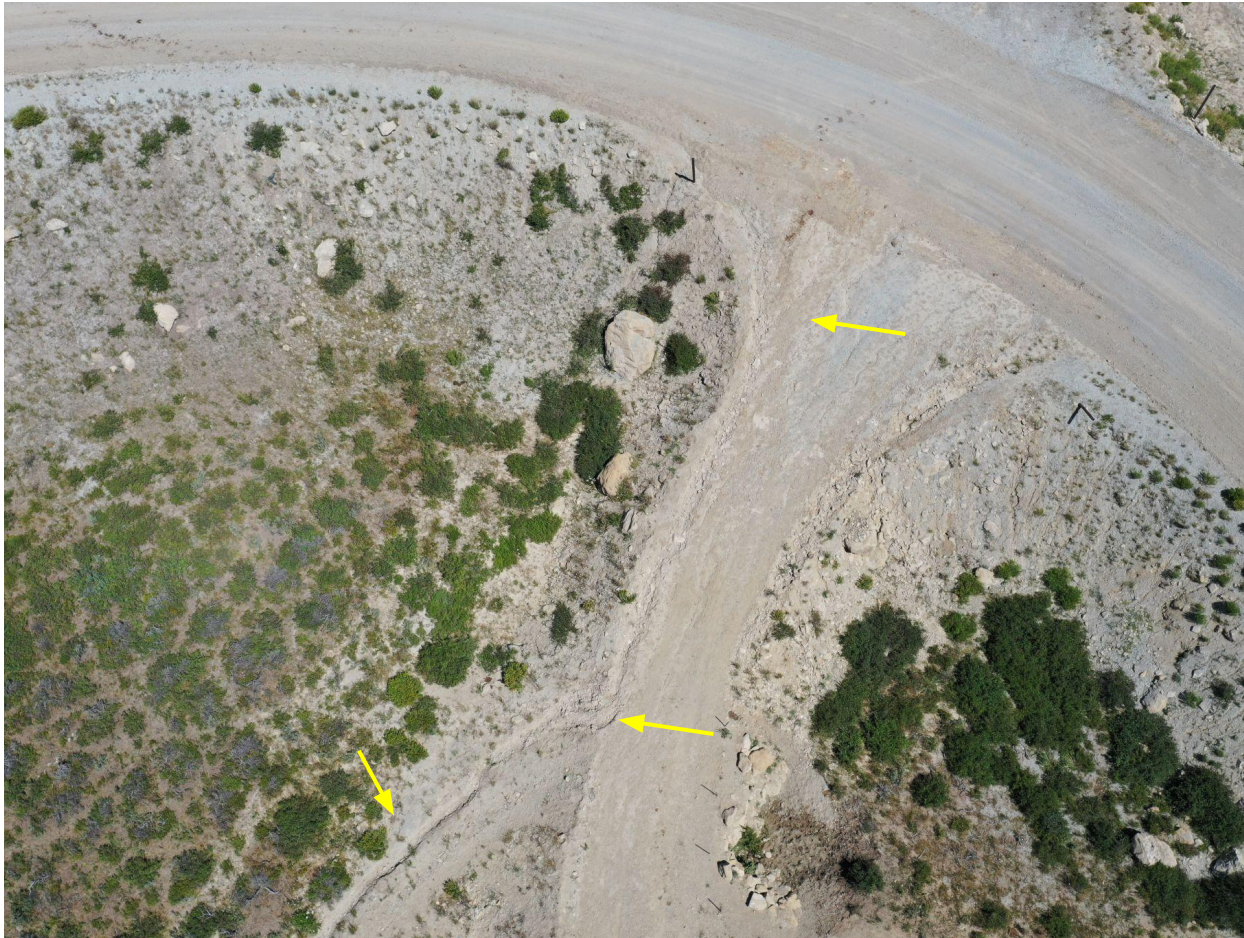
Photo 3: Photo taken with a sUAS. Photo shows erosion degradation along access road. Stormwater and Erosion control measures remain missing or insufficient to manage runoff in a manner that minimizes erosion, degradation and sediment transport.

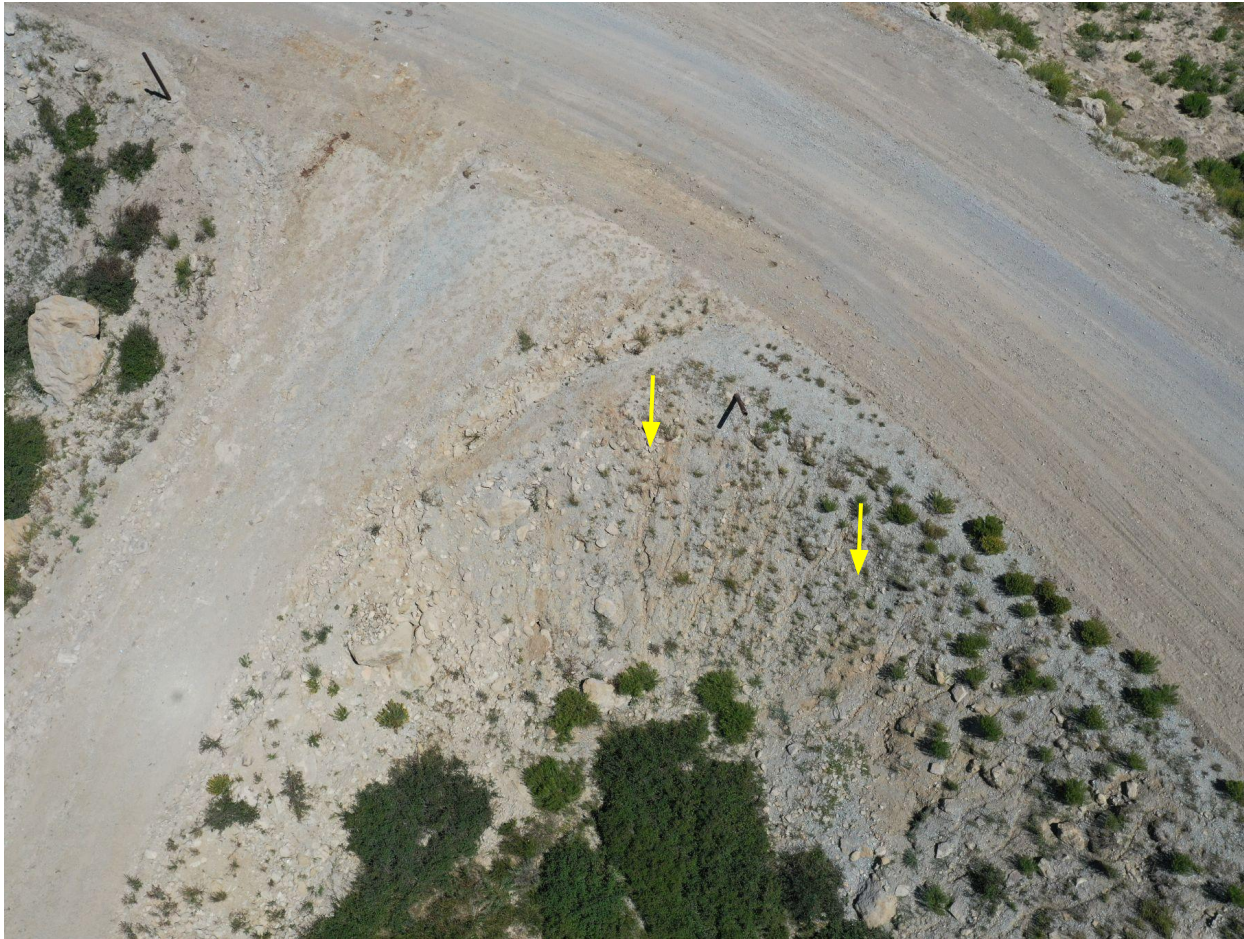
Photo 4: Photo taken with a sUAS. Photo shows erosion degradation along cut slopes. Stormwater and Erosion control measures remain missing or insufficient to manage runoff in a manner that minimizes erosion, degradation and sediment transport. Slopes/Reclamation not progressing towards 1003 standards.

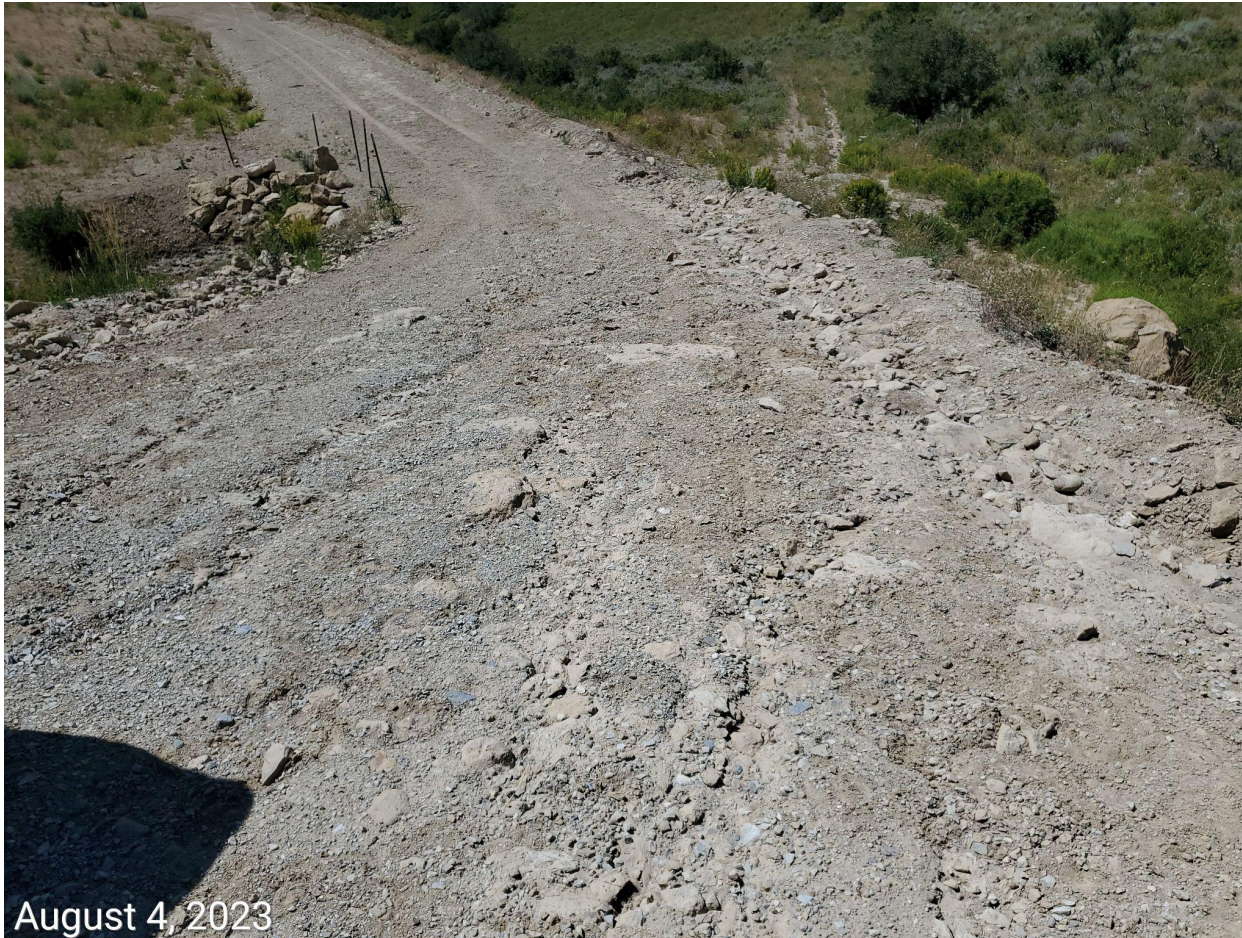
Photo 5: Photo taken from the access road. Photo shows erosion persistent stormwater and erosion degradation; Stormwater and Erosion control measures remain missing or insufficient to manage runoff in a manner that minimizes erosion, degradation and sediment transport.

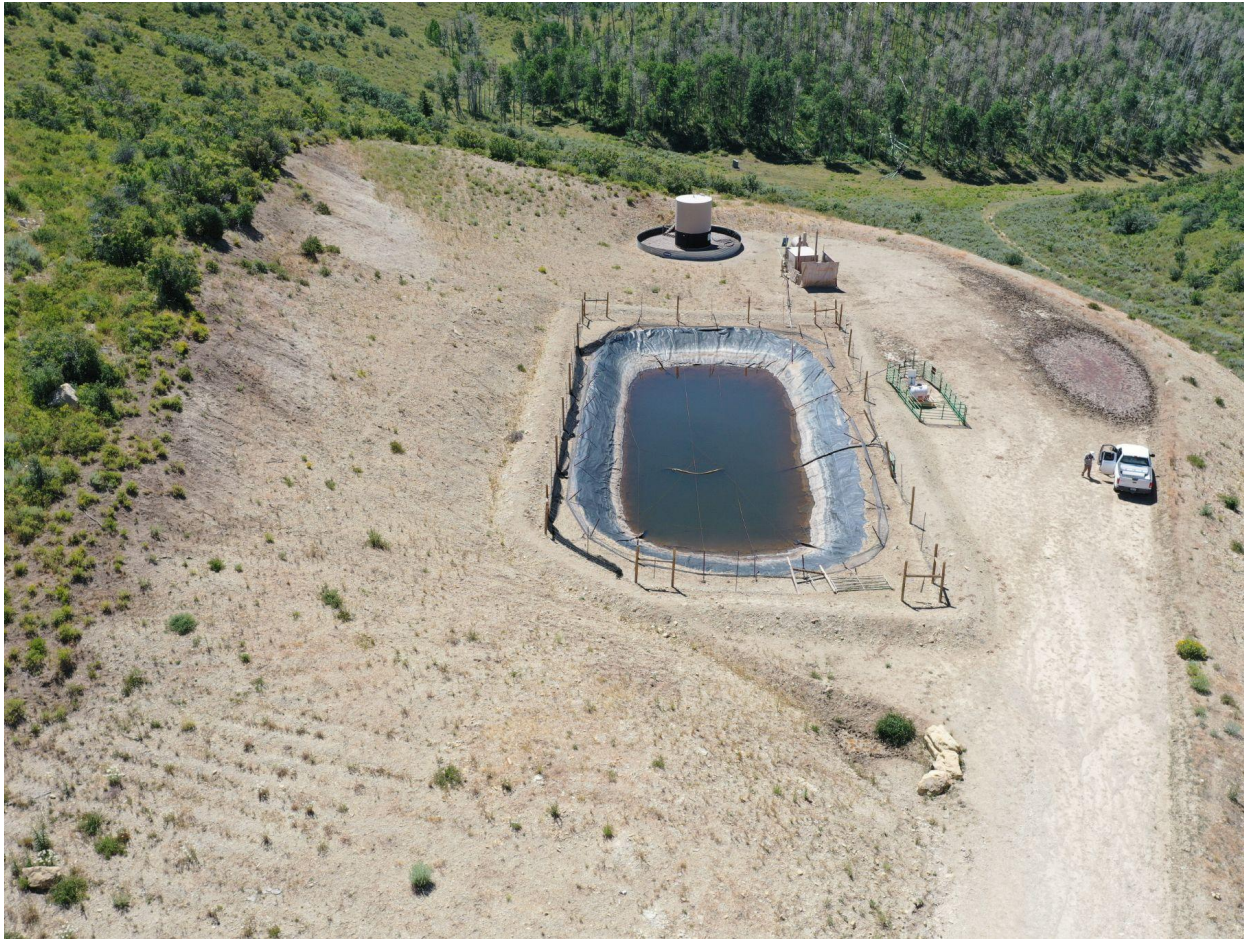
Photo 6: Photo taken with a sUAS. Photo shows pit on the Location; fence remains in disrepair and netting has not been replaced.

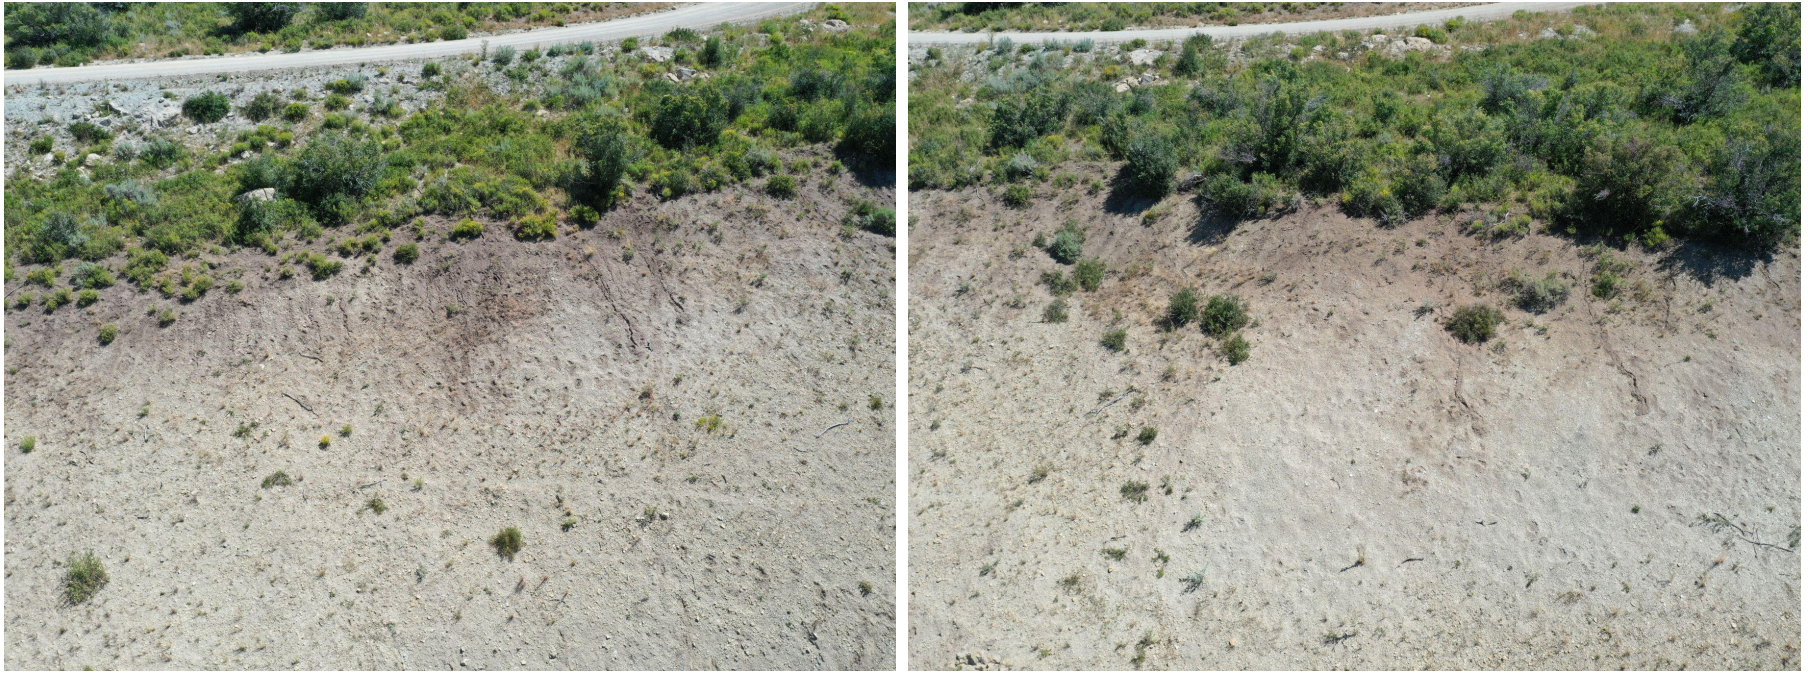
Photo 7: Photo taken with a sUAS. Photo shows erosion degradation along cut slopes. Stormwater and Erosion control measures remain missing or insufficient to manage runoff in a manner that minimizes erosion, degradation and sediment transport. Slopes/Reclamation not progressing towards 1003 standards.

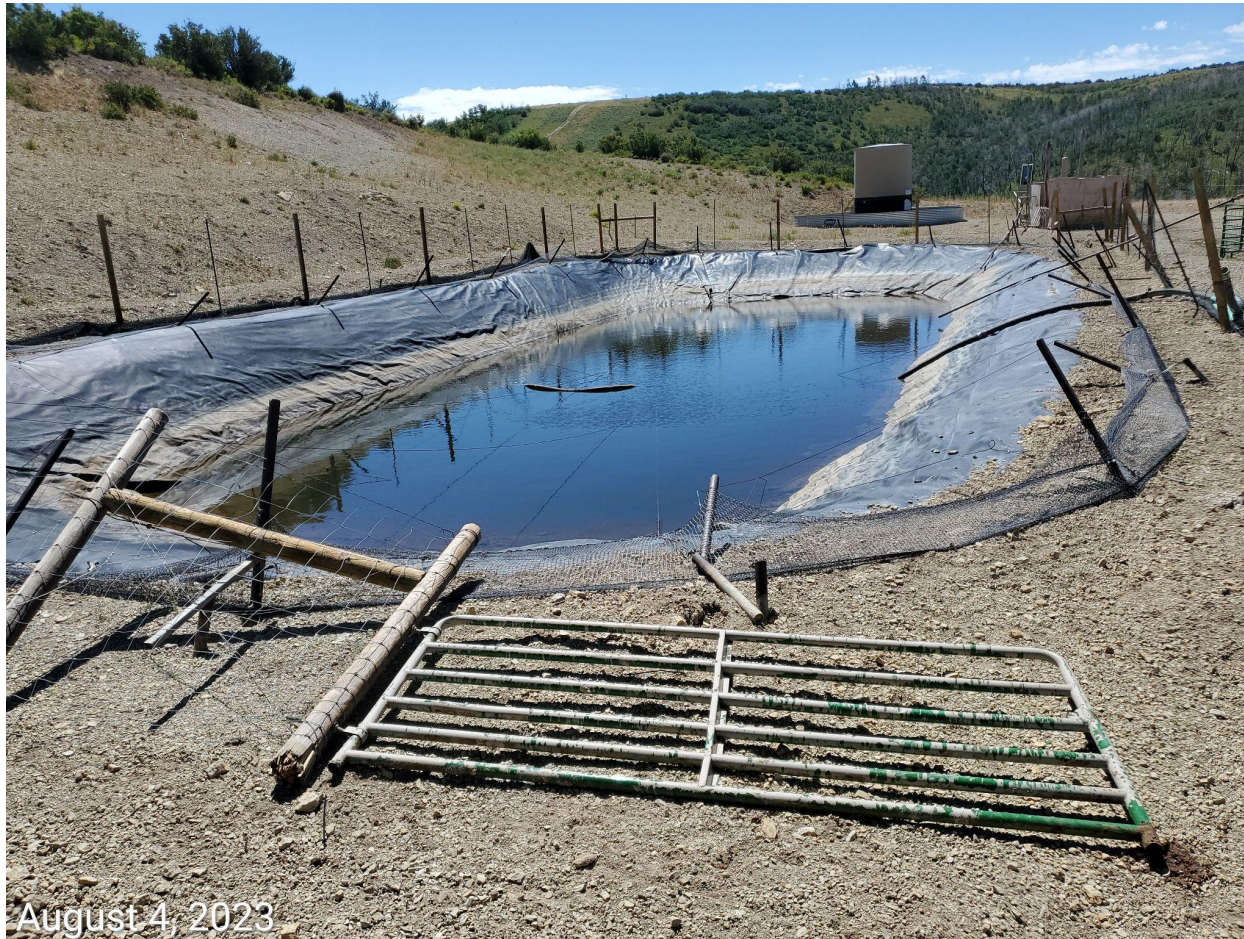
Photo 8: Photo taken from the pit. Photo shows fence at pit remains in disrepair, and the netting has not been replaced.

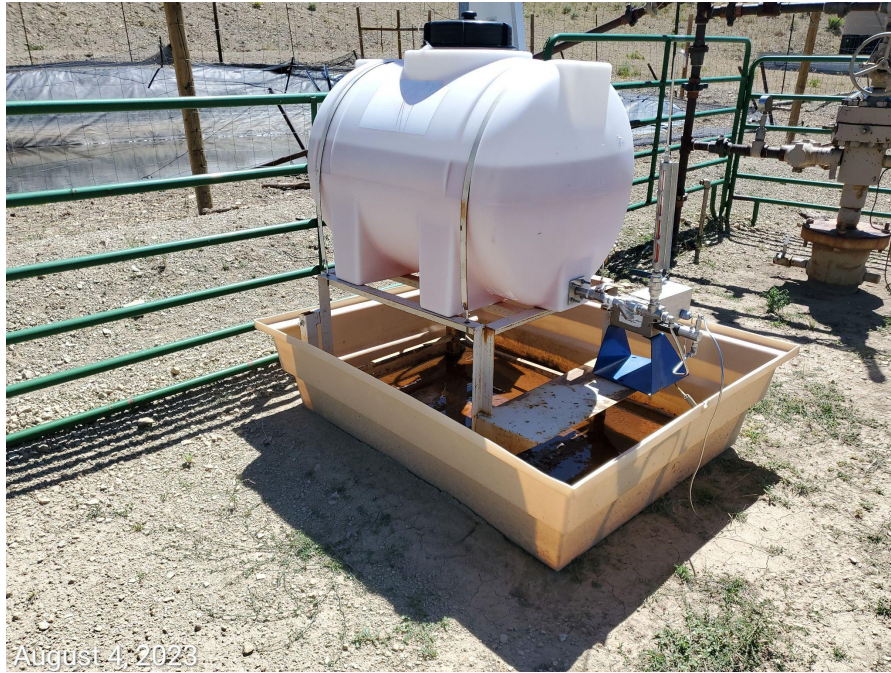
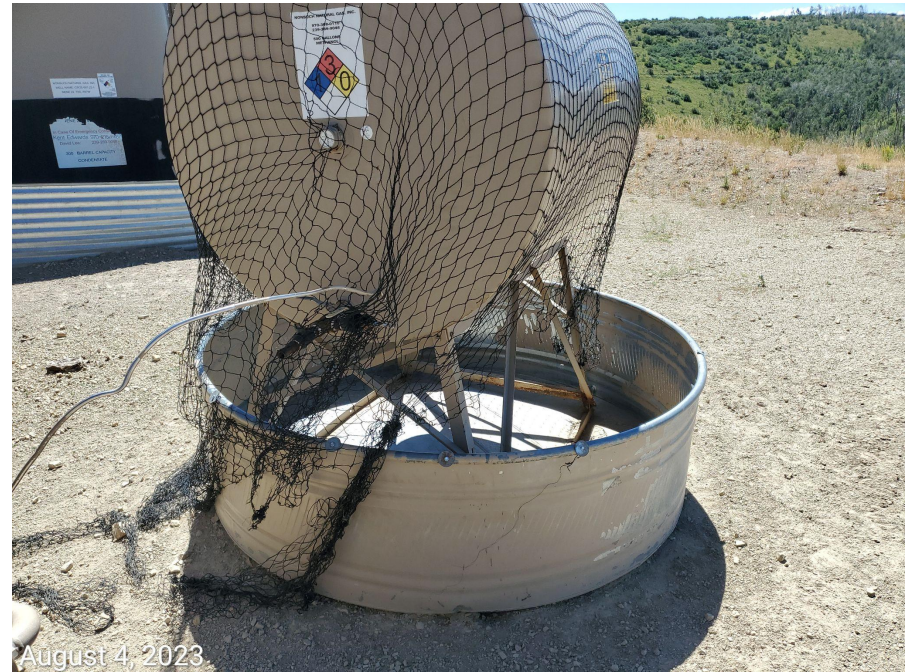
Photo 9: Photos show wildlife protection BMPs at the secondary containment BMPs remain missing, or insufficient.
