# Inspection Photos

8/4/2023

Operator: LARAMIE ENERGY LLC #10433

Location Number: 452807

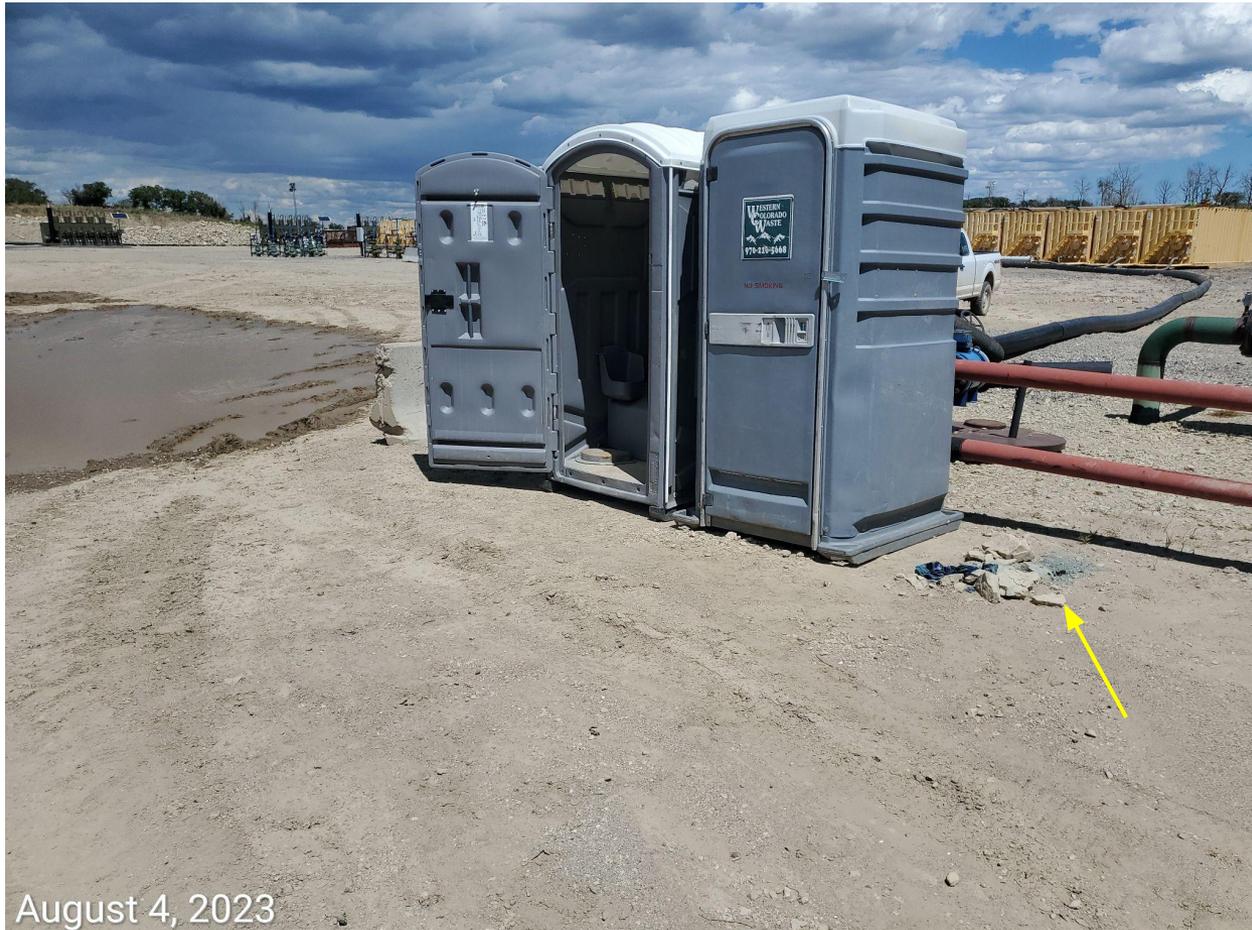
**Photo 1:** Photo taken from the entrance, on the south side of the Location. Photo shows BMPs to prevent or contain a spill at the porta-johns remain missing or insufficient; units not secured down. Photo also shows that BMPs to ensure that waste remains contained within the sanitary facilities is inadequate; chemicals and fecal material observed spilled onto the working pad surface next to porta-john.

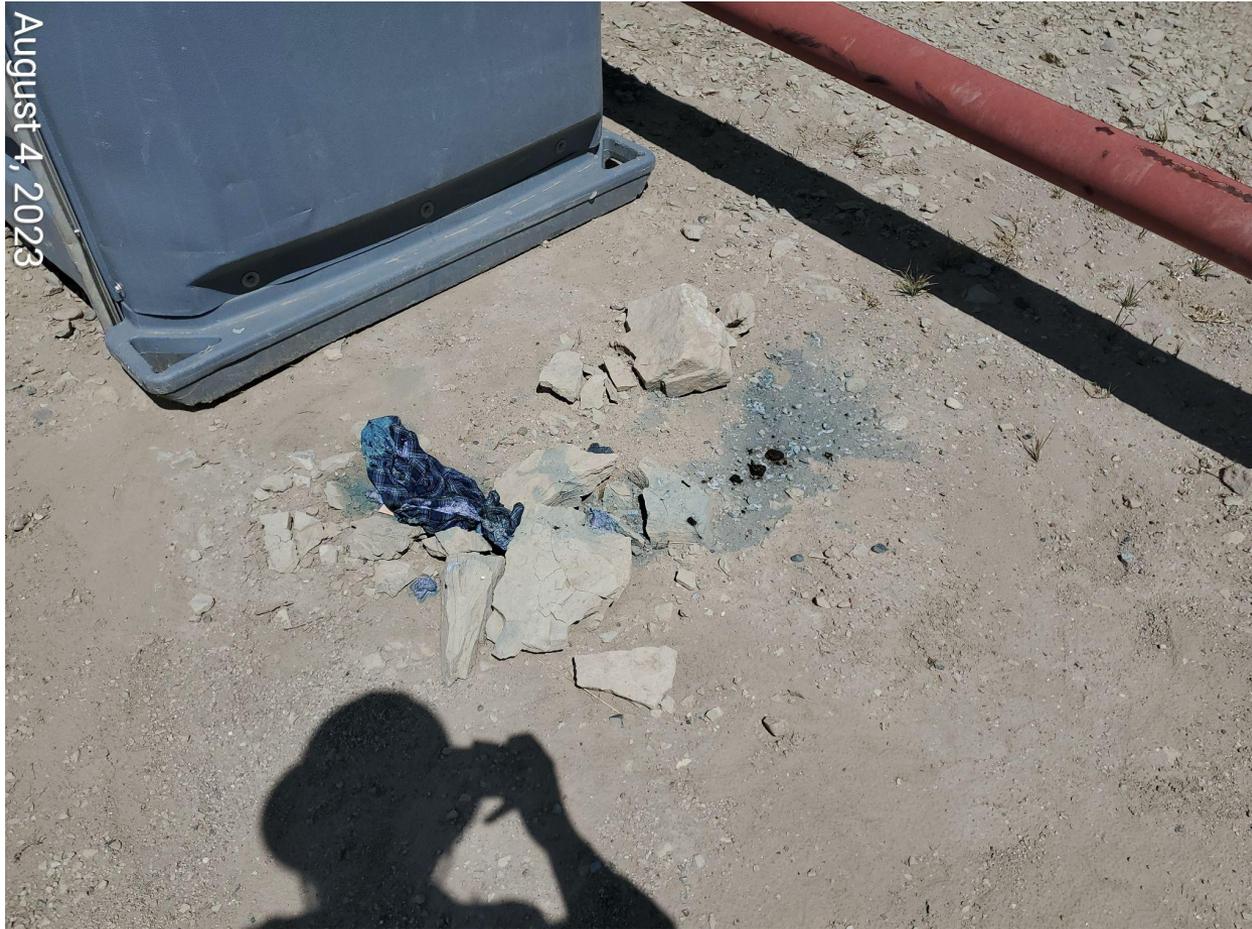
**Photo 2:** Continued from photo 1. Photo shows that BMPs to ensure that waste remains contained within the sanitary facilities is inadequate; chemicals and fecal material observed spilled onto the working pad surface next to porta-john.

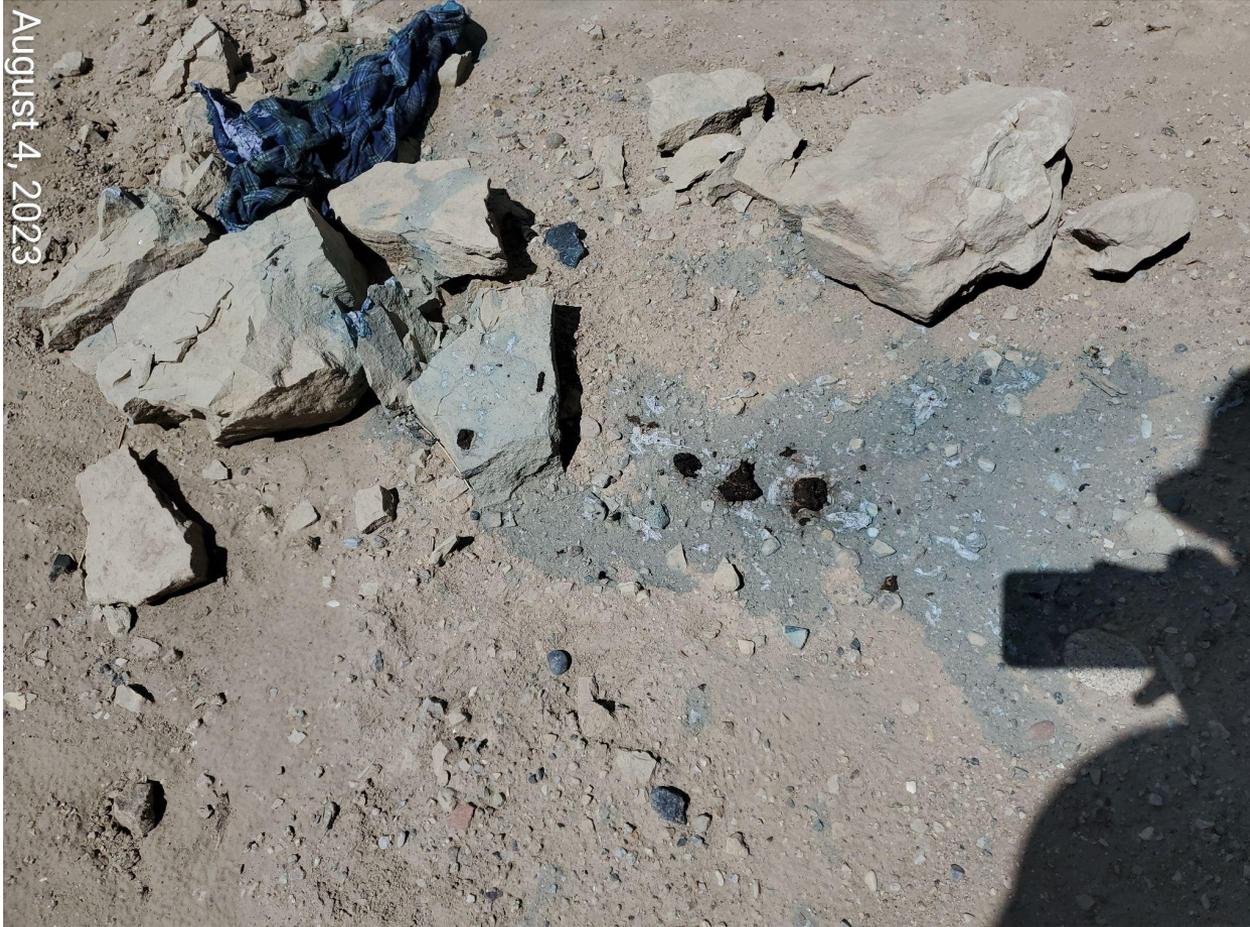
**Photo 3:** Continued from photo 1. Photo shows that BMPs to ensure that waste remains contained within the sanitary facilities is inadequate; chemicals and fecal material observed spilled onto the working pad surface next to porta-john.

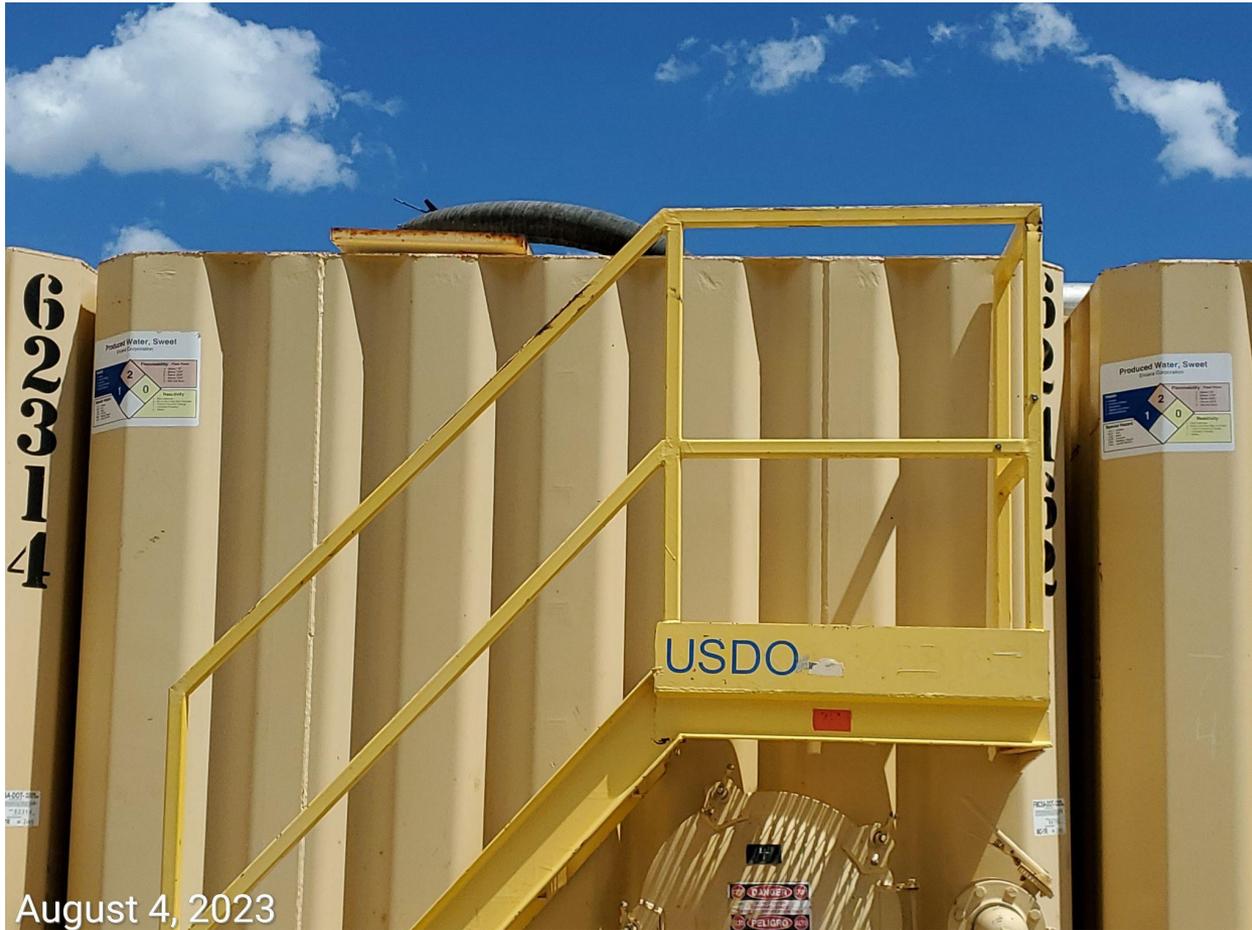
**Photo 4:** Photo example showing containers missing labeling information per 605 Rules.

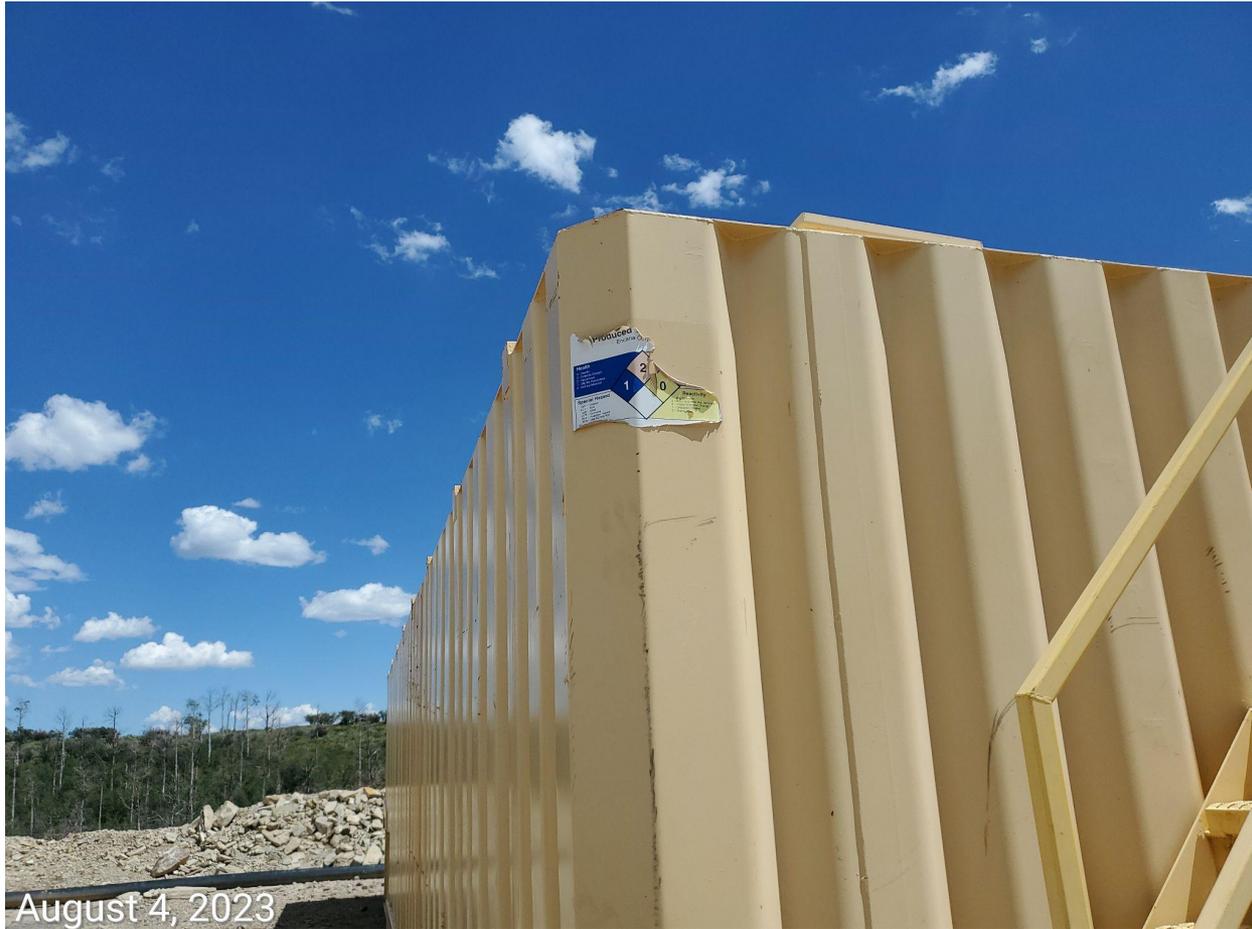
**Photo 5:** Photo example showing containers missing labeling information per 605 Rules.

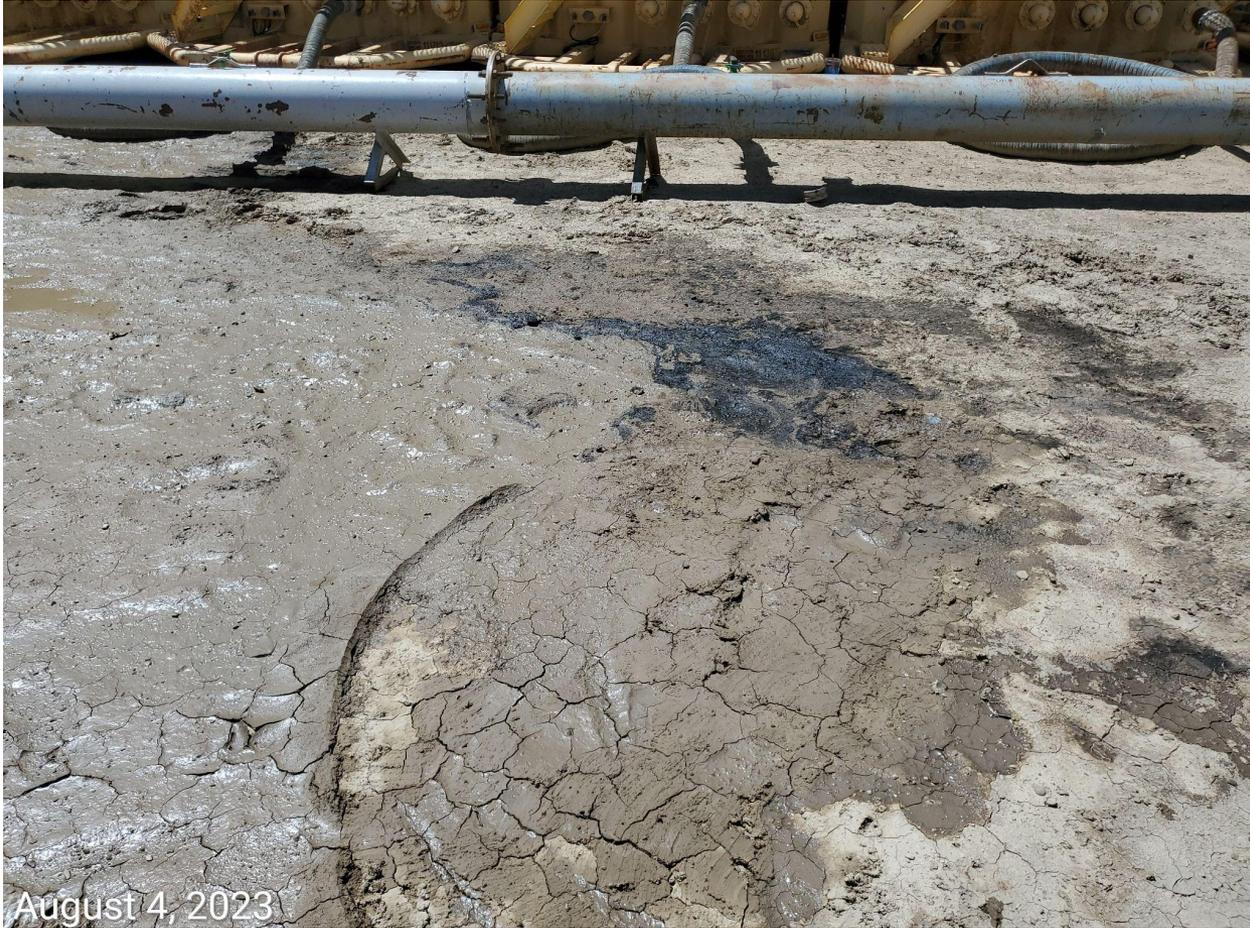
**Photo 6:** Recent winds have blown over a portable light unit, resulting in POLS spilling onto the working pad surface, and impacting stormwater.

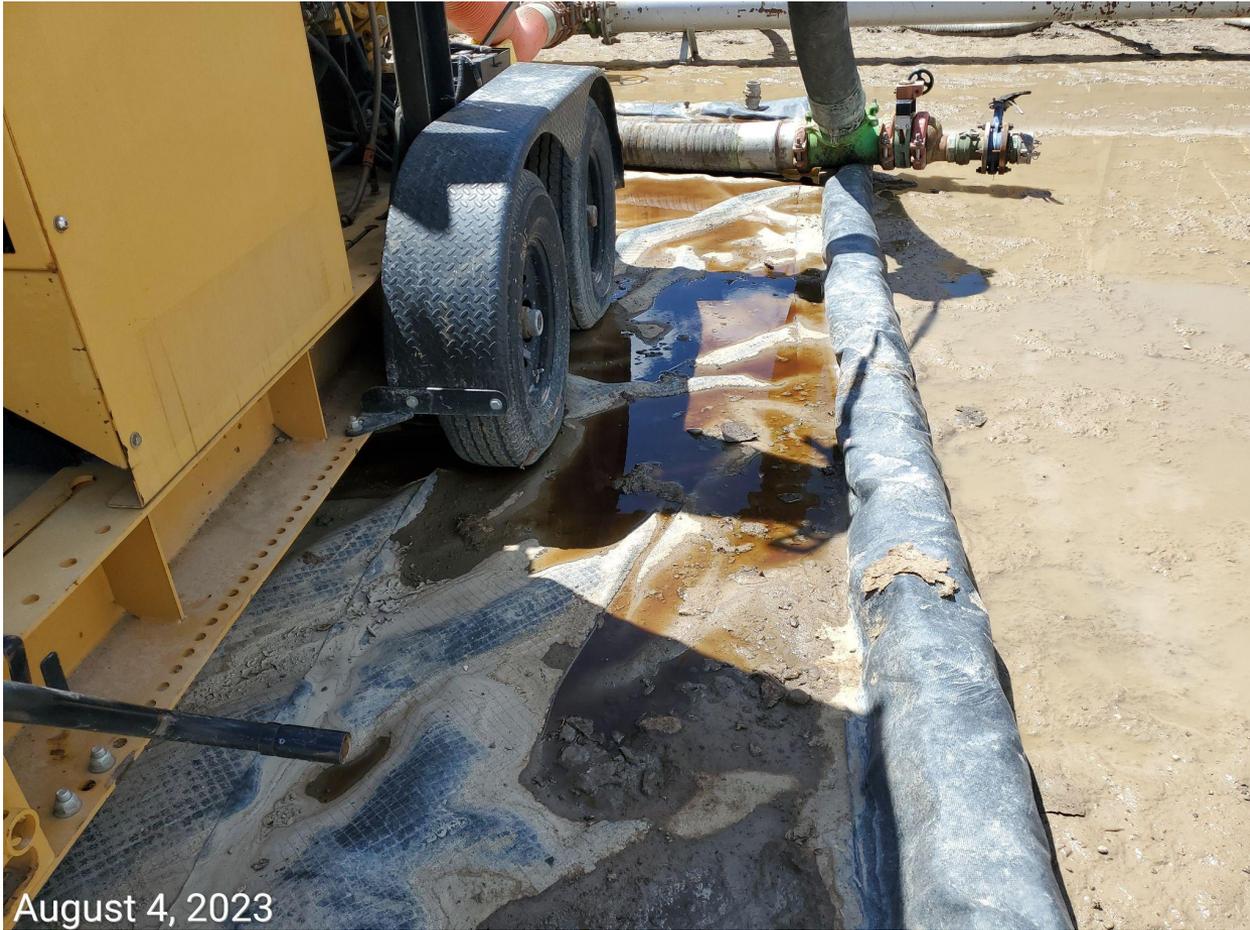
**Photo 7:** Fluids in containment require removal and proper disposal.

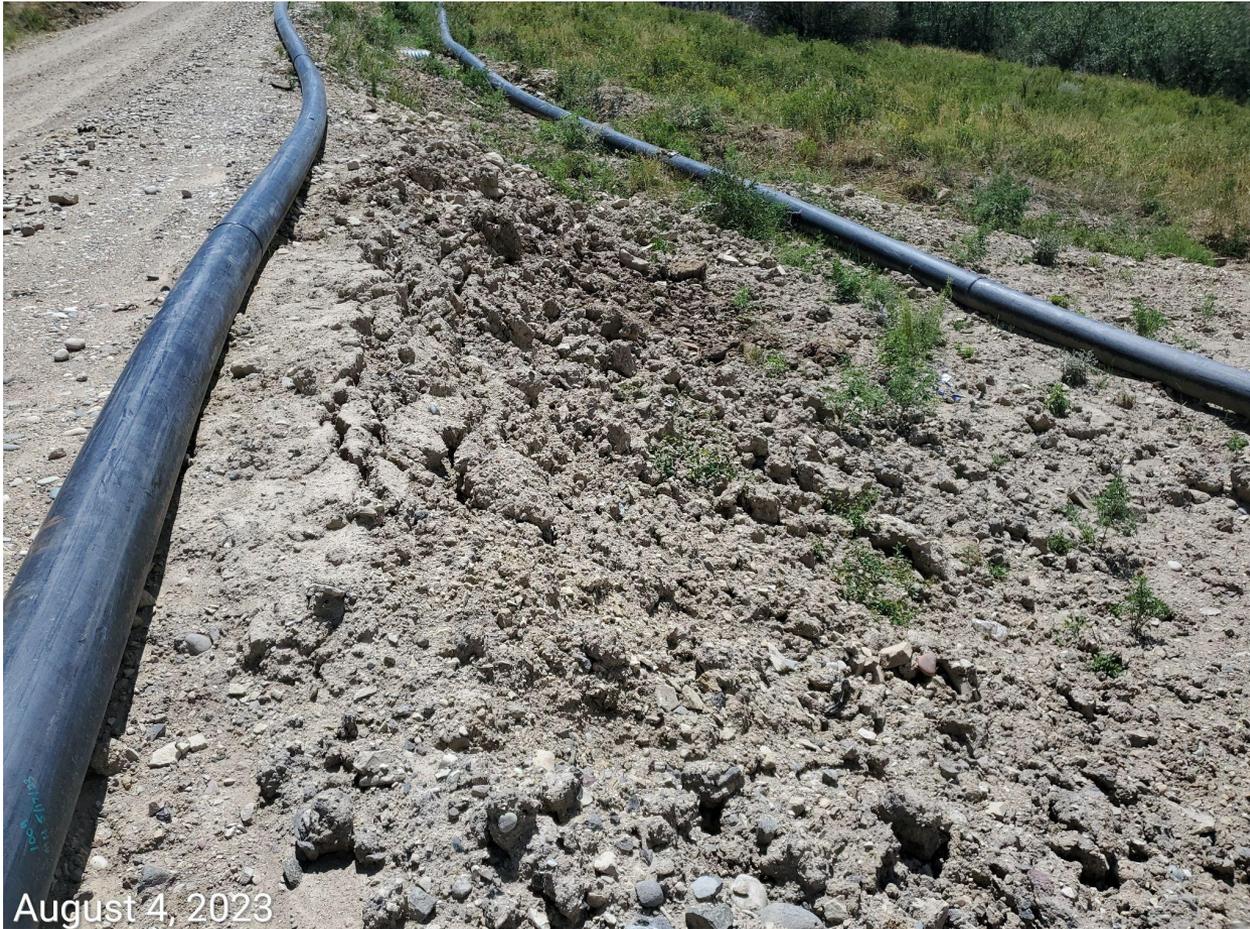
**Photo 8:** Stormwater and erosion control measures to minimize erosion and degradation missing or insufficient at slopes adjacent to Location entrance; slopes lack stabilization.

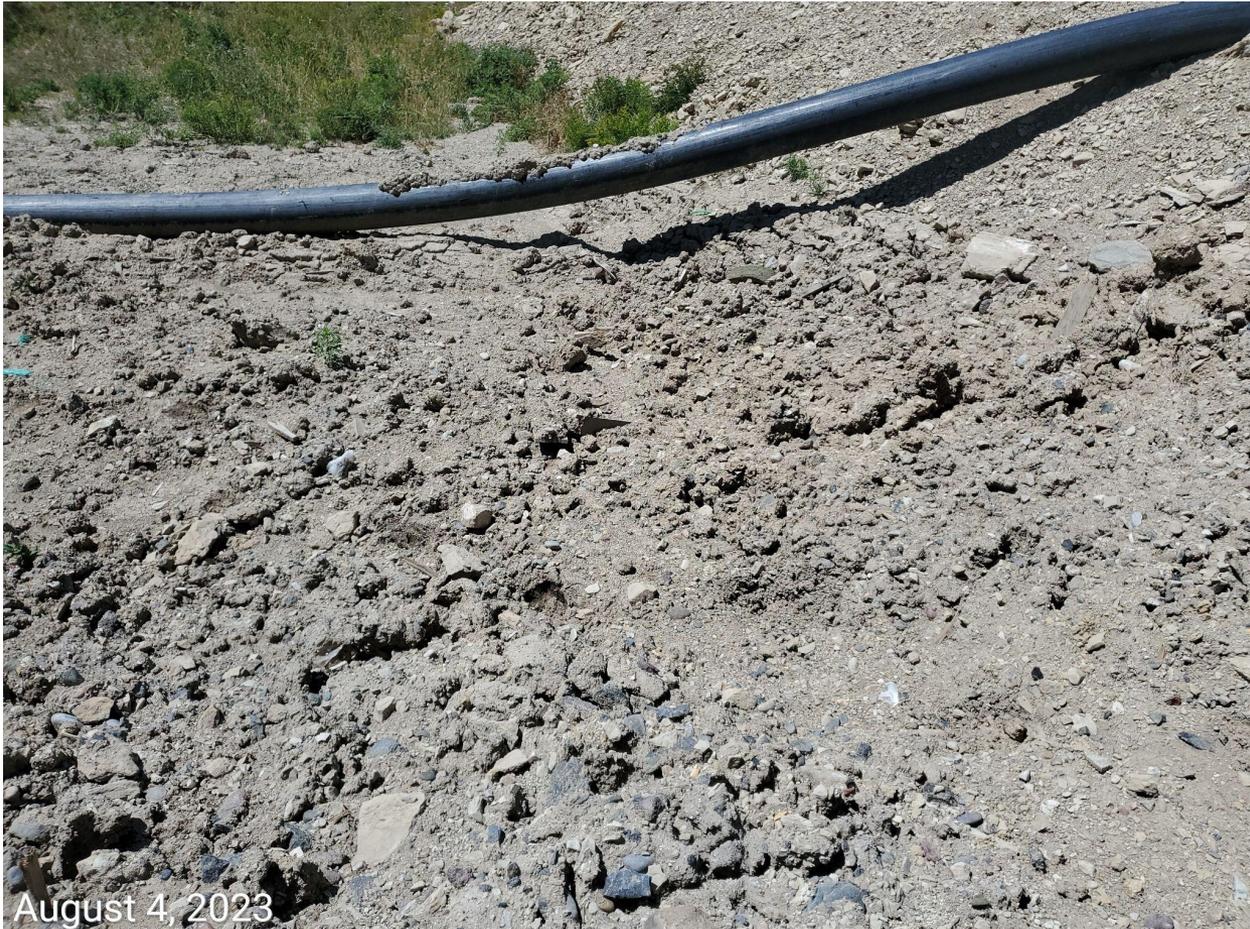
**Photo 9:** Stormwater and erosion control measures to minimize erosion and degradation missing or insufficient at slopes adjacent to Location entrance; slopes lack stabilization.
