# Inspection Photos

API: 061-05143

Operator: WESTERN OPERATING COMPANY

Inspection Date: 8/9/2023

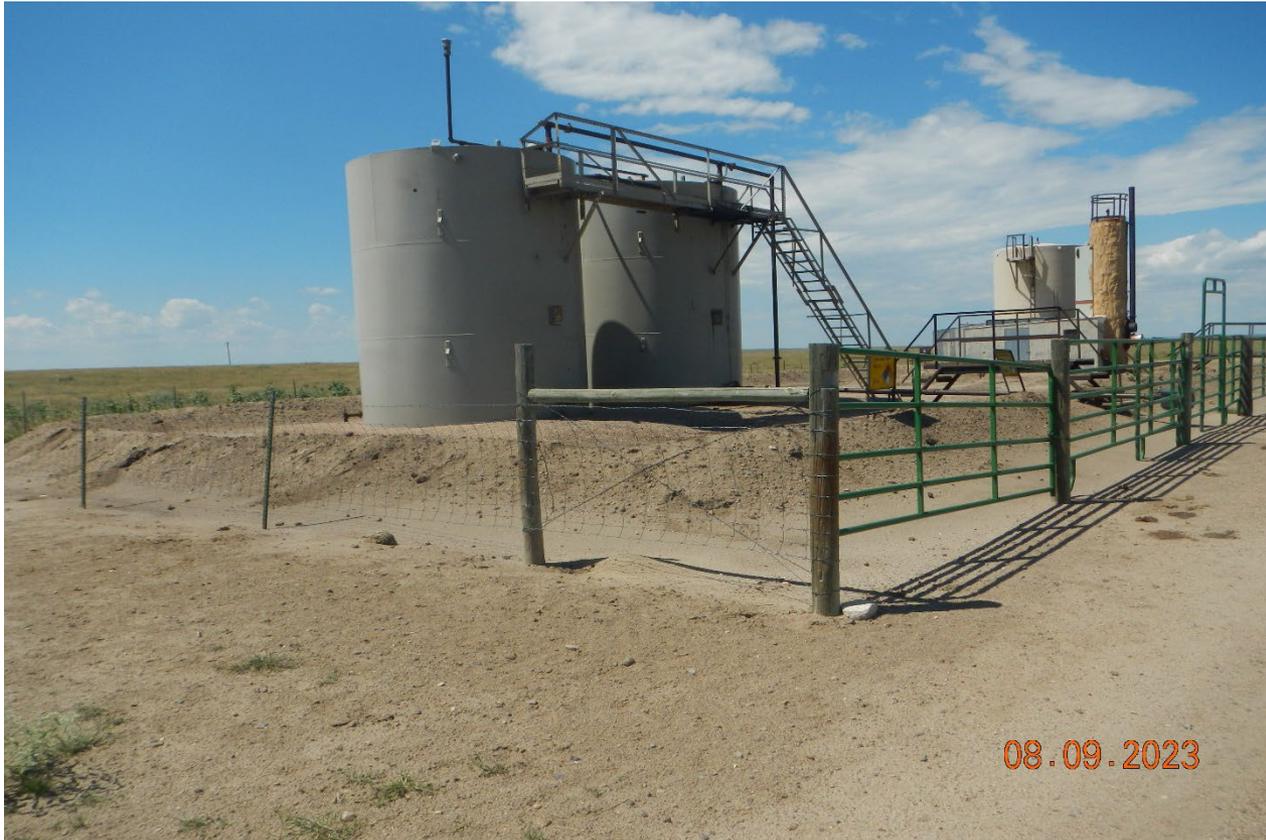
**Photo 1.** Facing toward the tank battery.

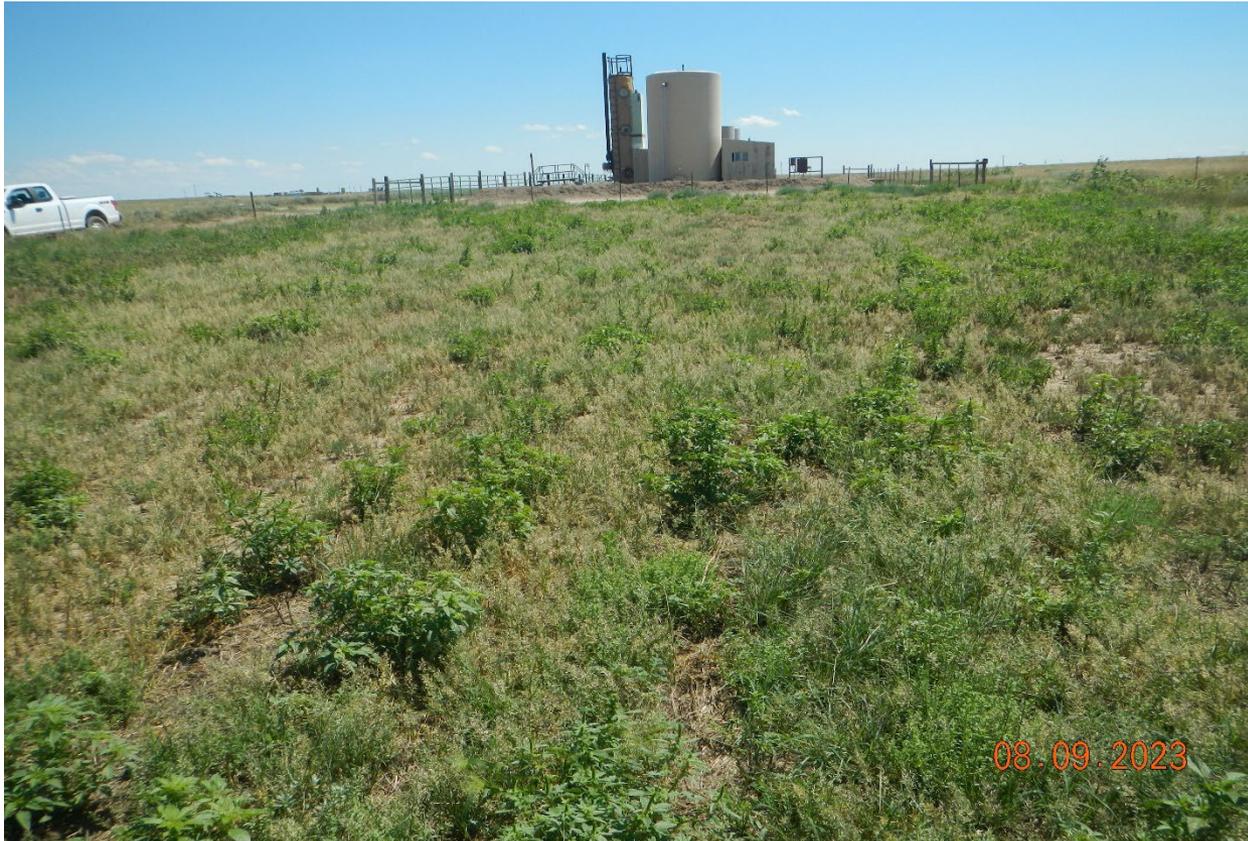
**Photo 2.** Facing south toward the area north of the tank battery where historic spilled occurred and is under remediation. There is mostly annual weedy vegetation but there are some desirable species beginning to establish. Observed some Sand dropseed.

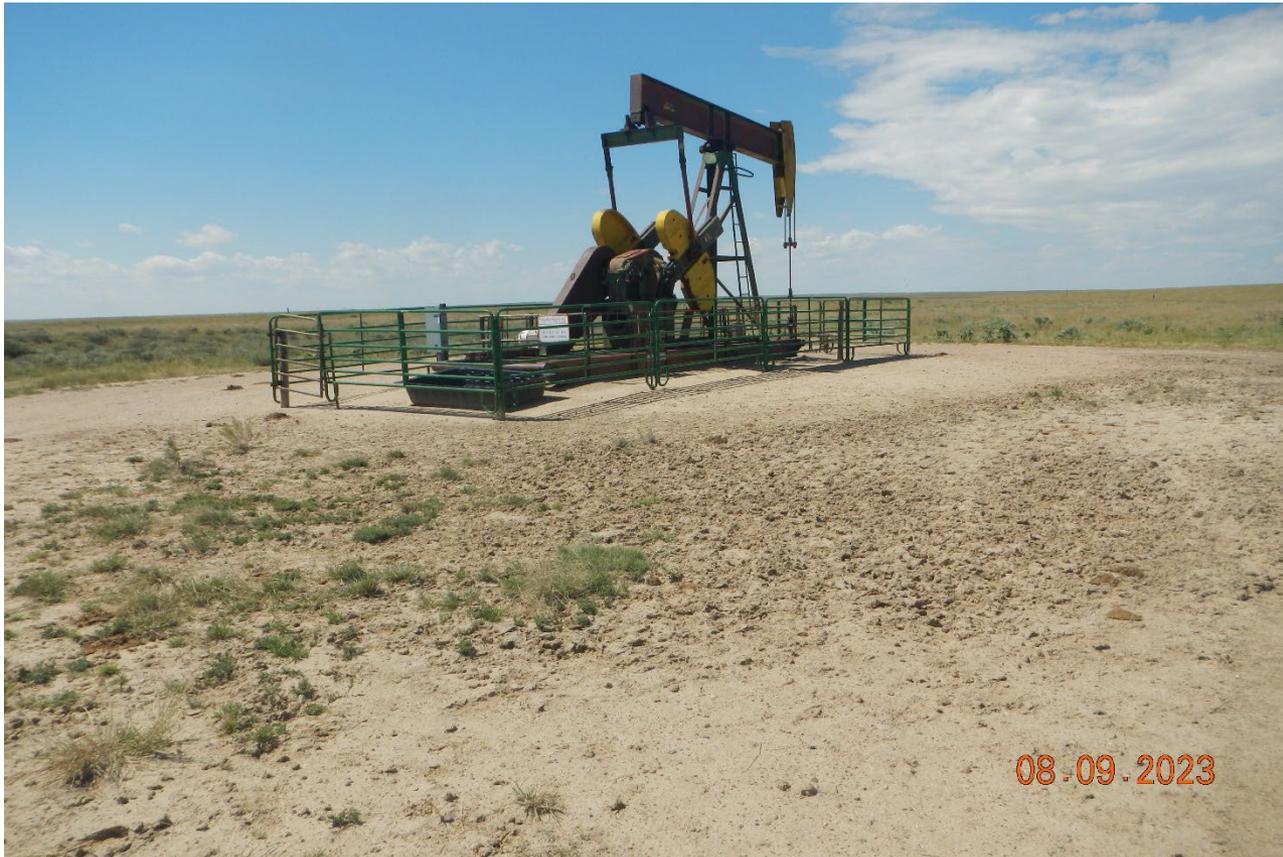
**Photo 3.** Facing northwest toward the wellsite.

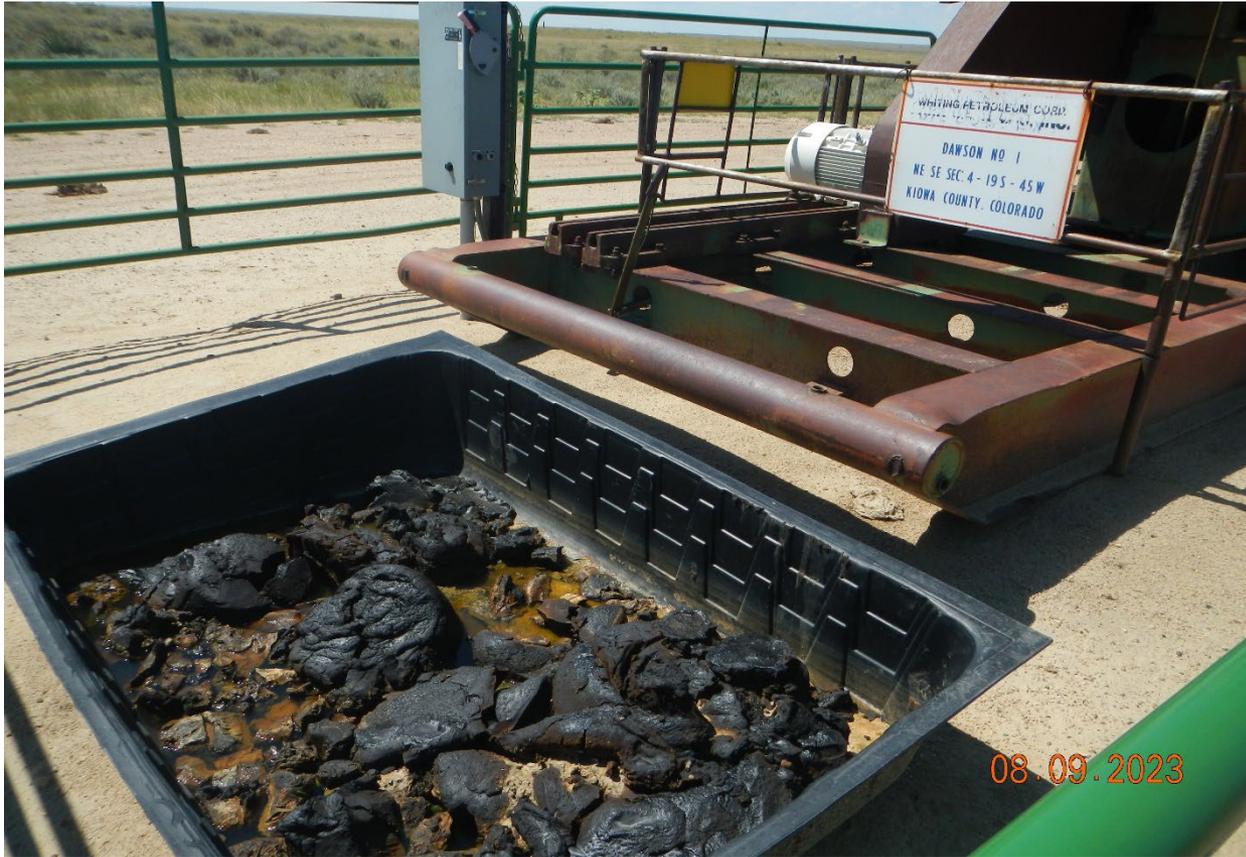
**Photo 4.** There is oily material being stored in this containment which needs to be removed and properly disposed. This is a potential stormwater and wildlife impact that needs to be removed.
