# Inspection Photos

Loc: 484587

Operator: WESTERN OPERATING COMPANY

Inspection Date: 8/9/2023

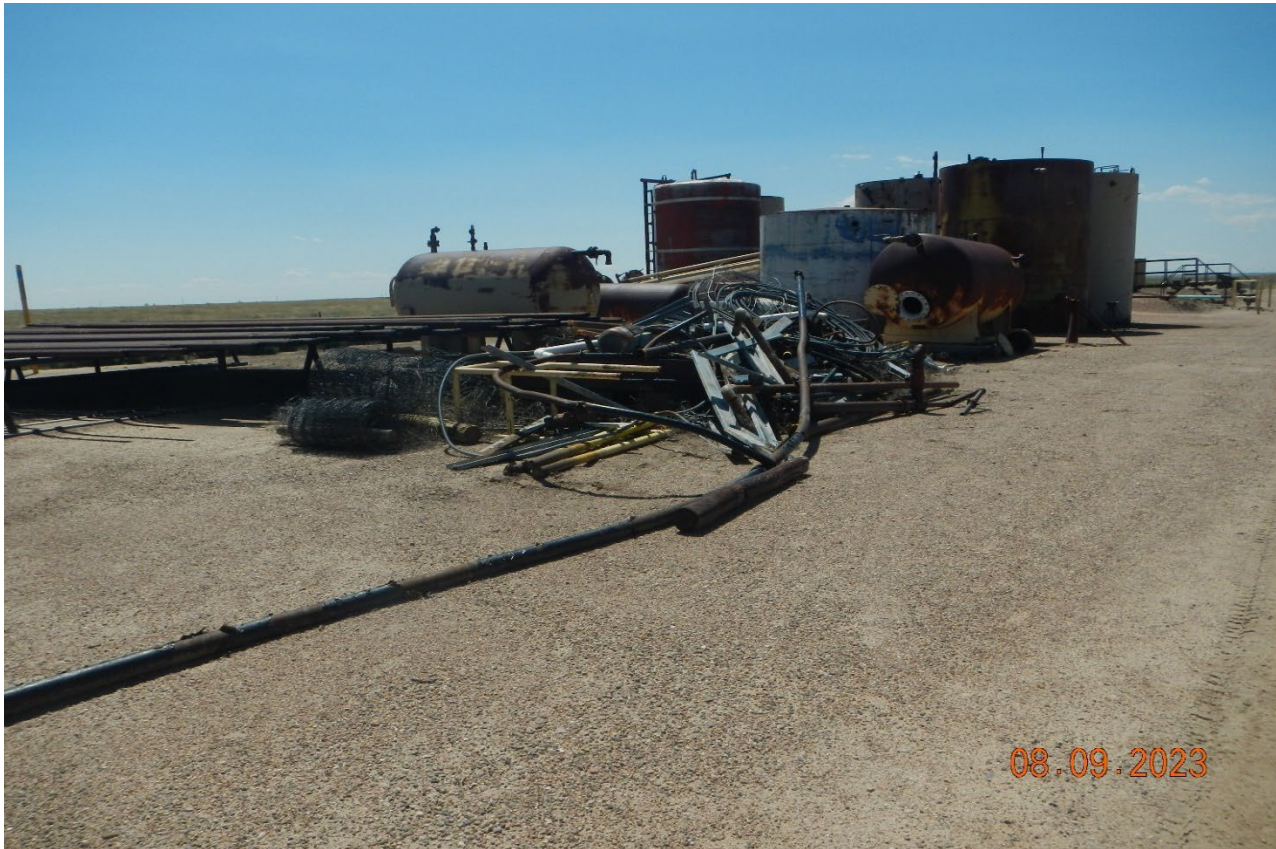
**Photo 2.** There is unused equipment being stored on location that needs to be removed. All equipment and supplies not necessary for use on this Oil and Gas Location is prohibited per Rule 606 and 1003.a.

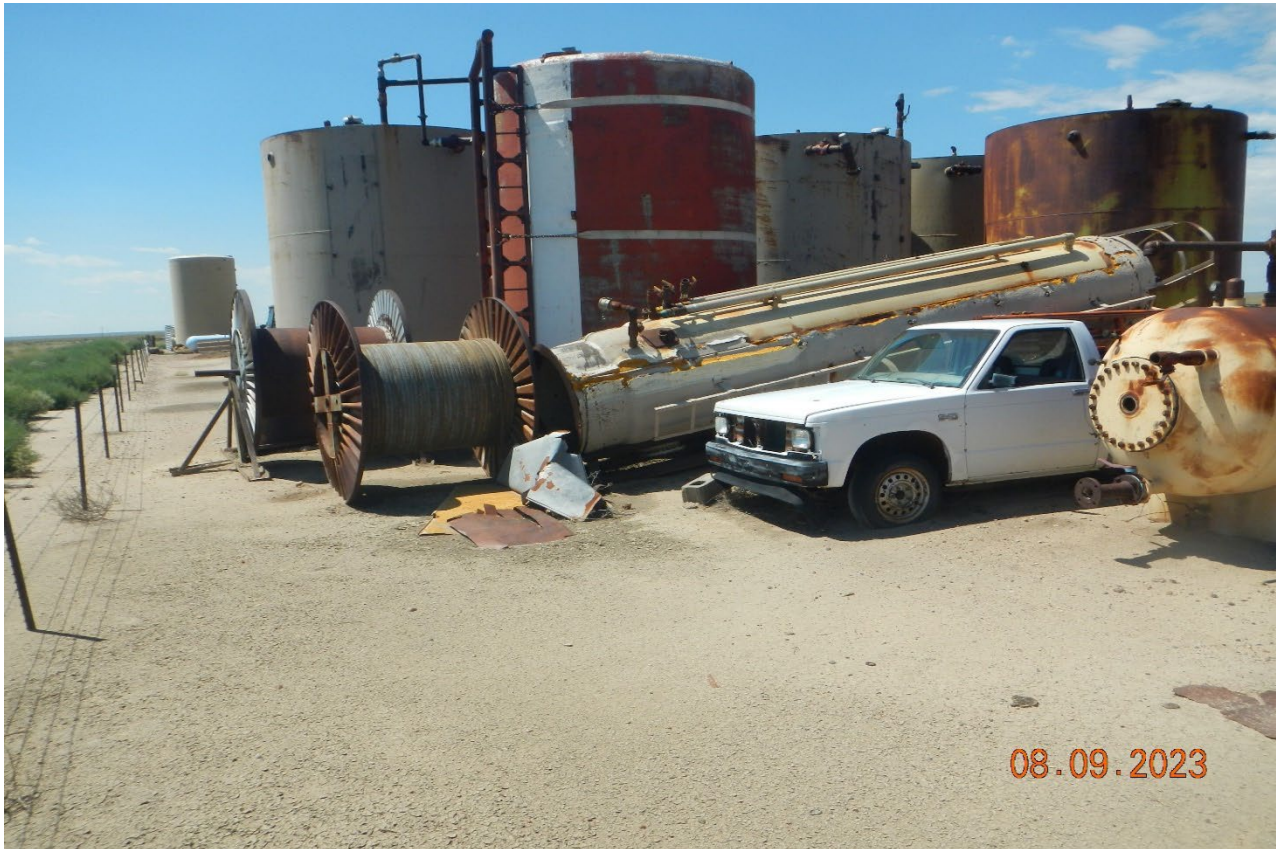
**Photo 3.** Facing west at the south side of the location. There is equipment and a vehicle that appears to have been sitting unused at this location for awhile.

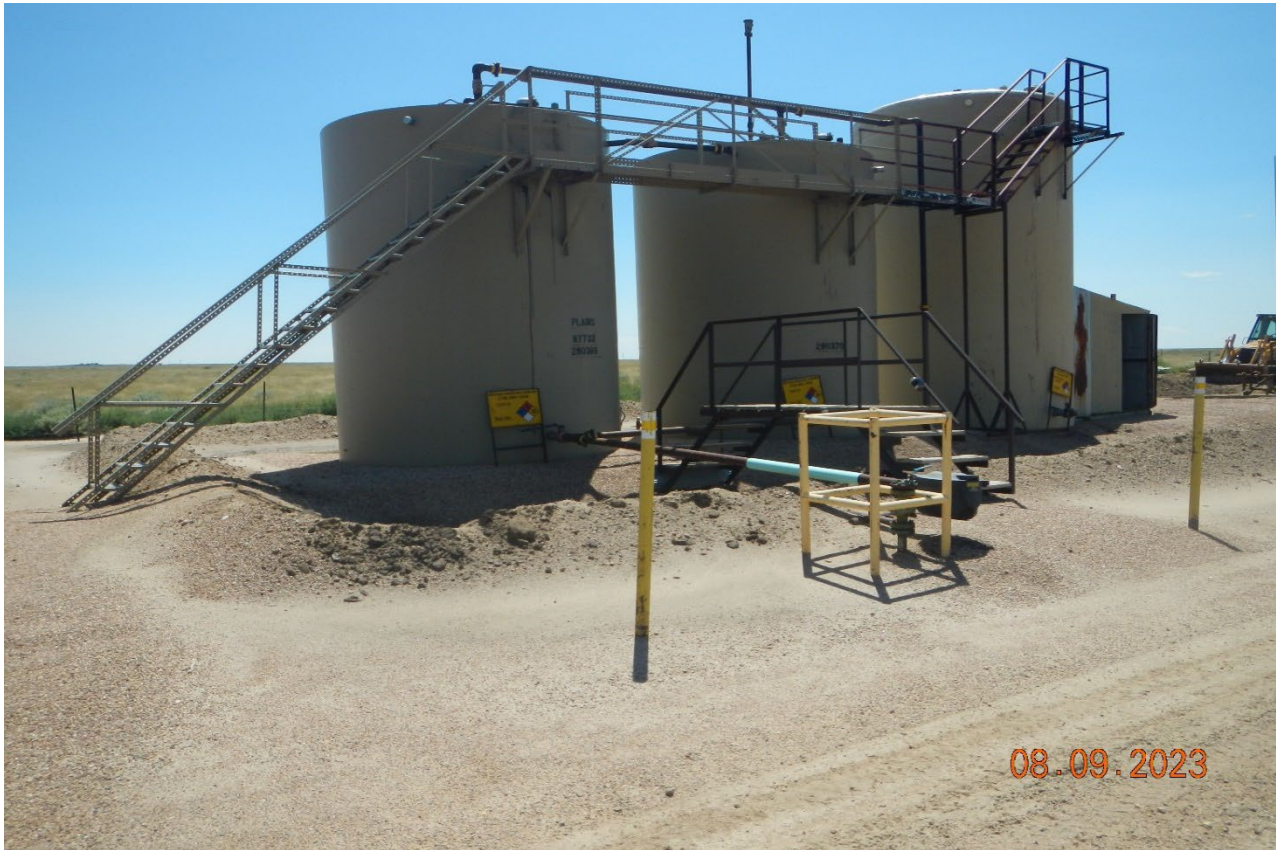
**Photo 4.** Facing toward the PYLES offsite tank battery at the location. Stained soil was removed from the outlet area.

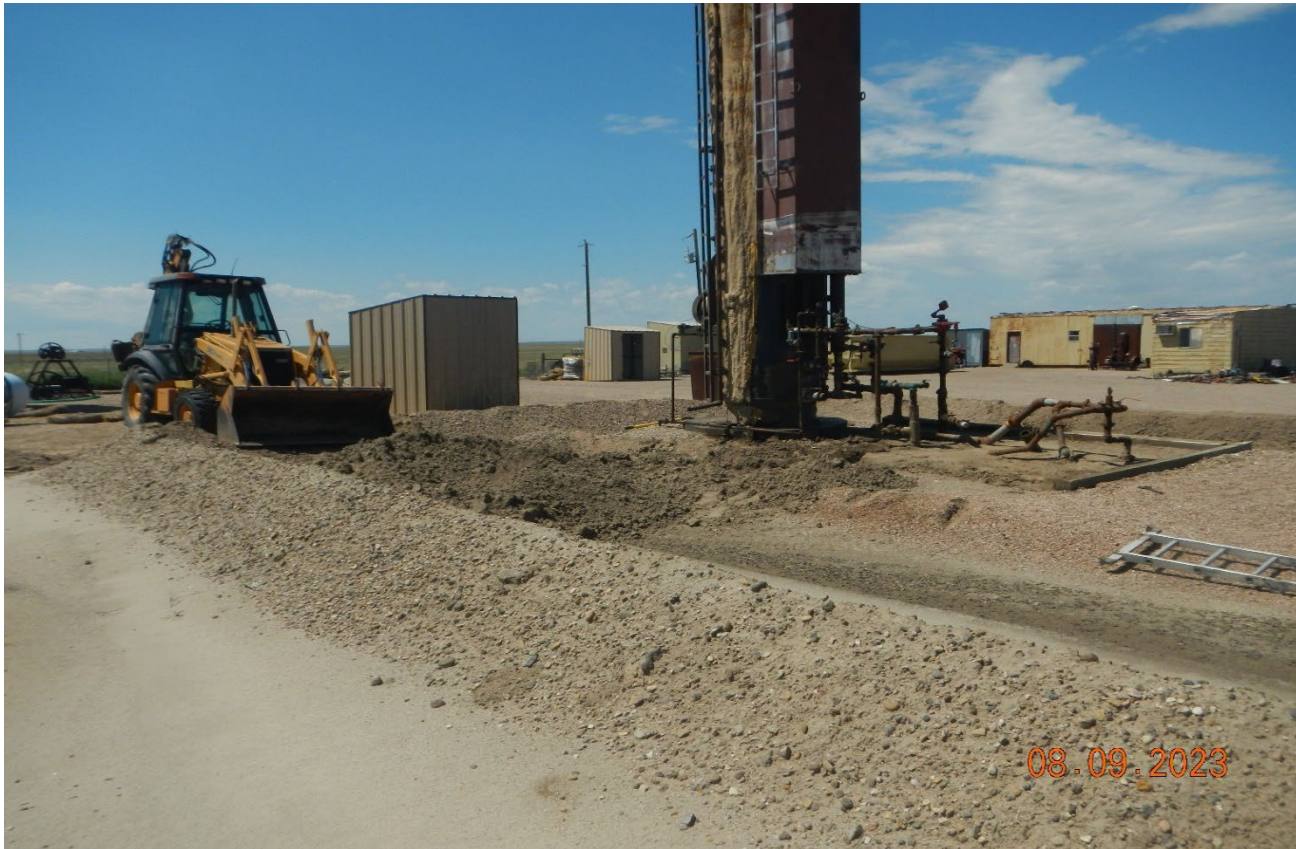
**Photo 5.** Facing northwest toward the vertical separator. The shed has been removed and there is excavation and work being performed at the separator.

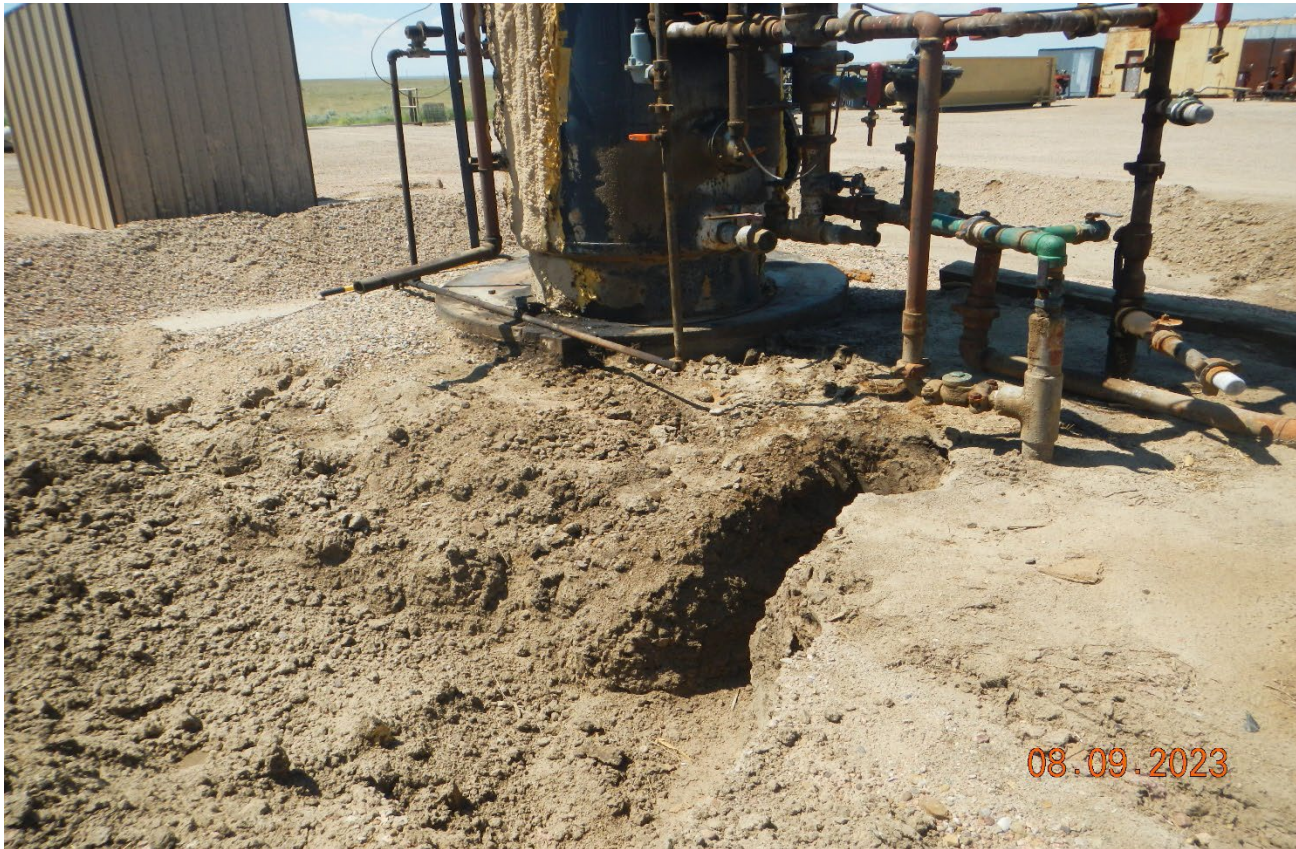
**Photo 6.** View of excavation and exposed piping at separator. There is oil stained soil observed in this area that will need to be cleaned up.

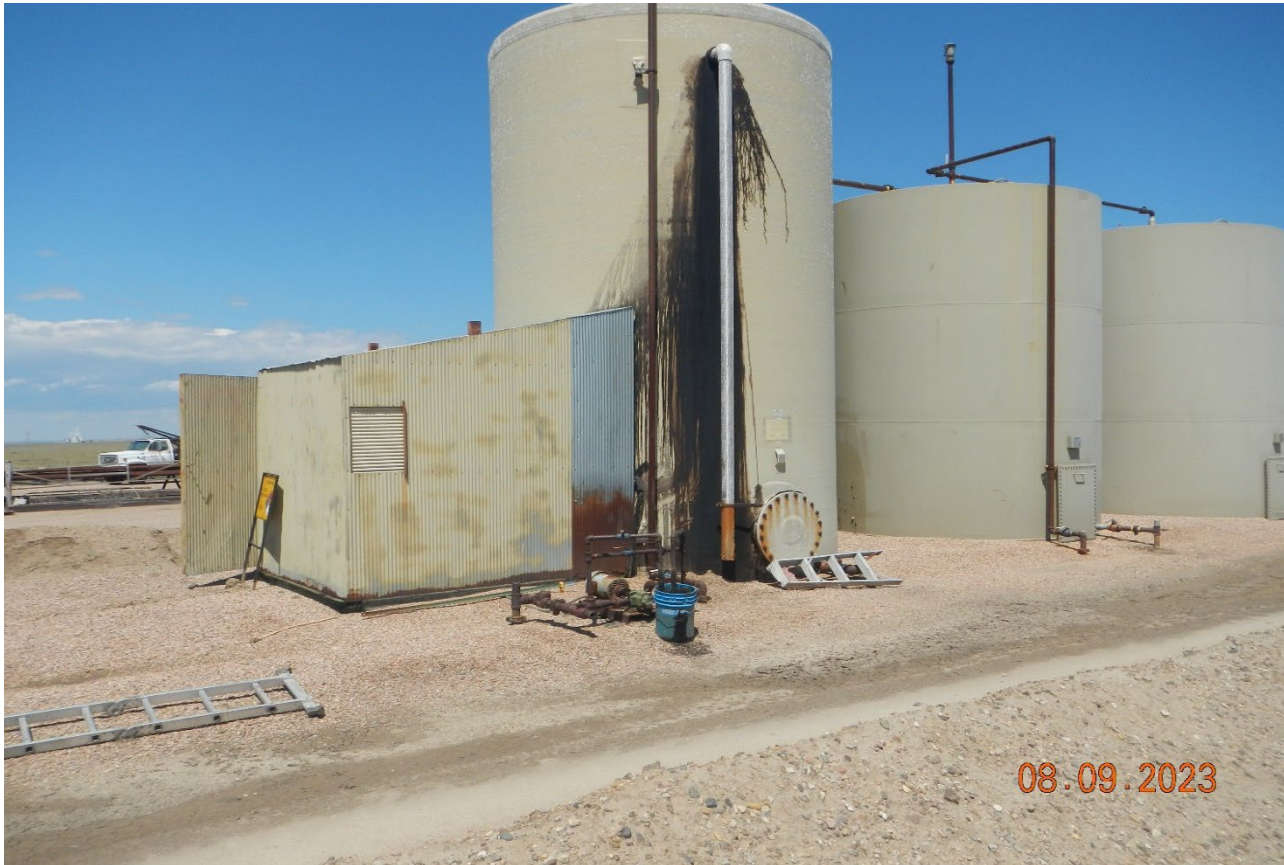
**Photo 7.** Facing at the back side of the tank battery. There was a spill from the tank which needs to be cleaned up. The blue bucket needs to be emptied and disposed of any oil. Previous corrective action was not completed.

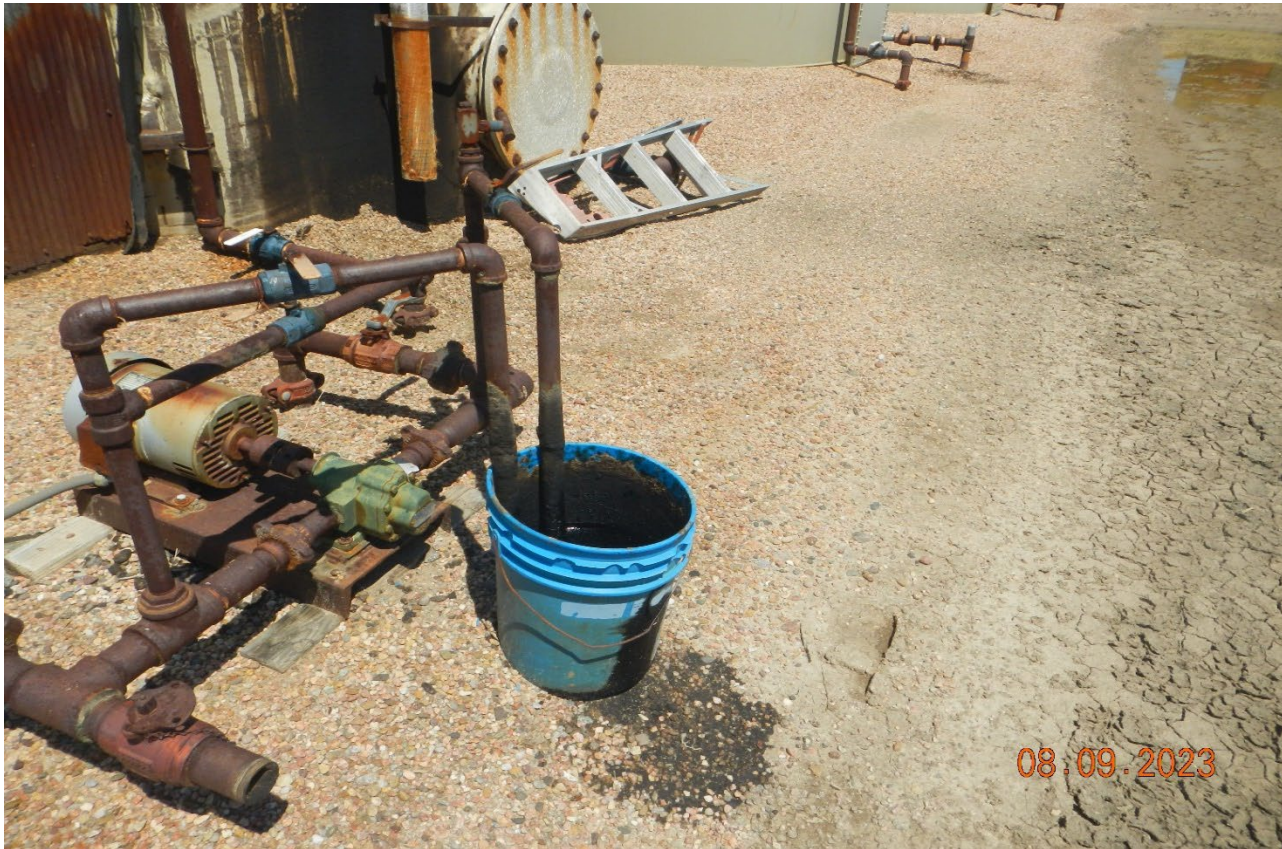
**Photo 8.** This bucket at the backside of the tank battery is full of oil which has spilled onto the ground. This needs to be cleaned up and covered to prevent entry.

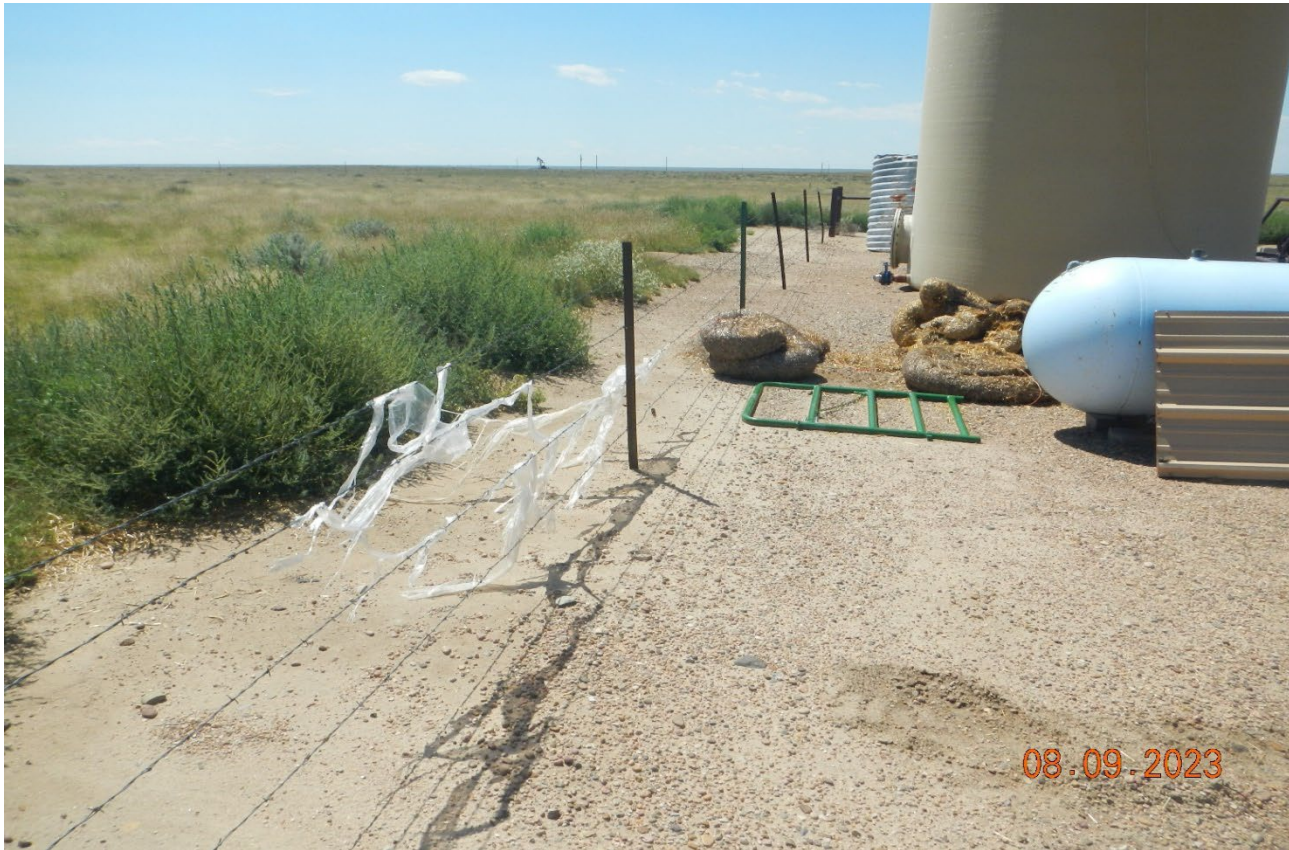
**Photo 9.** Facing toward the southwest side of the location. There is plastic trash debris that is caught in the fence that needs to be removed.

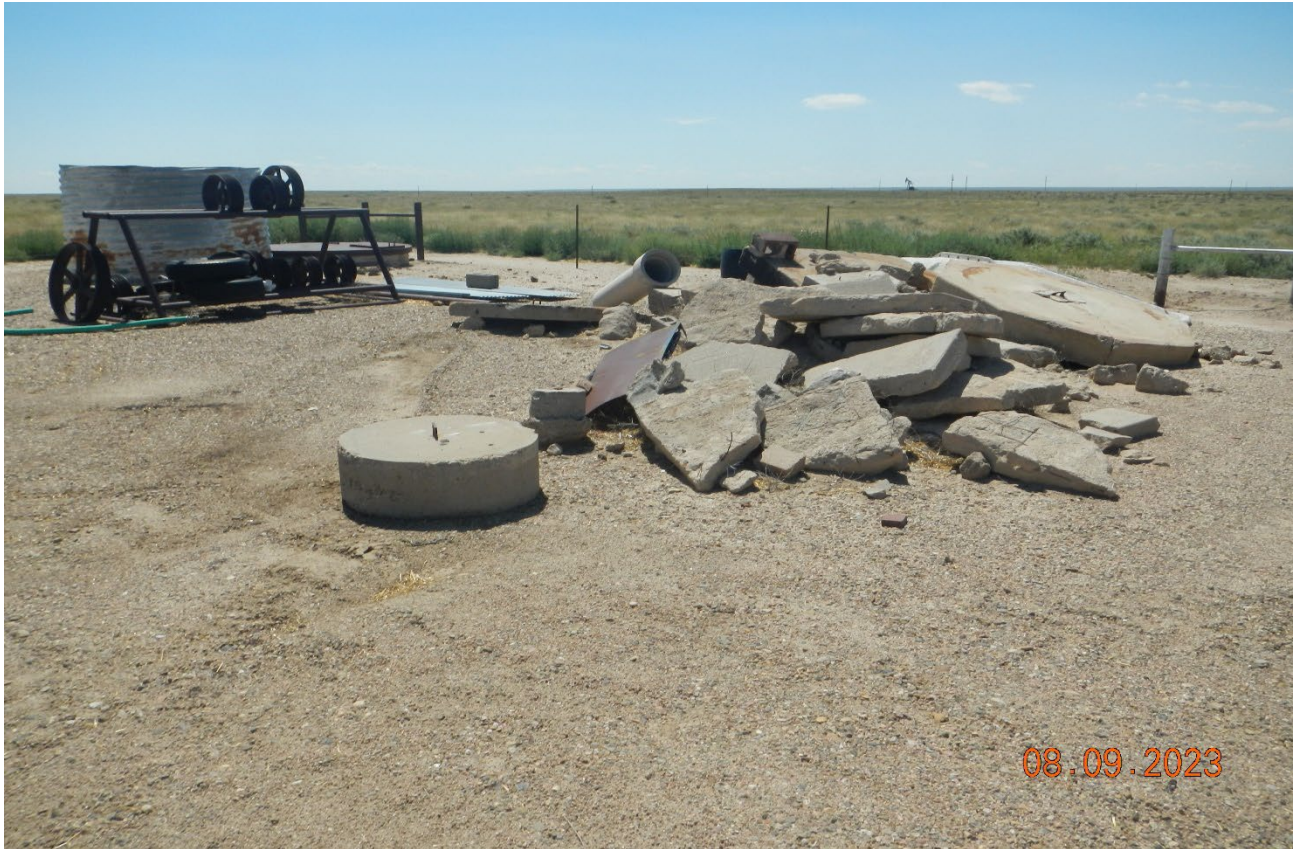
**Photo 10.** Facing toward the southwest side of the location. There is concrete debris and equipment that must be removed per Rule 606 & 1003.a.

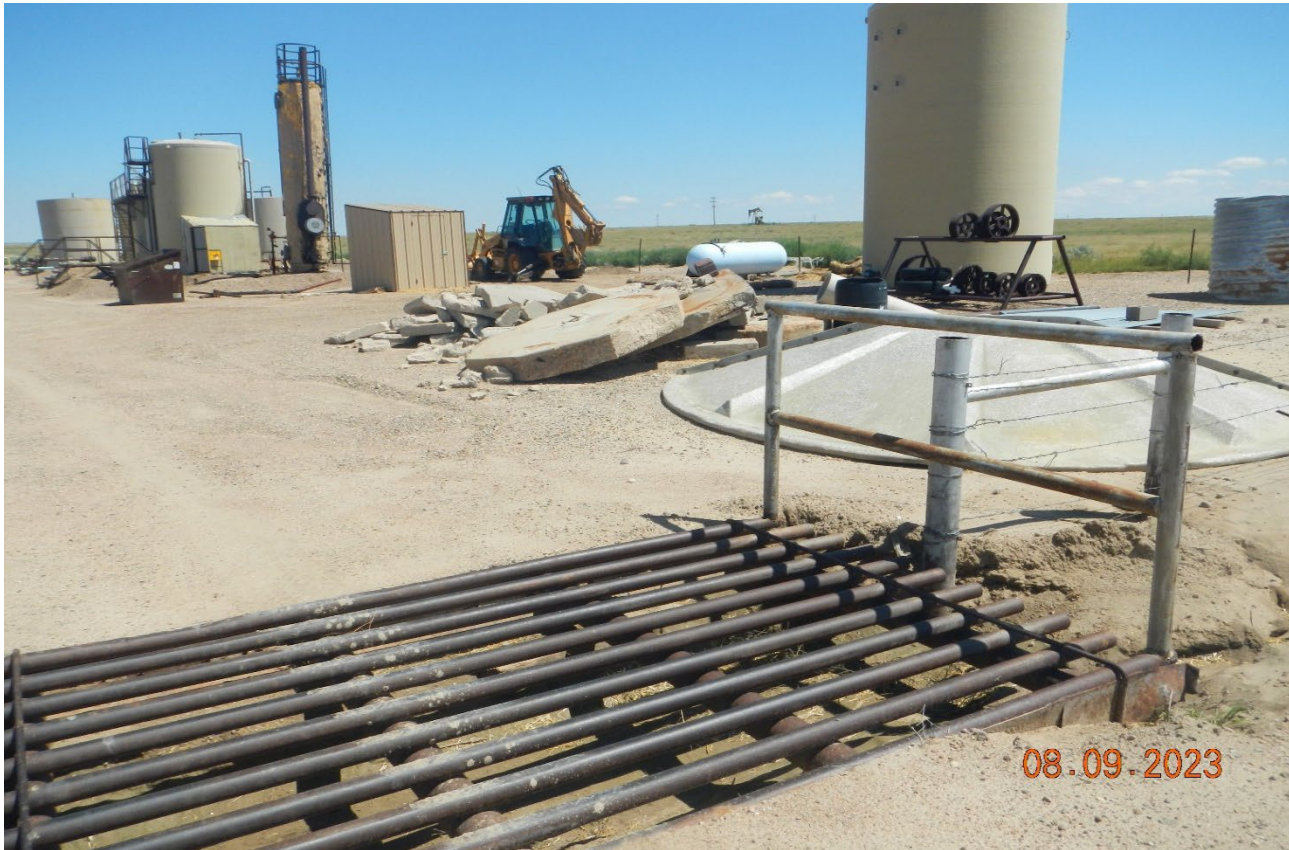
**Photo 11.** Facing southeast toward the PYLES offsite tank battery and storage yard. There is concrete debris and a broken bottom of a tank among other debris and equipment that must be removed per Rule 606 & 1003.a.

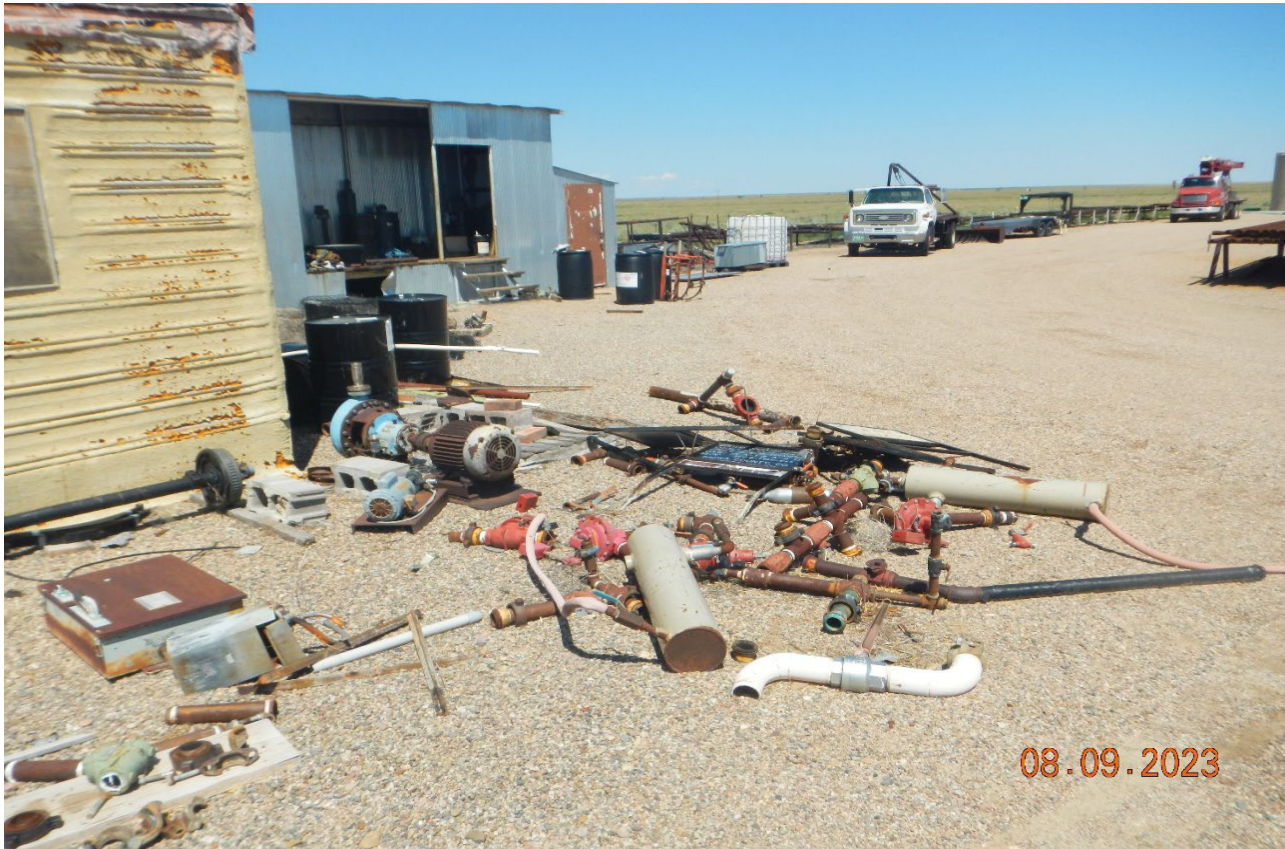
**Photo 13.** There is various parts and supplies being stored on location. All equipment and supplies not necessary for use on this Oil and Gas Location is prohibited per Rule 606 and 1003.a.

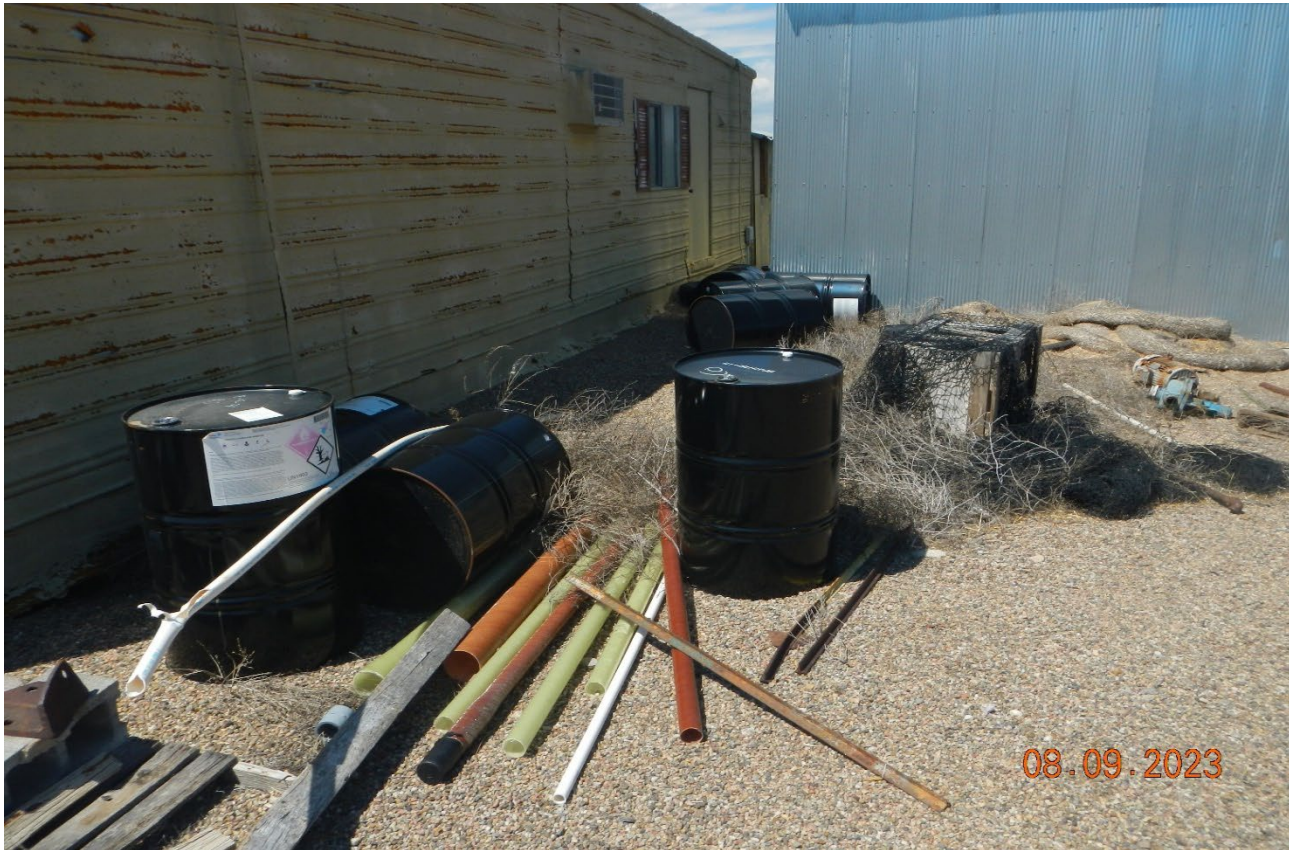
**Photo 14.** There are several chemical barrels on location with faded labeling and no secondary containment. Various pipe, supplies, and debris stored on location.

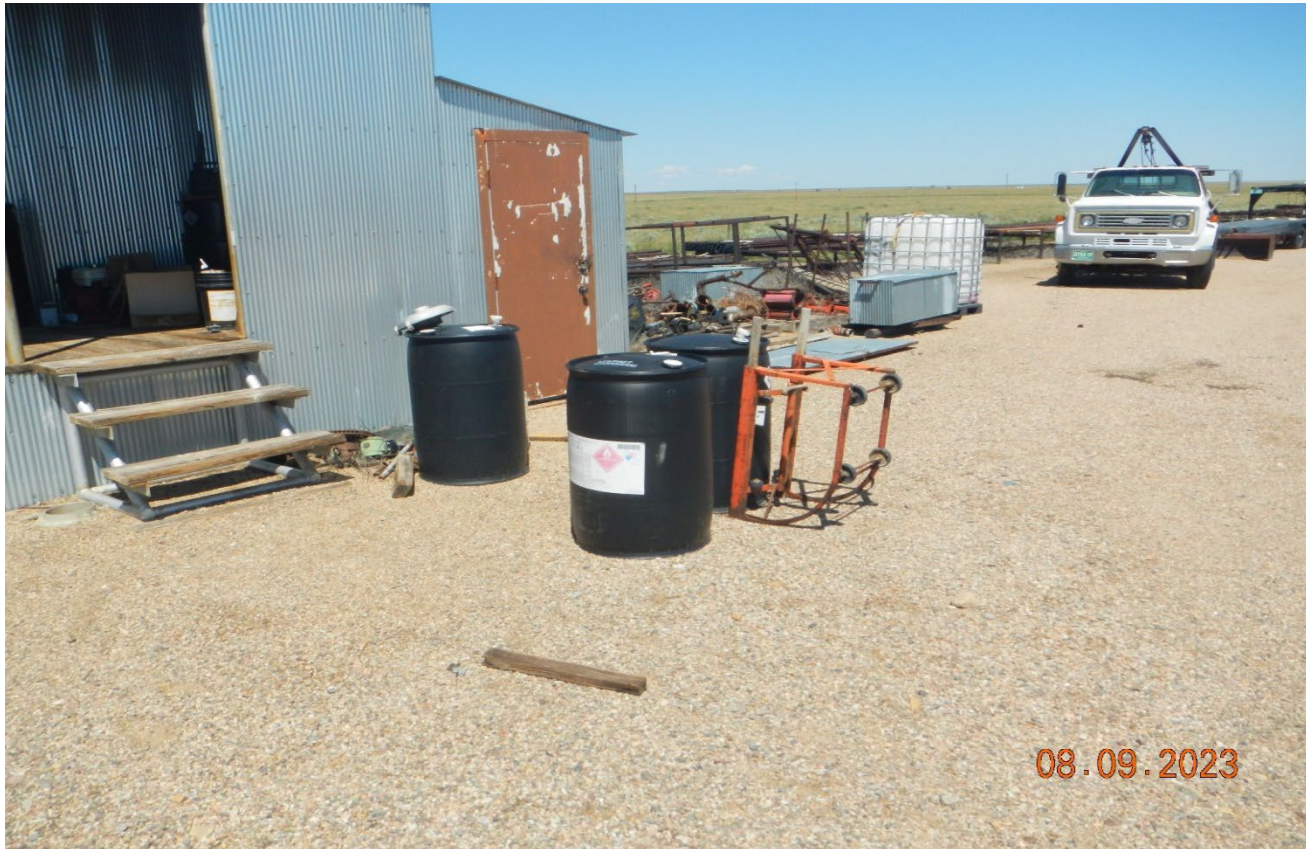
**Photo 15.** There are several chemical barrels on location with faded labeling and no secondary containment. Various pipe, supplies and debris stored on location.

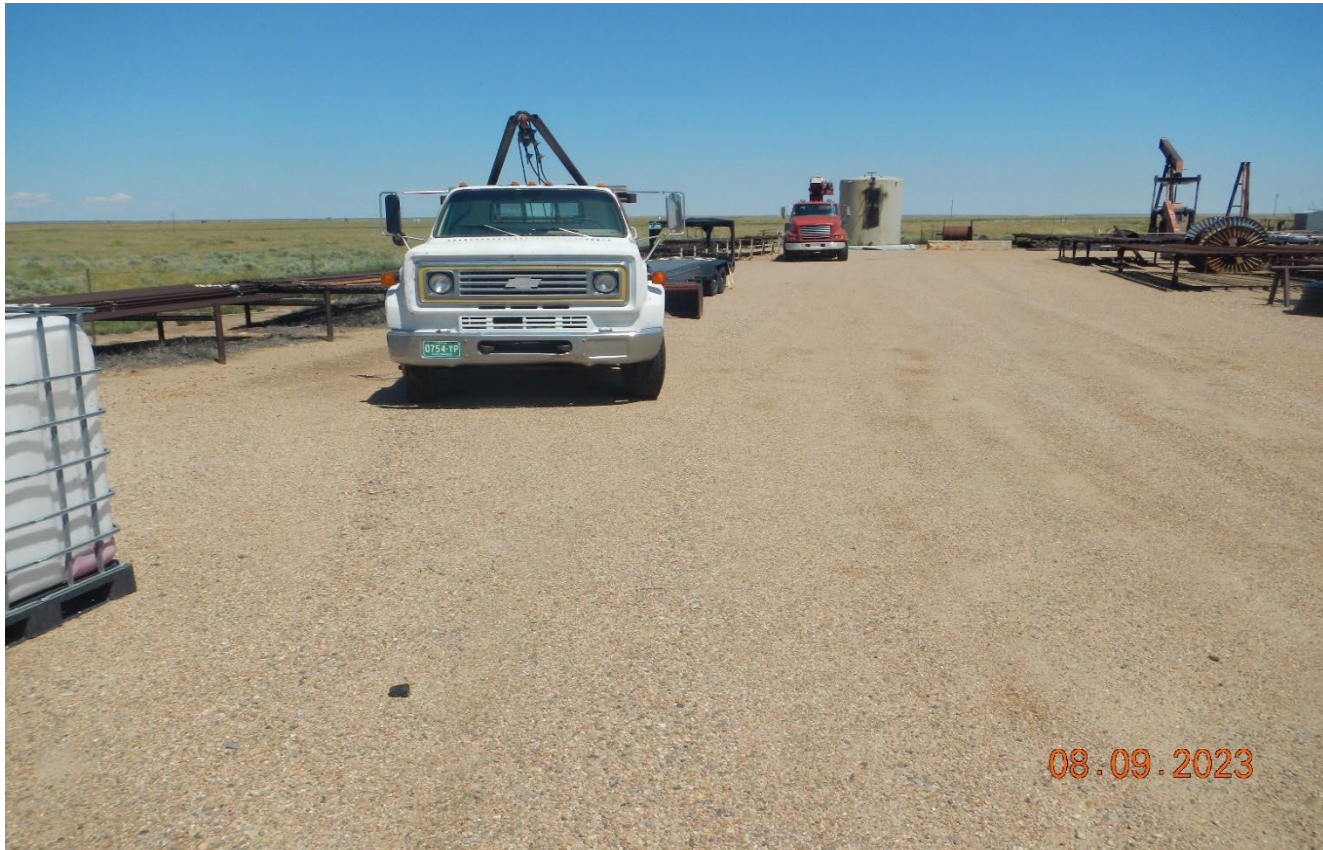
**Photo 16.** Facing east at the north side of the location. There is storage of unused drilling pipe, trailers, ect. All equipment and supplies not necessary for use on this Oil and Gas Location is prohibited per Rule 606 and 1003.a.

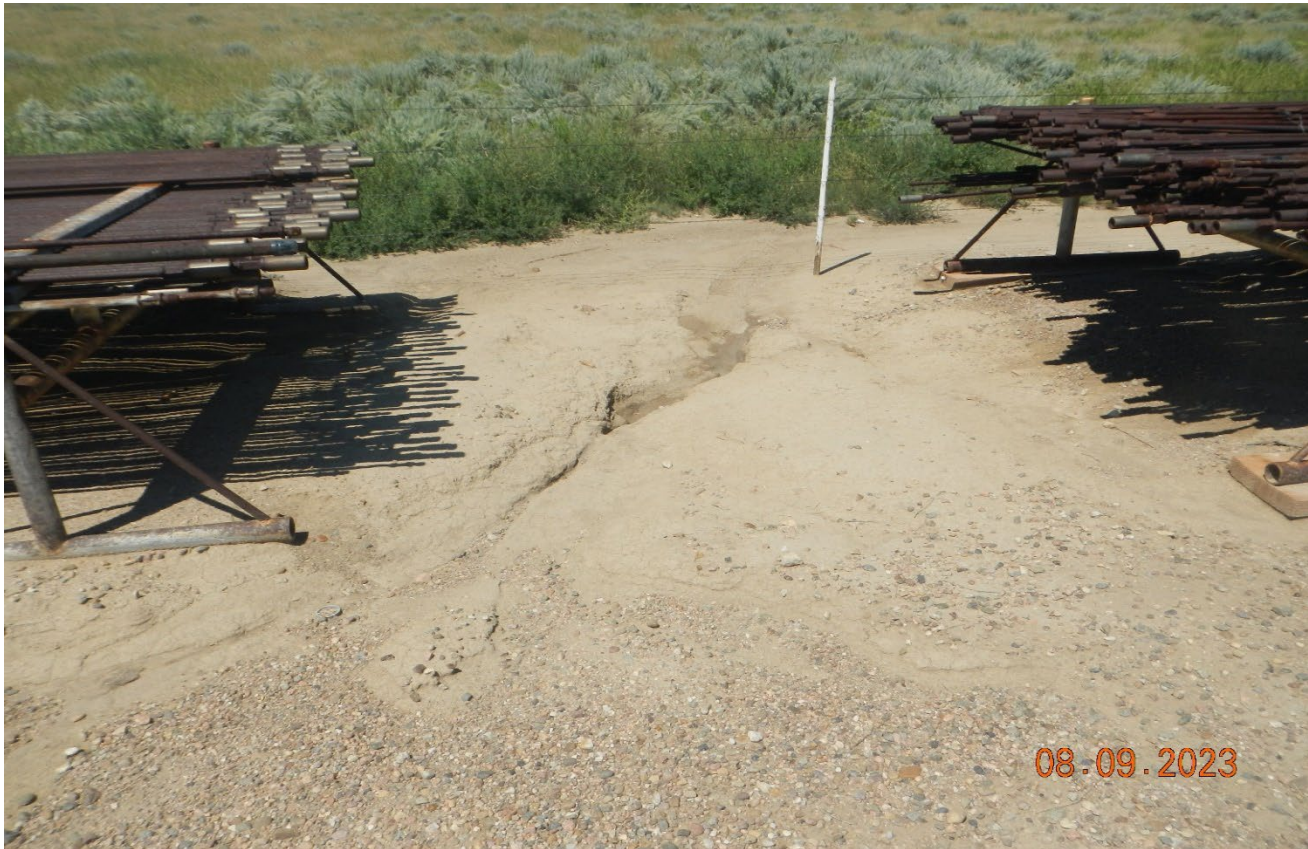
**Photo 17.** Facing toward the north central side of the location. There is an erosion channel beginning to develop in this area which is transporting sediment offsite.

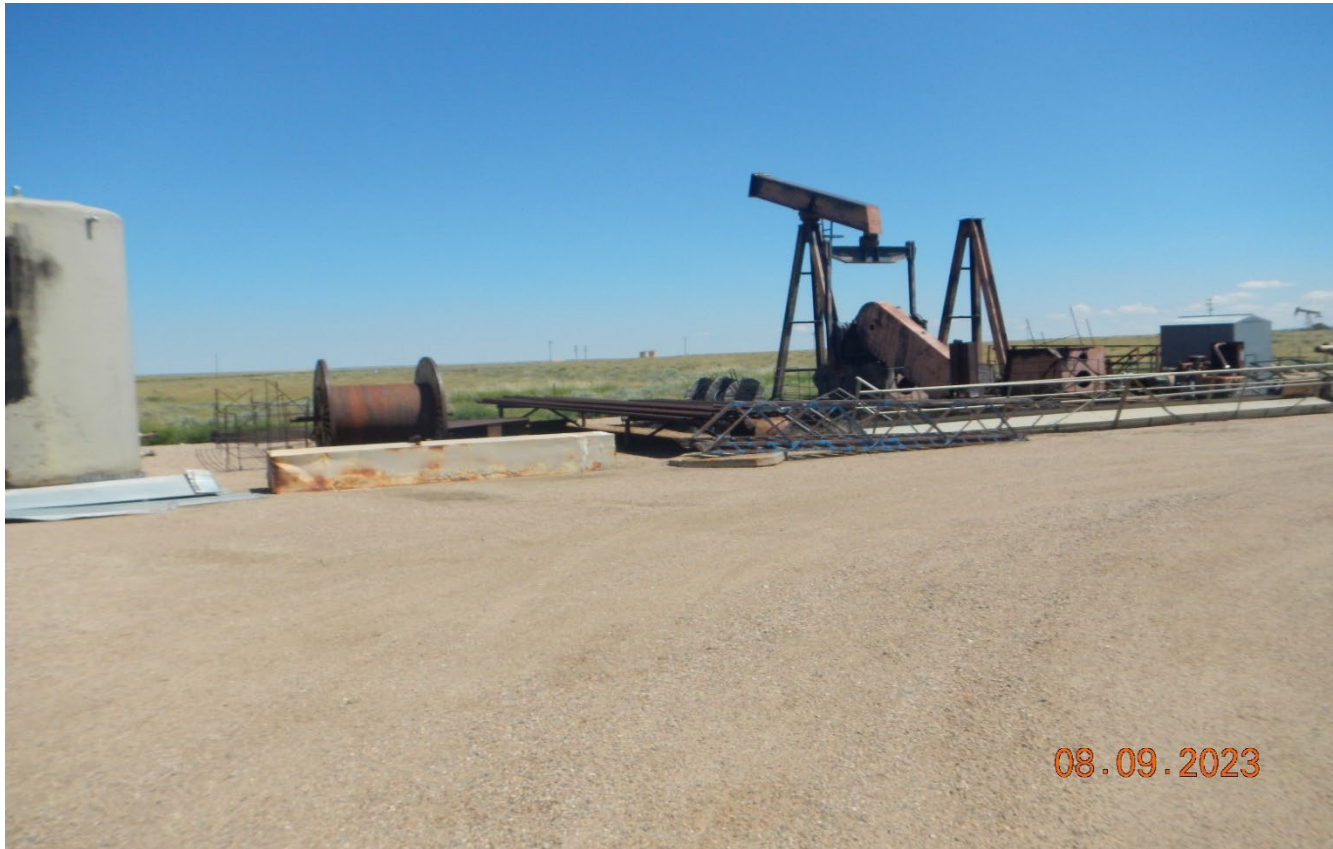
**Photo 18.** Facing southwest at the location PYLES offsite tank battery and storage yard. The use of this location as a storage yard is prohibited per the rules.

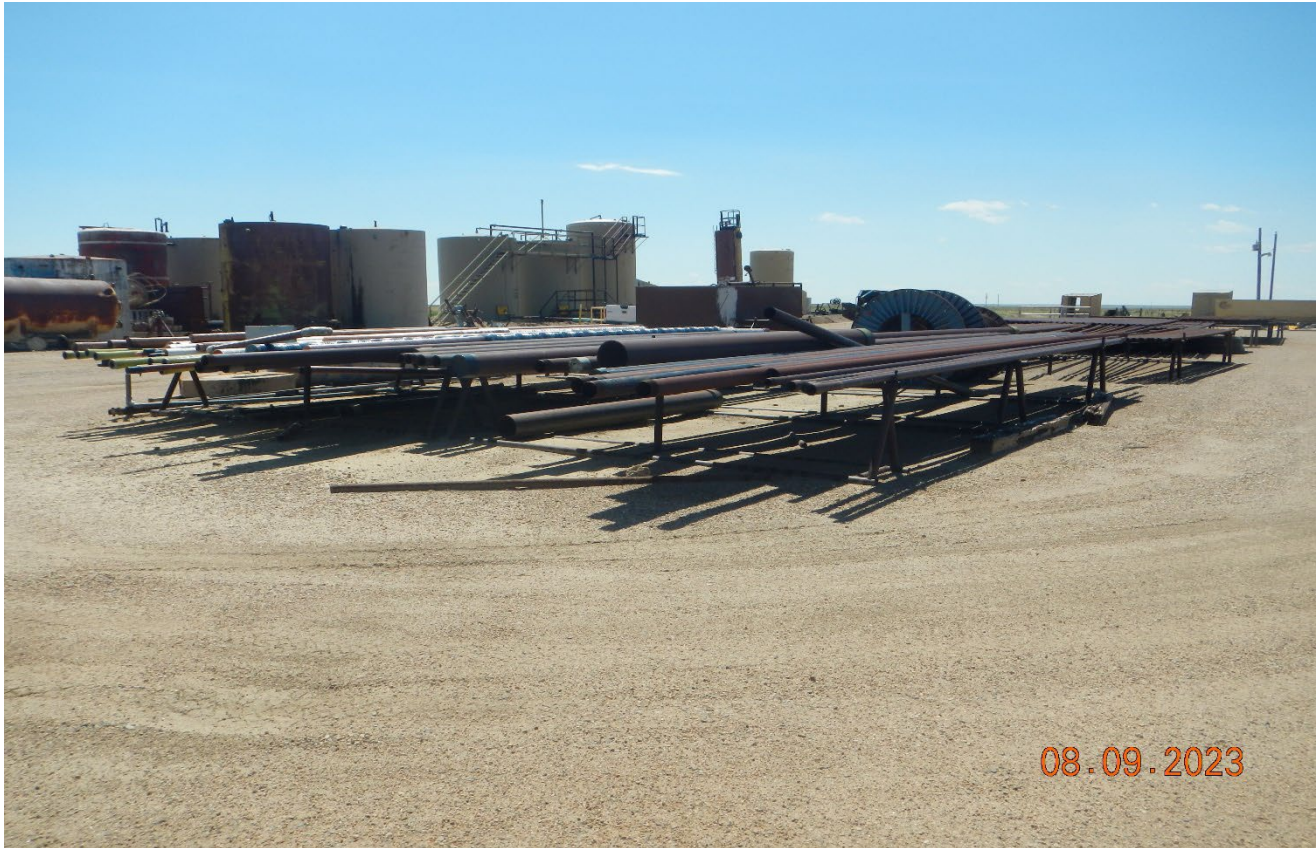
**Photo 19.** Facing southwest at the location PYLES offsite tank battery and storage yard. The use of this location as a storage yard is prohibited per the rules.

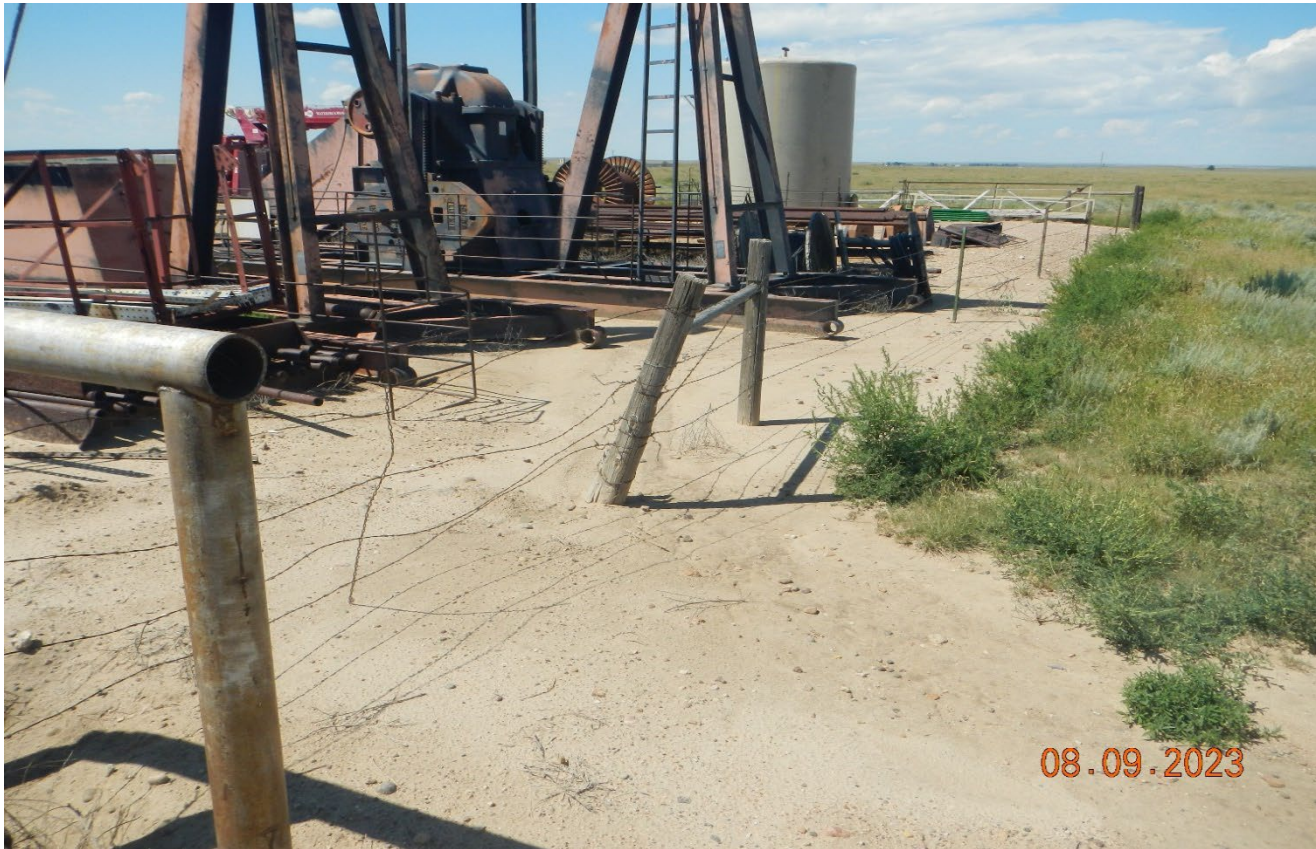
**Photo 20.** East side of the location at the cattleguard. The fence in this area has a large gap and may not prevent livestock entry. This area needs to be repaired.
