Final Reclamation Inspection

Operator: PDC ENERGY INC - 69175

Location ID: 323104

Inspection Photos
Location Name: FHA 10-1
Location ID: 323104

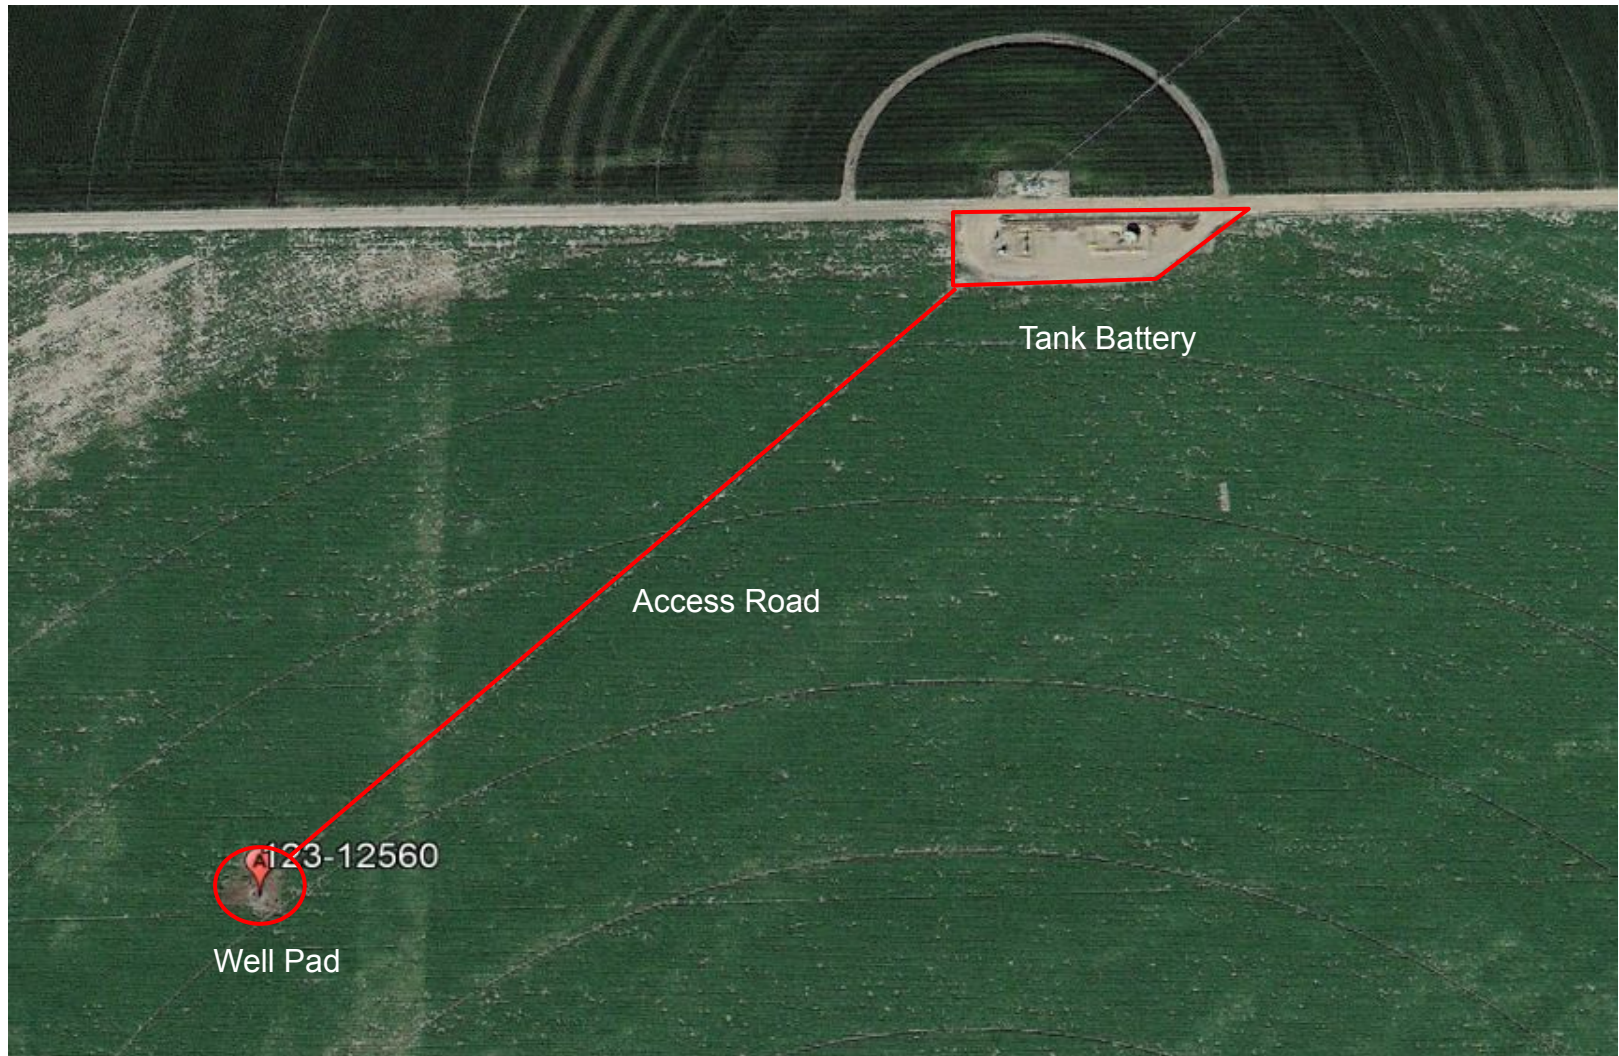
Photo 1. 2013 aerial imagery of the well pad, access road and tank battery (north is up).

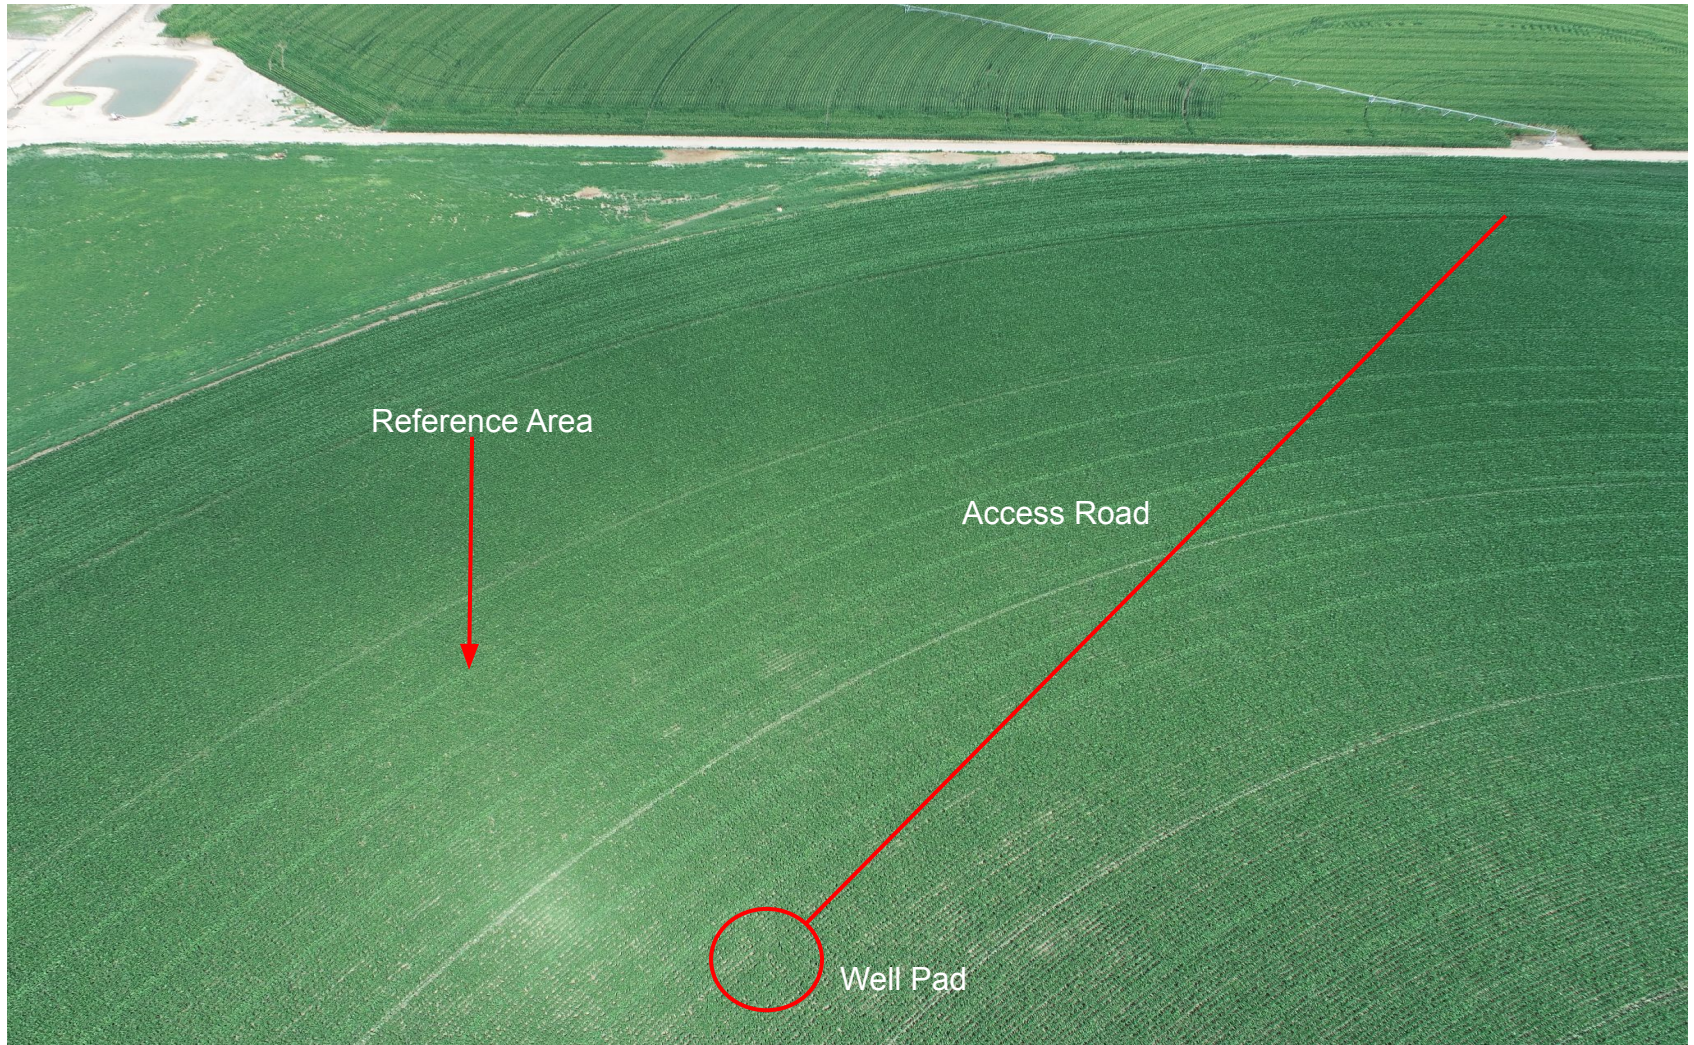
Photo 2. Overview photo of the well pad and access road taken with a drone from the southern edge facing north. Photo shows that the access road and well pad appear consistent with adjacent crop reference area.

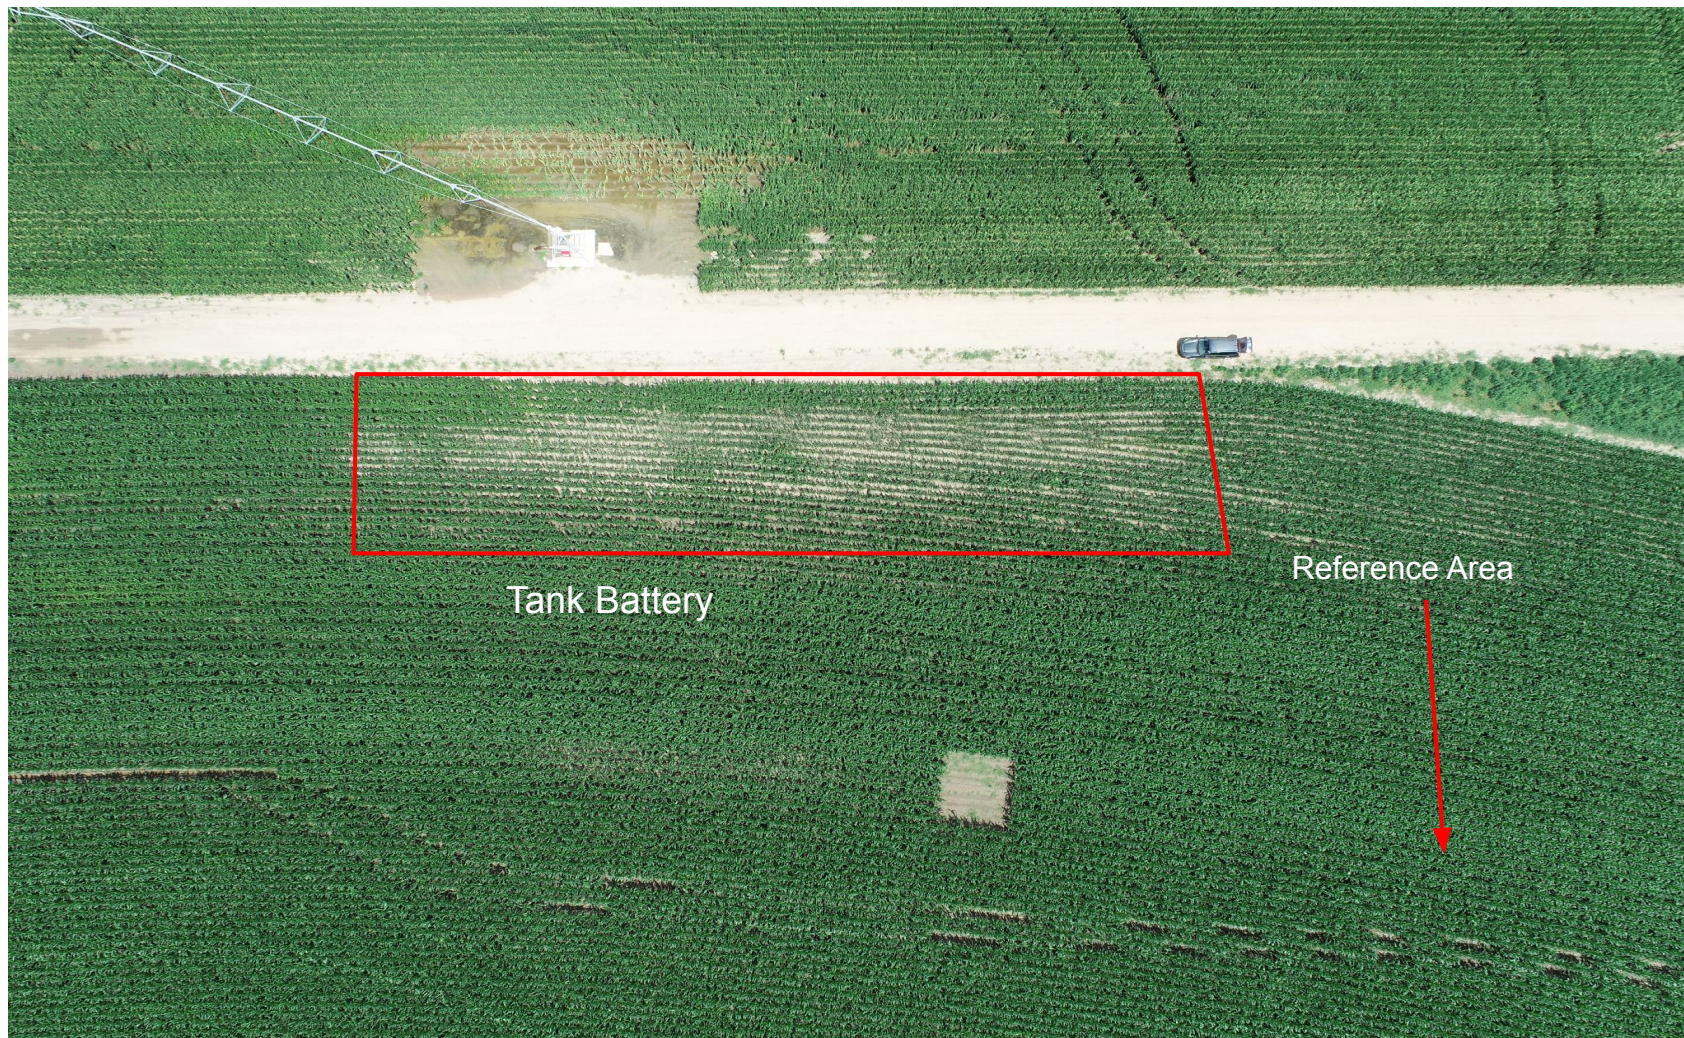
Photo 3. Overview photo of the tank battery taken with a drone from the southern edge facing north. Photo shows that the tank battery has stunted crop growth and does not appear consistent with adjacent crop reference area.

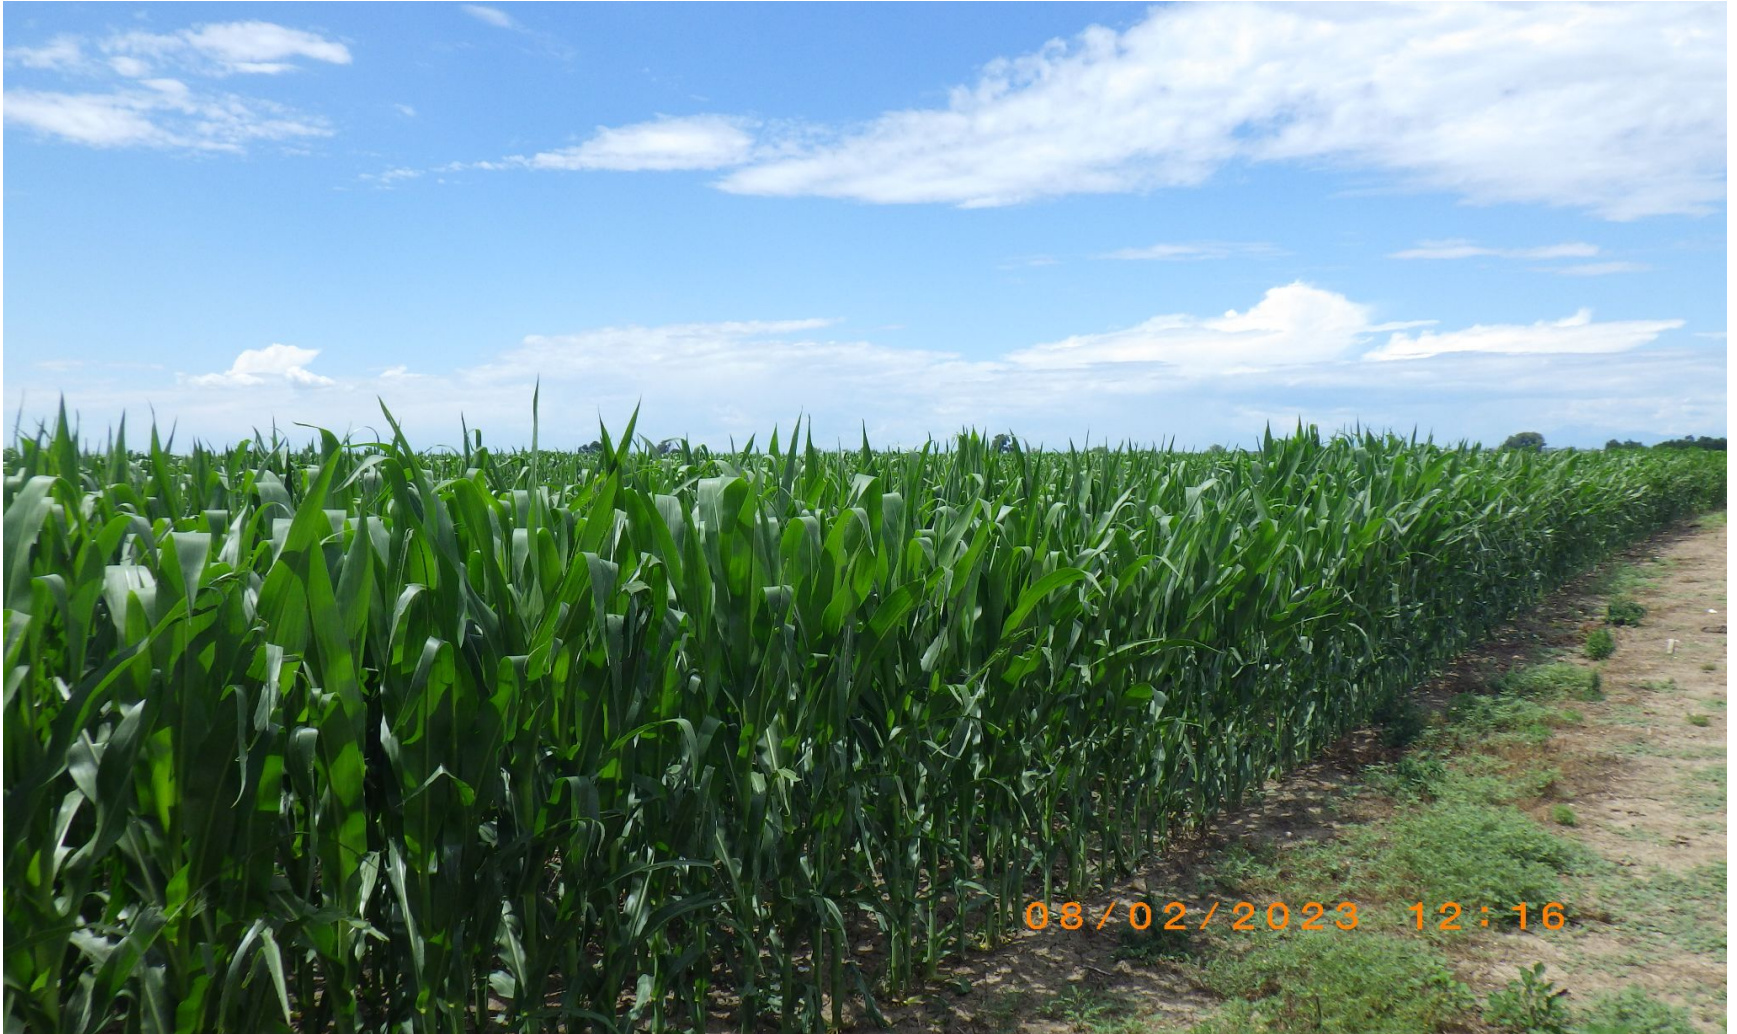
Photo 4. Ground photo of the well pad and tank battery crop field taken from the northern edge of the tank battery facing southwest.
