Inspection Photos

8/14/2023

Operator: GENESIS GAS & OIL COLORADO LLC
- 10384

Location Number: 414168
Rio Blanco County, CO

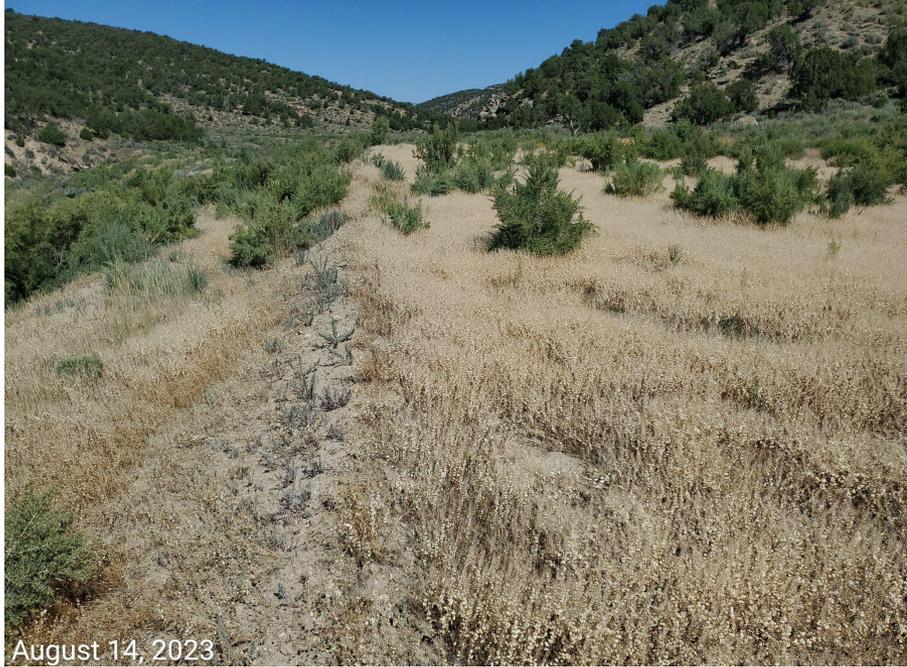
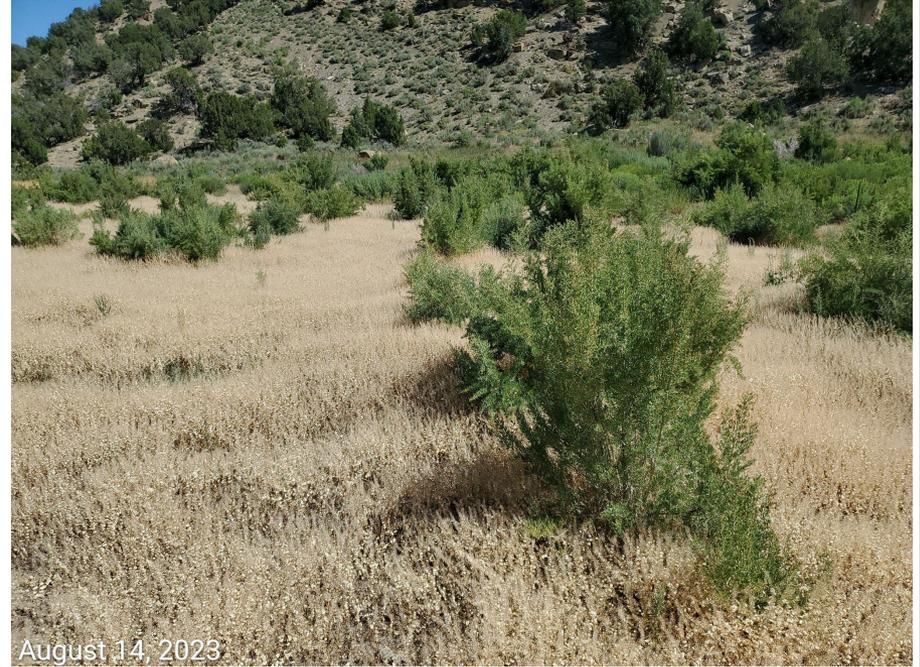
Photo 1: Location has not been decompacted, recontoured, regraded and reclaimed in accordance with 1004 Rules.

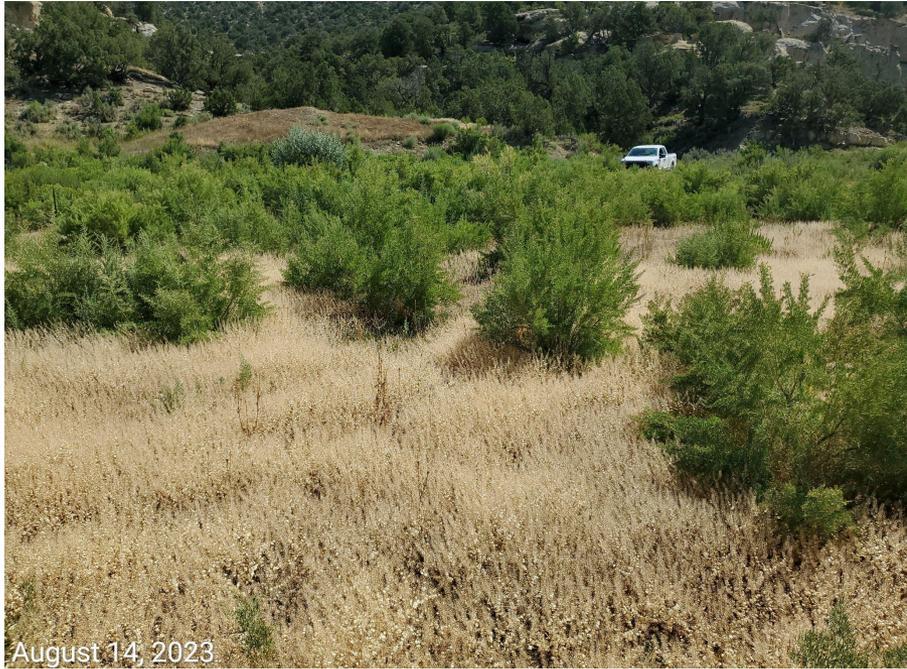
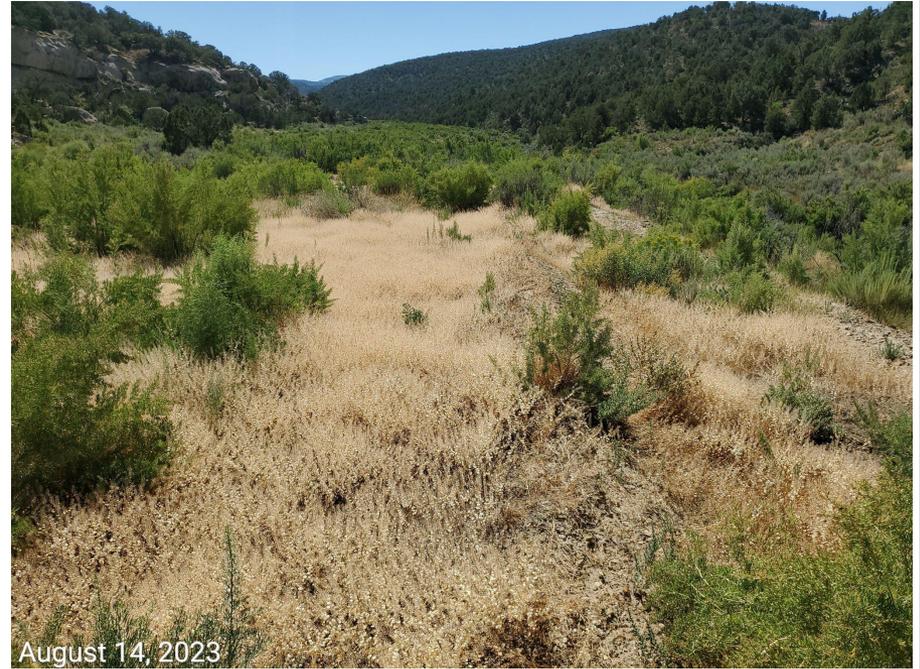
Photo 2: Location has not been decompacted, recontoured, regraded and reclaimed in accordance with 1004 Rules.

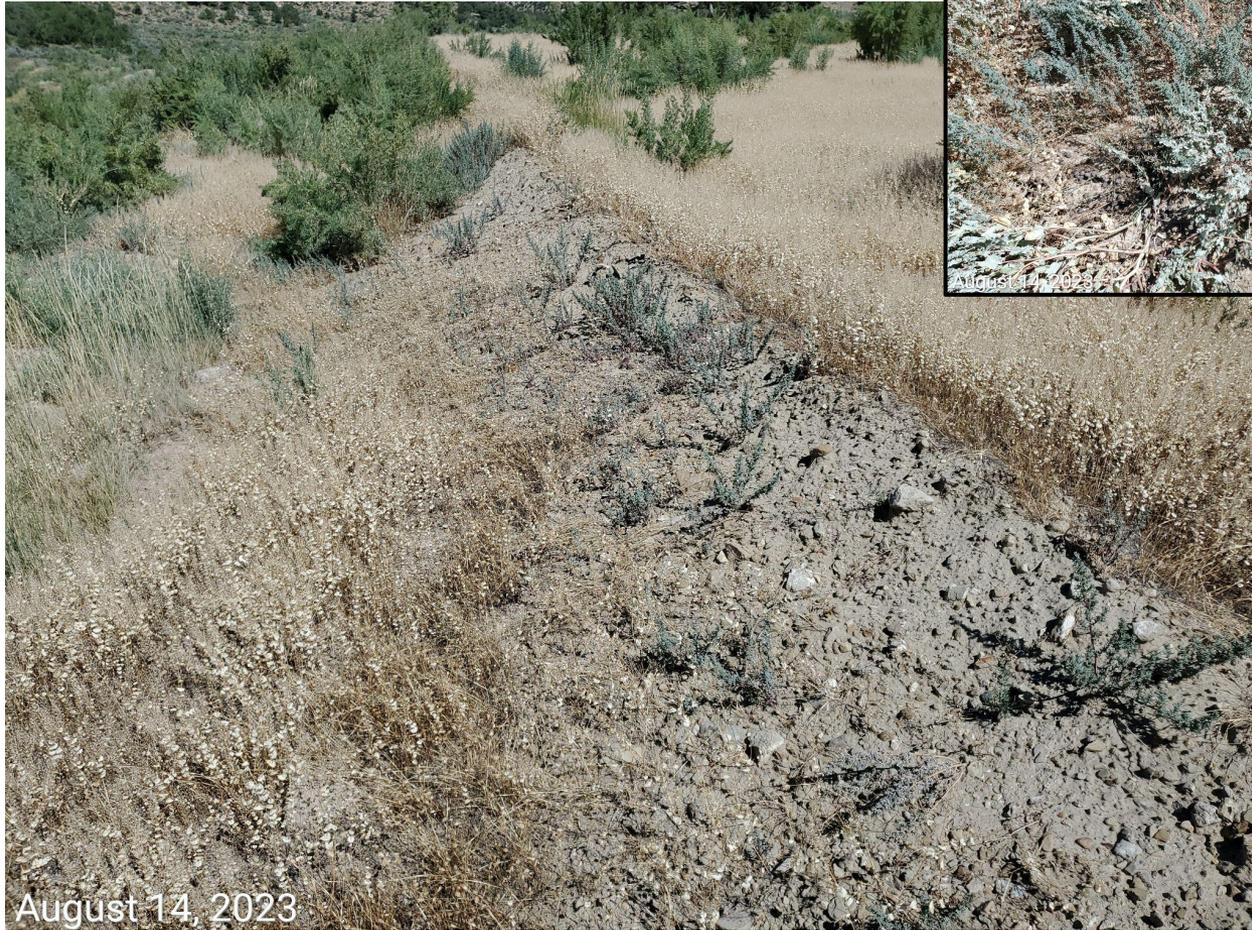
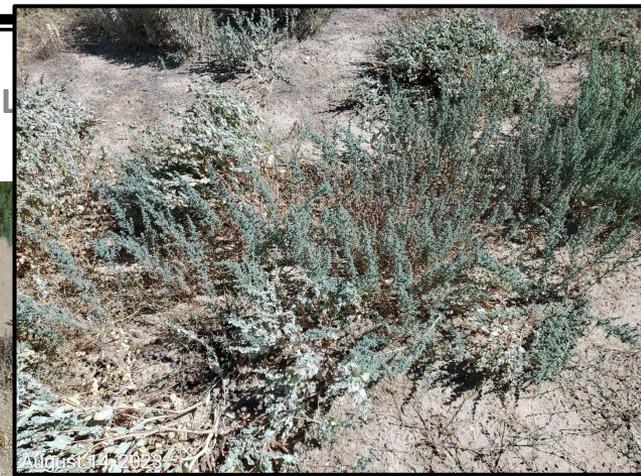
Photo 3: Fill slopes of the Location- Location has not been recontoured, regraded and reclaimed in accordance with 1004 Rules. Halogeton established on Location.

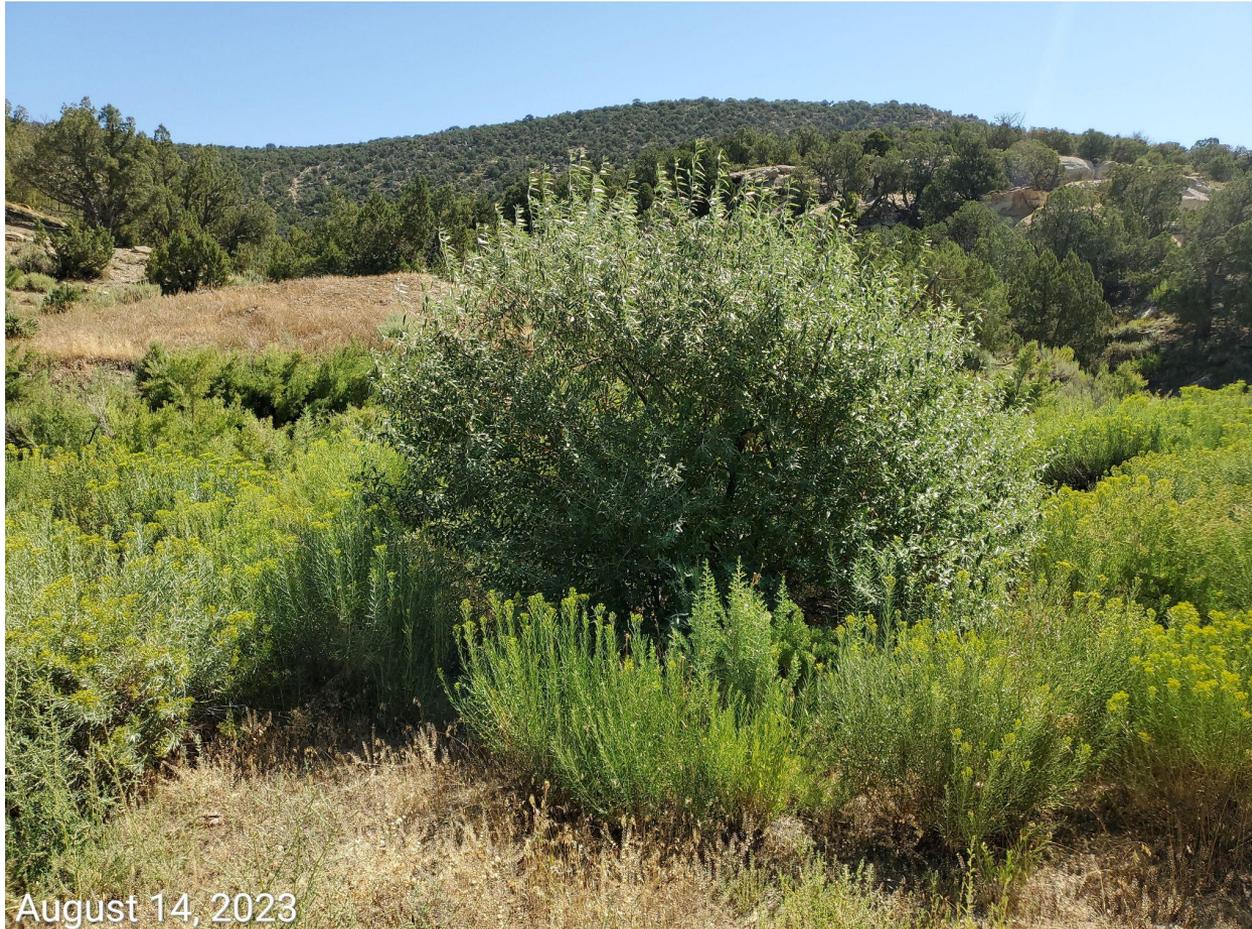
Photo 4: Russian Olive remains established on the Location

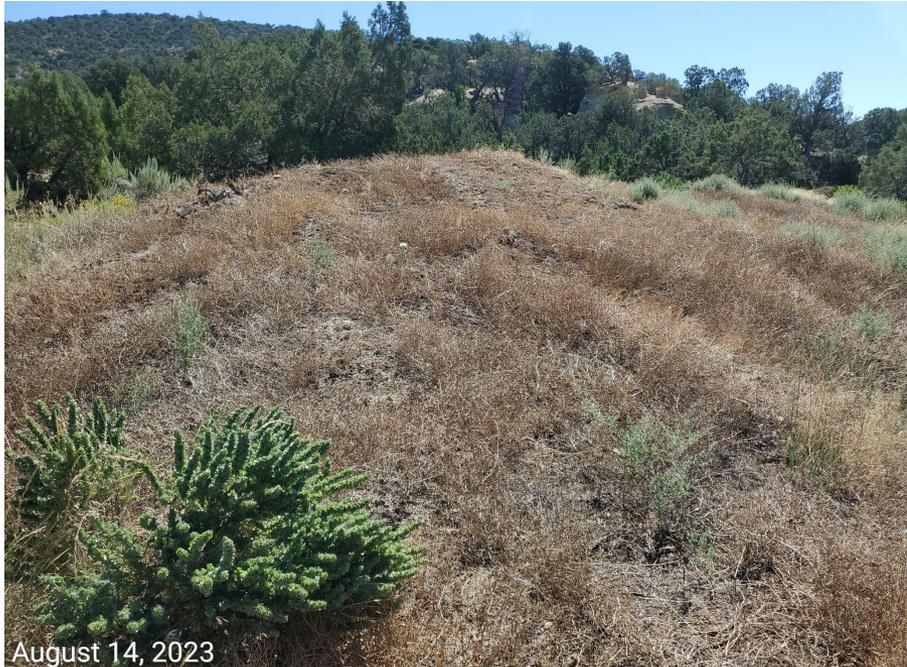
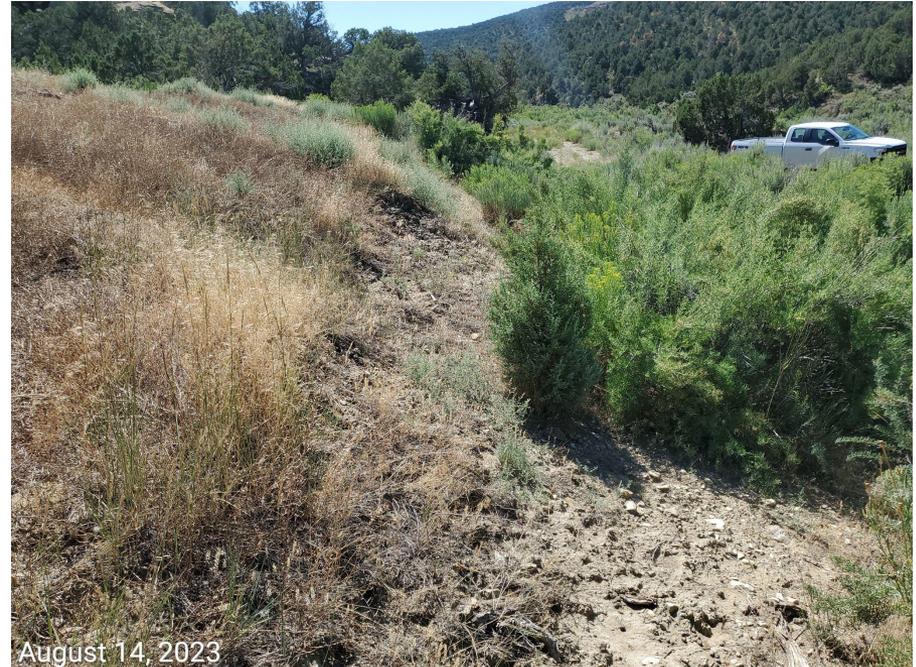
Photo 5: Photos weeds have matured and dispersed seeds on the topsoil stockpile. Photo also shows cut slope; Location has not been decompacted, recontoured, regraded and reclaimed in accordance with 1004 Rules. Stormwater and erosion control measures remain missing or insufficient on Location and access road.

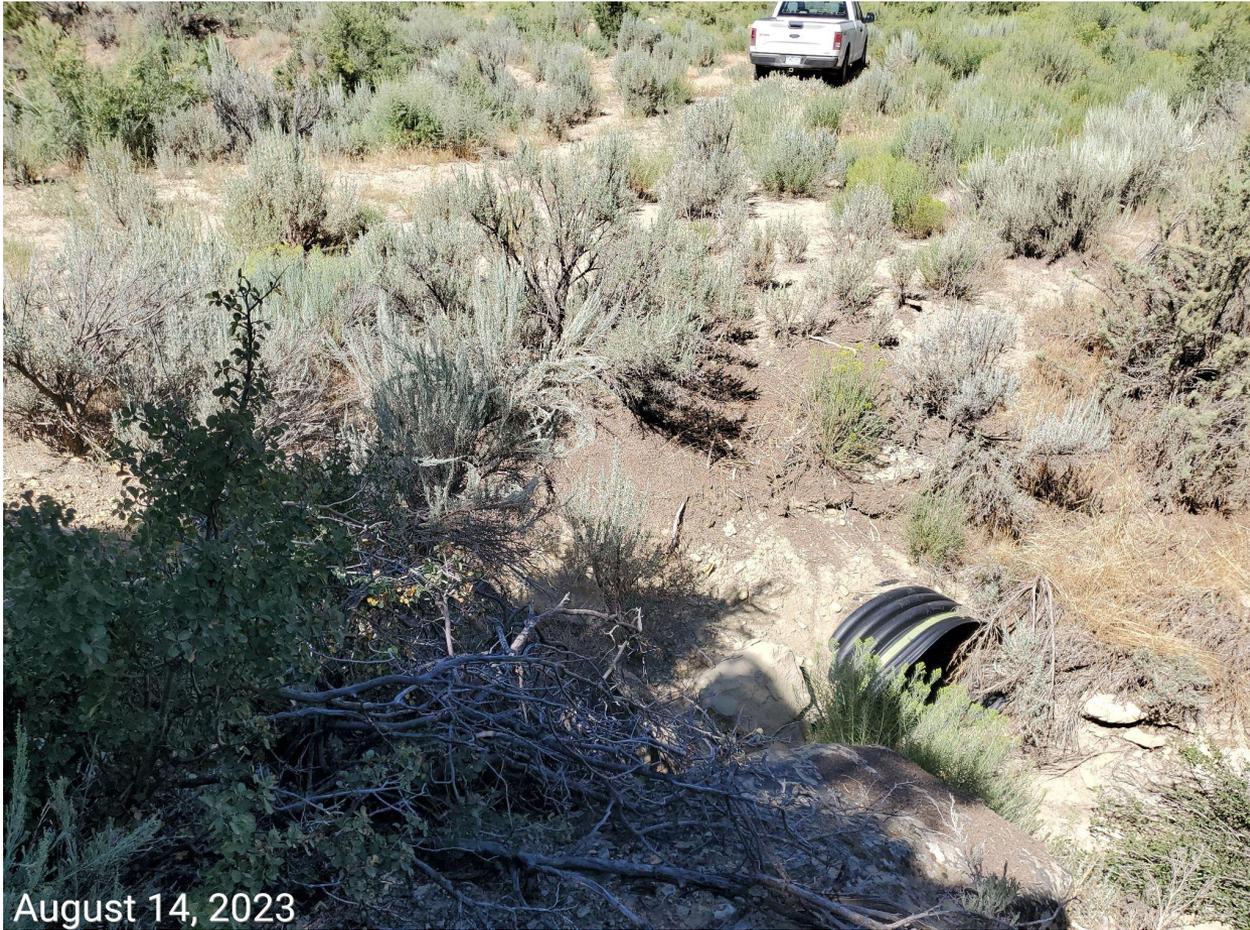
Photo 6: Example of culvert remaining at access road. Access road has not been decompacted, recontoured, regraded and reclaimed in accordance with 1004 Rules; drainages have not been restored.

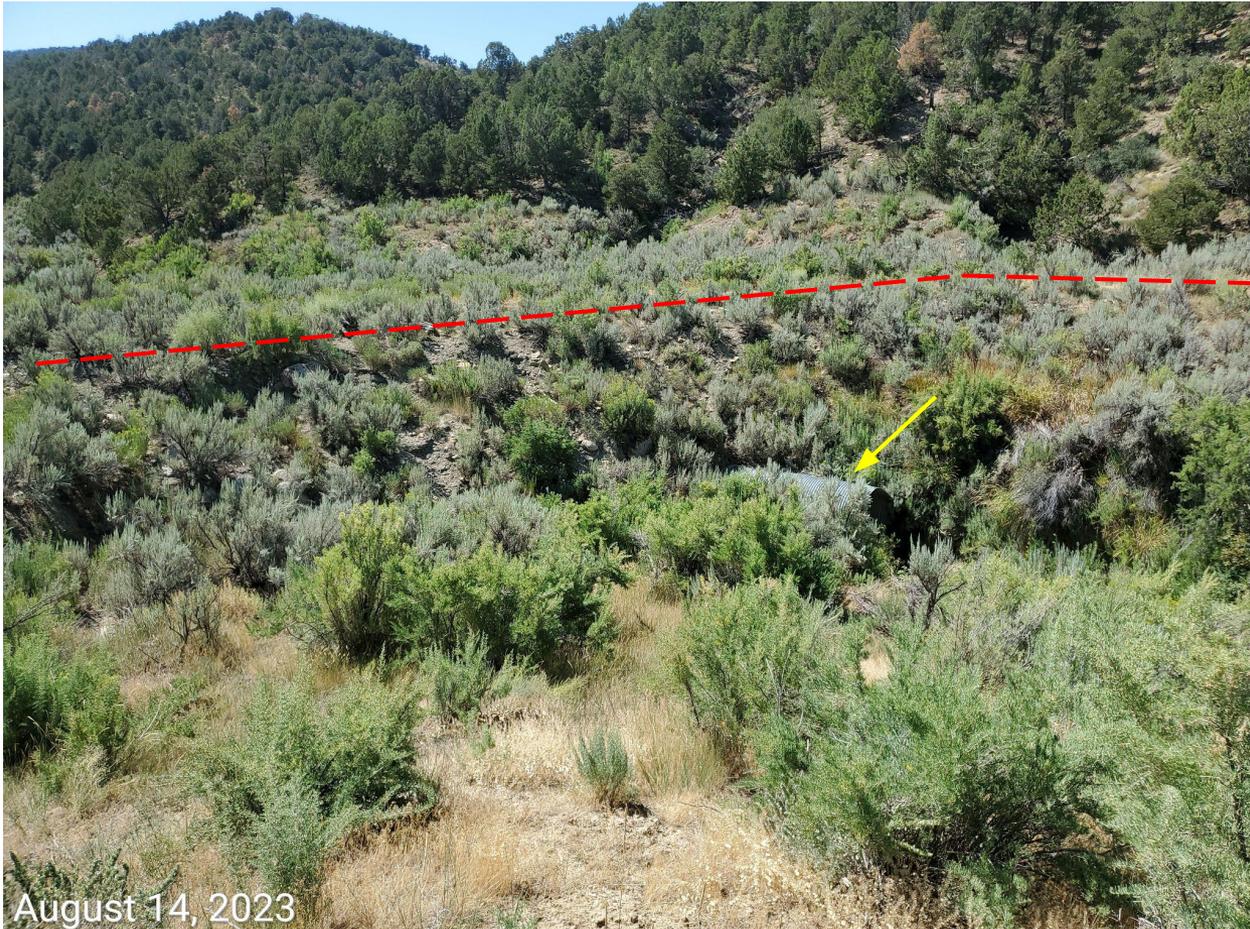
Photo 7: Example of culvert remaining at access road (arrow). Access road (red line) has not been decompacted, recontoured, regraded and reclaimed in accordance with 1004 Rules; drainage has not been restored

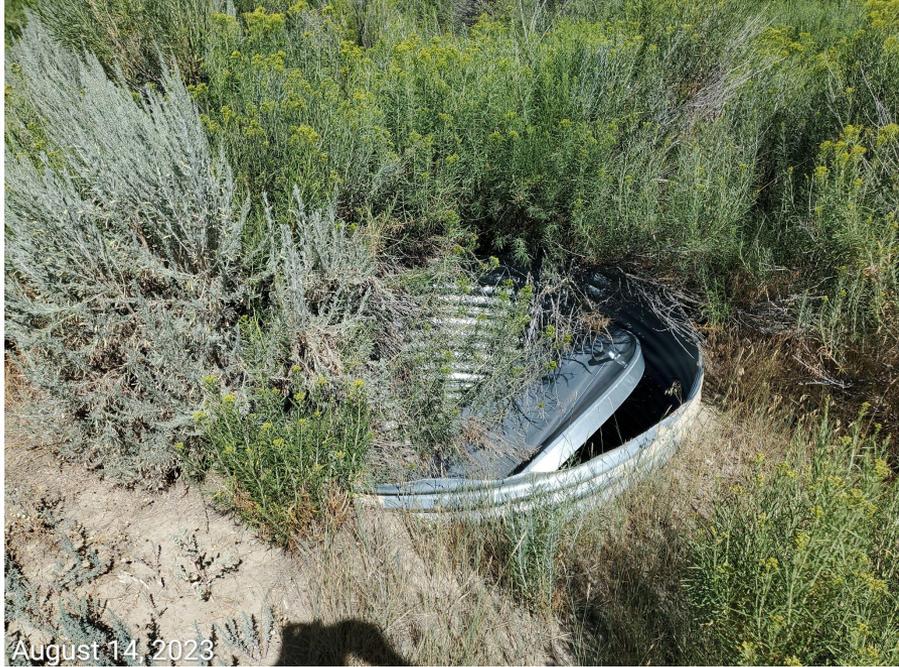
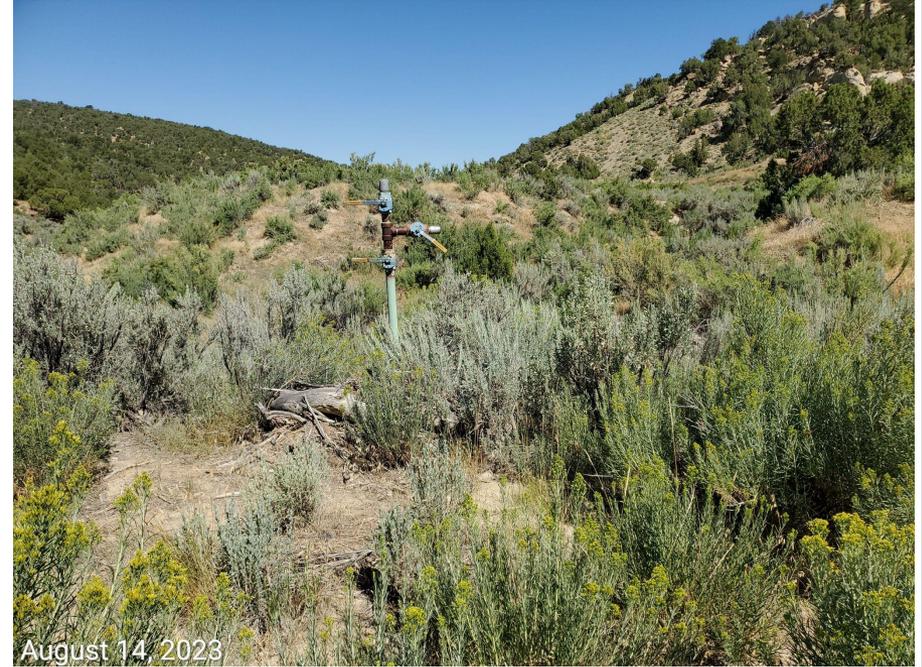
Photo 8: Equipment remaining on access road and Location- valve can cellar remains improperly covered.
