Final Reclamation and Stormwater Inspection

Operator: J W OPERATING COMPANY - 44350

Location ID: 410730

Inspection Photos
Location Name: R Korf 3-25
Location ID: 410730

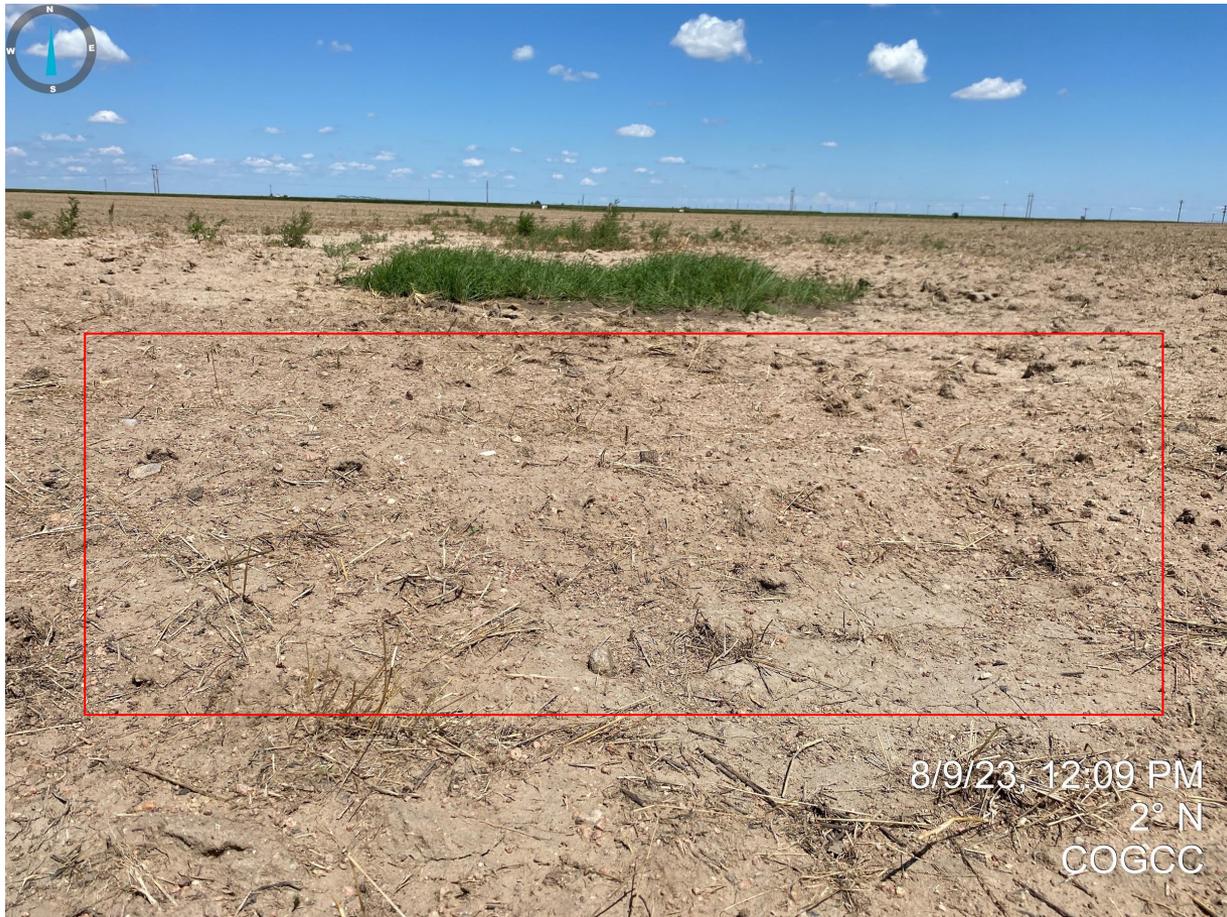
Photo 1. Facing towards the former well location. The presence of road base material was observed throughout the reclaimed portions. All road base material will need to be removed from the location in order to comply with Rule 1004.

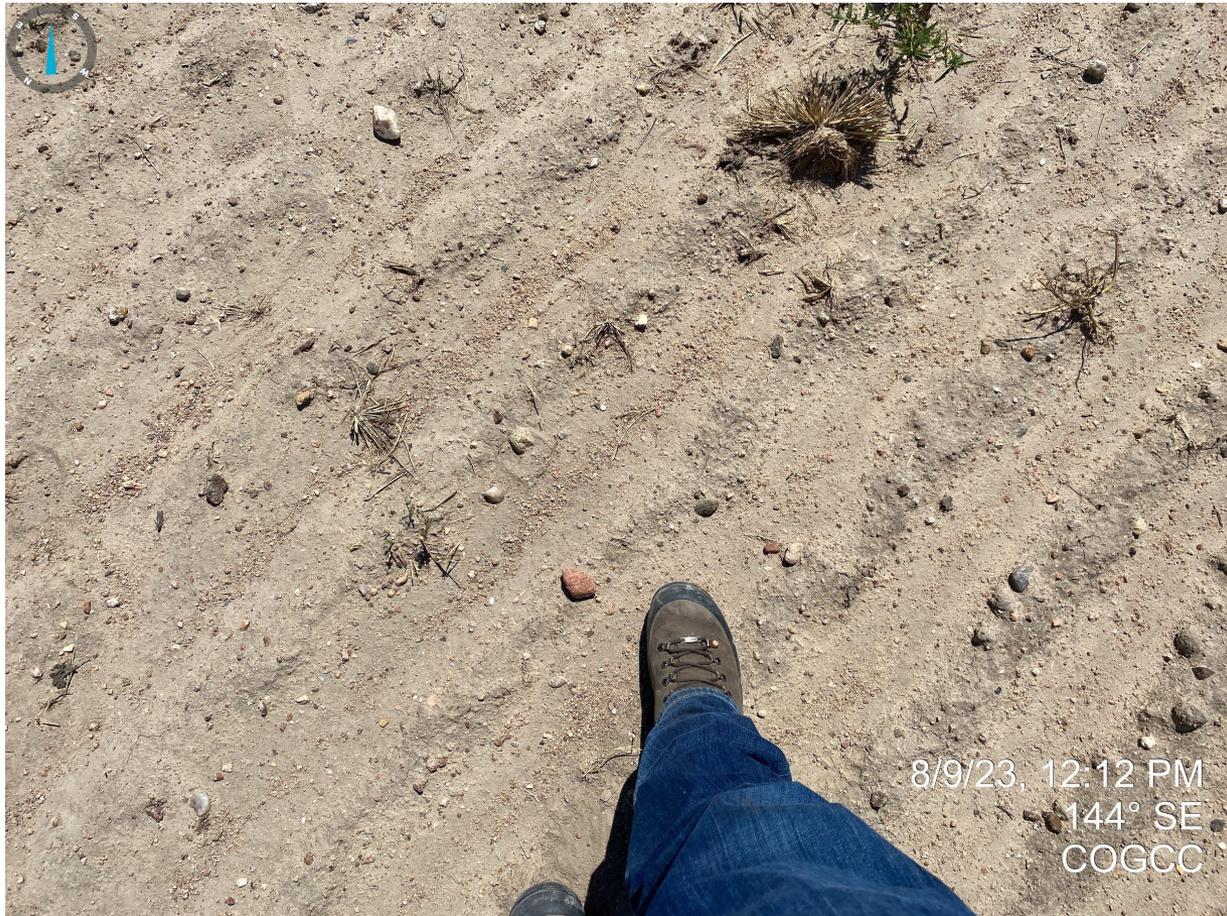
Photo 2. See comments in Photo 1.

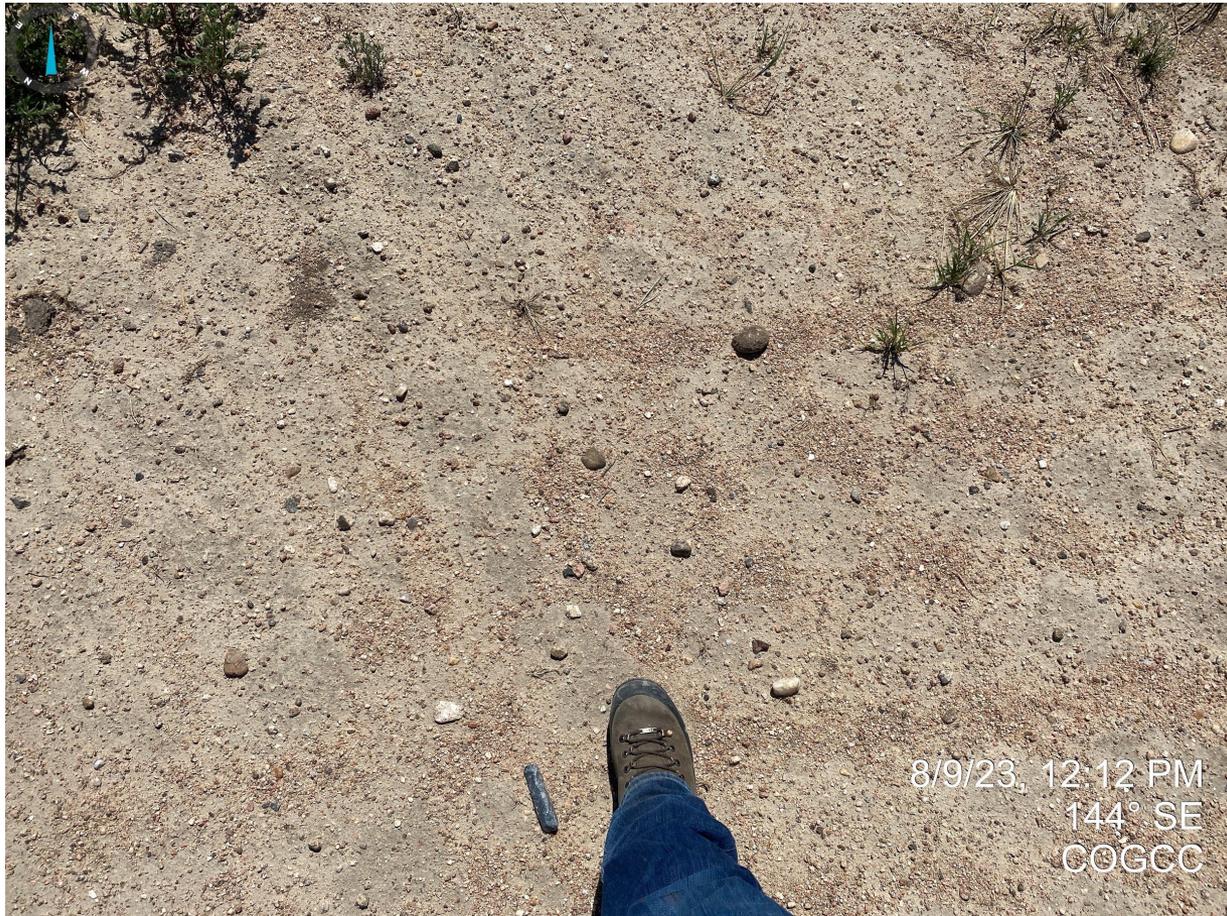
Photo 3. See comments in Photo 1.

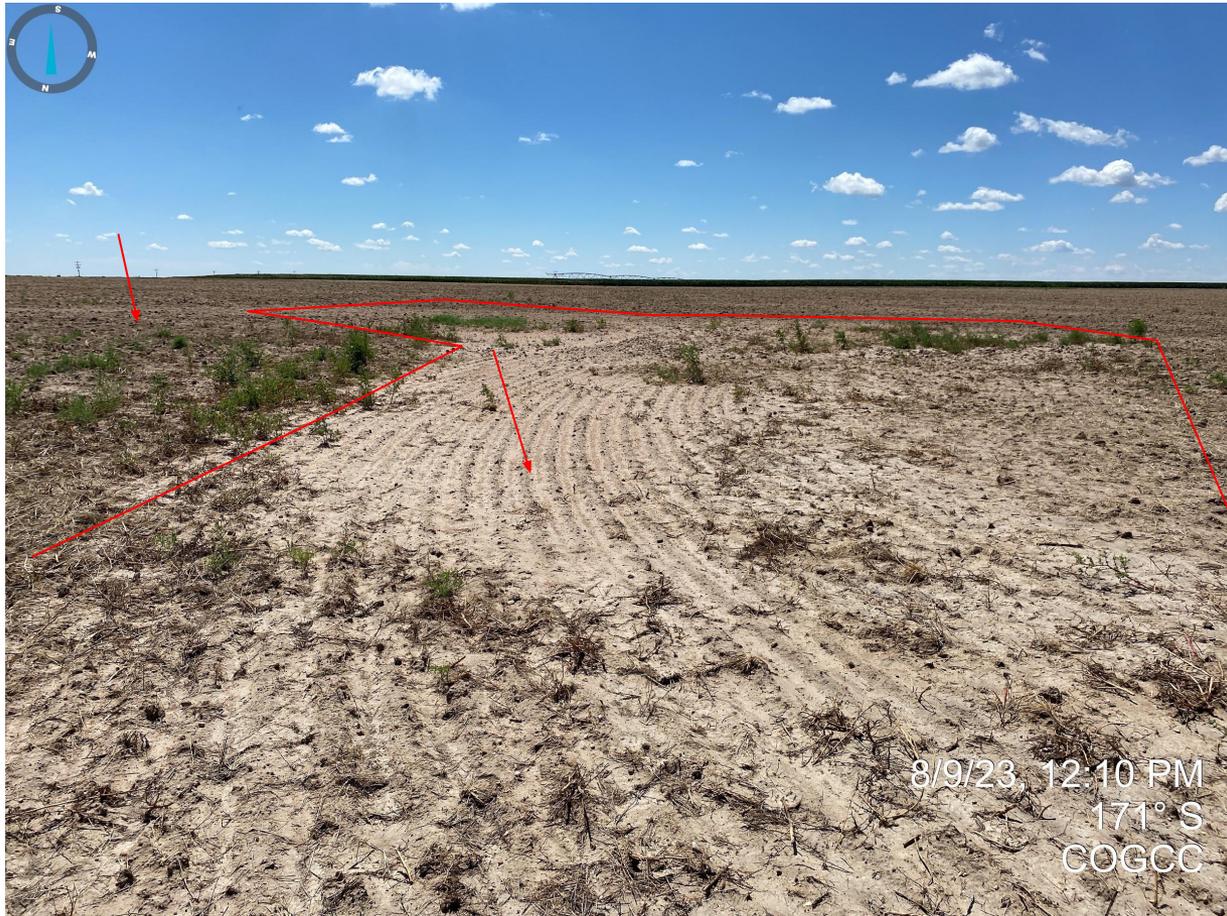
Photo 4. The highlighted portion of the location shows the contrast, or difference, in material (e.g. road base) to that of the adjacent farm ground.

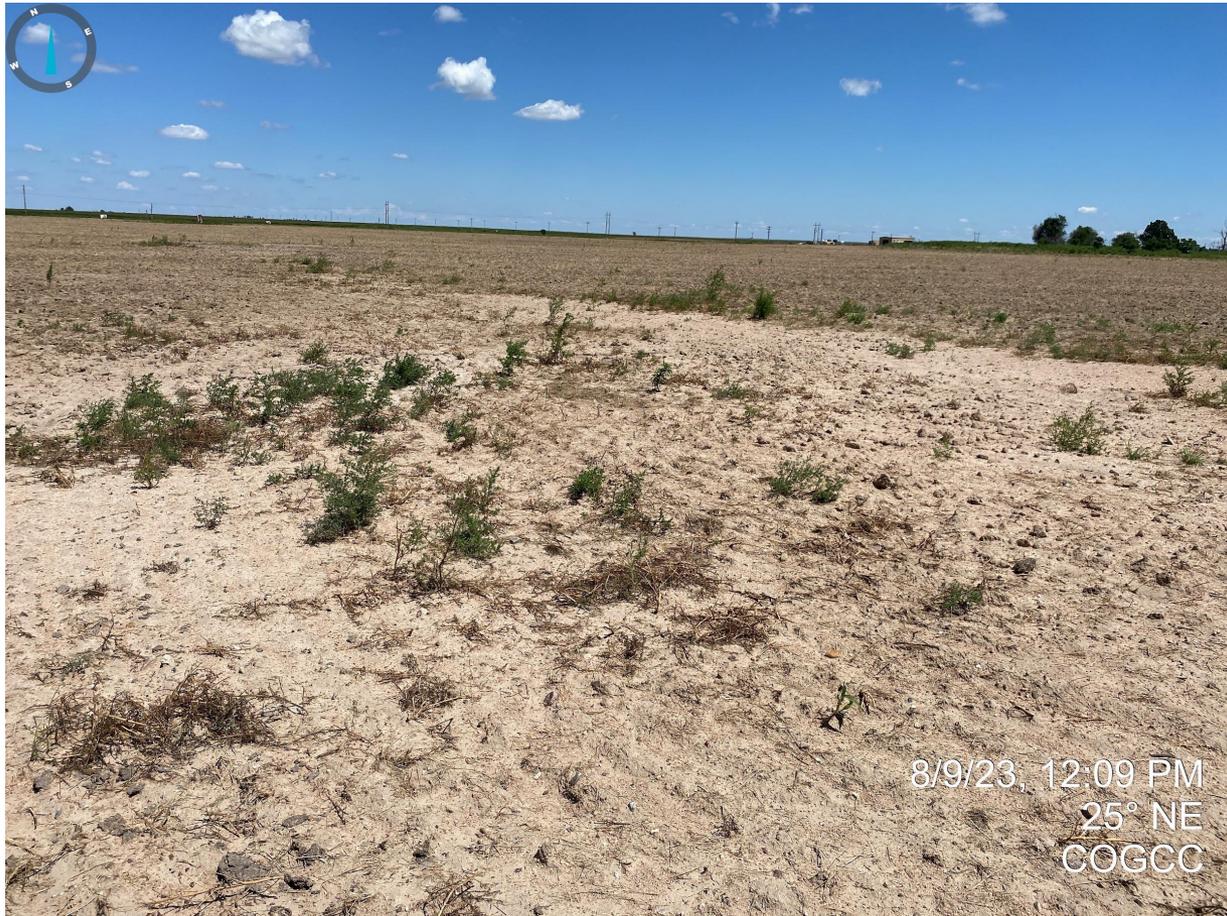
Photo 5. Undesirable vegetation observed to be growing within the reclaimed area. The location will need to be managed to prevent the spread and establishment of undesirable vegetation. Note: the location will need to be inspected at a future date as the field was currently fallow.

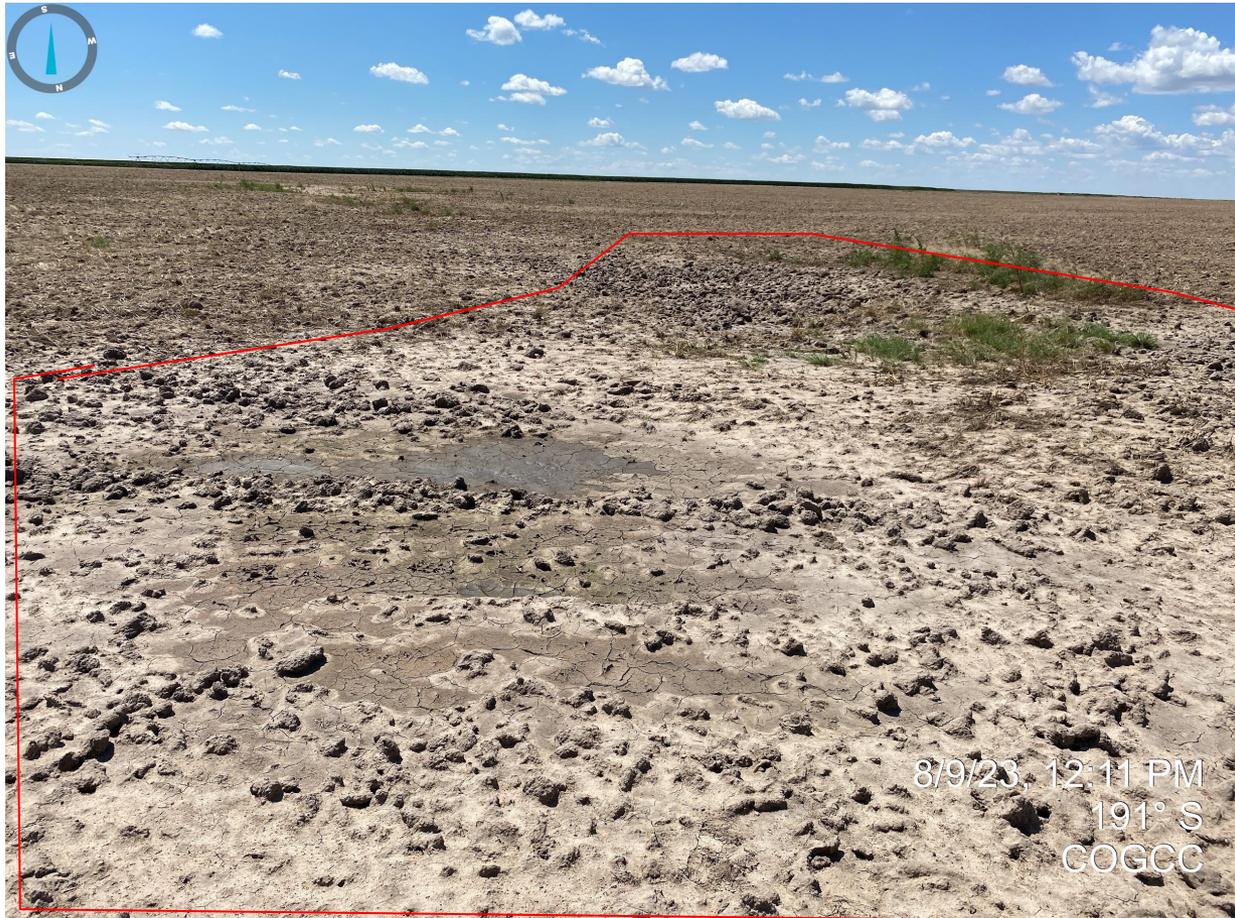
Photo 6. Taken north of the former well location, looking over the potential salt kill portion identified in previous inspections. A future inspection will be conducted to verify growth when a crop has been planted.
