Inspection Photos

8/14/2023

Operator: GENESIS GAS & OIL COLORADO LLC
- 10384

Location Number: 413496
Rio Blanco County, CO

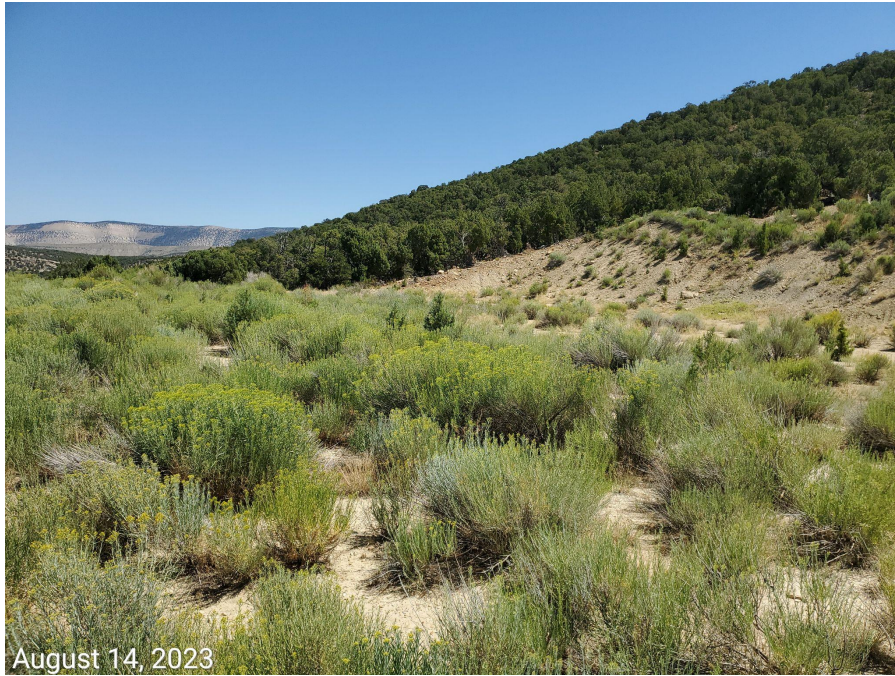
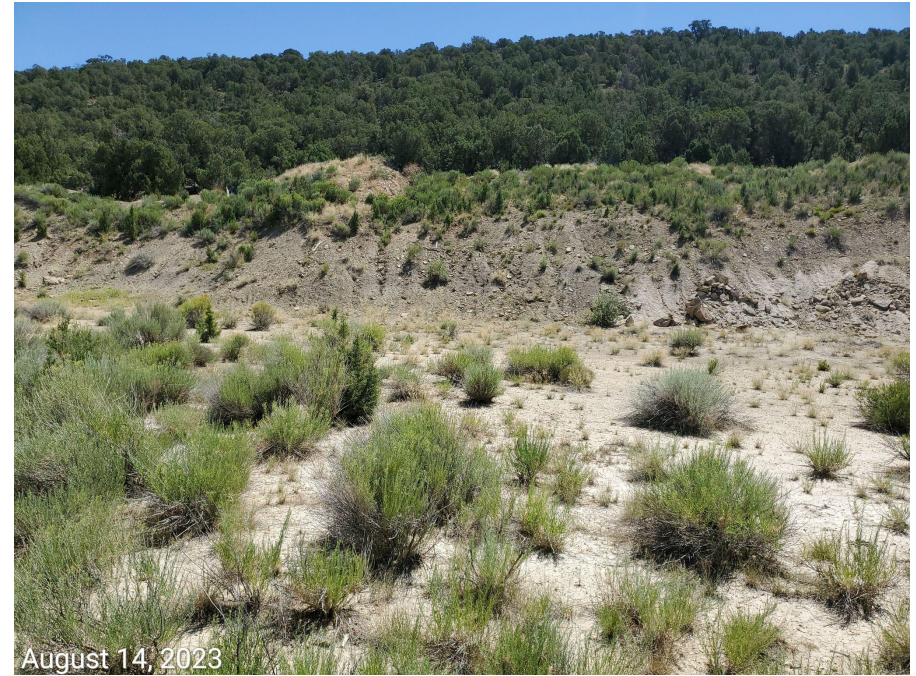
Photo 1: Photos 1-2 provide an overview of the Location. Photos also show cut slopes of the Location; Location has not been decompacted, recontoured, regraded and reclaimed in accordance with 1004 Rules. Cut slopes lack stabilization.

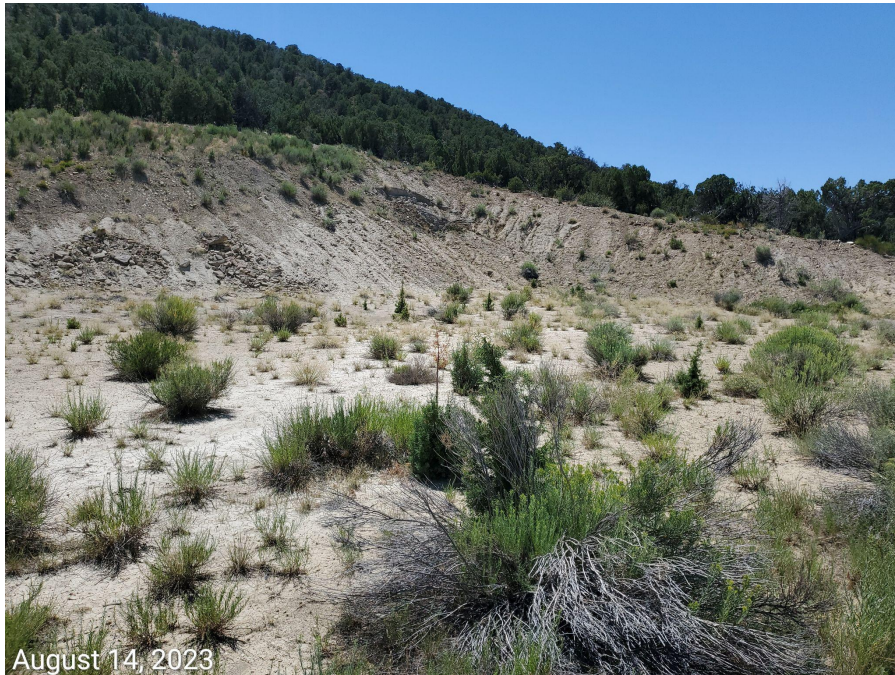
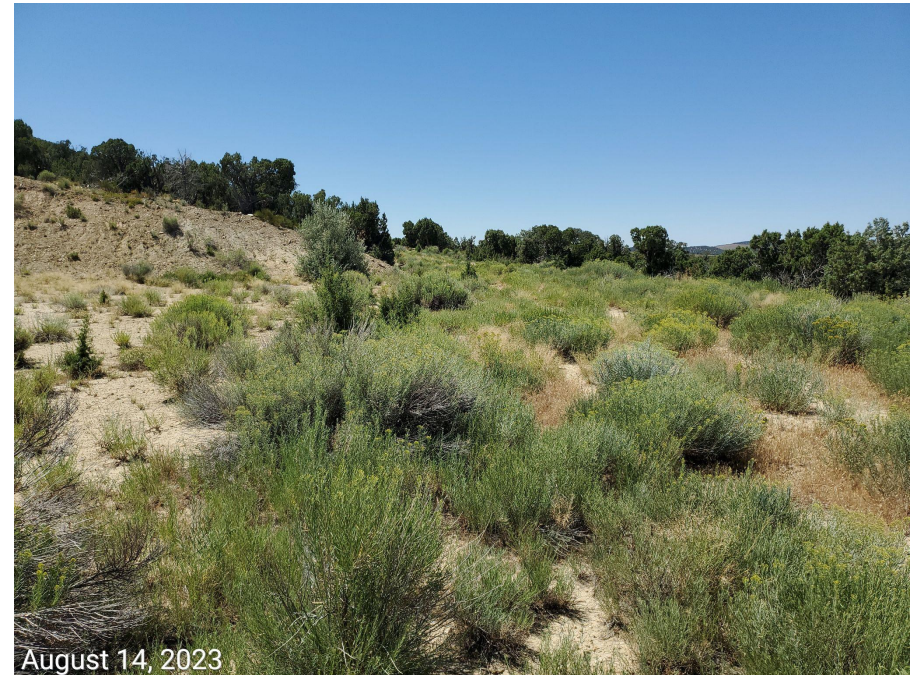
Photo 2: See comments under photo 1.

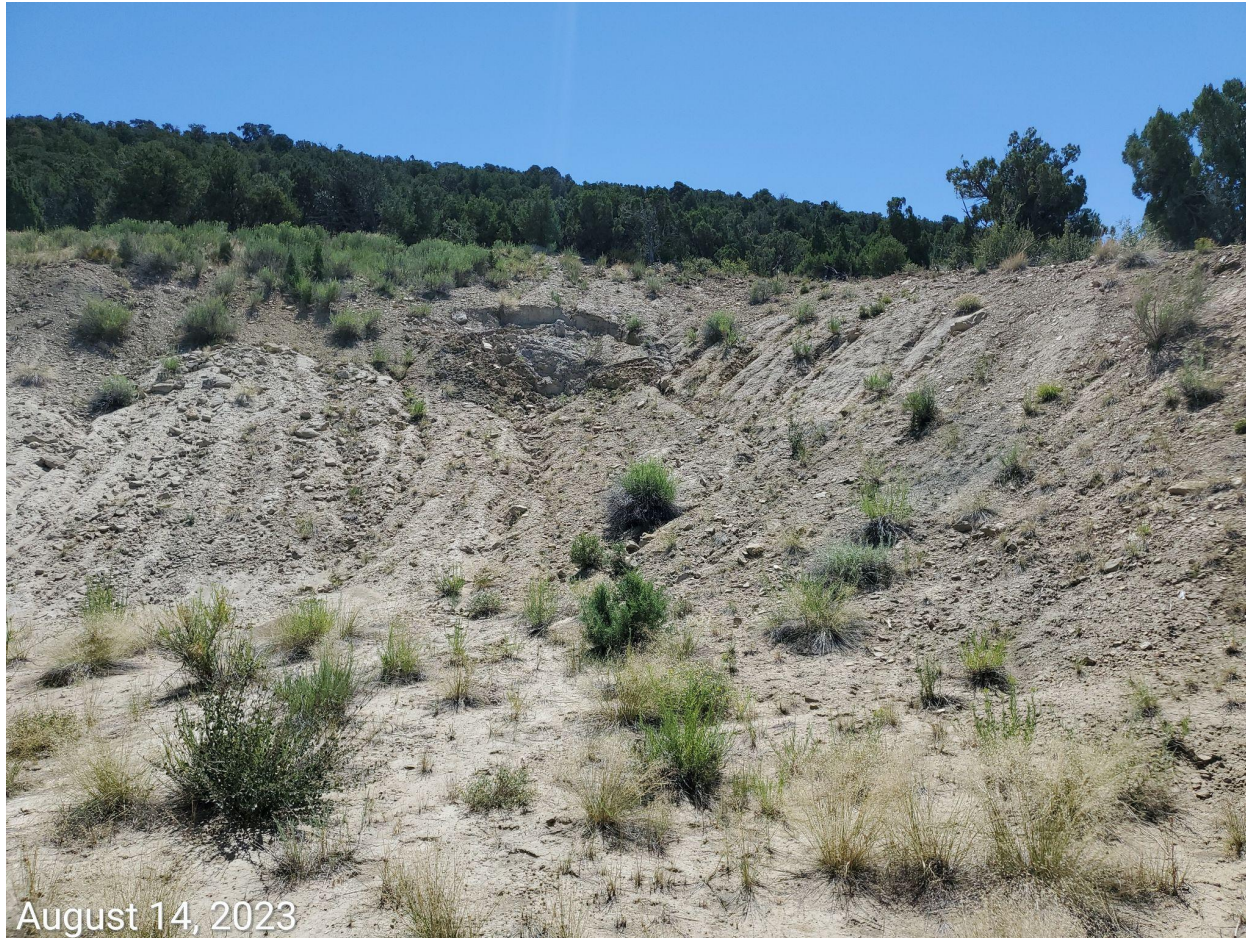
Photo 3: Photo shows erosion degradation, and mass soil migration, has persisted on the cut slopes; control measures to stabilize slopes and manage runoff remain inadequate.

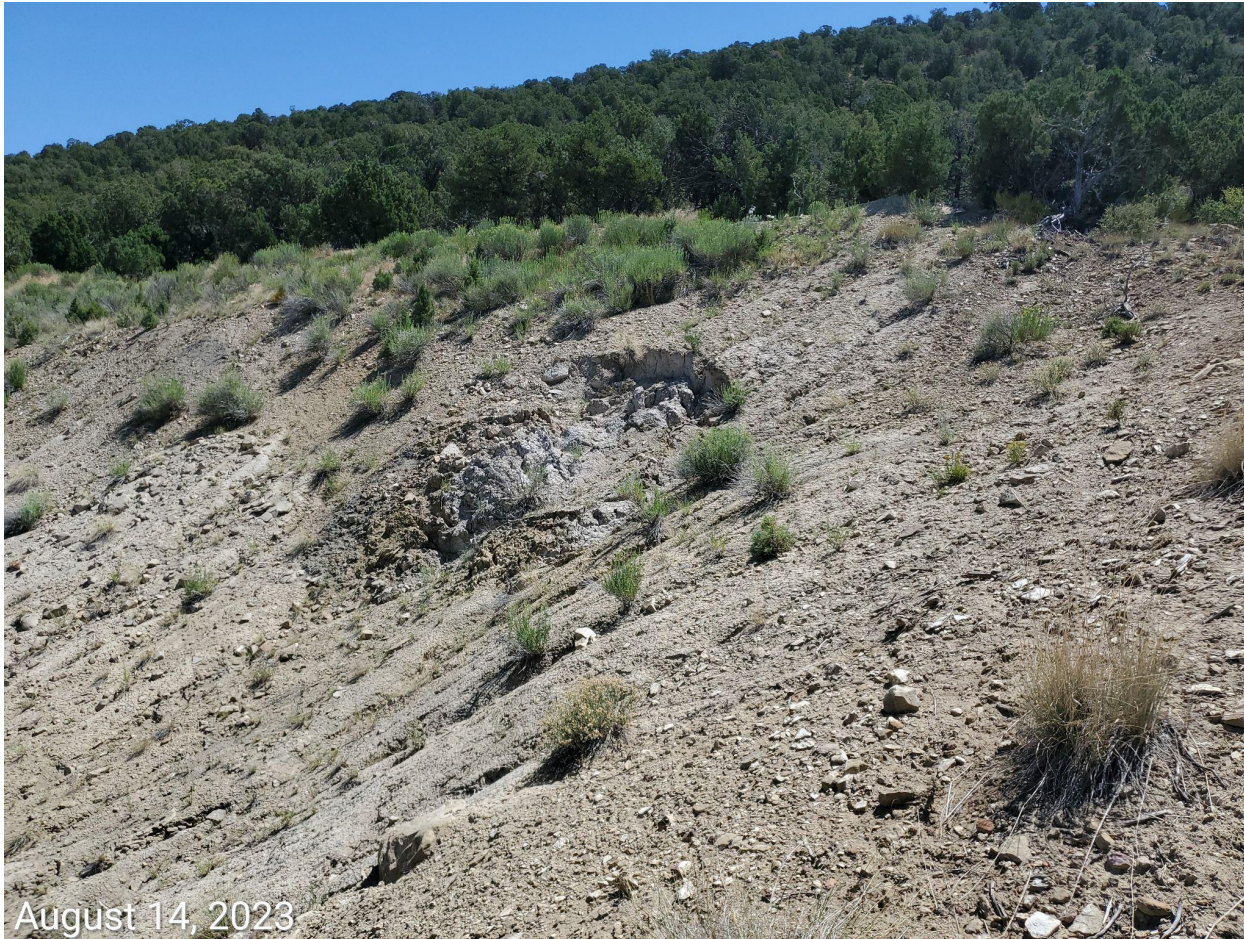
Photo 4: Photo shows erosion degradation, and mass soil migration, has persisted on the cut slopes; control measures to stabilize slopes and manage runoff remain inadequate.

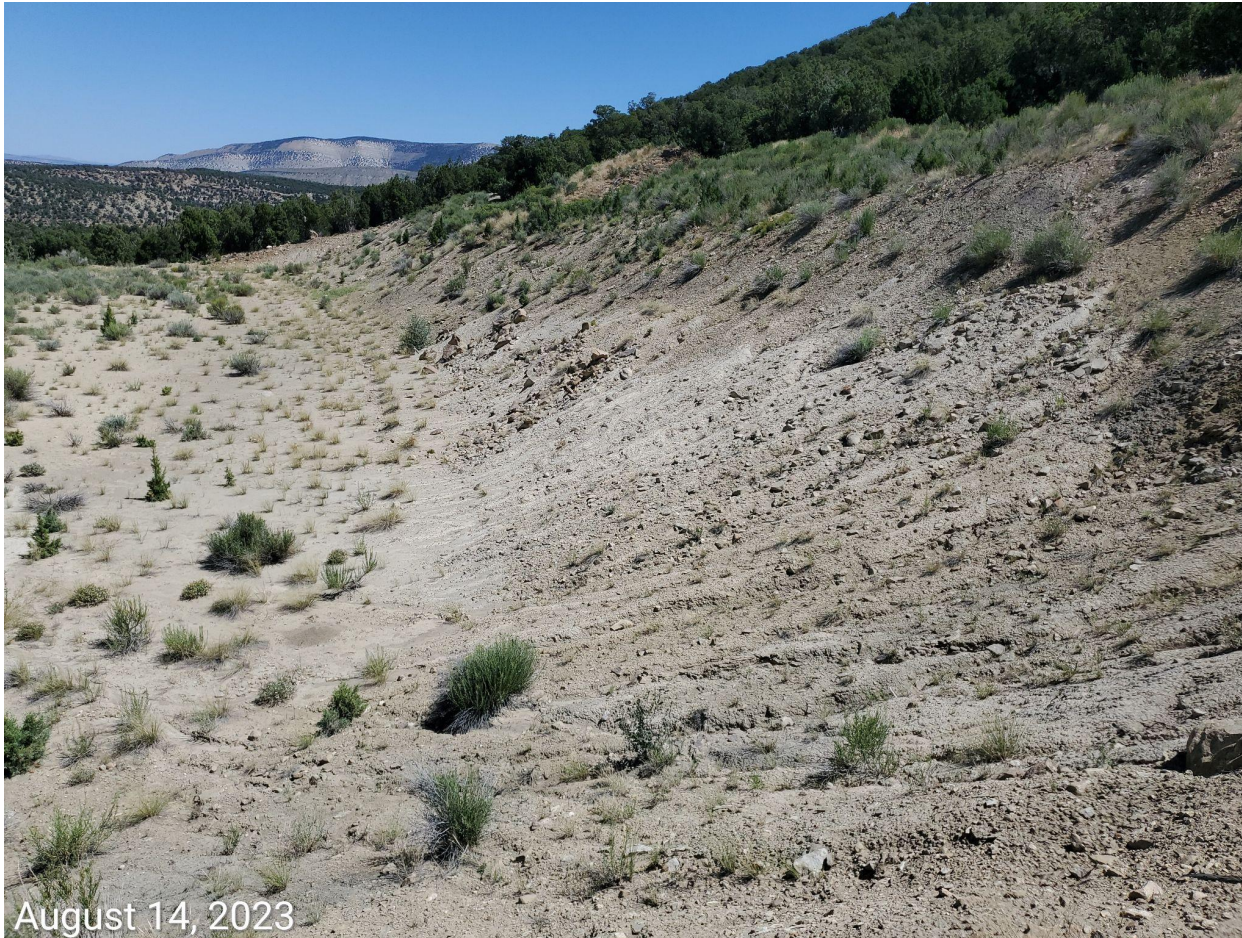
Photo 5: Photo shows erosion degradation, and mass soil migration, has persisted on the cut slopes; control measures to stabilize slopes and manage runoff remain inadequate.

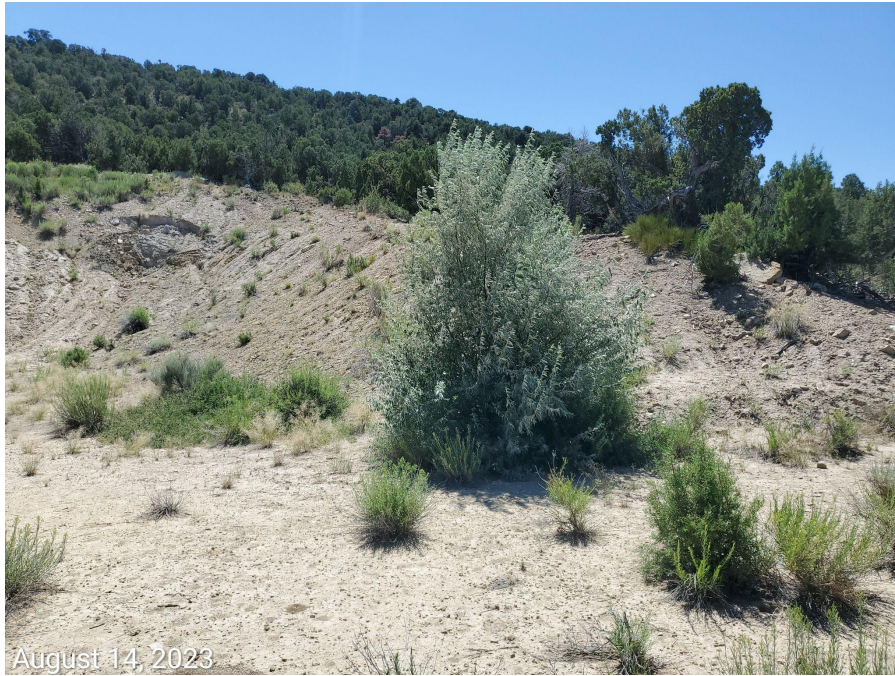
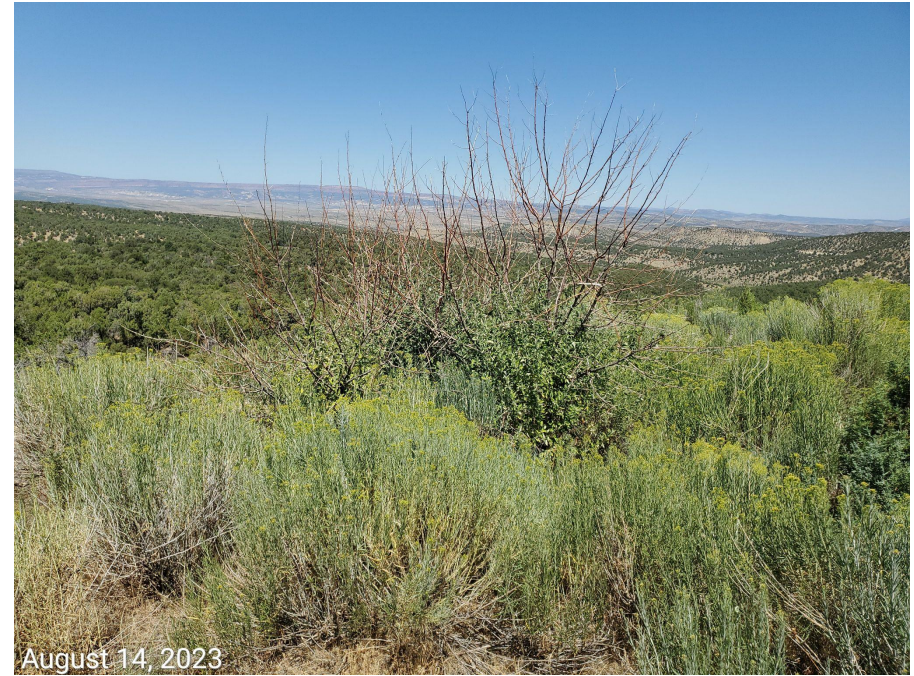
Photo 6: Photos examples showing weeds (Russian Olive) remaining at the Location, and along the access road.

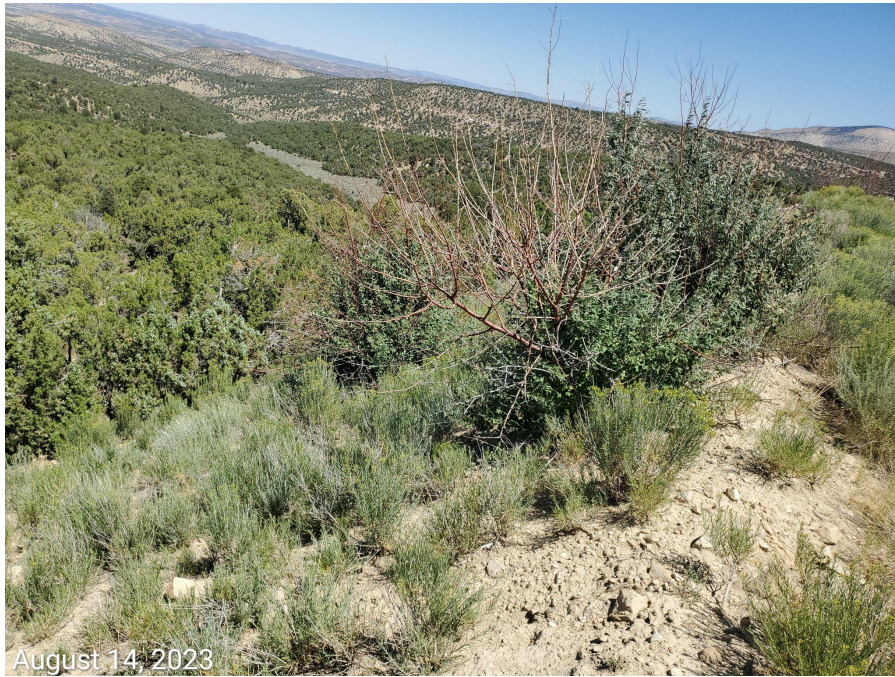
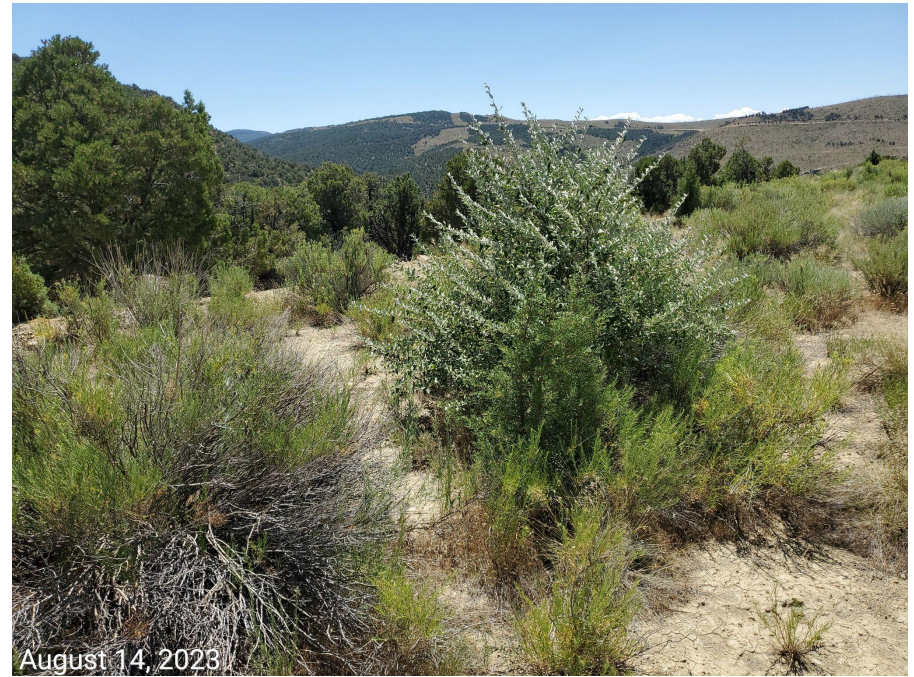
Photo 7: Photos examples showing weeds (Russian Olive) remaining at the Location, and along the access road.

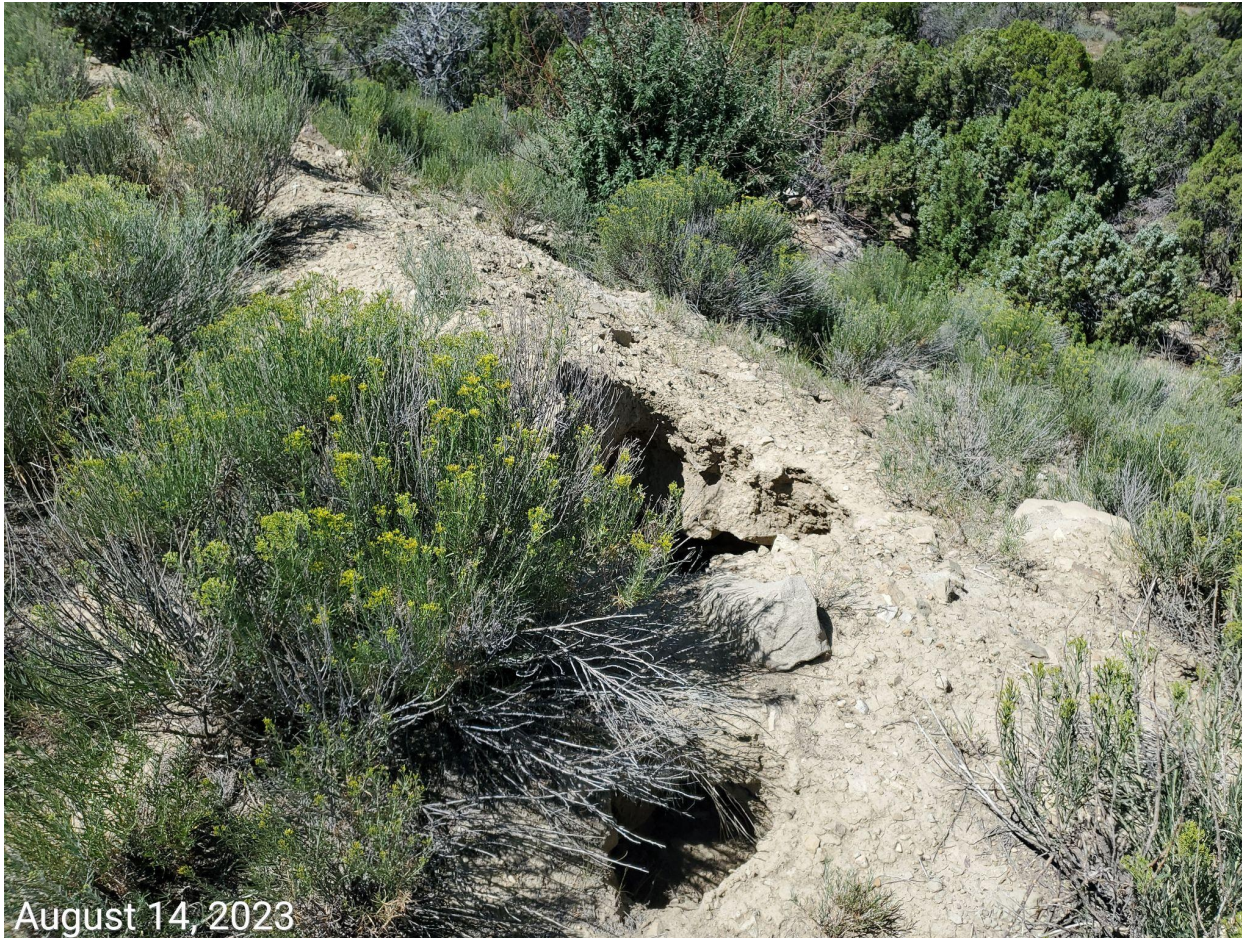
Photo 8: Photo taken from the fill slopes. Photo shows erosion degradation due to stormwater runoff.

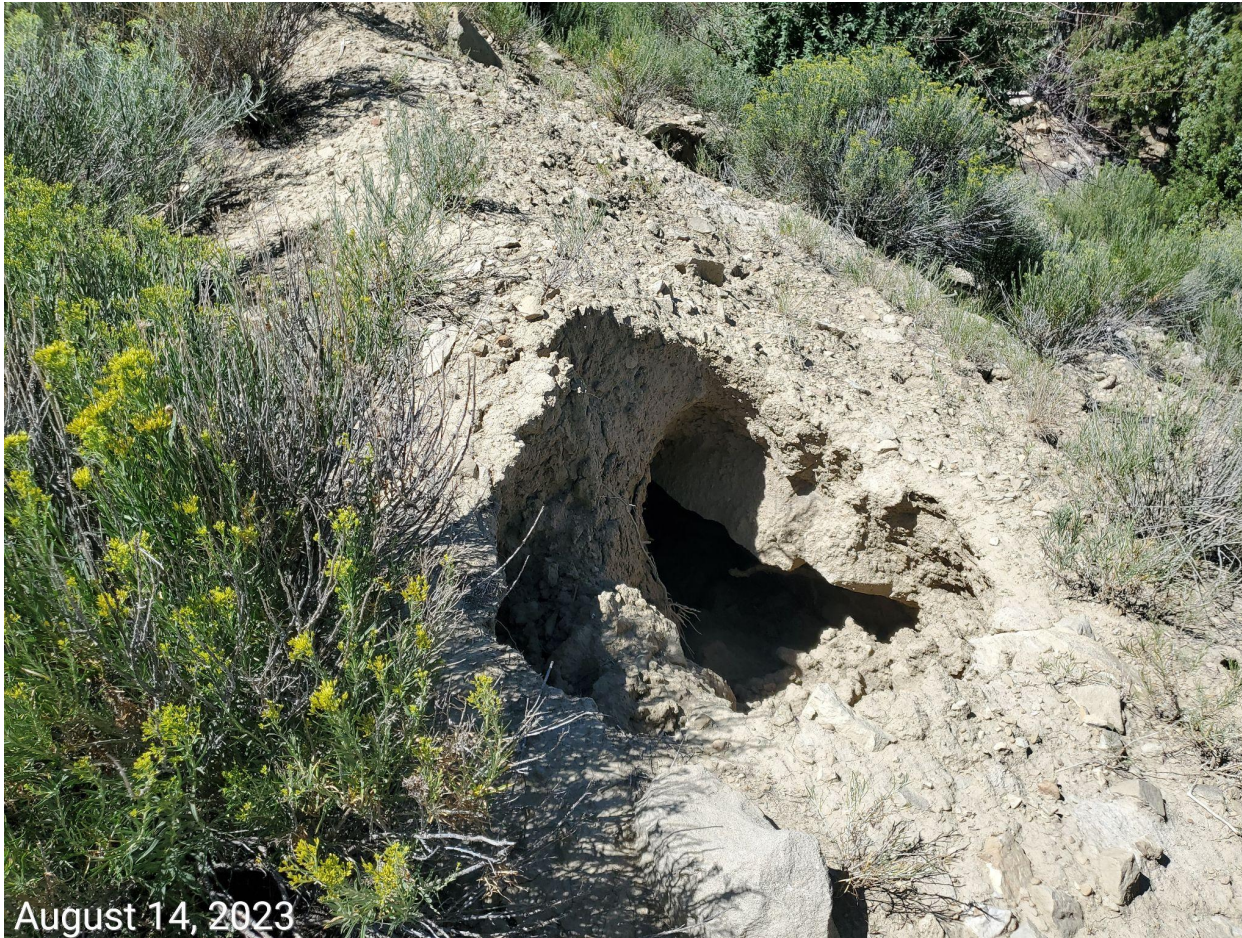
Photo 9: Photo taken from the fill slopes. Photo shows erosion degradation due to stormwater runoff.

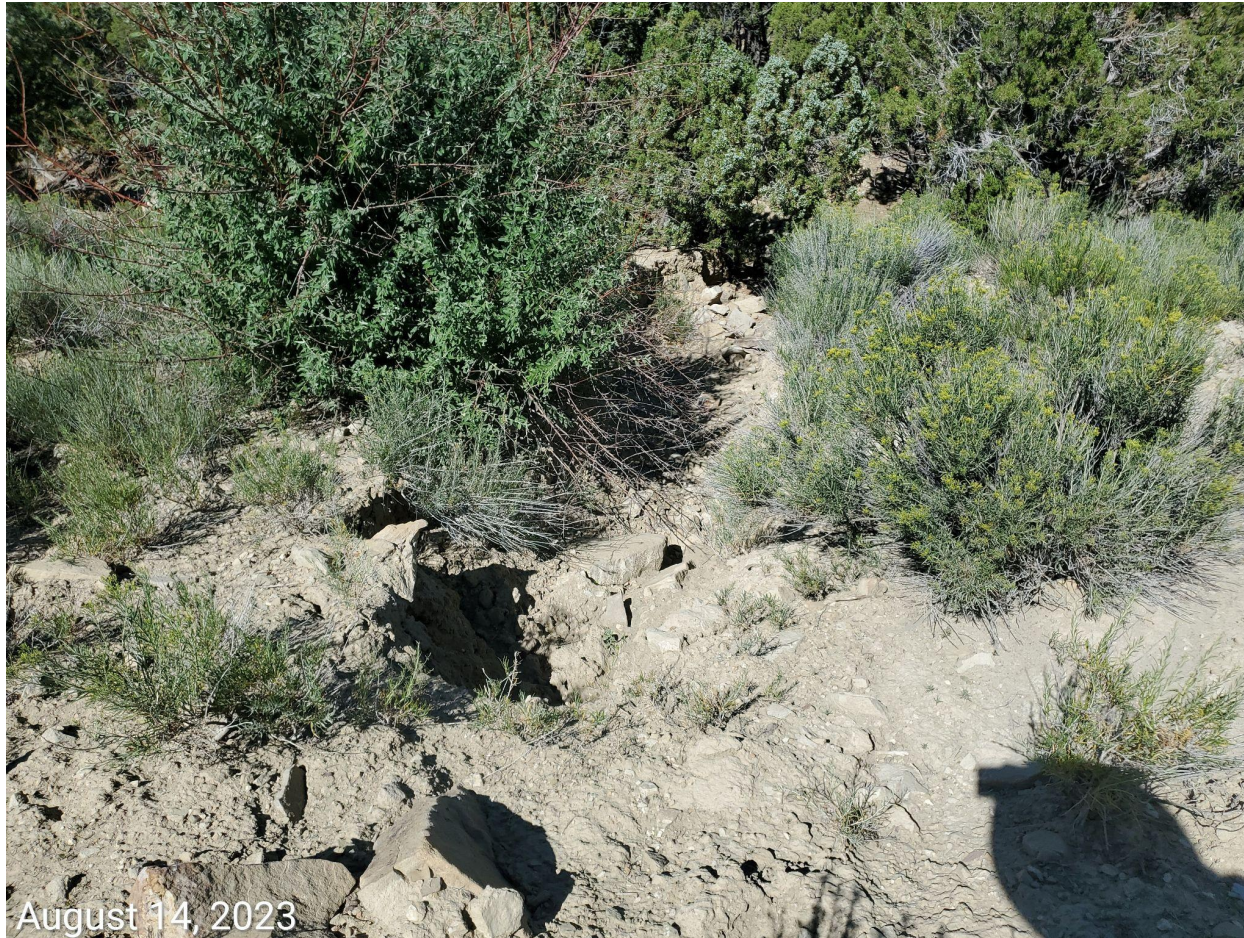
Photo 10: Photo taken from the fill slopes. Photo shows erosion degradation due to stormwater runoff.

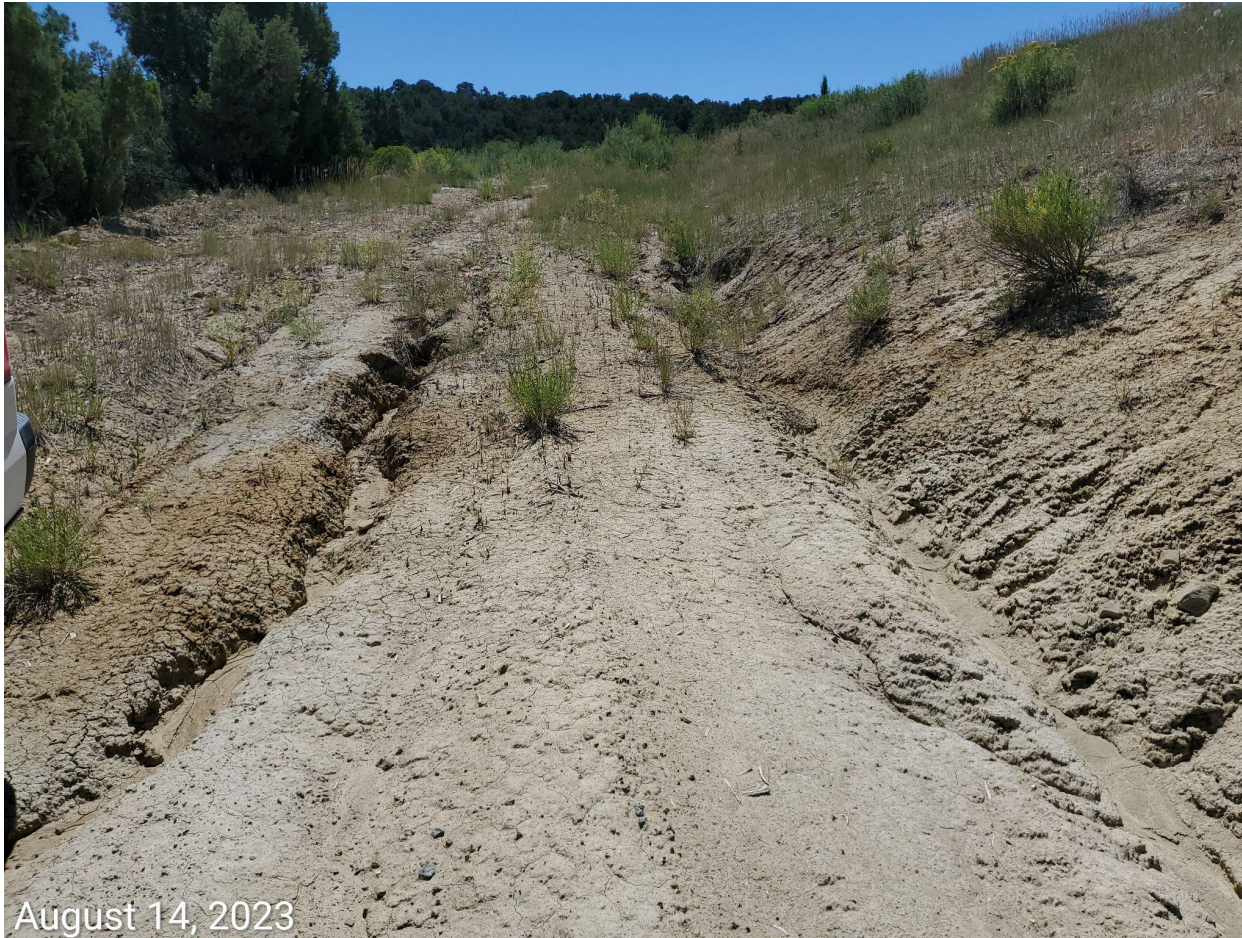
Photo 11: Photo example showing persisting erosion degradation along access road. Stormwater and erosion control measures remain inadequate. Access road has not been decompacted, recontoured, regraded and reclaimed in accordance with 1004 Rules.

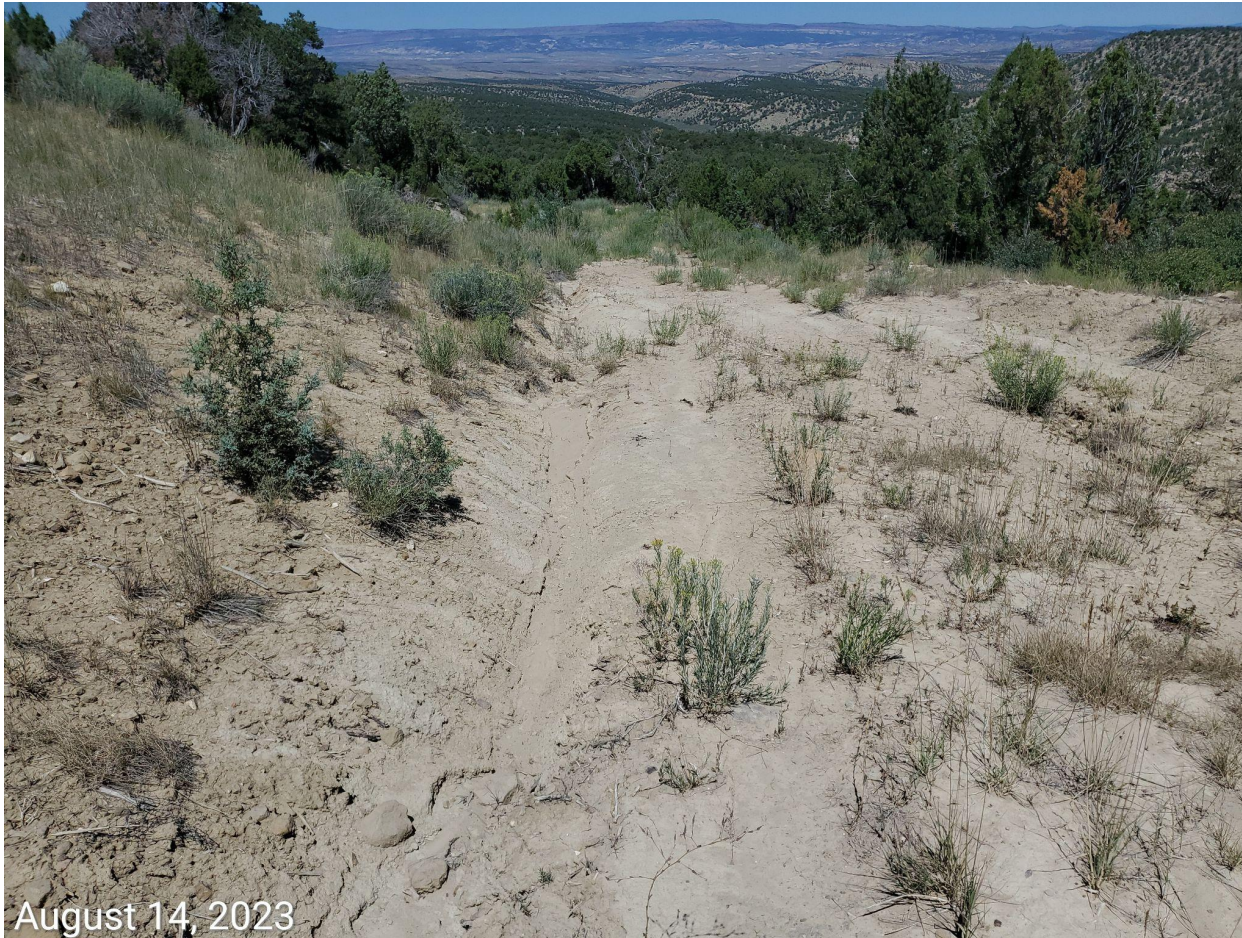
Photo 12: Photo example showing persisting erosion degradation along access road. Stormwater and erosion control measures remain inadequate. Access road has not been decompacted, recontoured, regraded and reclaimed in accordance with 1004 Rules.

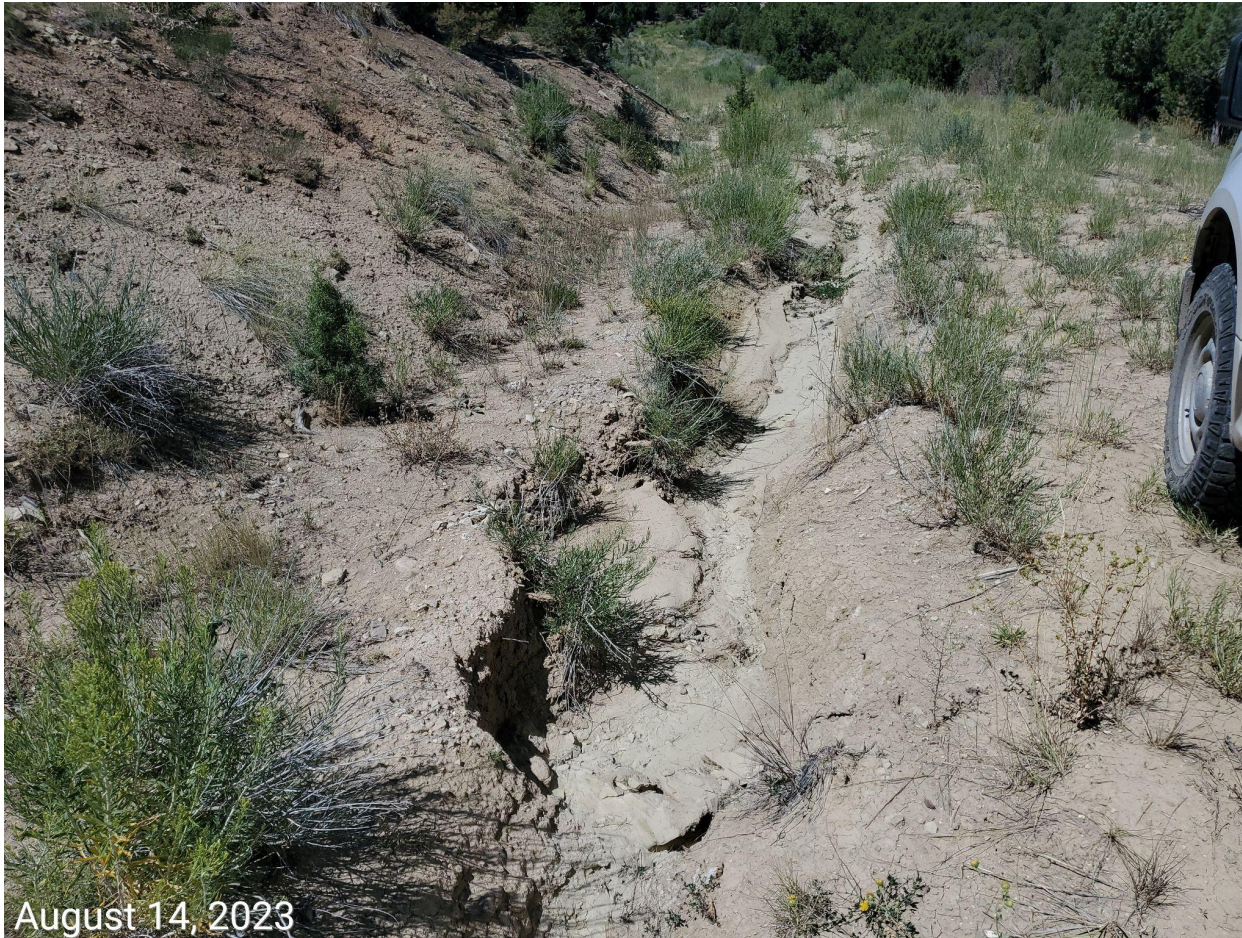
Photo 13: Photo example showing persisting erosion degradation along access road. Stormwater and erosion control measures remain inadequate. Access road has not been decompacted, recontoured, regraded and reclaimed in accordance with 1004 Rules.

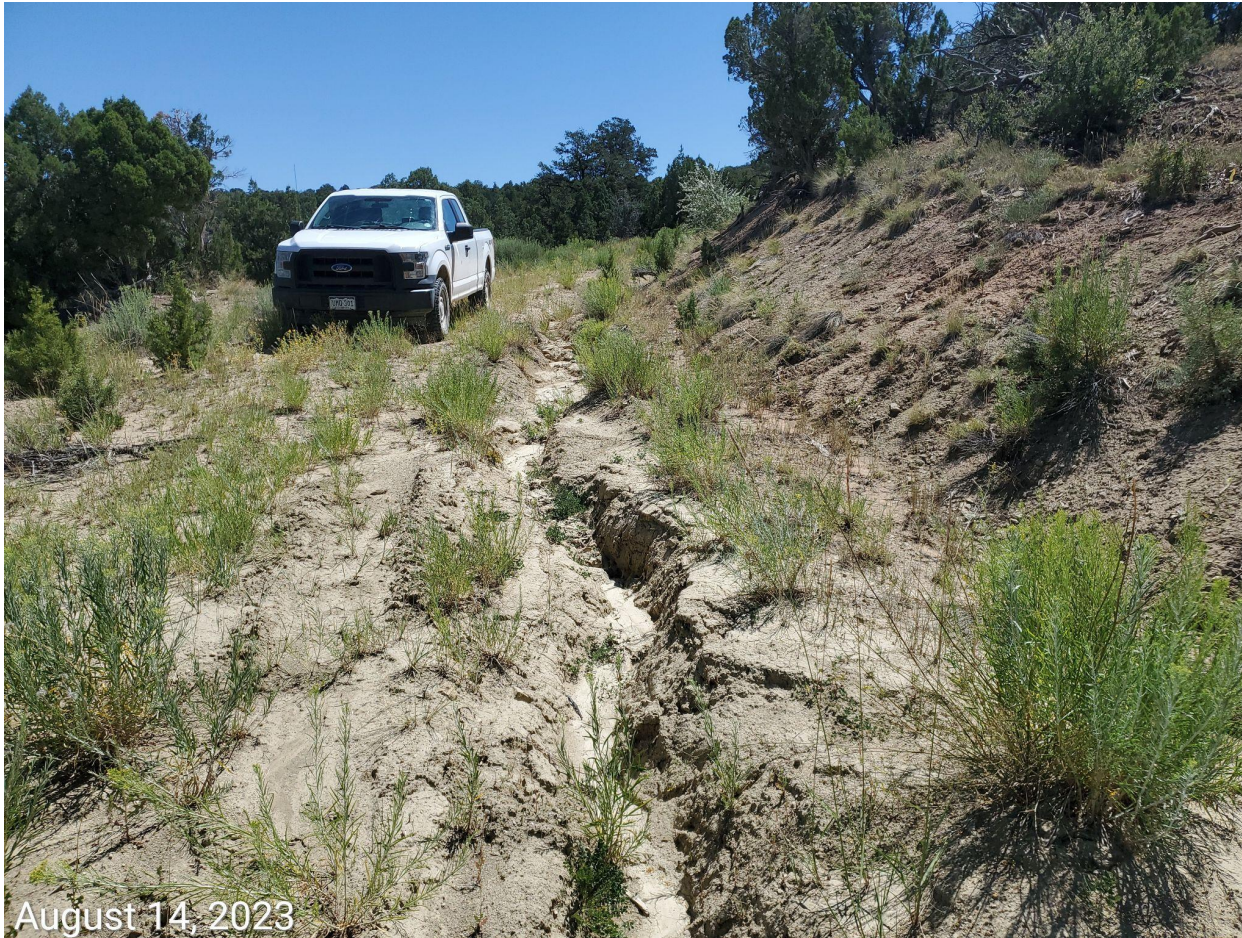
Photo 14: Photo example showing persisting erosion degradation along access road. Stormwater and erosion control measures remain inadequate. Access road has not been decompacted, recontoured, regraded and reclaimed in accordance with 1004 Rules.

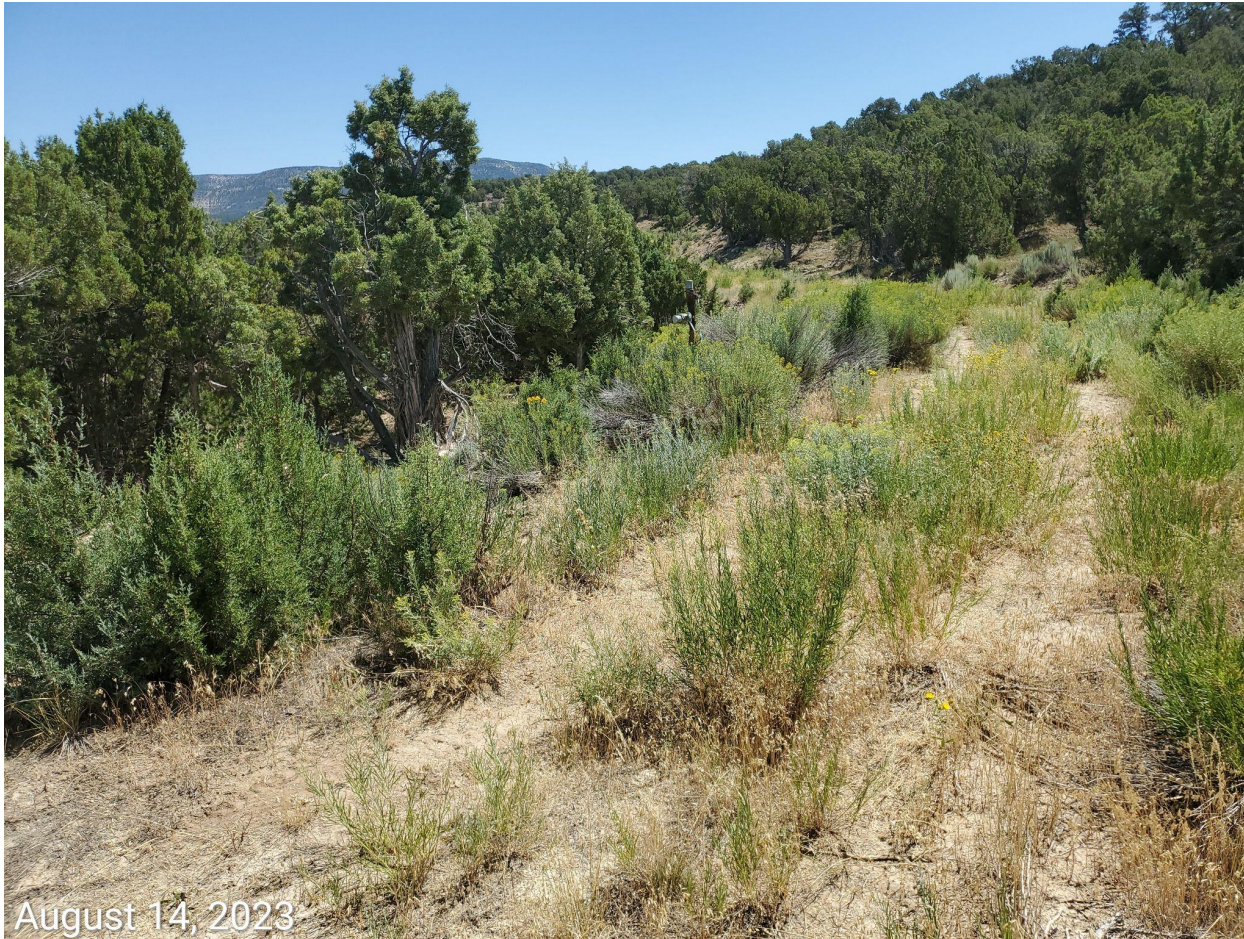
Photo 15 Photo shows riser equipment remaining along access road. Photo also shows access road has not been decompacted, recontoured, regraded and reclaimed in accordance with 1004 Rules
