Inspection Photos

8/14/2023

Operator: GENESIS GAS & OIL COLORADO LLC
- 10384

Location Number: 413495
Rio Blanco County, CO

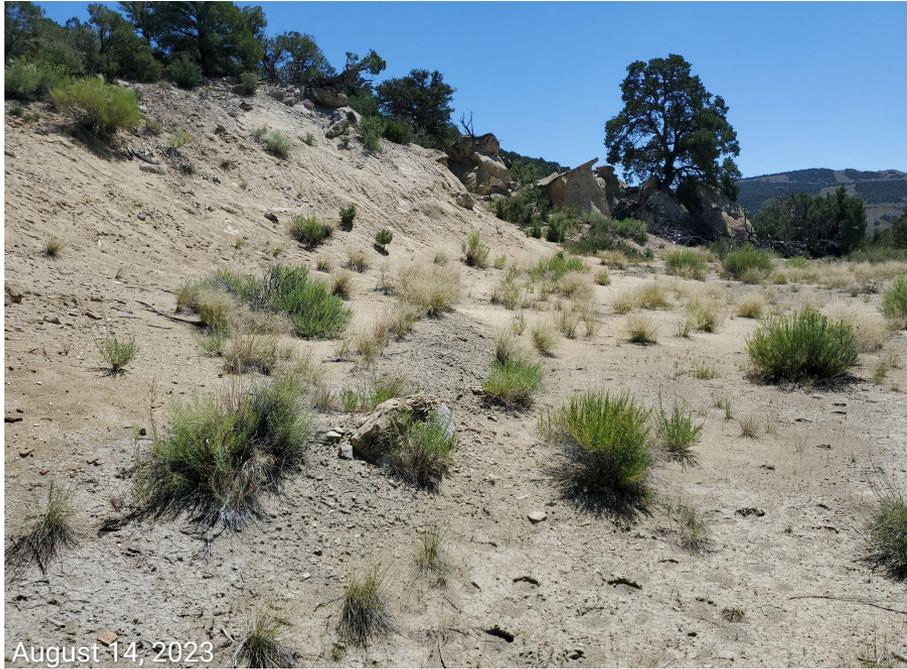
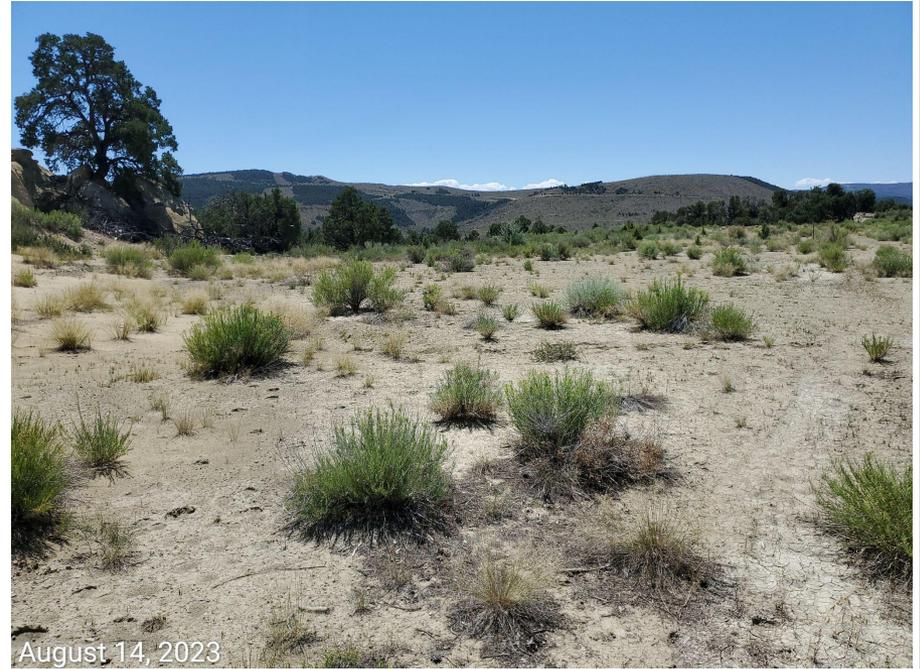
Photo 1: Photos 1-2 provide an overview of the Location. Photos also show cut slopes of the Location; Location has not been decompacted, recontoured, regraded and reclaimed in accordance with 1004 Rules. Cut slopes lack stabilization.

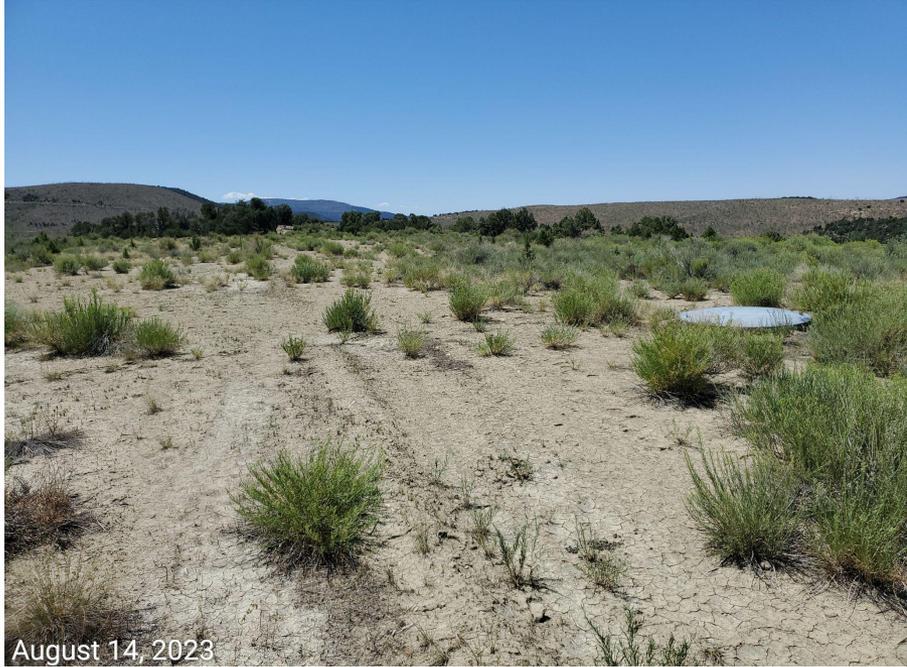
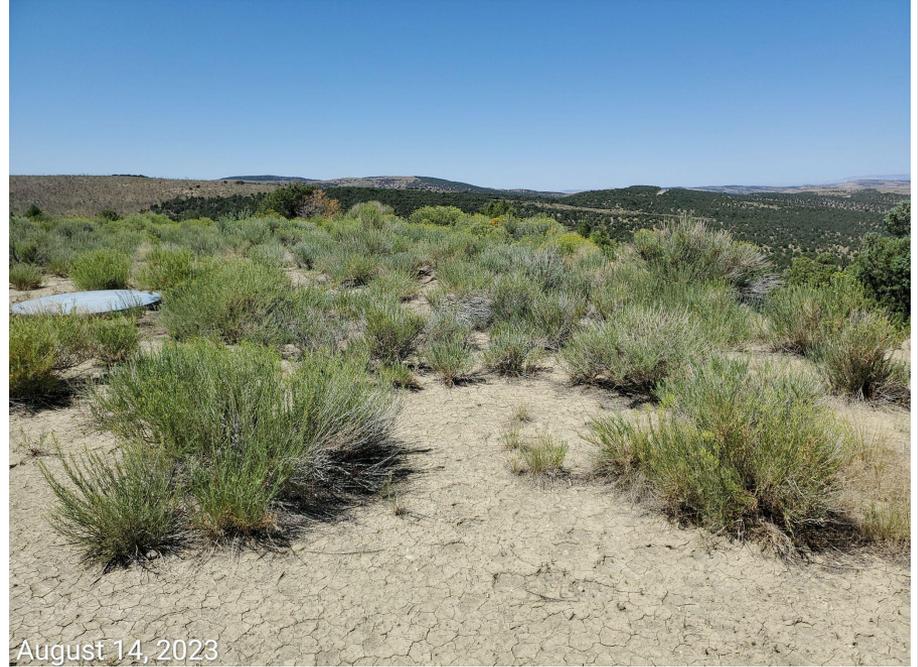
Photo 2: See comments under photo 1.

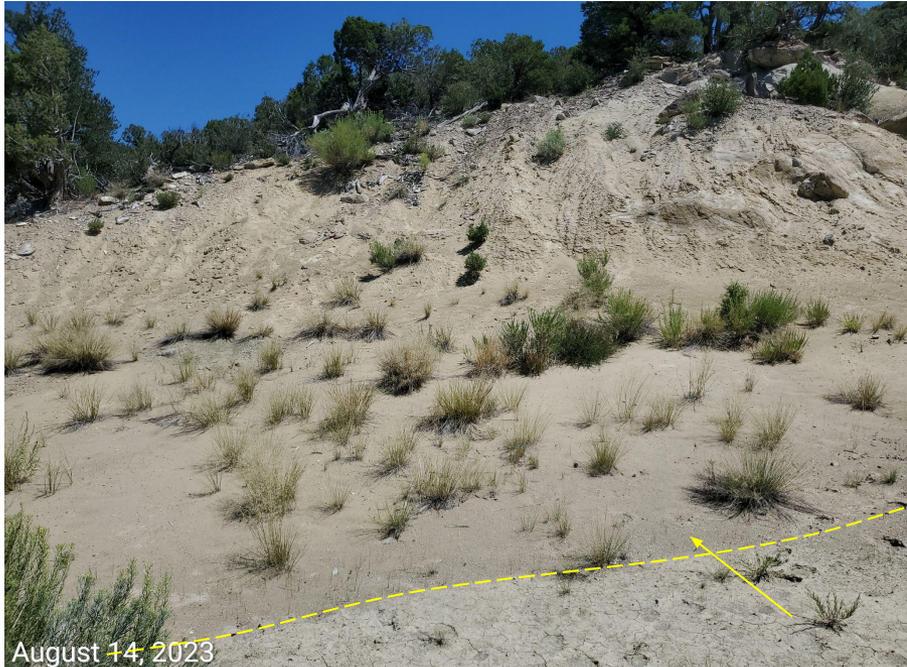
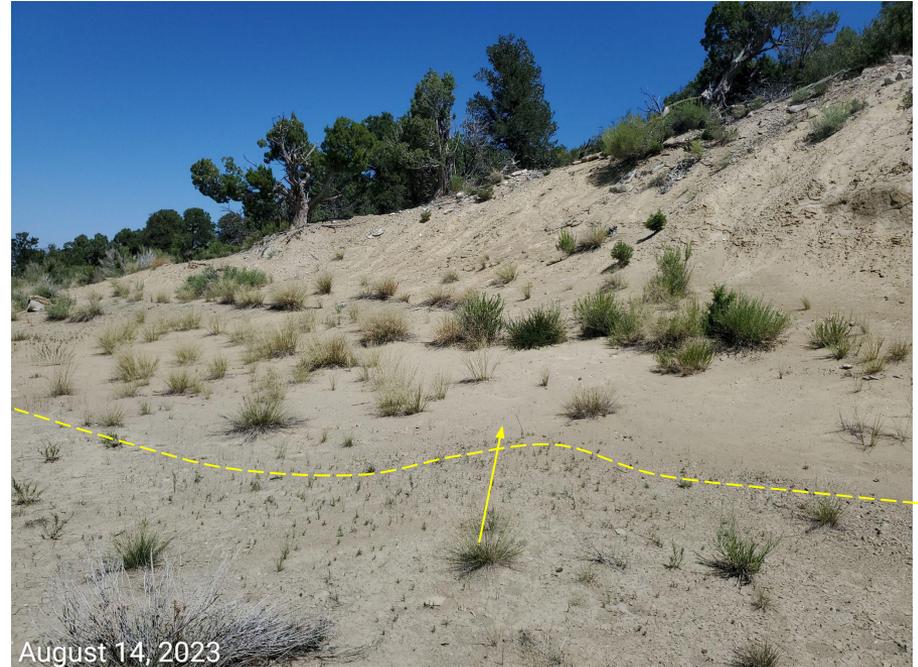
Photo 3: Unstabilize cut-slopes; erosion degradation and sediment transport has persisted. Darker soils represented by the arrow in photos is sediment deposition onto the pad surface, due to erosion from the cut slopes

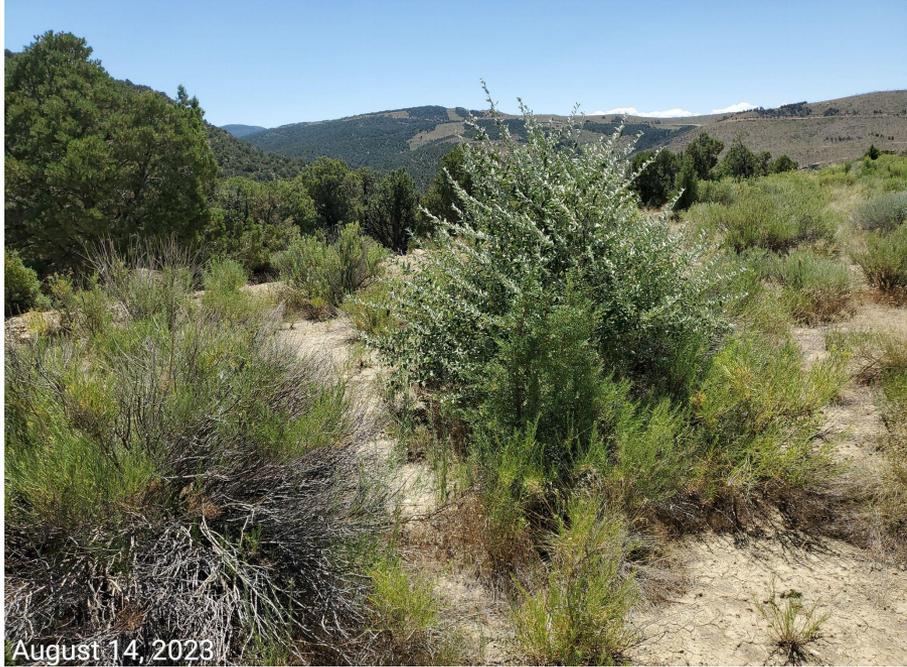
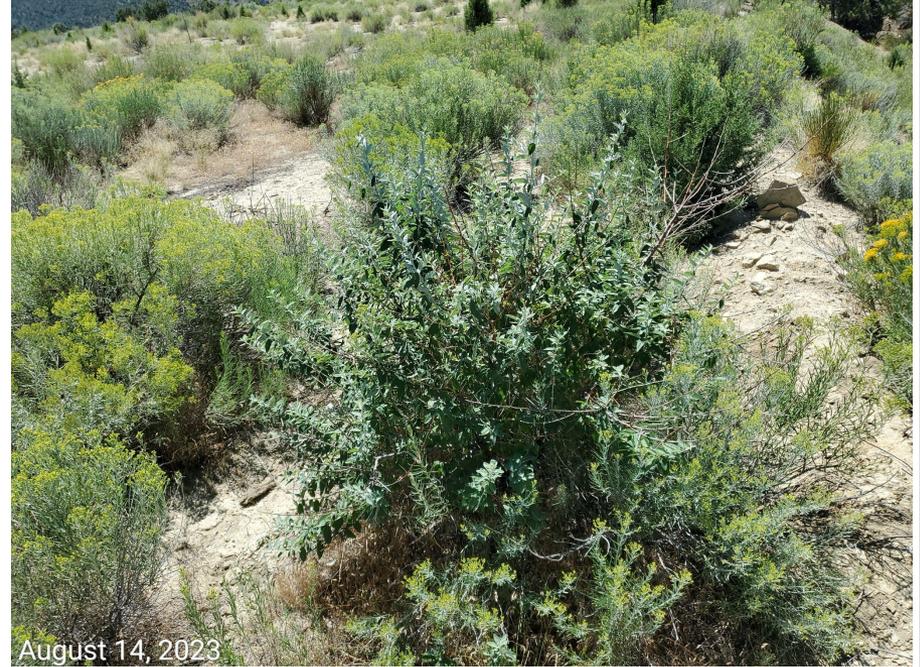
Photo 4: Noxious weeds (Russian Olive) established on the Location.

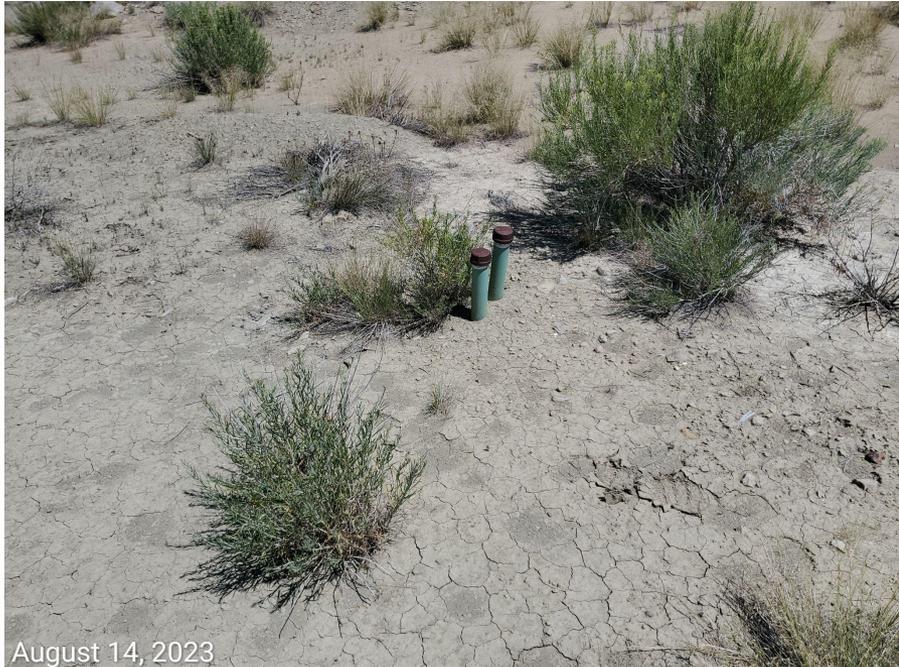
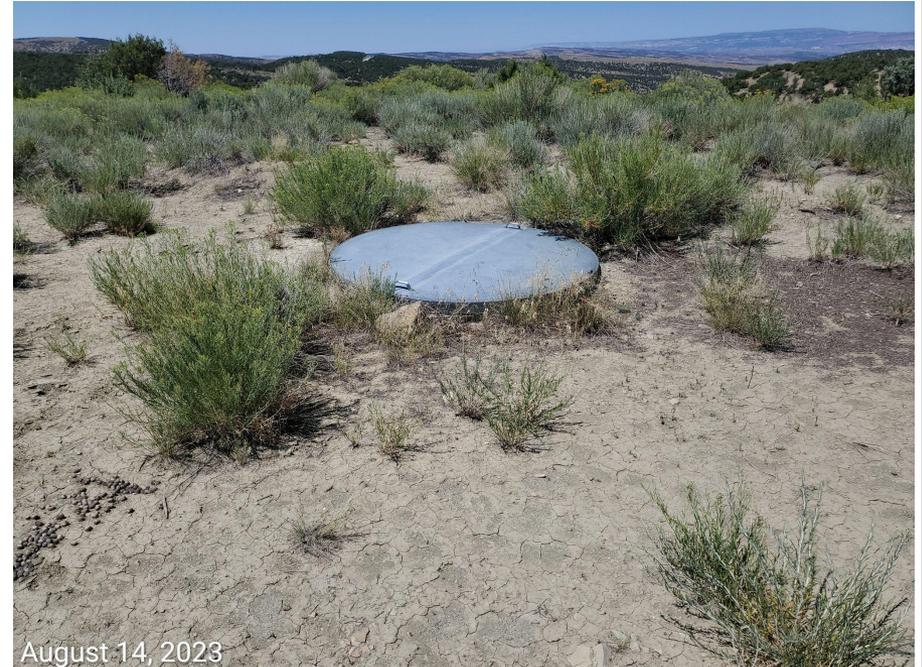
Photo 5: Equipment remaining on the Location.

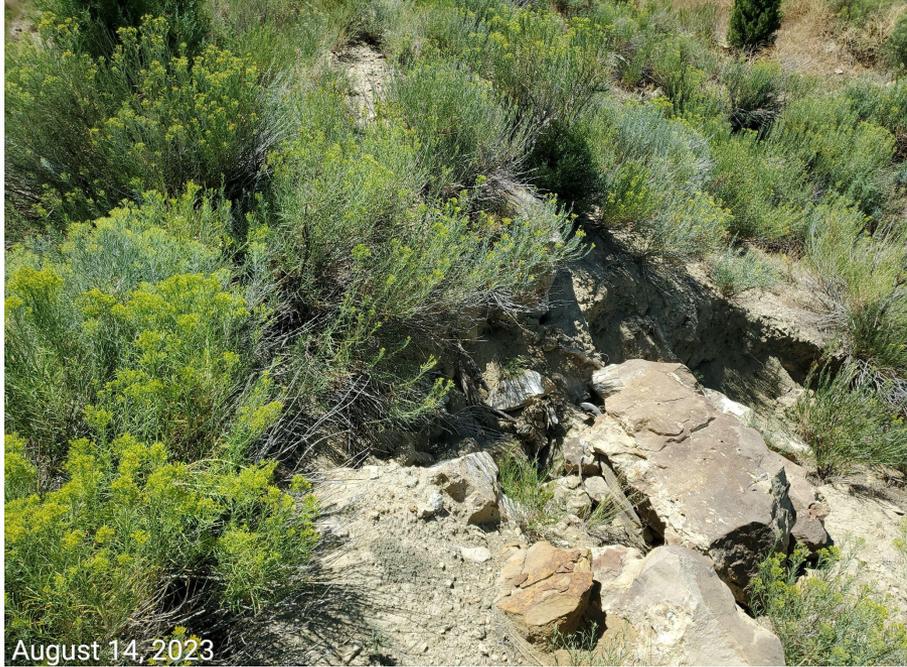
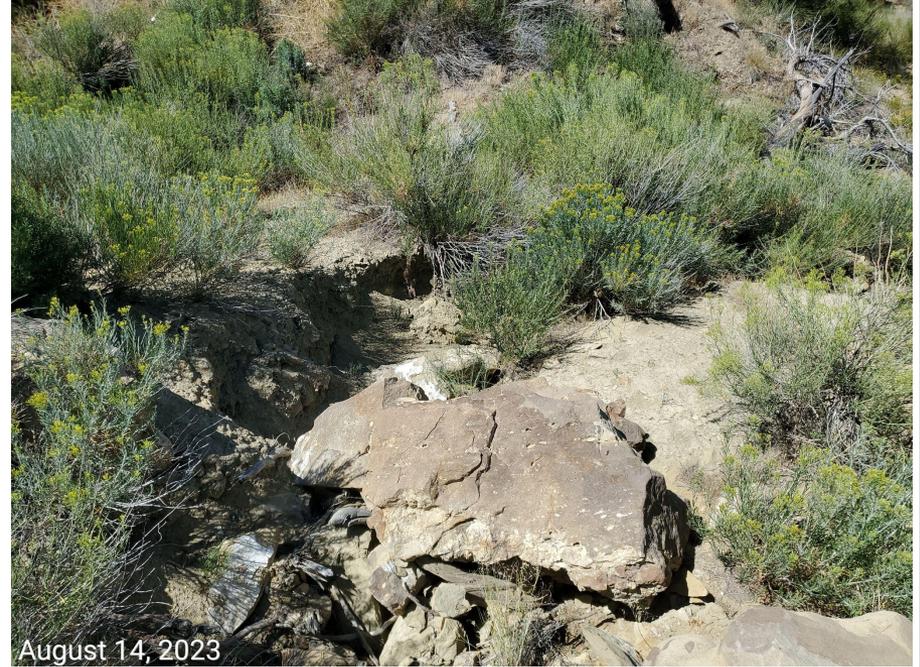
Photo 6: Persisting erosion degradation on the fill slopes of the Location; gully erosion due to inadequate stormwater and erosion control measures to manage runoff.

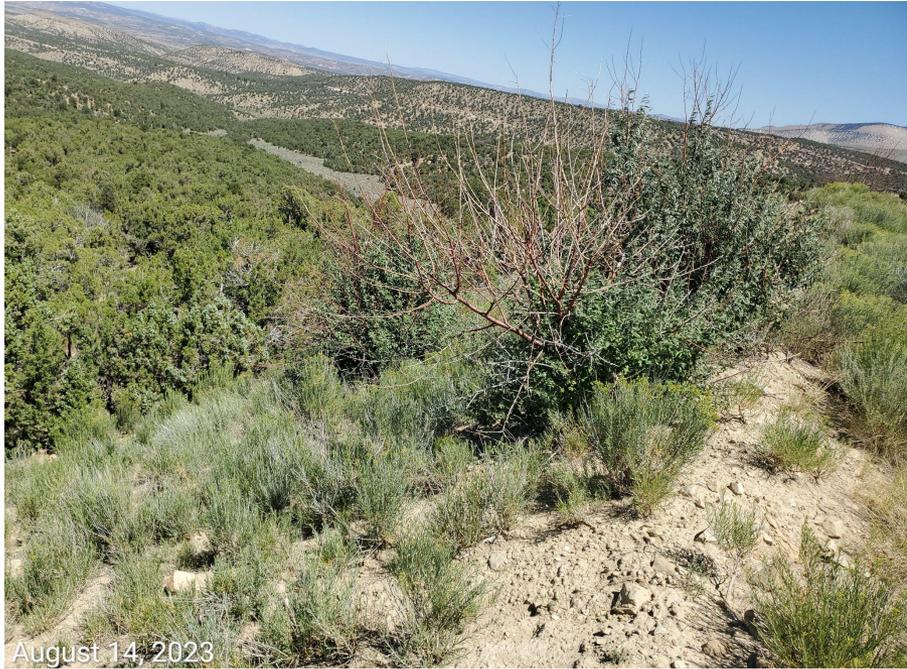
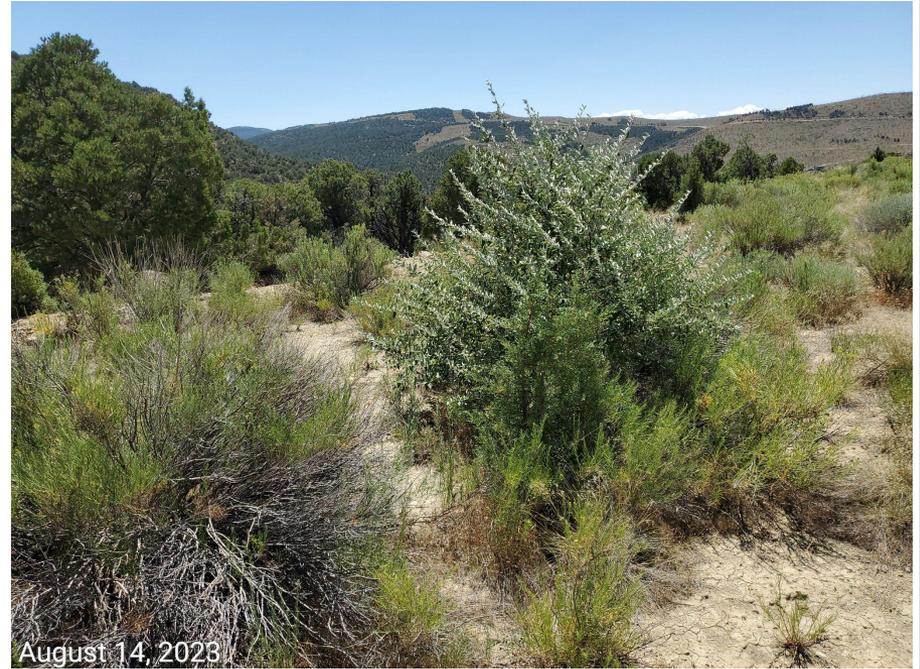
Photo 7: Photos examples showing weeds (Russian Olive) remaining along the access road.

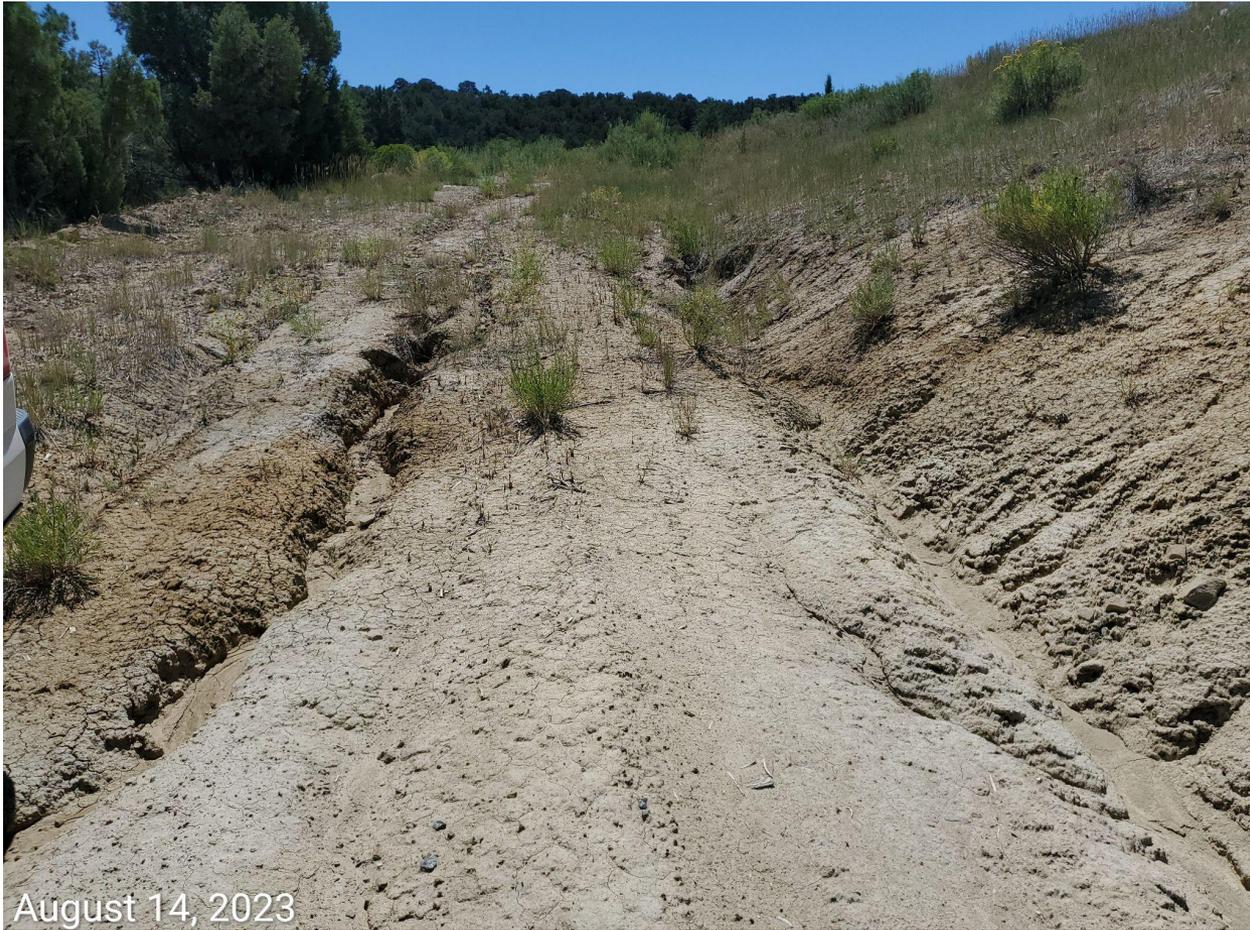
Photo 8: Photo example showing persisting erosion degradation along access road. Stormwater and erosion control measures remain inadequate. Access road has not been decompacted, recontoured, regraded and reclaimed in accordance with 1004 Rules.

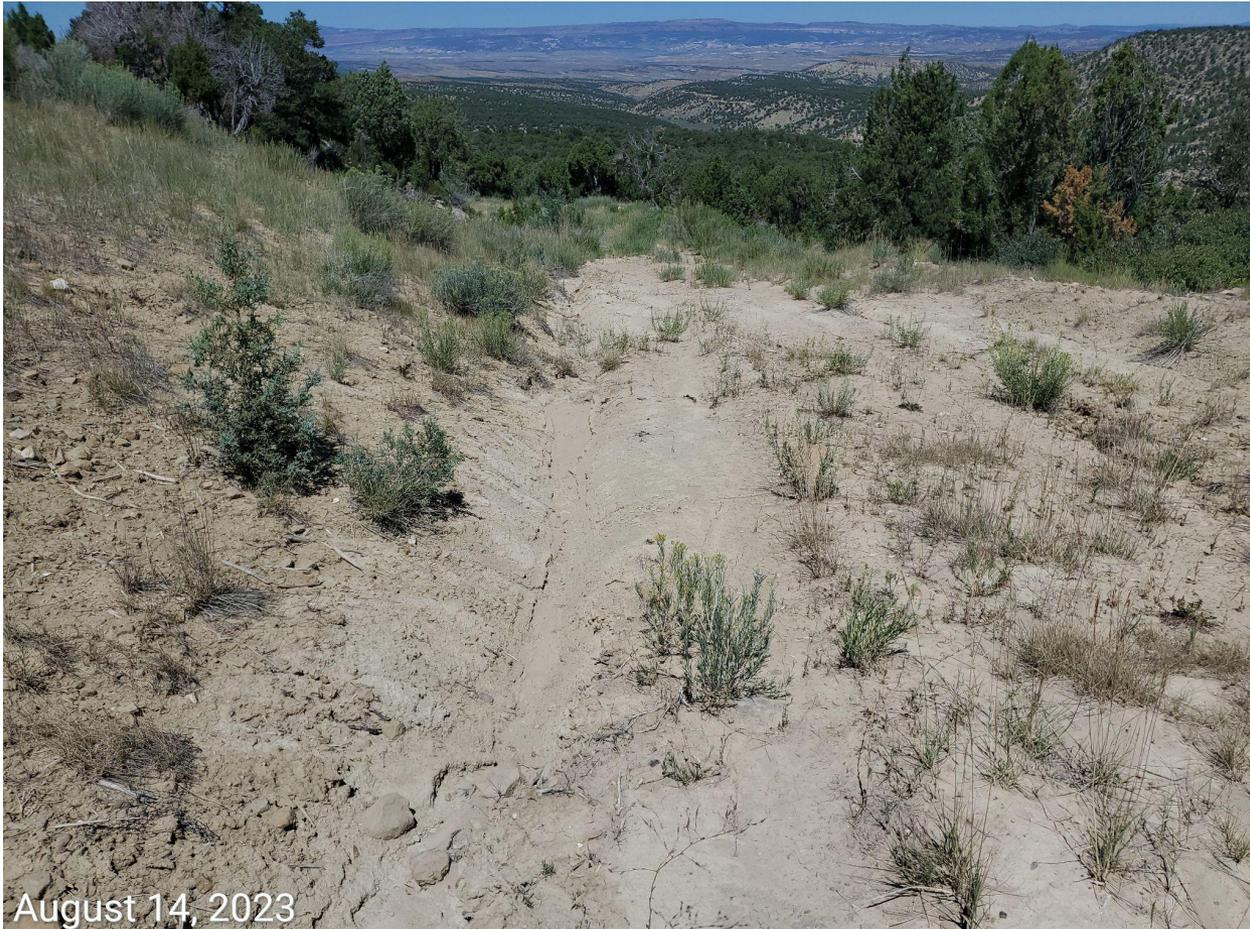
Photo 9: Photo example showing persisting erosion degradation along access road. Stormwater and erosion control measures remain inadequate. Access road has not been decompacted, recontoured, regraded and reclaimed in accordance with 1004 Rules.

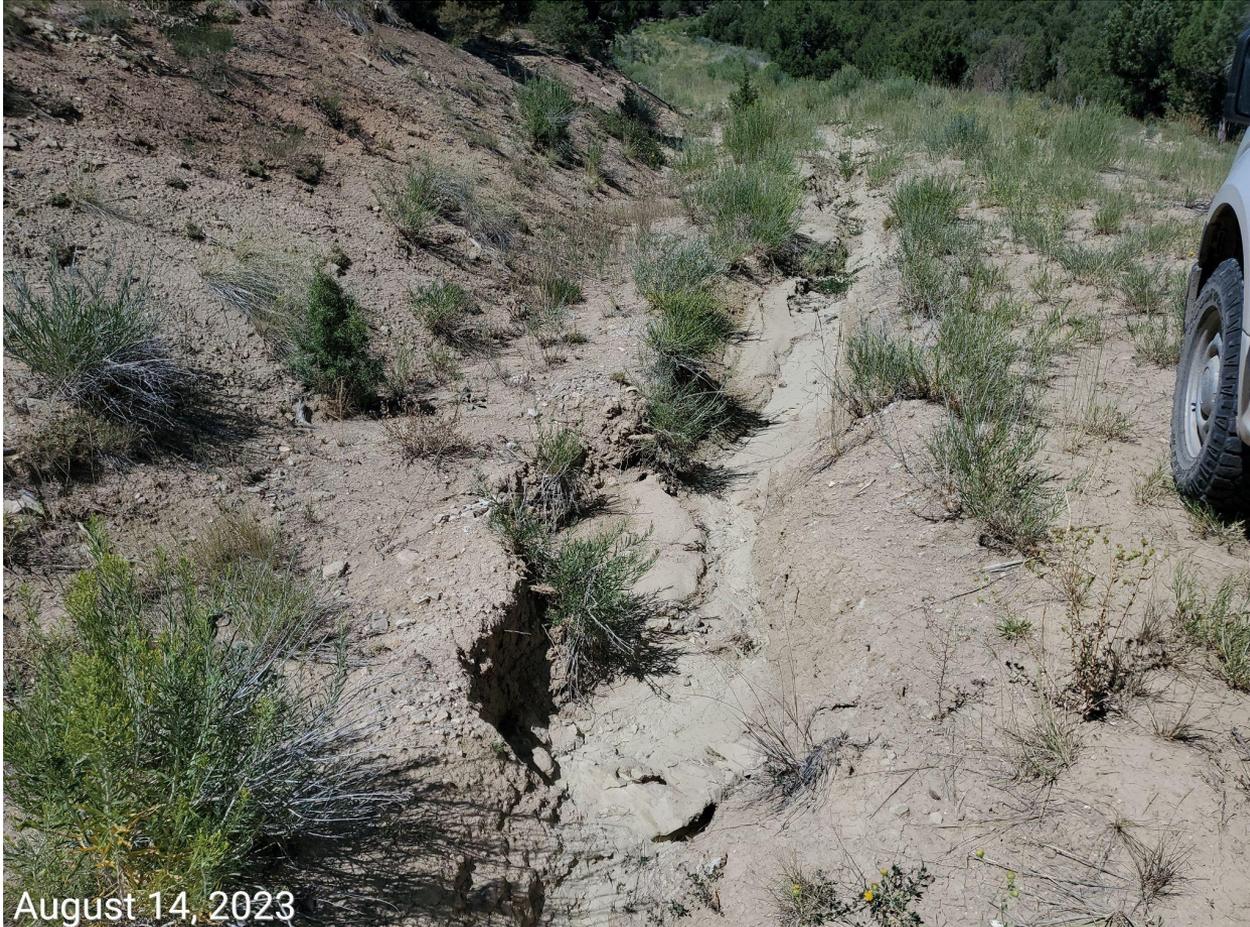
Photo 10: Photo example showing persisting erosion degradation along access road. Stormwater and erosion control measures remain inadequate. Access road has not been decompacted, recontoured, regraded and reclaimed in accordance with 1004 Rules.

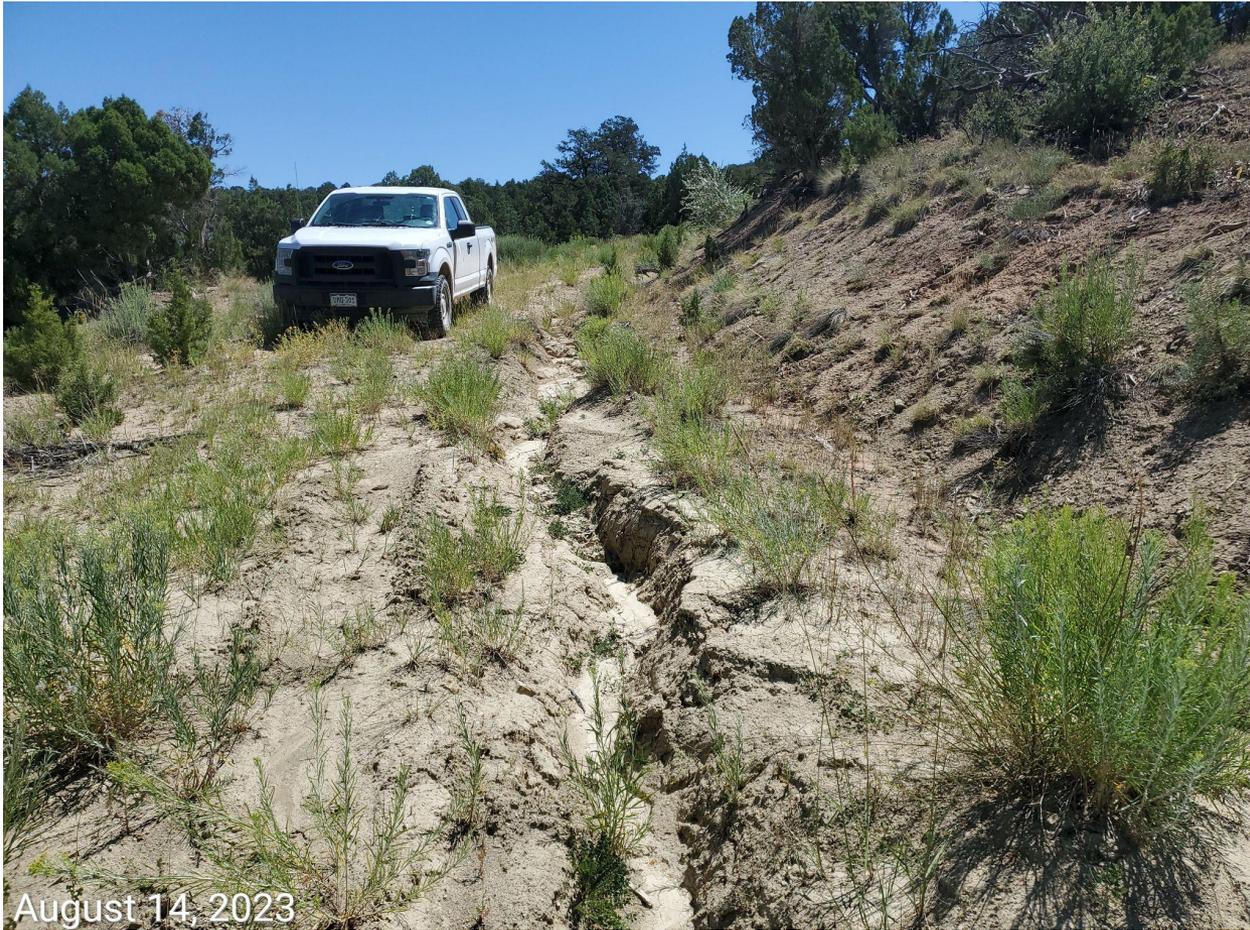
Photo 11: Photo example showing persisting erosion degradation along access road. Stormwater and erosion control measures remain inadequate. Access road has not been decompacted, recontoured, regraded and reclaimed in accordance with 1004 Rules.

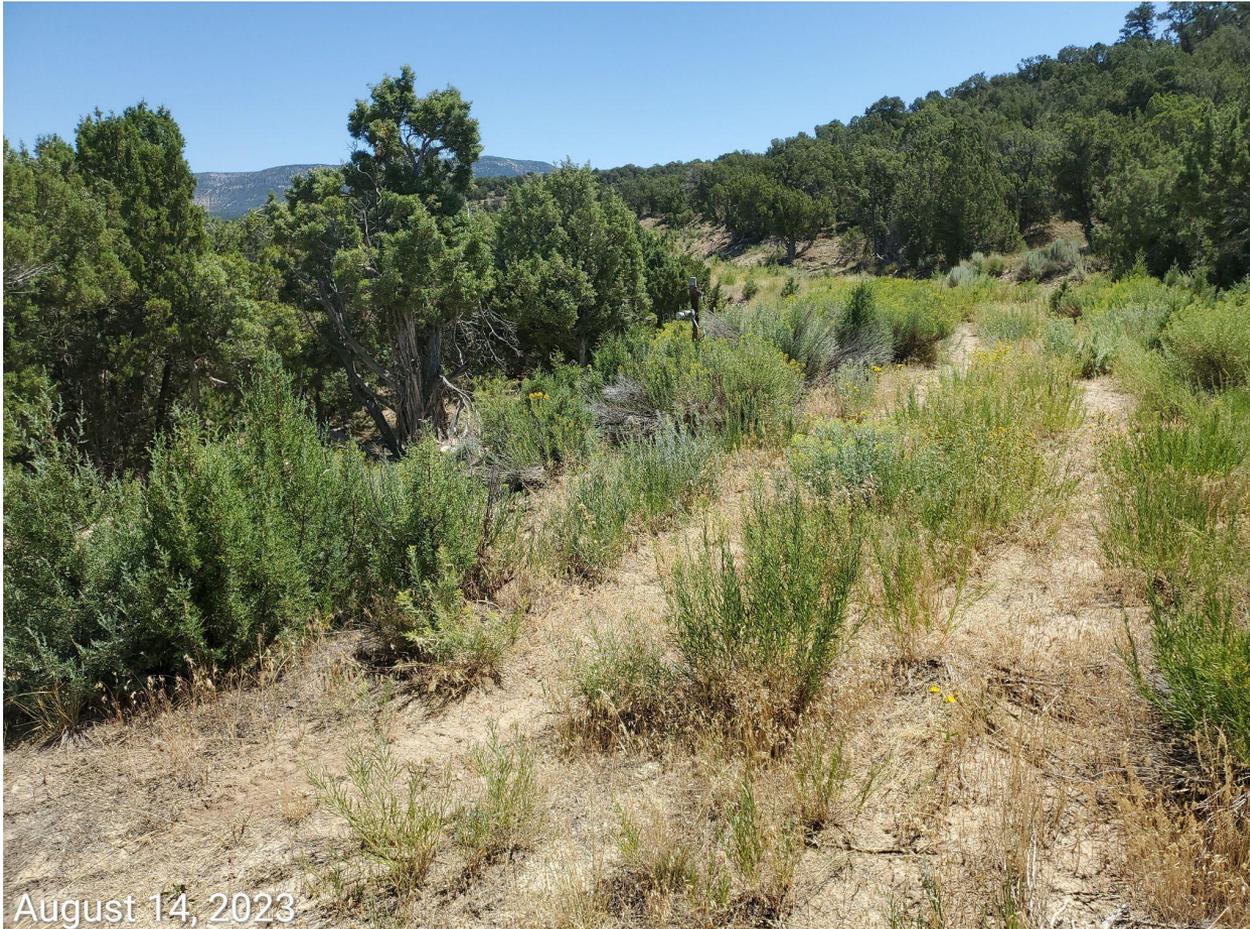
Photo 12 Photo shows riser equipment remaining along access road. Photo also shows access road has not been decompacted, recontoured, regraded and reclaimed in accordance with 1004 Rules
