Inspection Photos

8/14/2023

Operator: GENESIS GAS & OIL COLORADO LLC
- 10384

Location Number: 316583
Rio Blanco County, CO

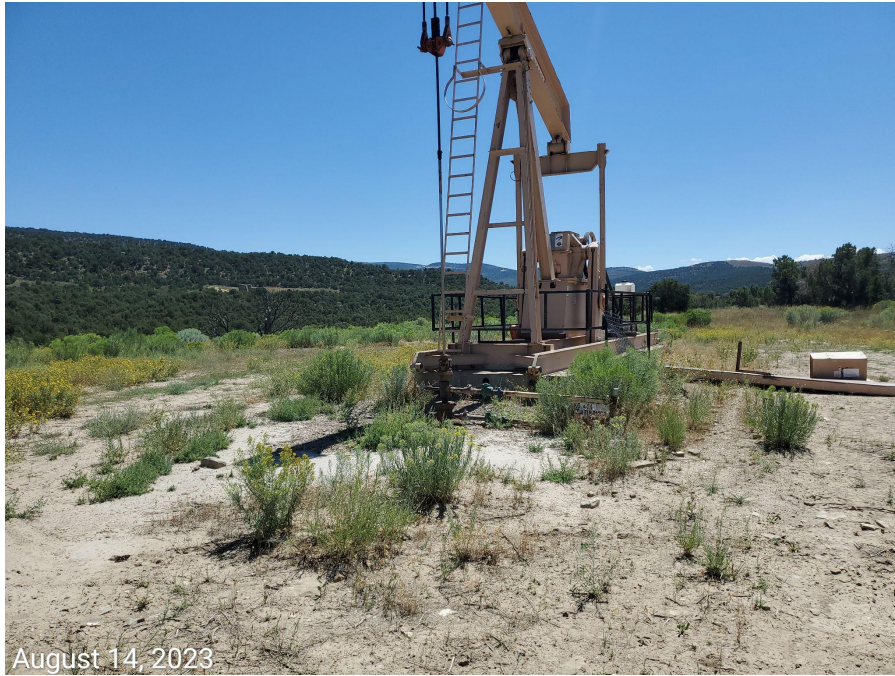
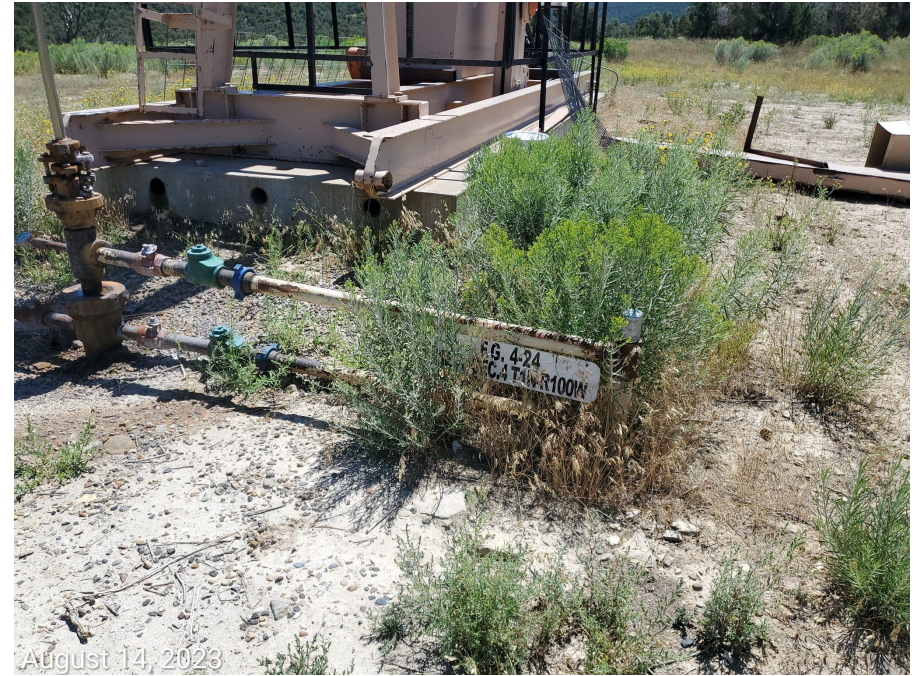
Photo 2: Photos show vegetation established around production area; this is a potential fire hazard and requires removal; undesirable plant species established throughout Location. Photo right also shows signage at the well does not comport with 605.d requirements.

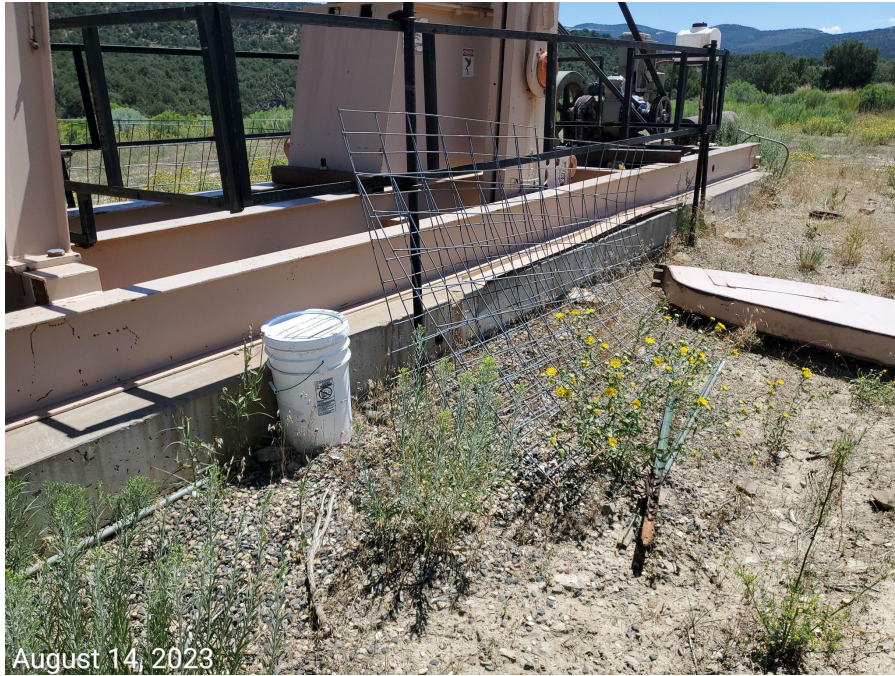
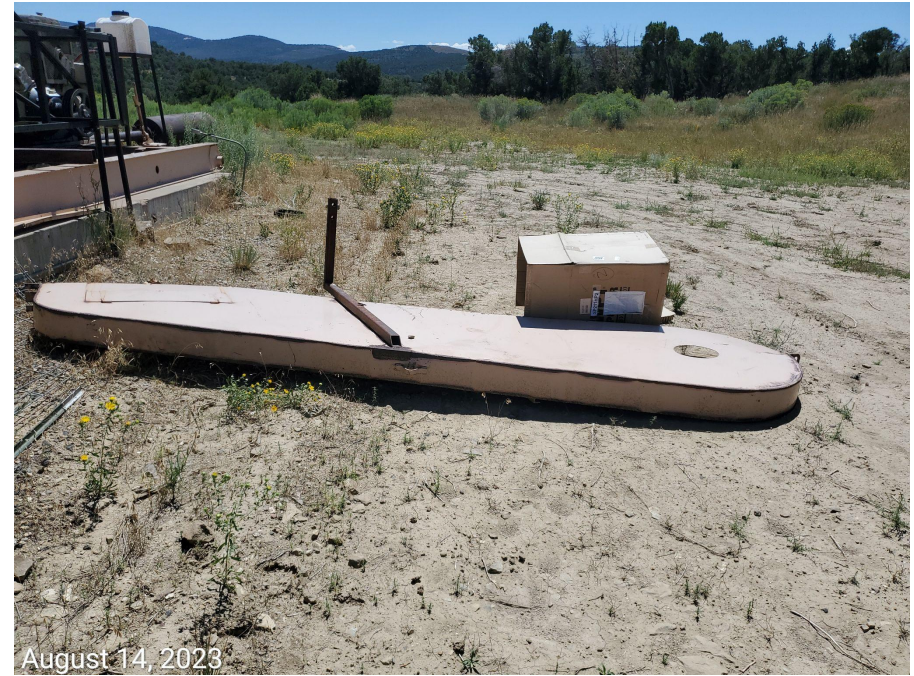
Photo 3: Photos show trash debris and unused equipment not stored in a workmanlike manner. Unused equipment, or equipment not necessary for production requires removal.

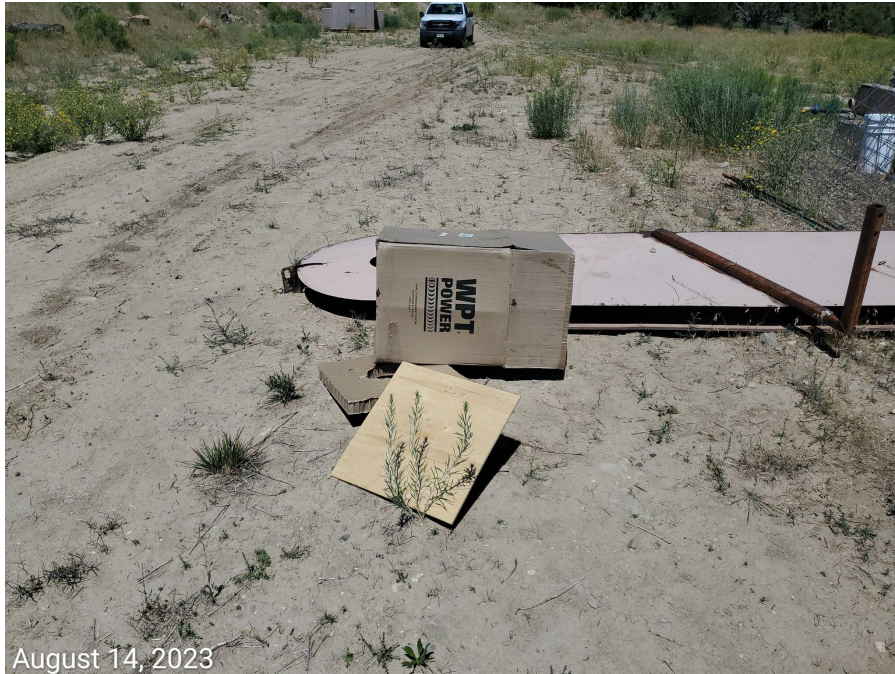
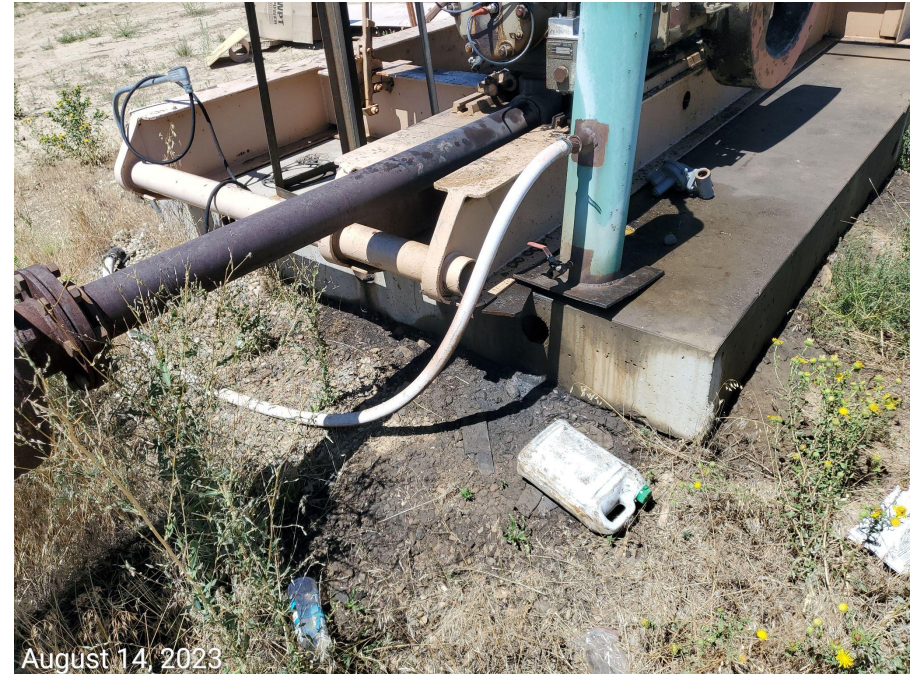
Photo 4: Photos show trash debris on Location. Photo right also shows stained soils due to leak at pumpjack; stained soils apparent around entire unit.

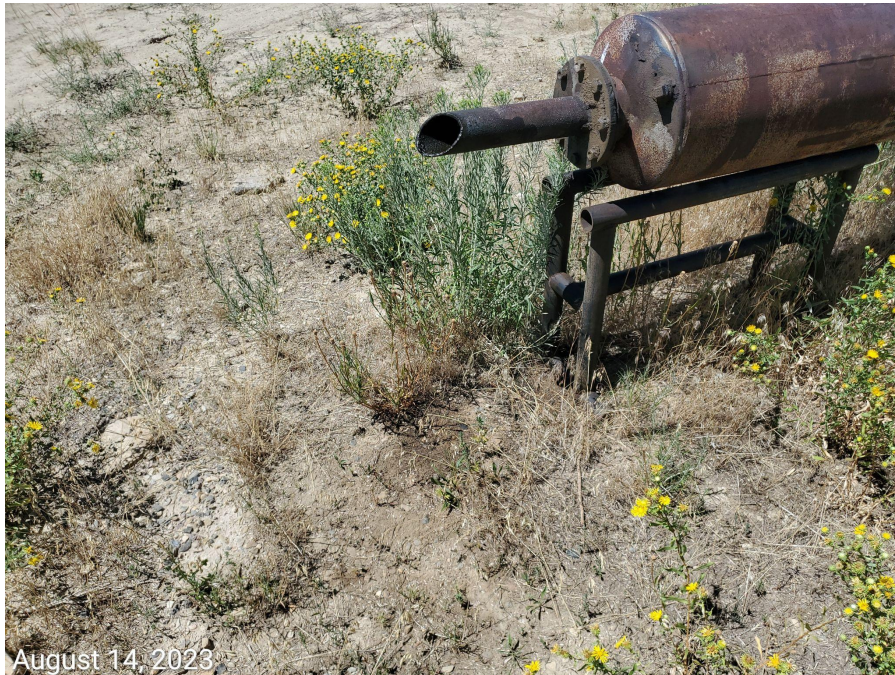
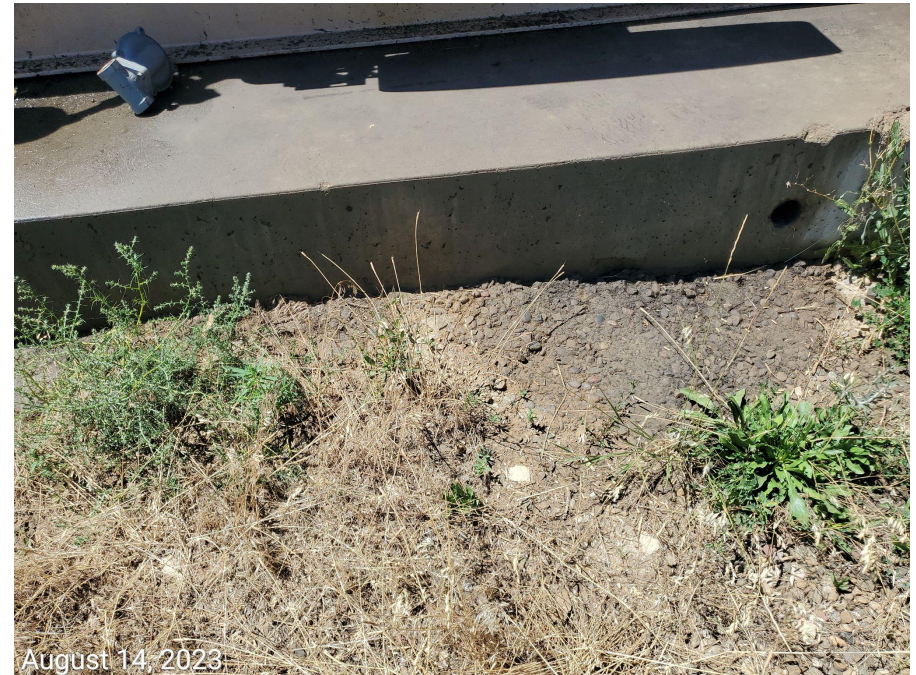
Photo 5: Stained soils observed below muffler, and at the base of the pump-jack.

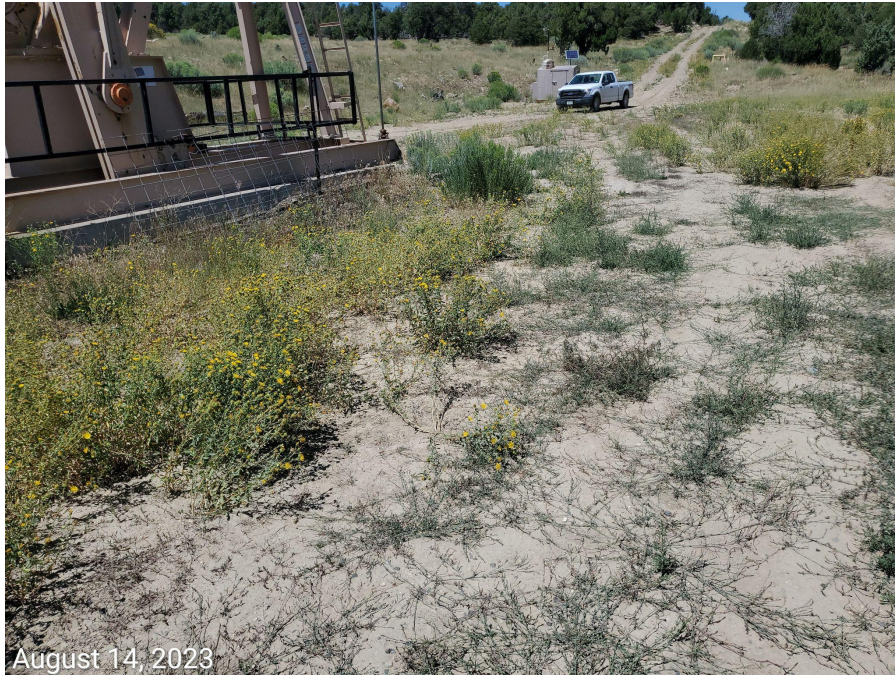
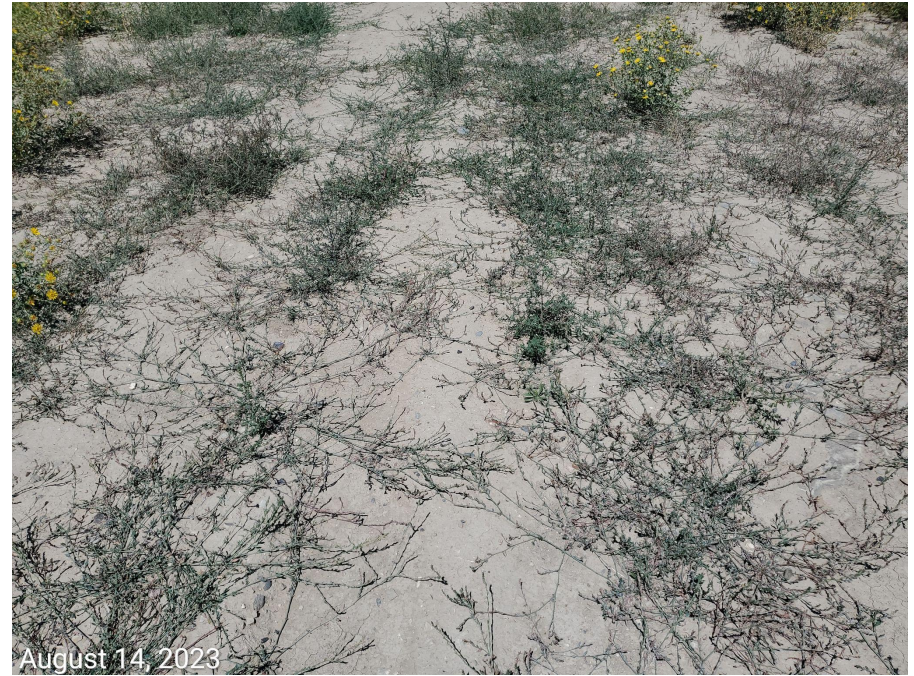
Photo 6: Photos show Undesirable and Noxious Plant Species (Russian thistle, Knotweed, etc..) established on the Location, and around production equipment.

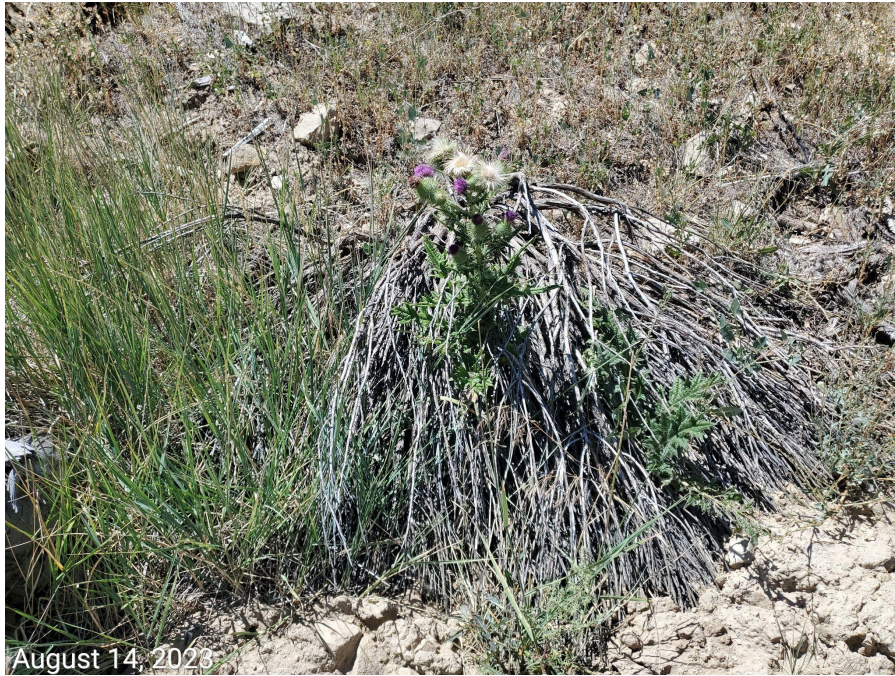
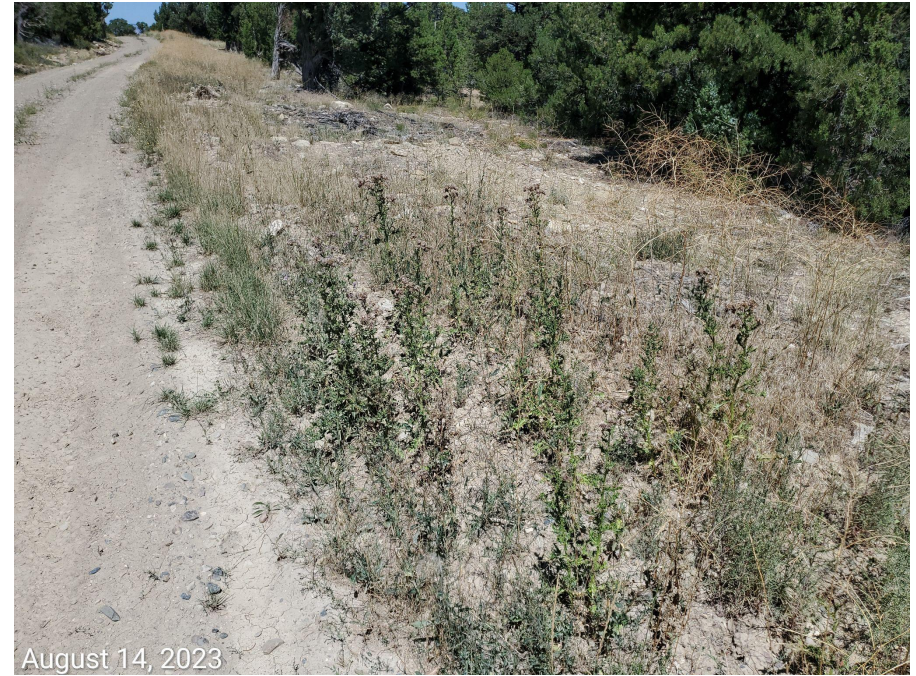
Photo 7: Photos show Undesirable and Noxious Plant Species (Bull thistle, Canada thistle) established on the Location, and access road.
