Final Reclamation and Stormwater Inspection

Operator: ROSEWOOD RESOURCES INC - 75027

Location ID: 303013

Inspection Photos
Location Name: Lott 1-35
Location ID: 303013

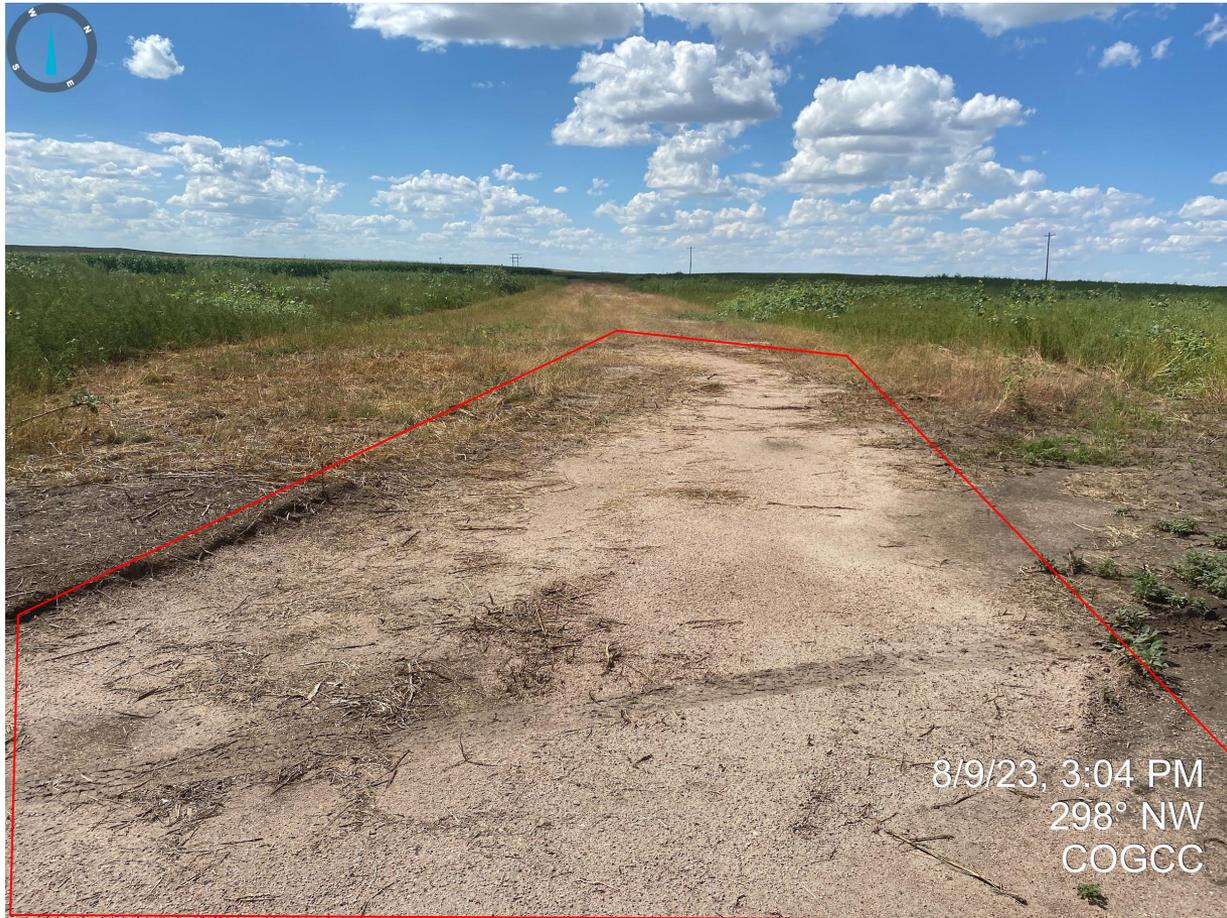
Photo 1. Road base/gravel remains on the former access road and will need to be removed per Rule 1004 regulations and standards.

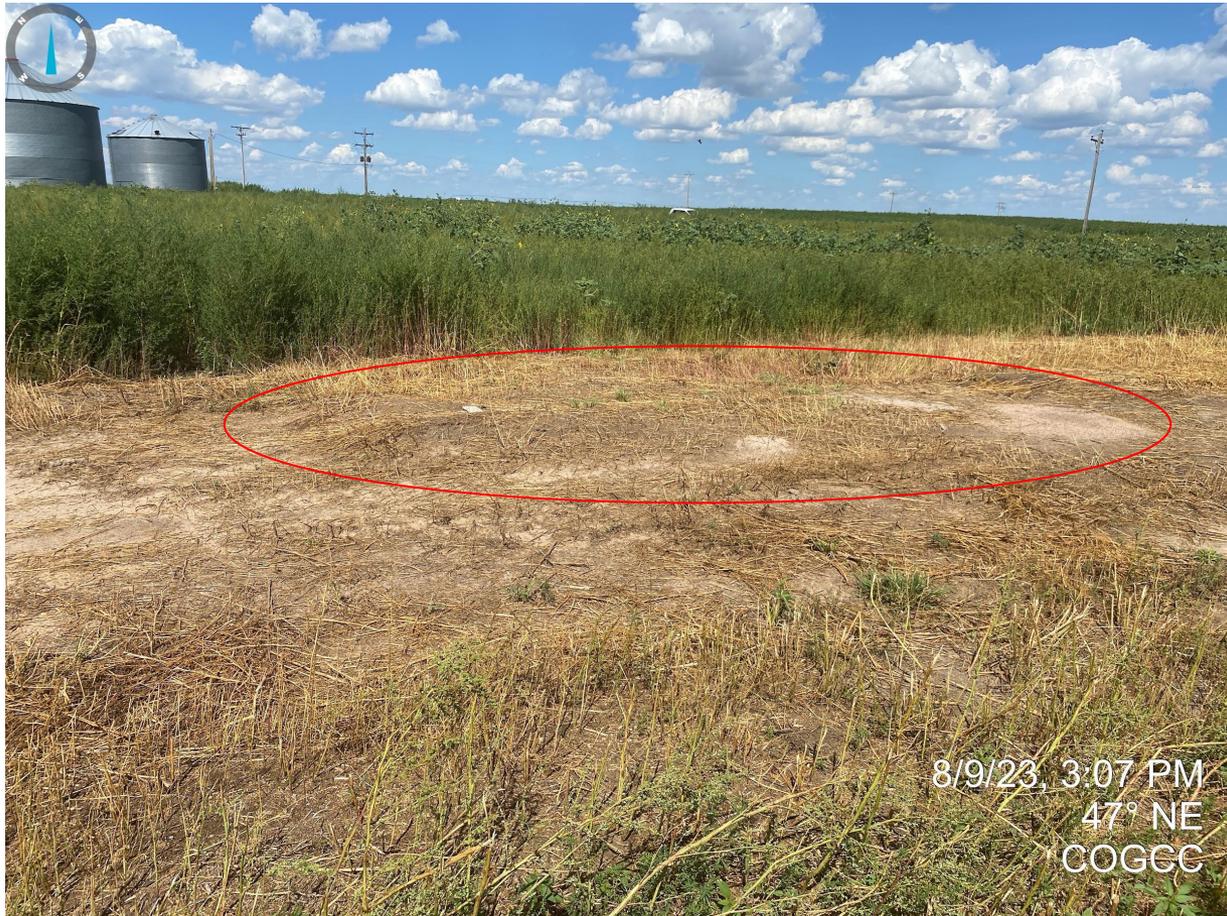
Photo 2. The former location will need to be leveled/graded as there was evidence of contouring issues at the time of this inspection (highlighted in red).

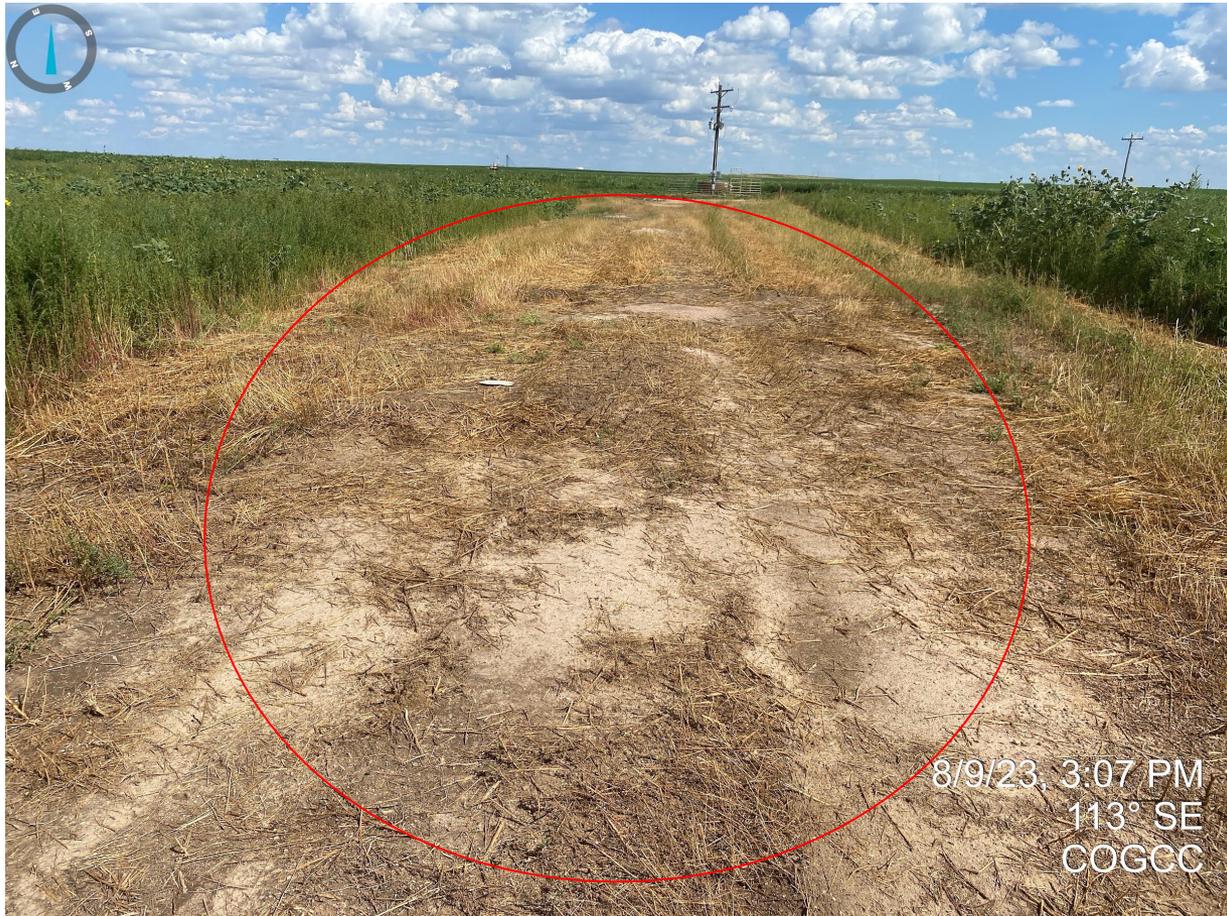
Photo 3. See comments in Photo 2.

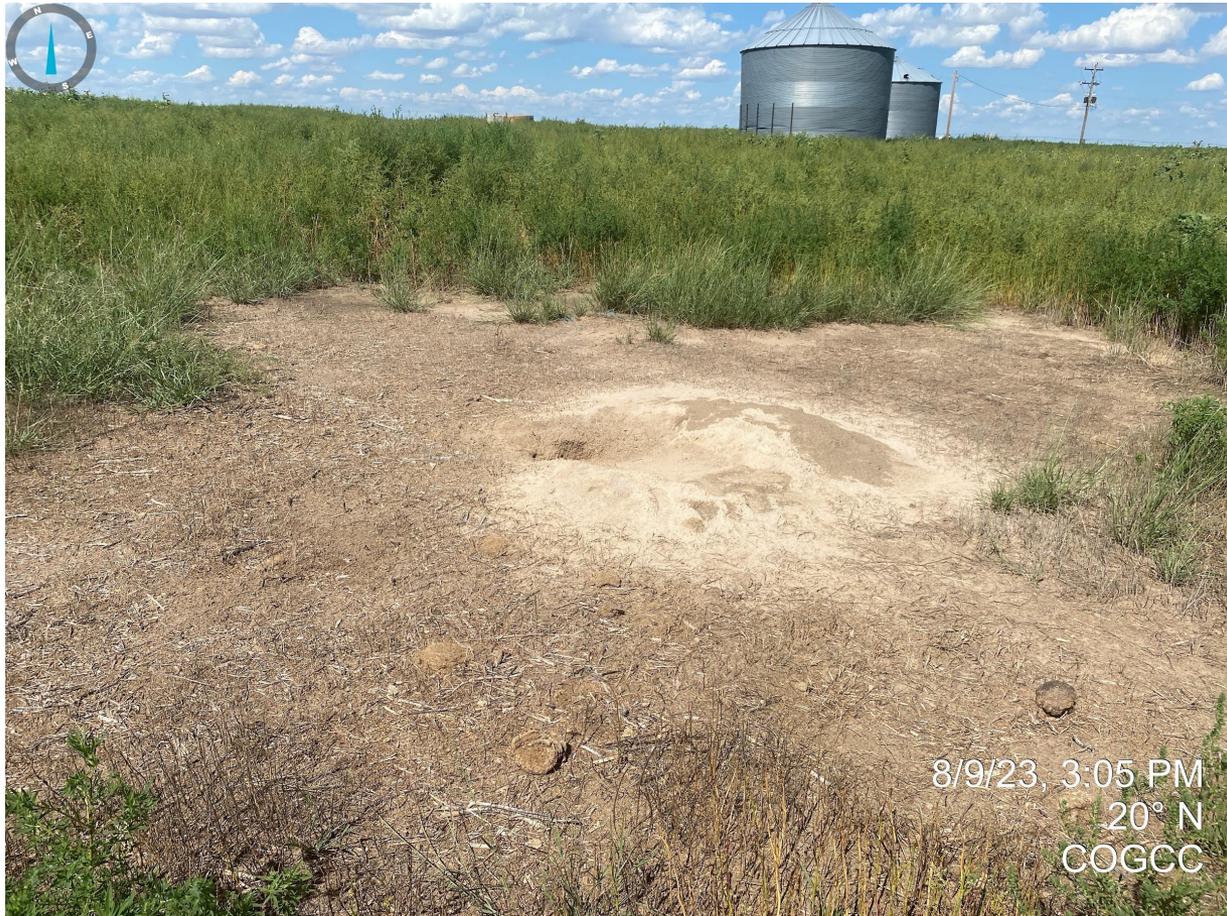
Photo 4. The former well location does not appear to be progressing towards Rule 1004 reclamation standards. Evidence of bare/exposed soil was observed, possibly a result of compaction issues or soil suitability exceedances. Further soil investigation and/or reclamation activities are required.
