#1 - Phelps Facility

Photo Log

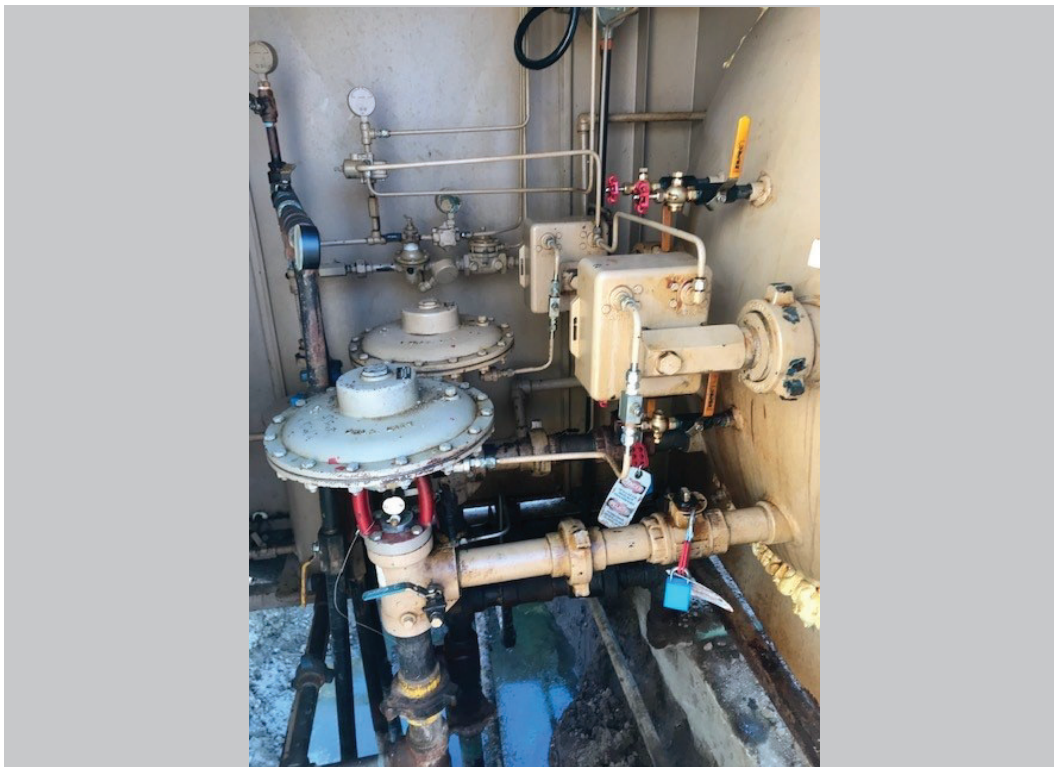
#2 - Looking North into Doghouse where Sight Glass Failed. Note Presence of Groundwater in Floor of Excavation.

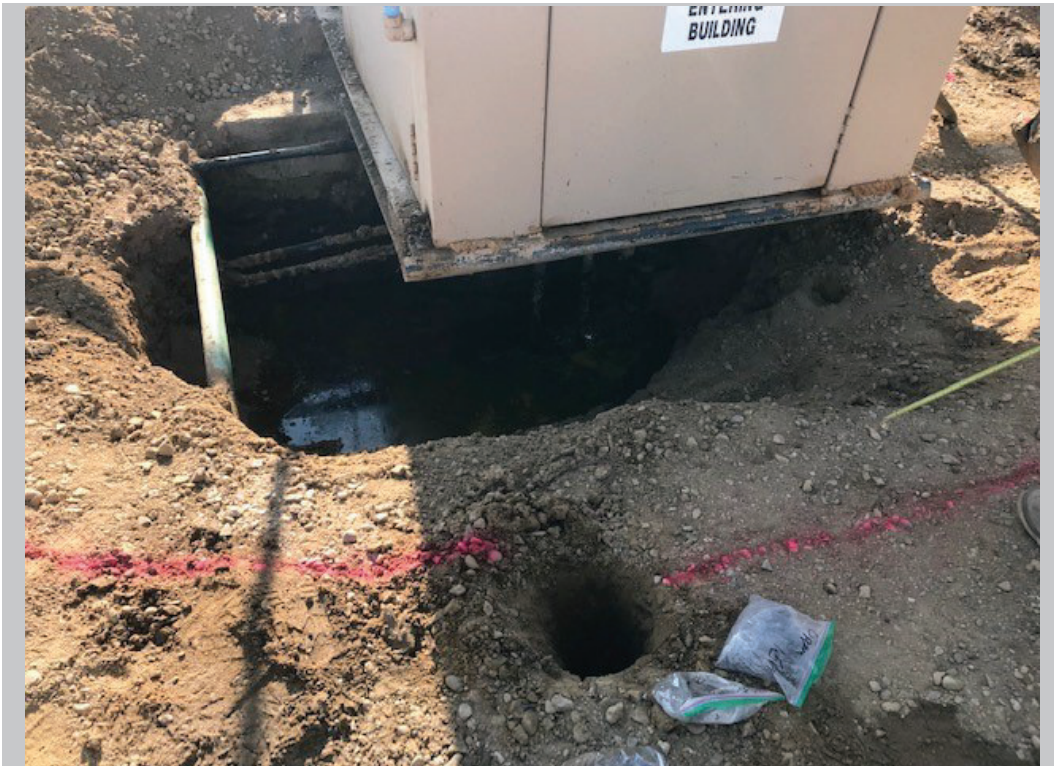
#3 - Looking East at Separator. Groundwater is present in Excavation. Hand augered boring has delineated extent of impacts.

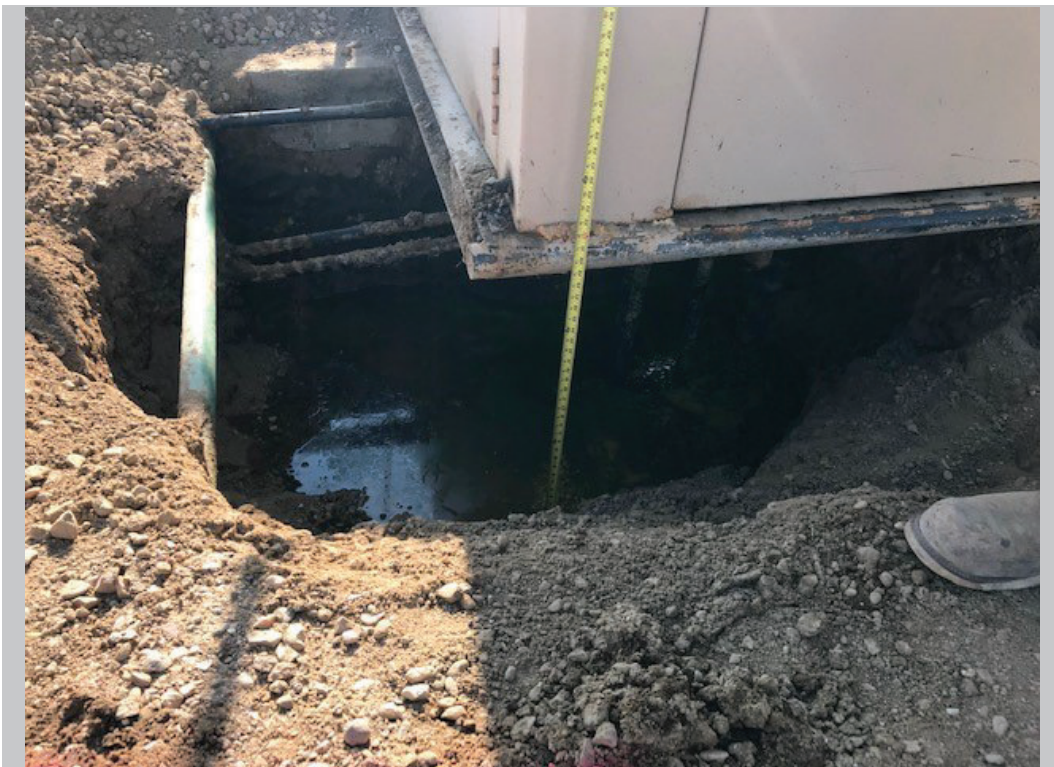
#4 - Depth to Groundwater is Approximately 2.5 Feet. Free phase oil was present on Groundwater.
