Third Party Flowline Abandon in place Verification Letter

Wardell 7A 1

Client: Crestone Peak Resources Operating LLC

Facility Name: Wellhead Line 7 SESE

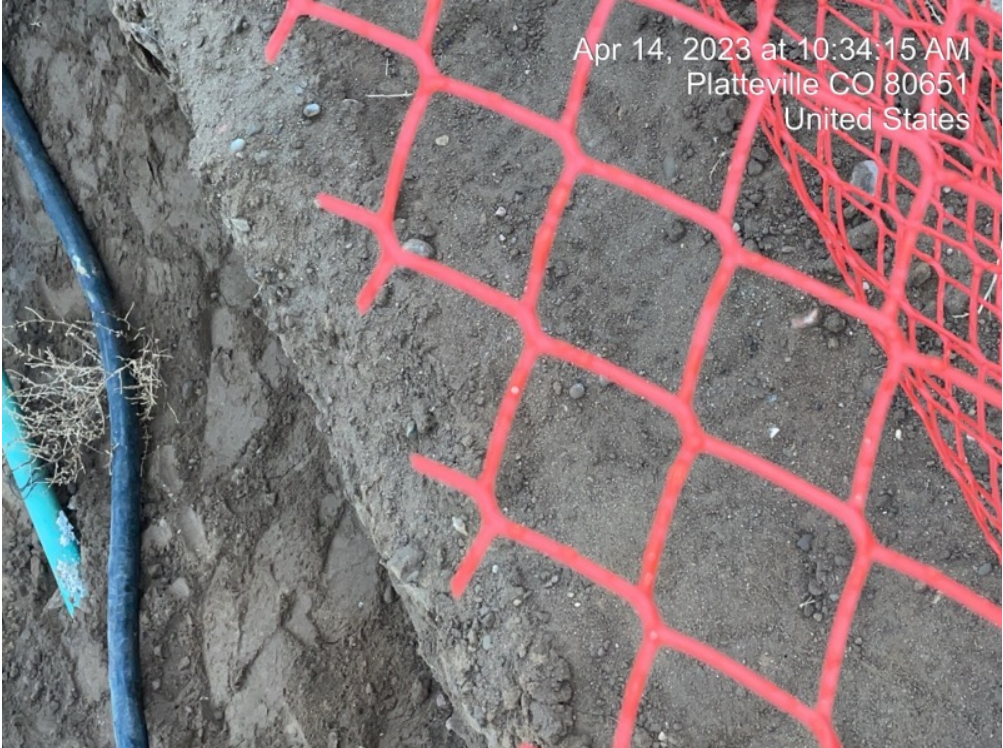
Information		Photo
Photo #: Location: Description:	1 Wellhead End A prior to flushing activity

Prior to flushing operations, end A was uncapped at 10:30 AM and end B was uncapped at 10:27 AM per attached report and released to atmospheric pressure. Upon fluid evacuation described above, the hydrovac hoses and valve sets were safety removed allowing the flanged pipe ends full exposure to normalize to atmospheric pressure.

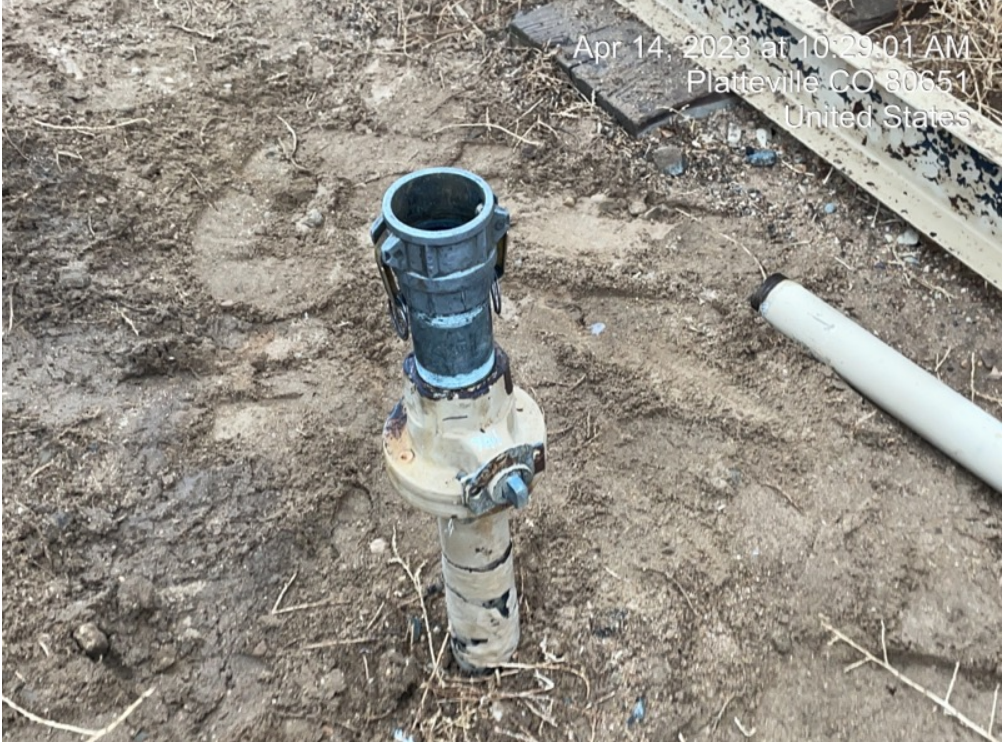
<p>Apr 14, 2023 at 10:34:15 AM Platteville CO 80651 United States</p>
Photo #: Location: Description:	2 Separator End B prior to flushing activity

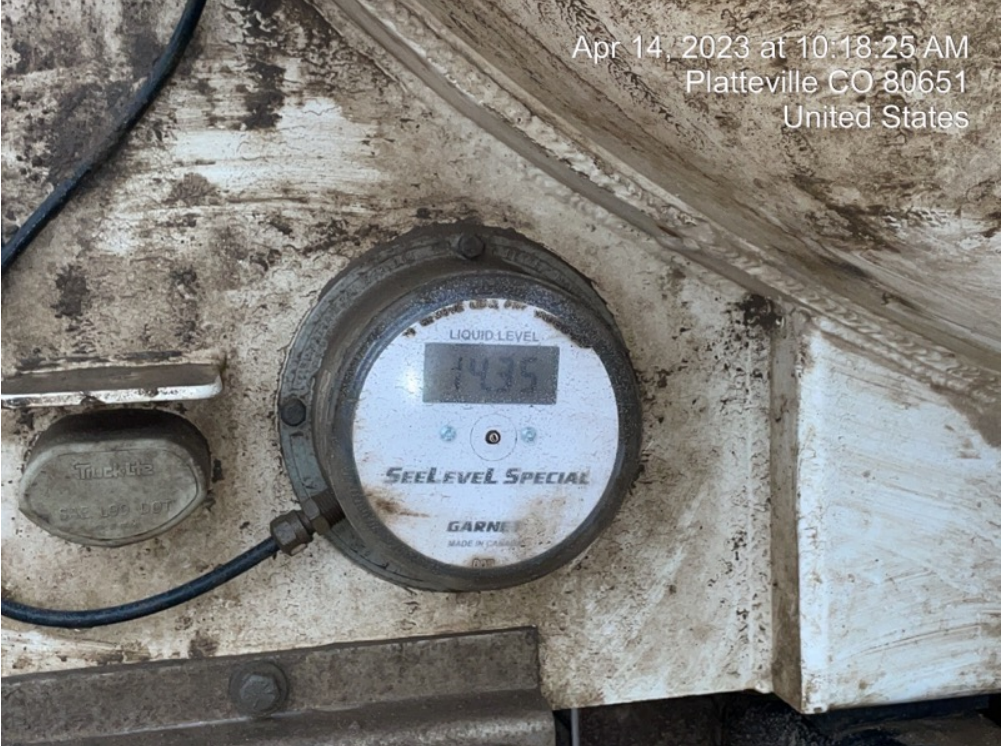
Information		Photo
Photo #: Location: Description:	3 Wellhead Vacuum truck meter prior to flushing activity

The line was flushed using two hydrovac trucks. A total of 20.75 barrels of freshwater was used to flush and evacuate the flowline. All water and fluids from the pipe were removed from the site and properly disposed of.

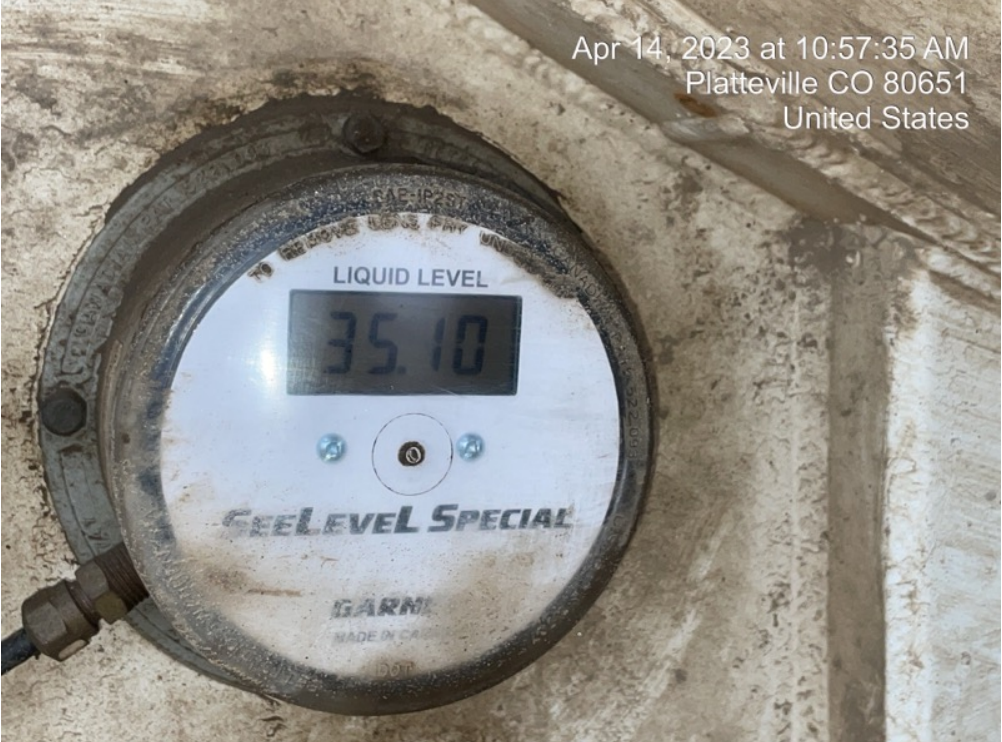
<p>Apr 14, 2023 at 10:18:25 AM Platteville CO 80651 United States</p>
Photo #: Location: Description:	4 Wellhead Vacuum truck meter post flushing activity
