Third Party Flowline Abandon in place Verification Letter

Aristocrat Angus 33-2

Client: Crestone Peak Resources Operating LLC

Facility Name: Aristocrat Angus 33-2

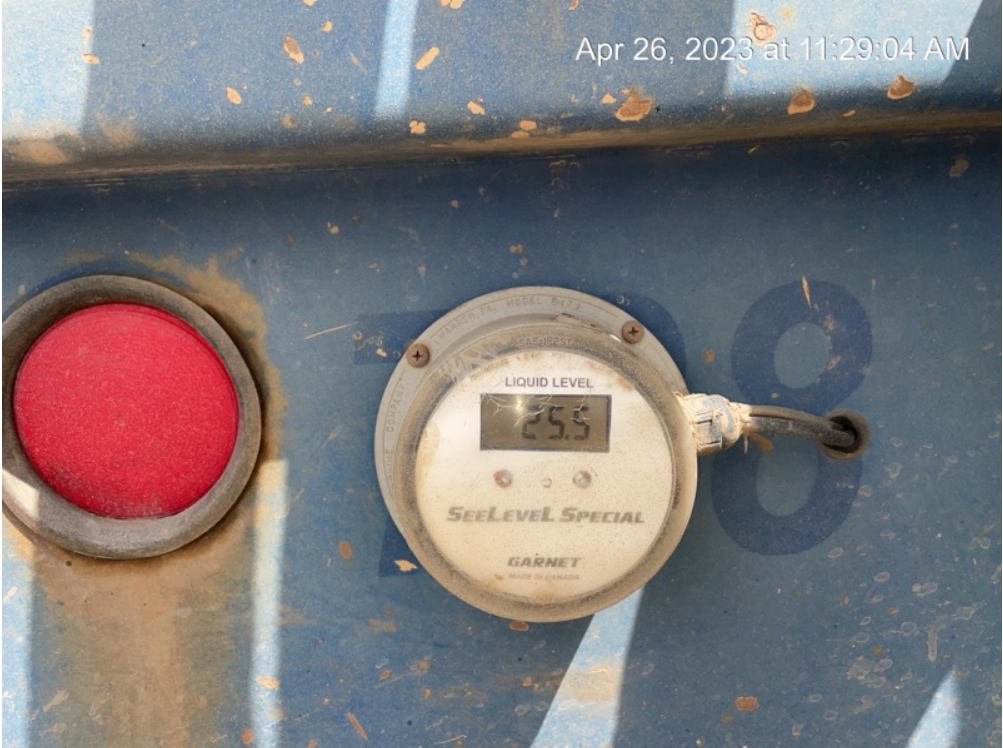
Information		Photo
<p>Photo #: Location: Description:</p>	<p>1 Separator Meter on hydro vac truck prior to flushing activity</p>

The line was flushed using two hydrovac trucks. A total of 25.5 barrels of freshwater was used to flush and evacuate the flowline. All water and fluids from the pipe were removed from the site and properly disposed of.

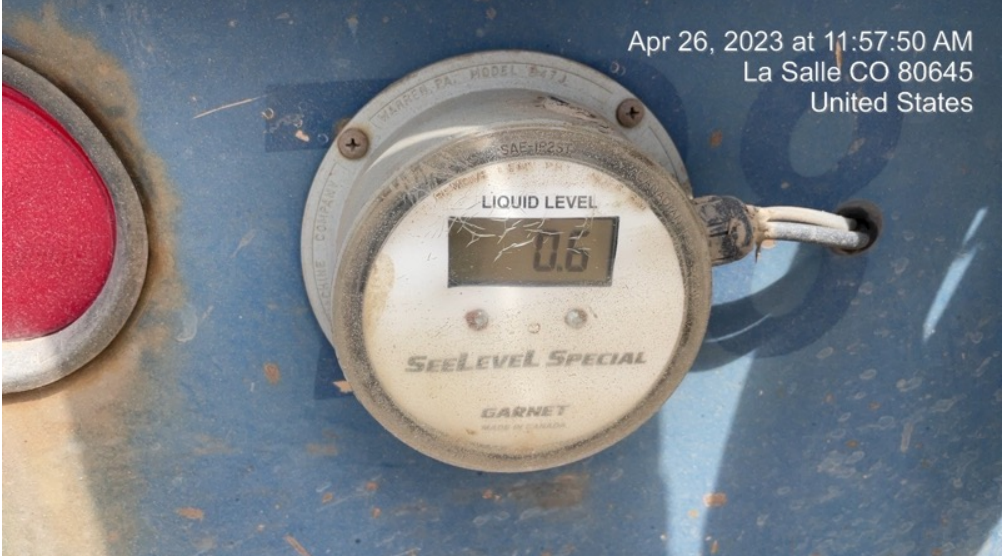
<p>Apr 26, 2023 at 11:29:04 AM</p>
<p>Photo #: Location: Description:</p>	<p>2 Separator Meter on hydro vac truck post flushing activity. Please note that operator confirmed that the truck was empty.</p>

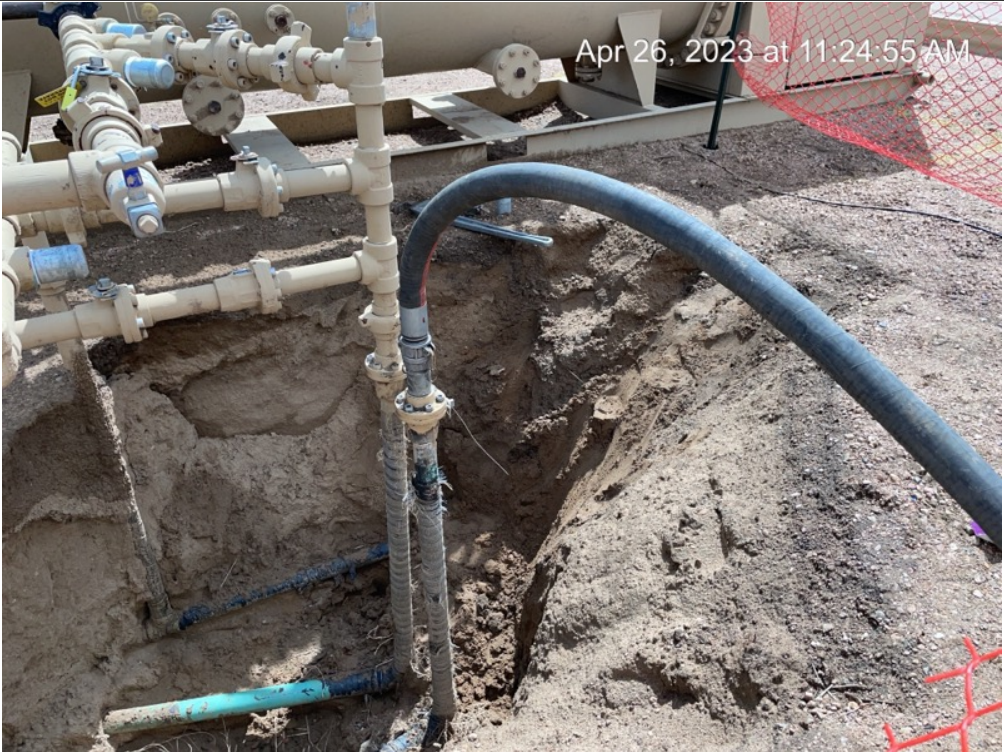
Information		Photo
Photo #: Location: Description:	3 Separator End B prior to flushing activity

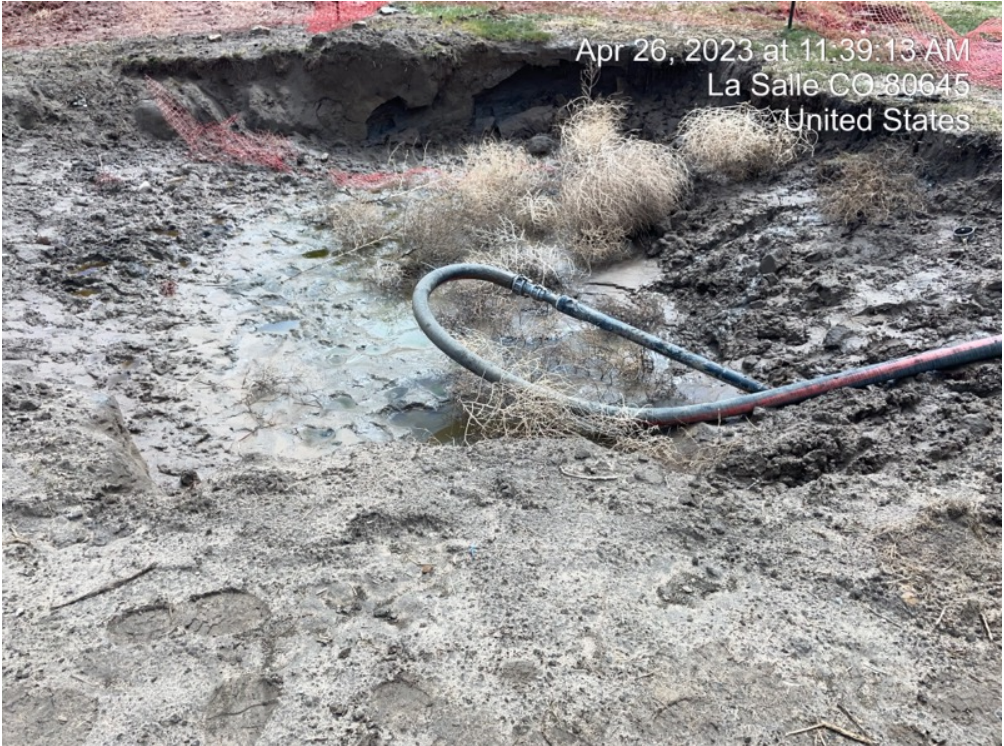
<p>Apr 26, 2023 at 11:24:55 AM</p>
Photo #: Location: Description:	4 Wellhead End A during flushing activity
