Operator: EXTRACTION OIL & GAS INC

Location Name: Lind 26-D

Loc ID: 458152

Inspection: 697007736

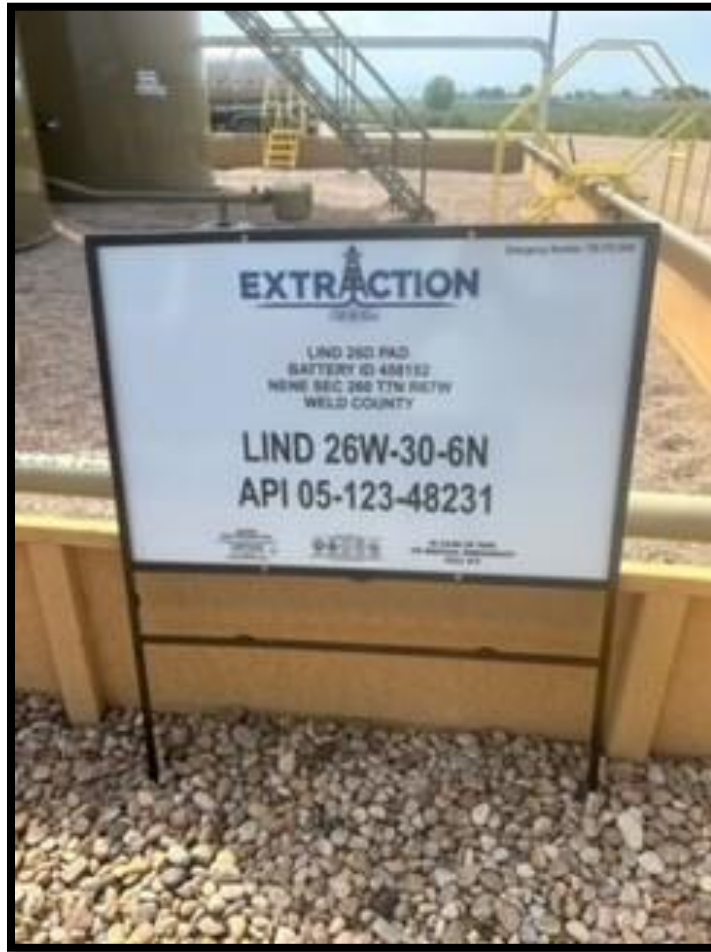
Exhibit A

CA: Sign not posted at battery. Install sign to comply with Rule 605.e.

CA Resolution: Field has reported and provided photo evidence that signage has been appropriately installed at the battery to comply with Rule 605.e.

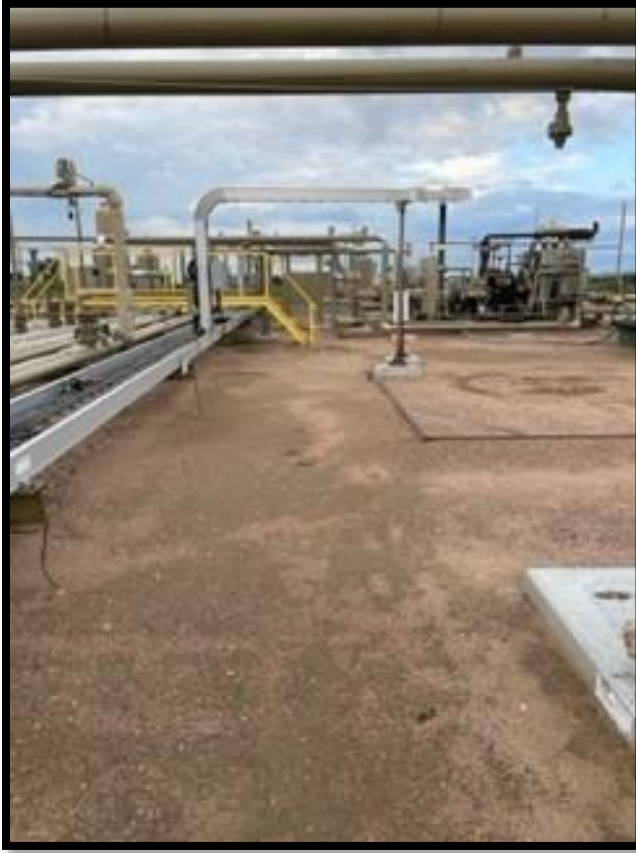
Exhibit A

CA: Miscellaneous equipment around location; see attached photos. Comply with Rule 606.

CA Resolution: Field has reported and provided photo evidence that the identified unused equipment has been removed from the location to comply with Rule 606.

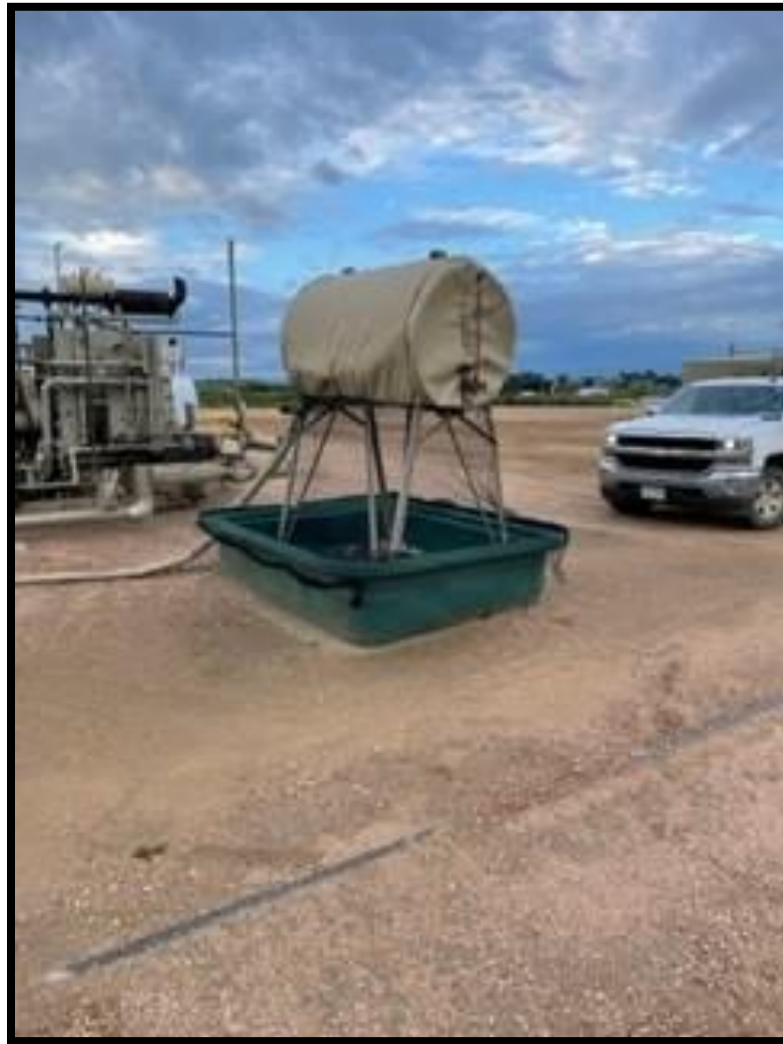
Exhibit A

CA: Bulk lube oil storage tank lacks wildlife protection, see attached photo. Install or repair wildlife protection equipment.

CA Resolution: Field has reported and provided photo evidence to show that netting for wildlife protection has been appropriately installed on the bulk lube oil storage tank to comply with Rule 902.b.
