# Inspection Photos

ID: 333719

Operator: OGRIS OPERATING LLC

Inspection Date: 8/21/2023

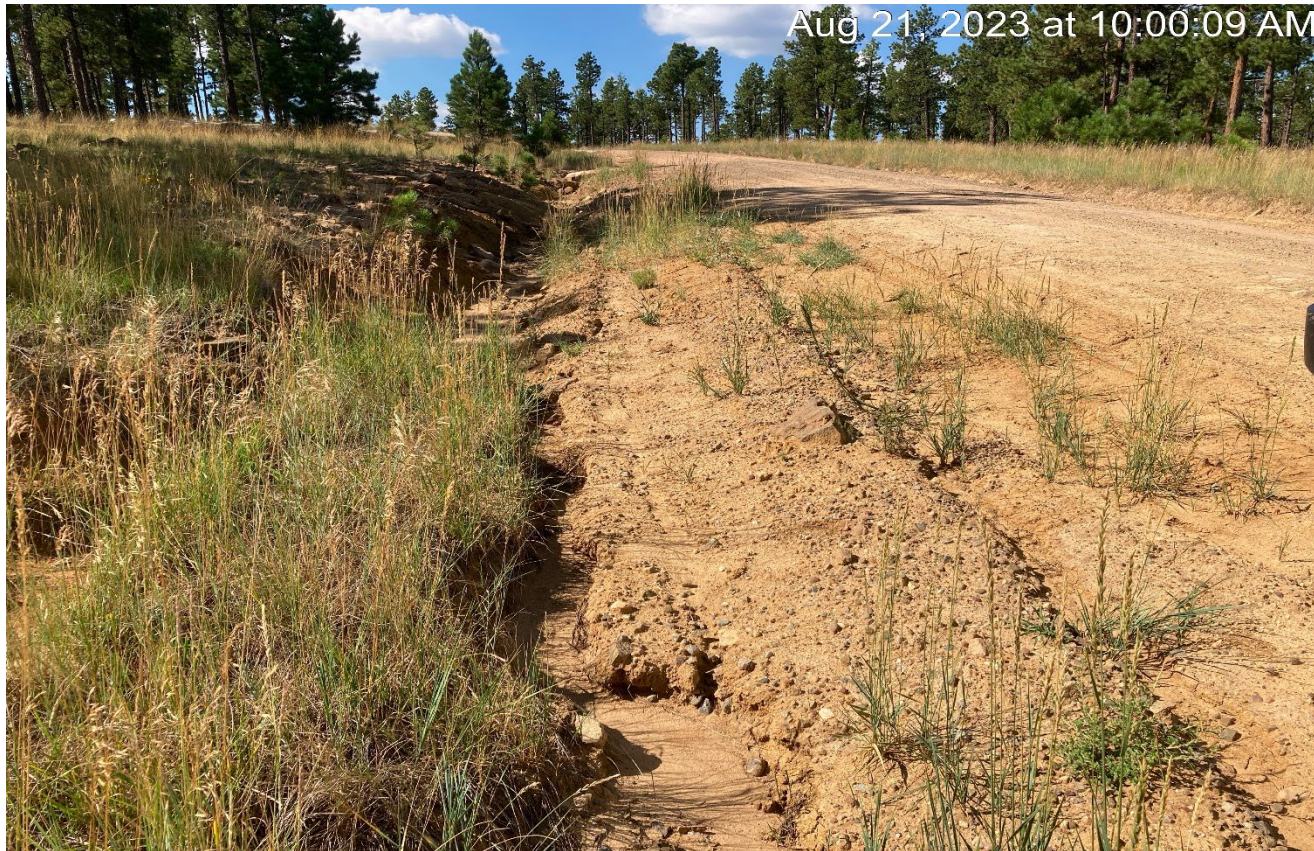
**Photo 1.** Facing southwest along the main access road at Lat/Long: 37.01620,-104.89531. There is erosion along this area which needs to be controlled.

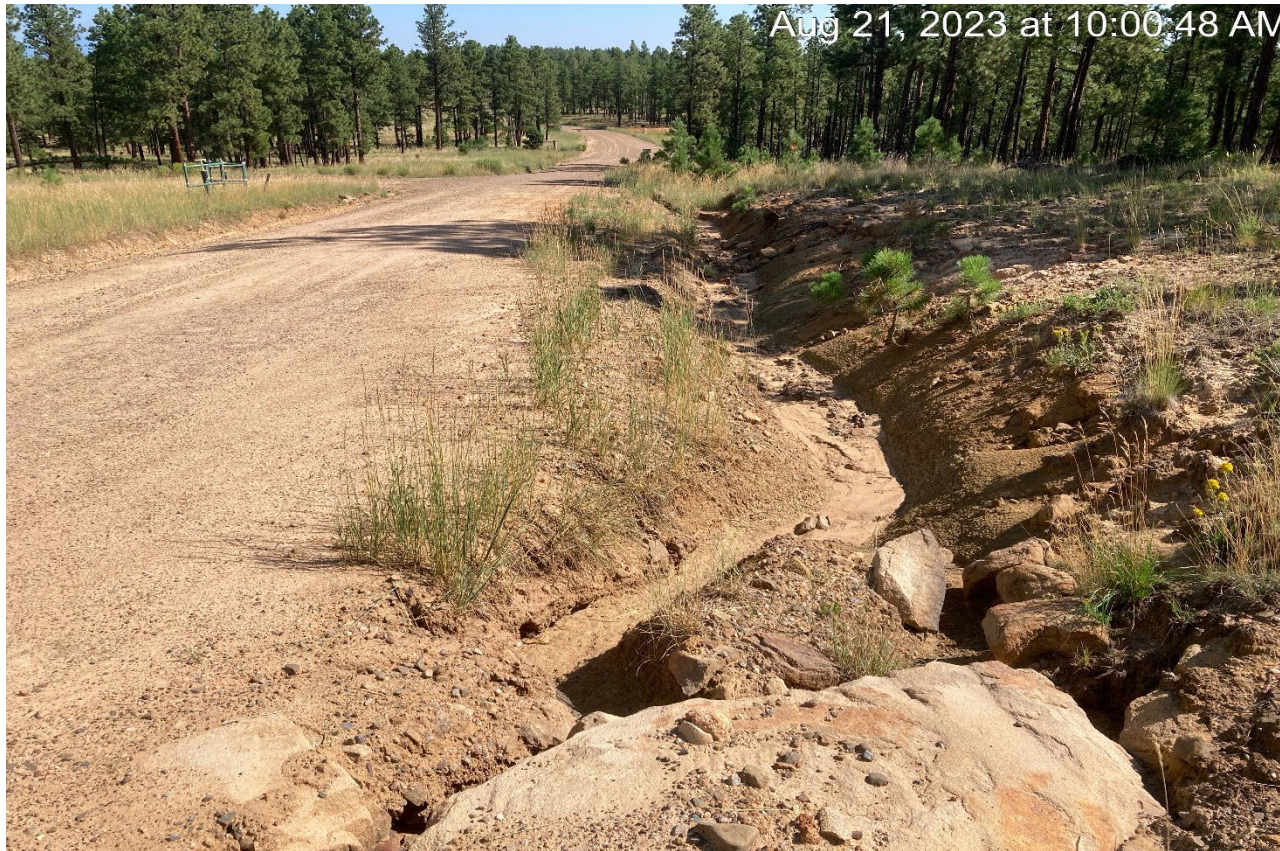
**Photo 2.** Facing northeast along the main access road at Lat/Long: 37.01620,-104.89531. There is erosion along this area which needs to be controlled.

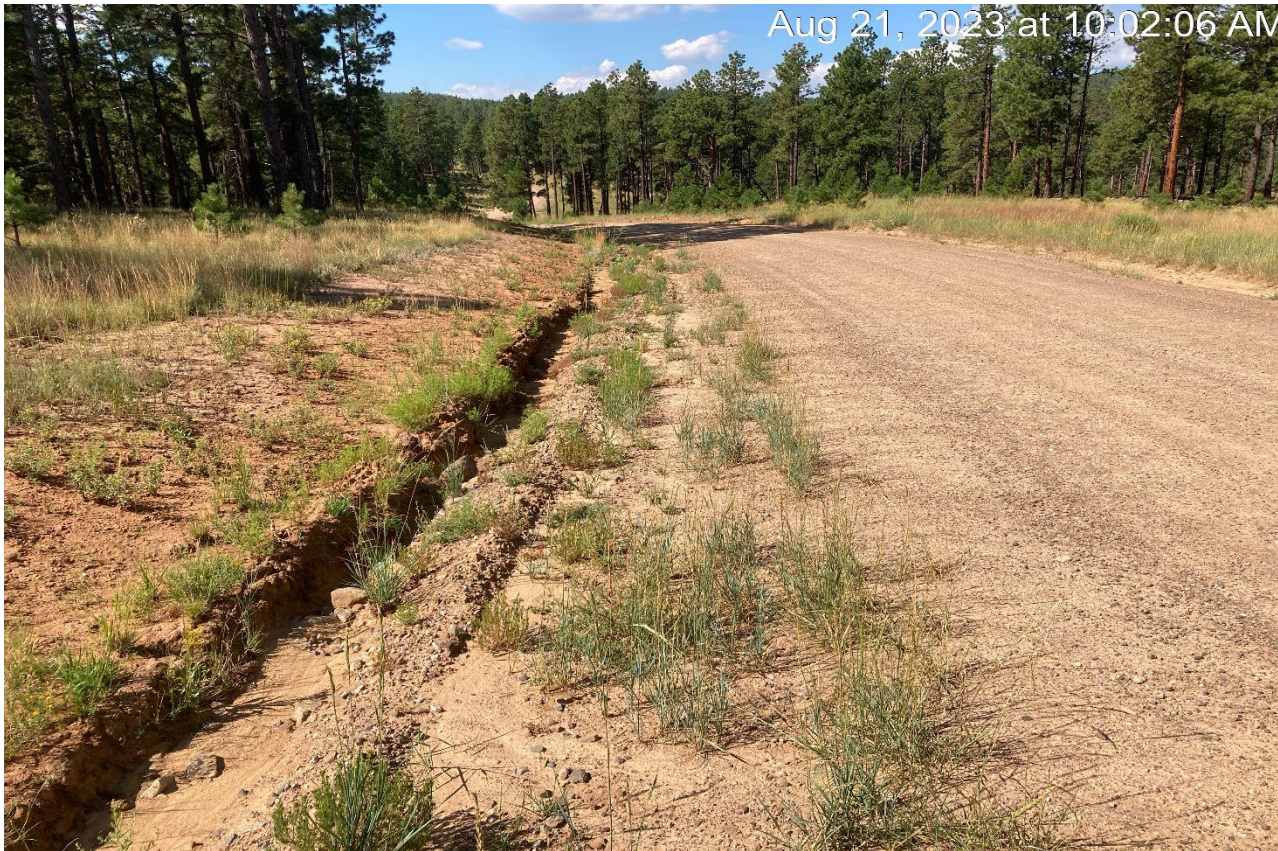
**Photo 3.** Facing south along the main access road. This area was graded and vegetation is establishing. Additional BMP's such as check dams may be needed to prevent erosion.

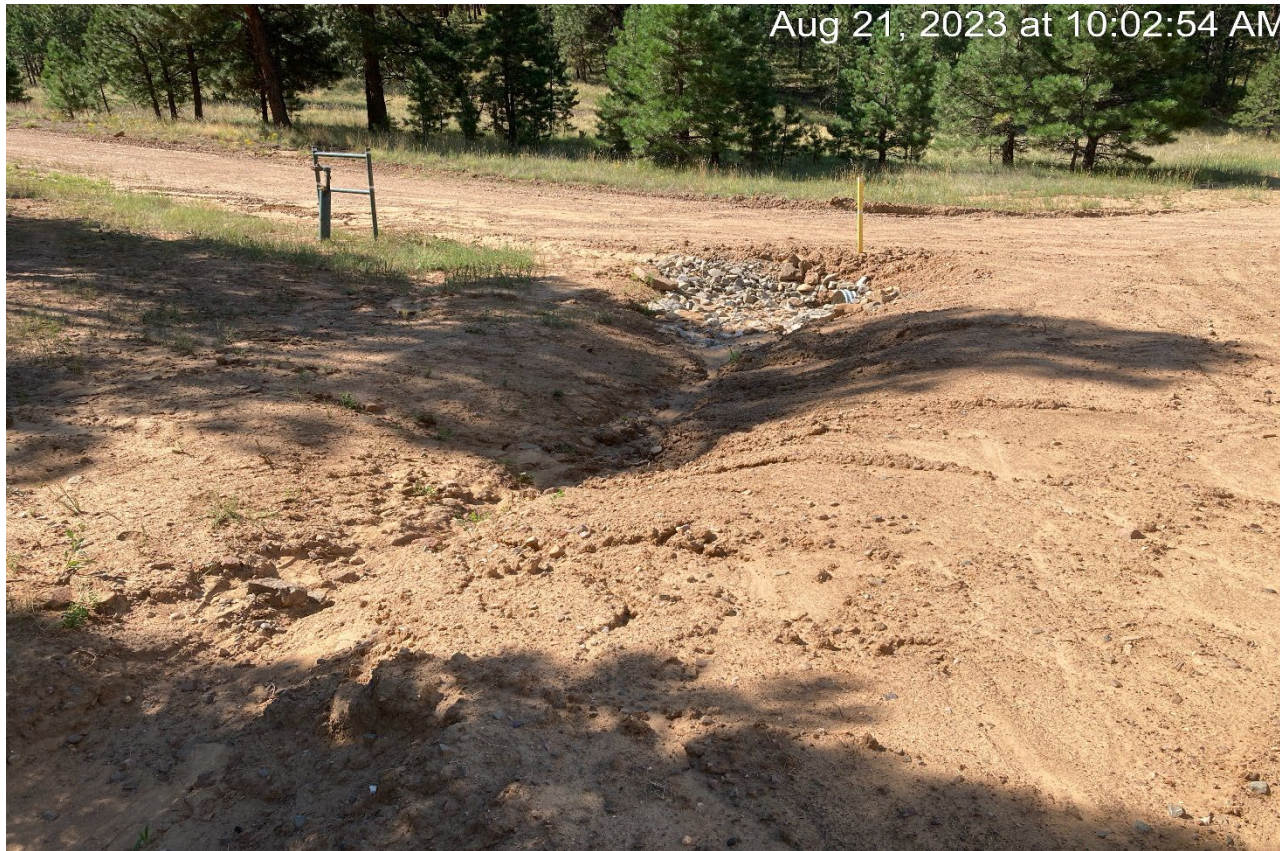
**Photo 4.** Facing southeast at Lat/Long: 37.01055, -104.89653. A culvert was installed at this area of the road. Disturbed soils need to be seeded and stabilized.

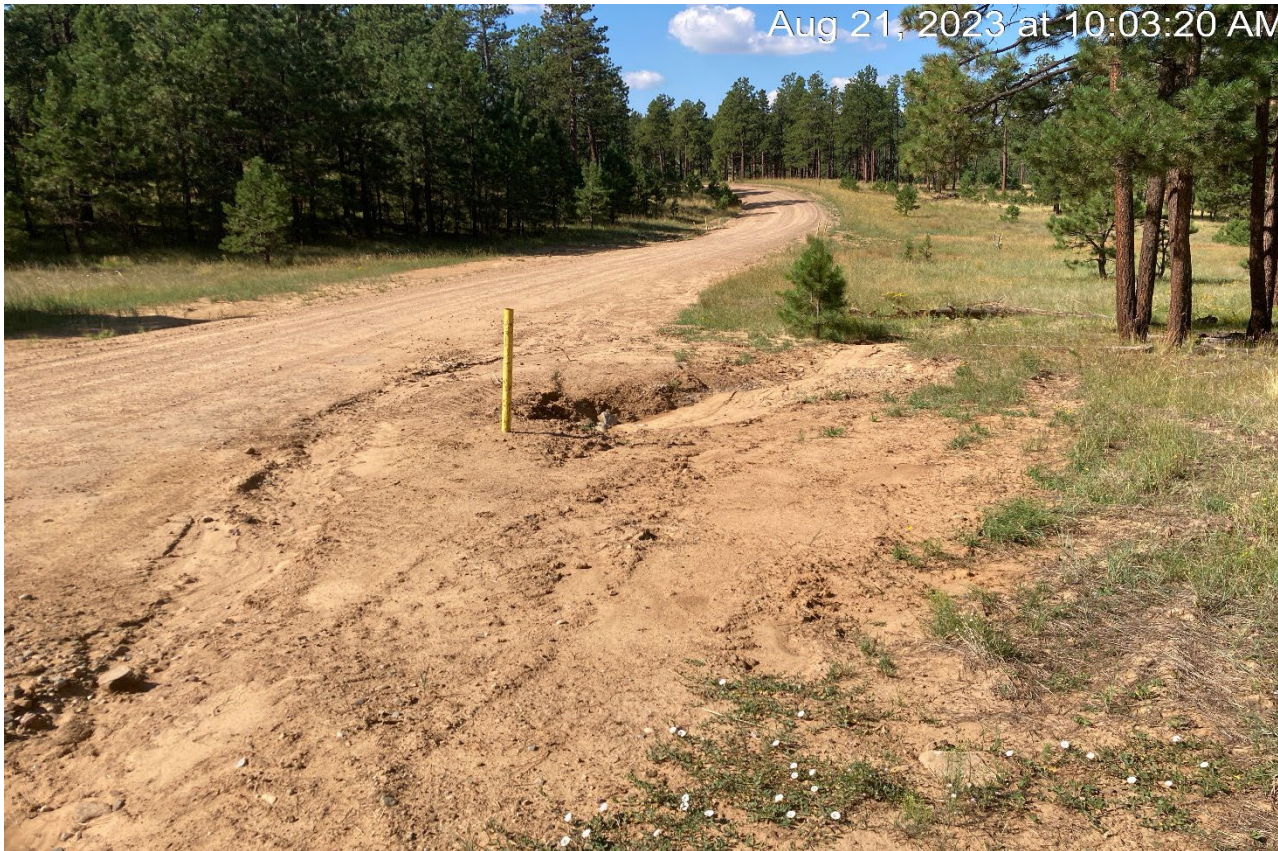
**Photo 5.** Facing southeast at Lat/Long:37.01055,-104.89653. A culvert was installed at this area of the road. Disturbed soils need to be seeded and stabilized.

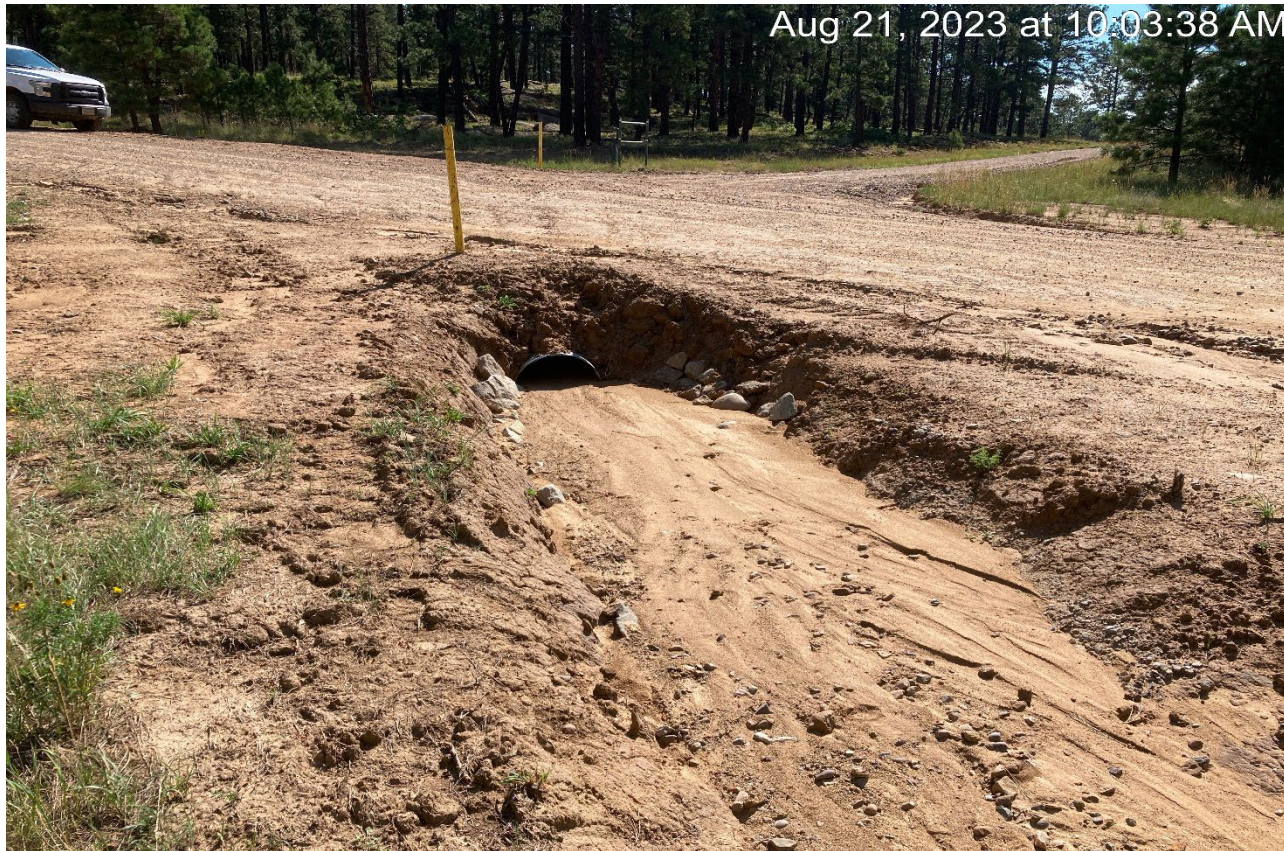
**Photo 6.** The culvert outlet is half full of sediment and needs to be cleaned out. A sediment trap could be beneficial to contain erosion.
