# Interim Reclamation and Stormwater Inspection

Date: 09/05/2023

Operator: YOUNG GAS STORAGE COMPANY LTD -  
98220

Location ID: 313960

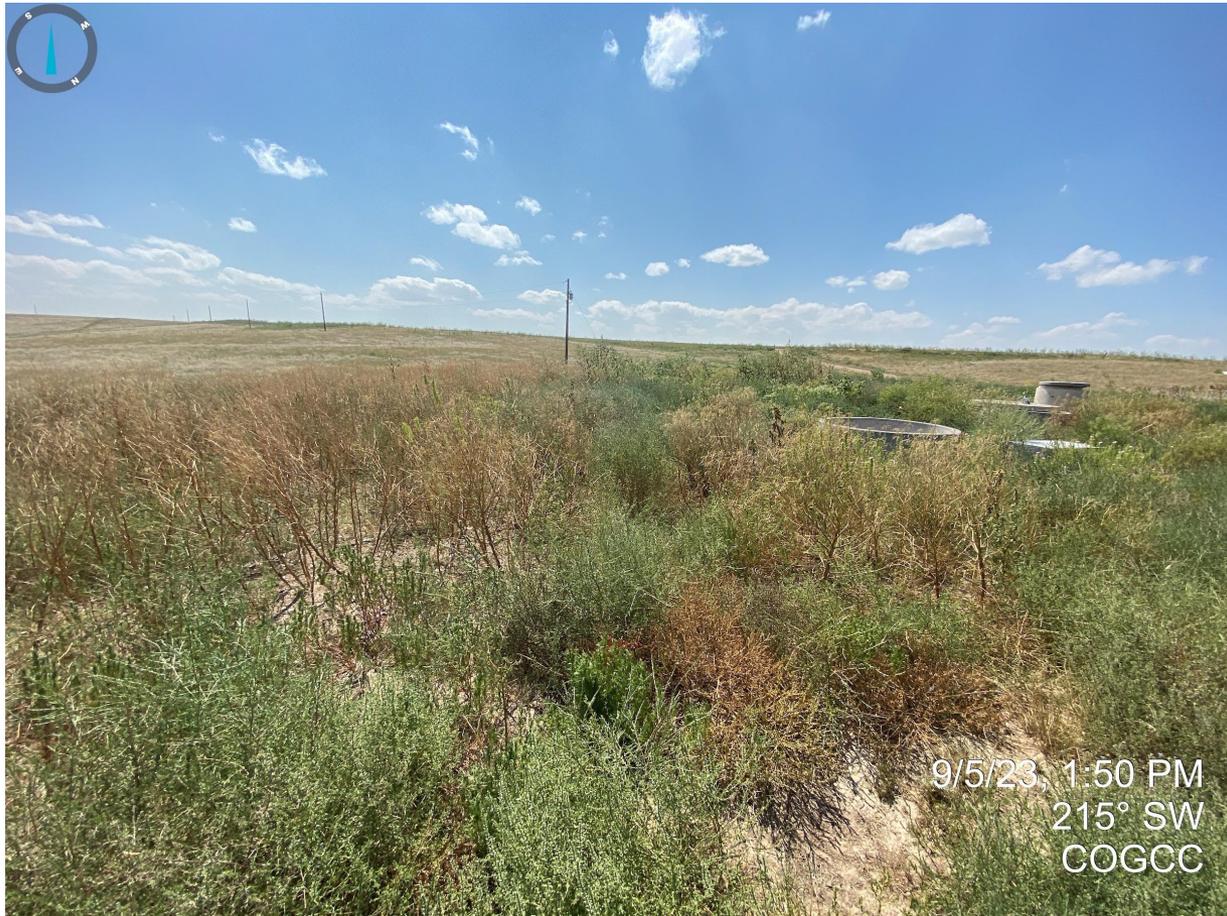
**Photo 1.** Taken from the southern portion of the location. The interim areas are predominantly undesirable vegetation (e.g. kochia and russian thistle). Additional management of weeds and interim reclamation activities are required.

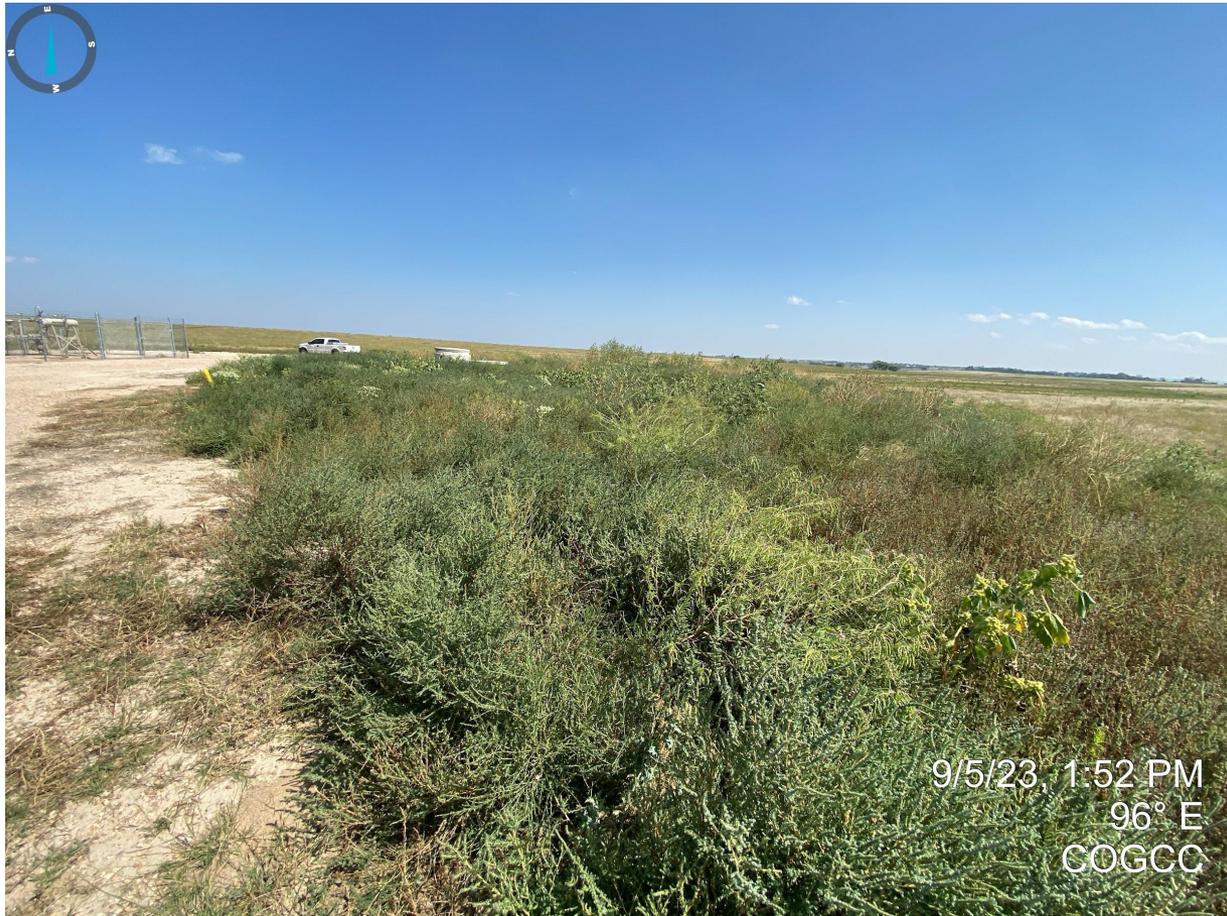
**Photo 2.** See comments in Photo 1.

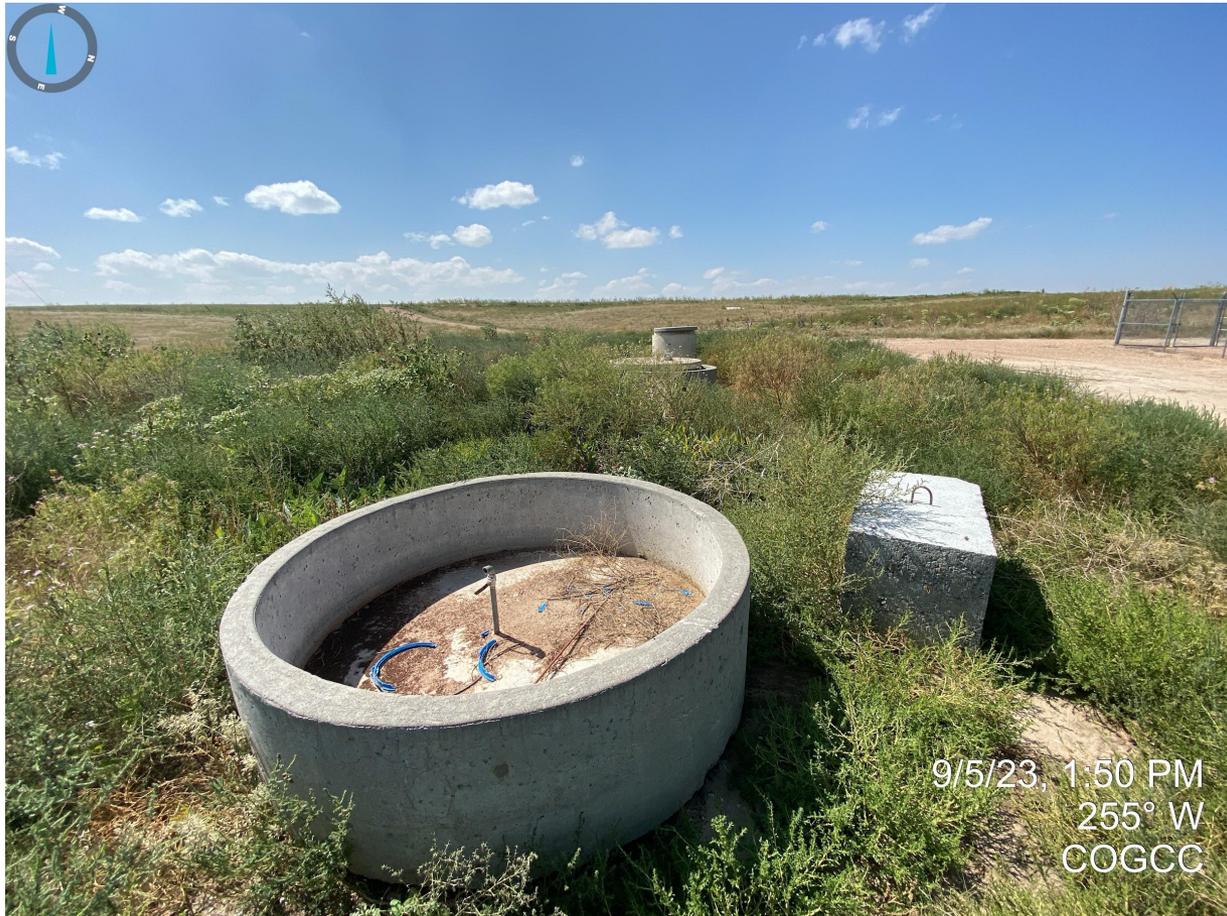
**Photo 3.** Concrete structures on location do not appear to be used and require removal per Rule 606.

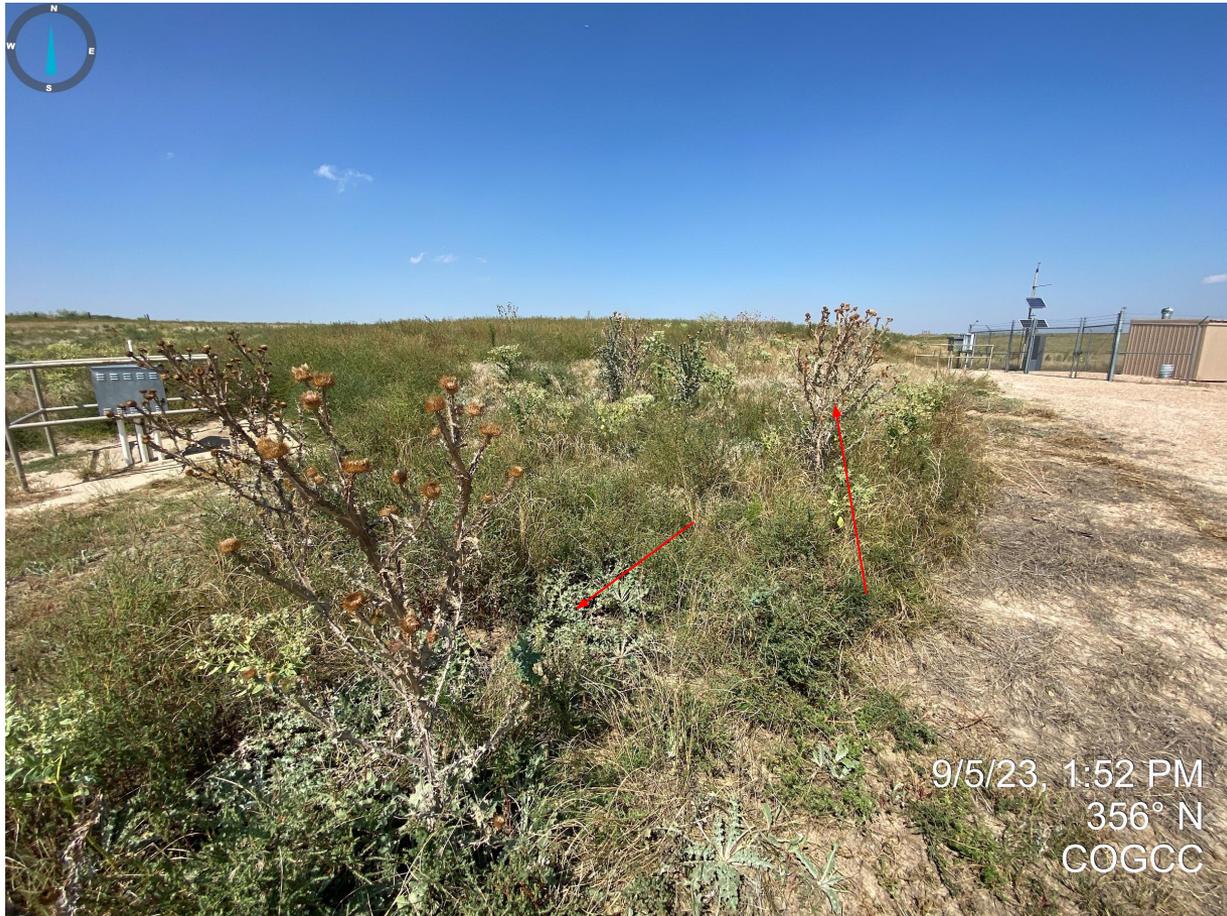
**Photo 4.** Colorado List B Noxious Weed- Scotch Thistle- observed on location that requires management to prevent spread onto adjacent land.

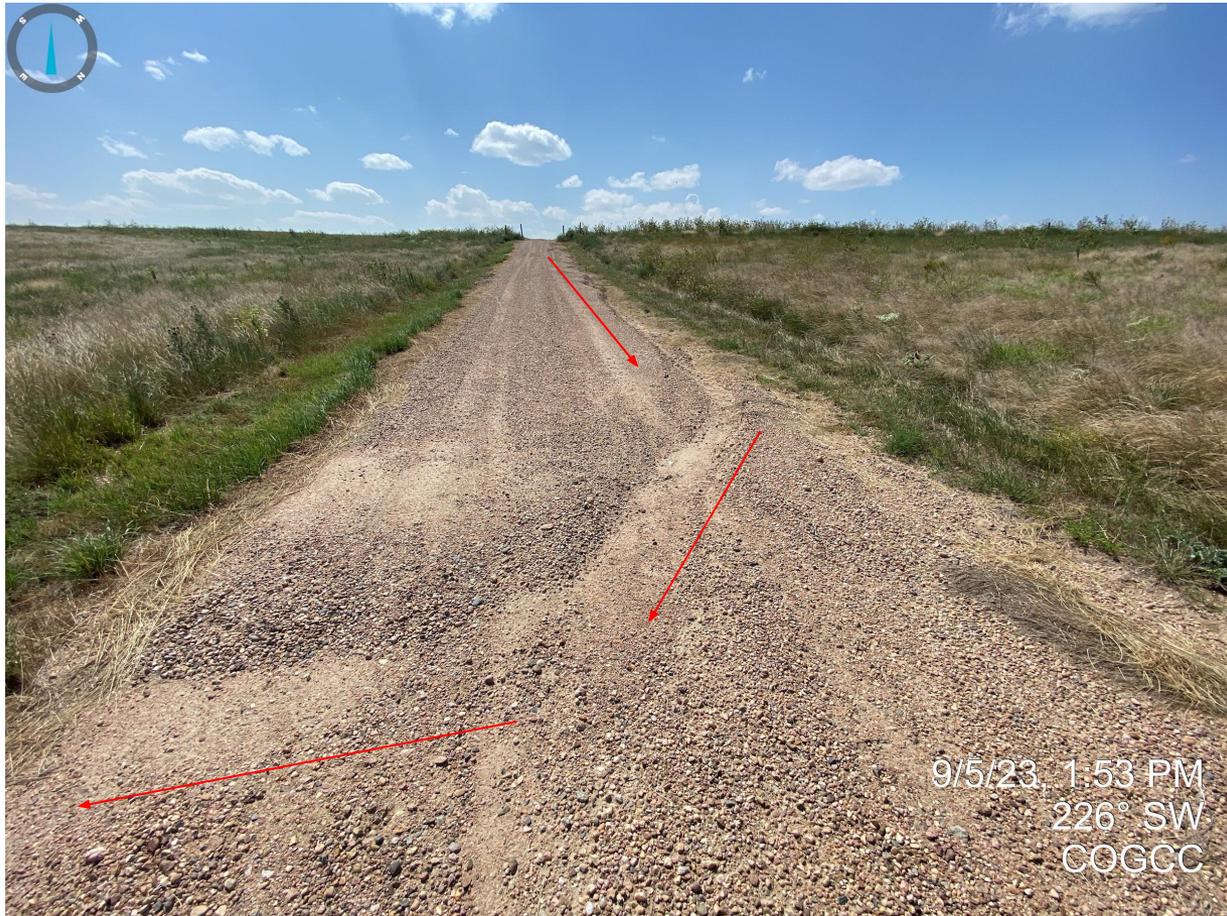
**Photo 5.** Rill erosion degradation occurring on the access roads. No apparent stormwater controls/BMPs were observed to prevent sediment from exiting off location.

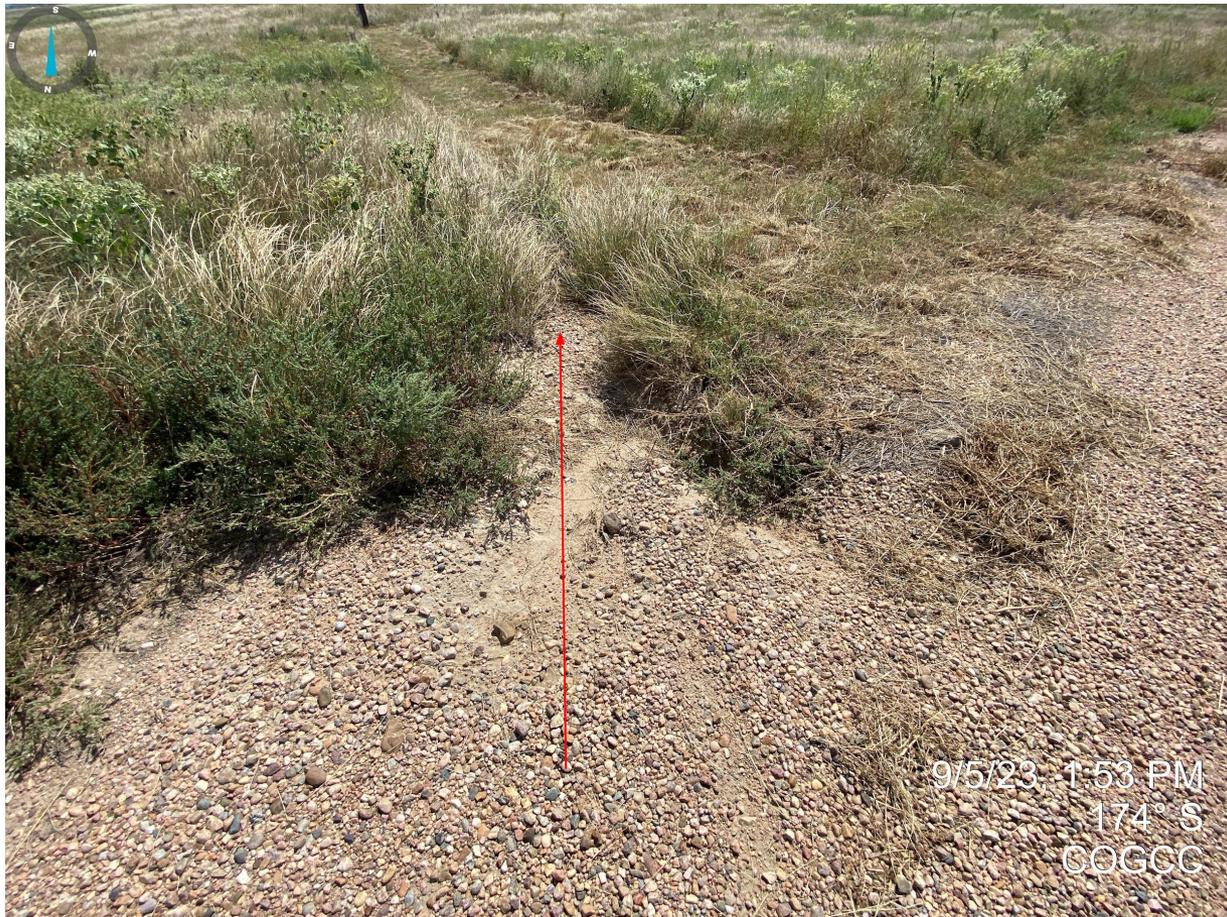
Photo 6. Continued from Photo 5.

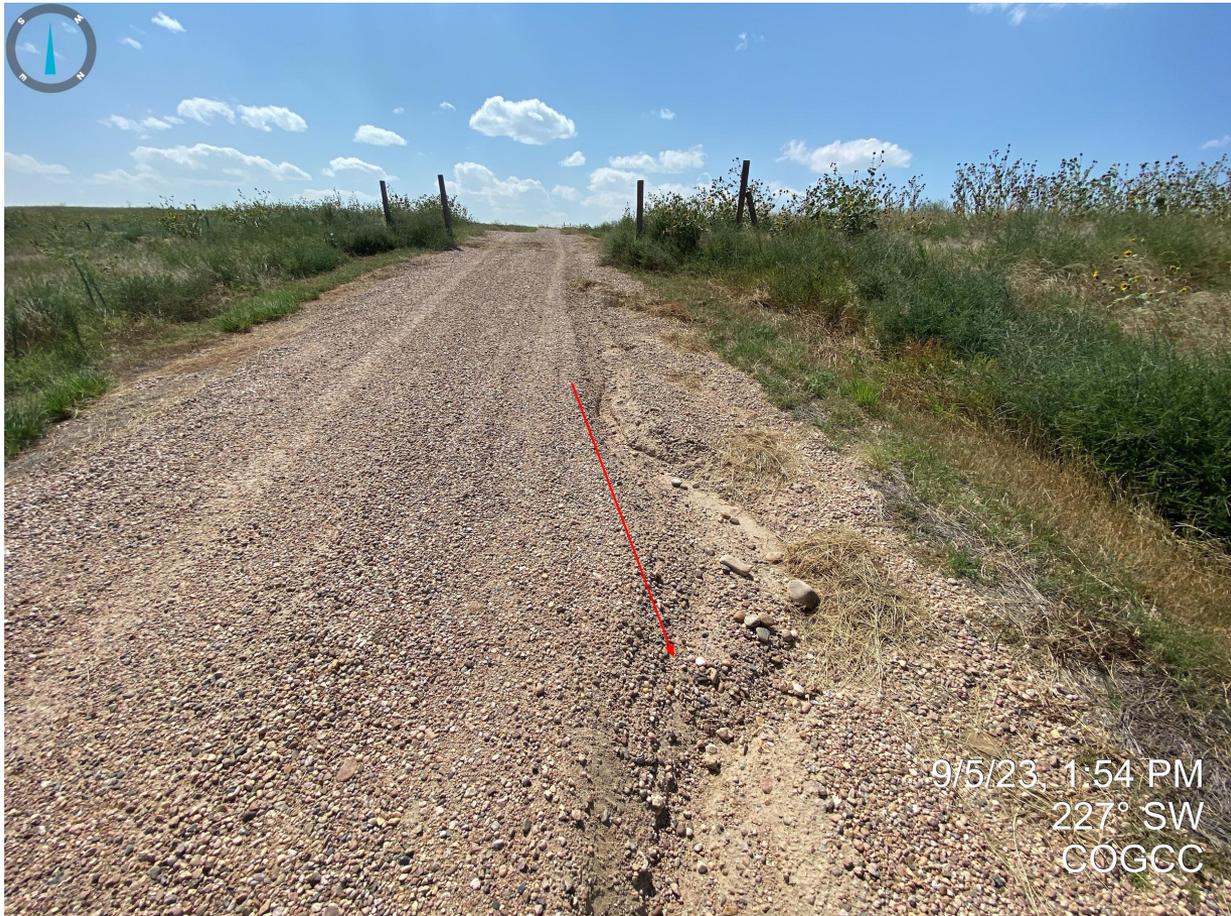
Photo 7. See comments in Photo 5.

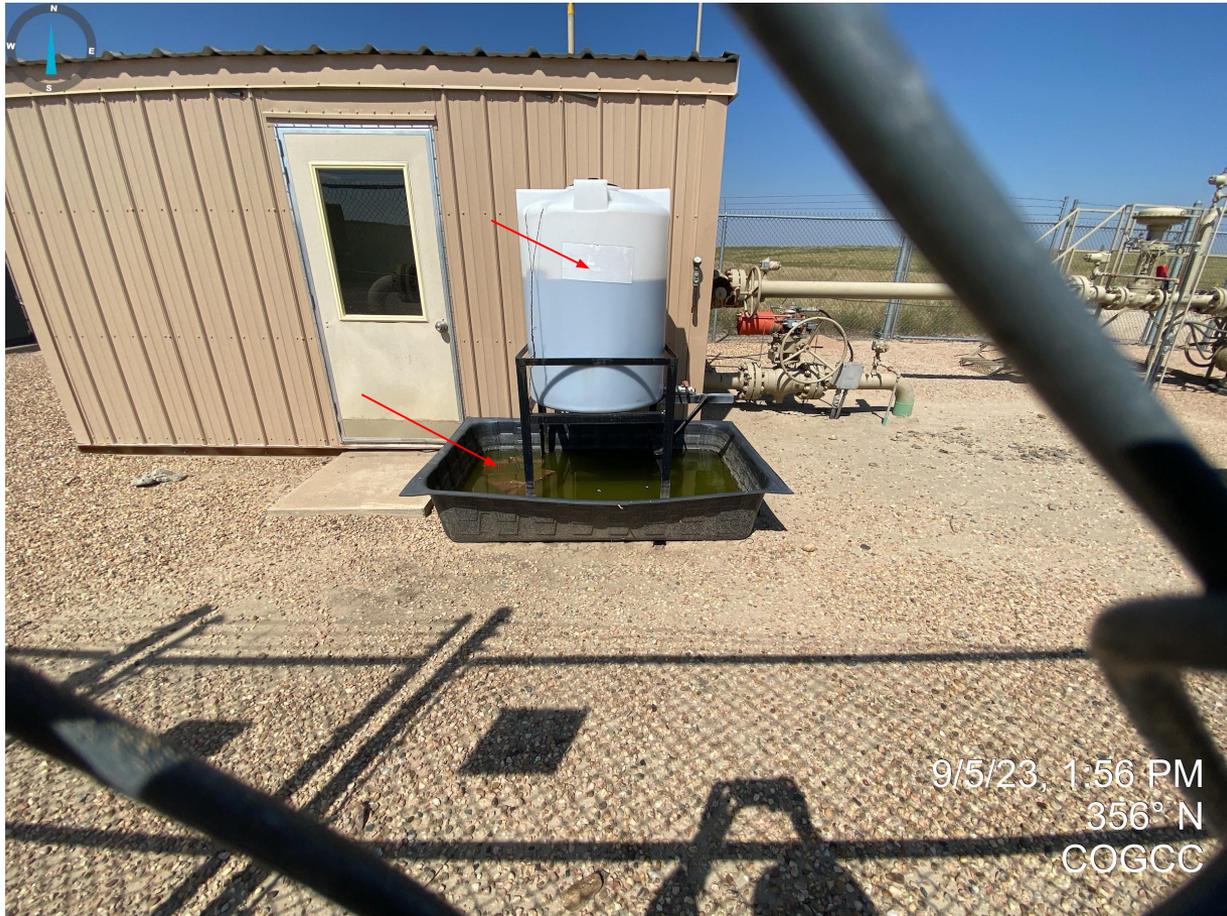
**Photo 8.** Day tank without legible labels and no wildlife protection/exclusion device installed around secondary containment.

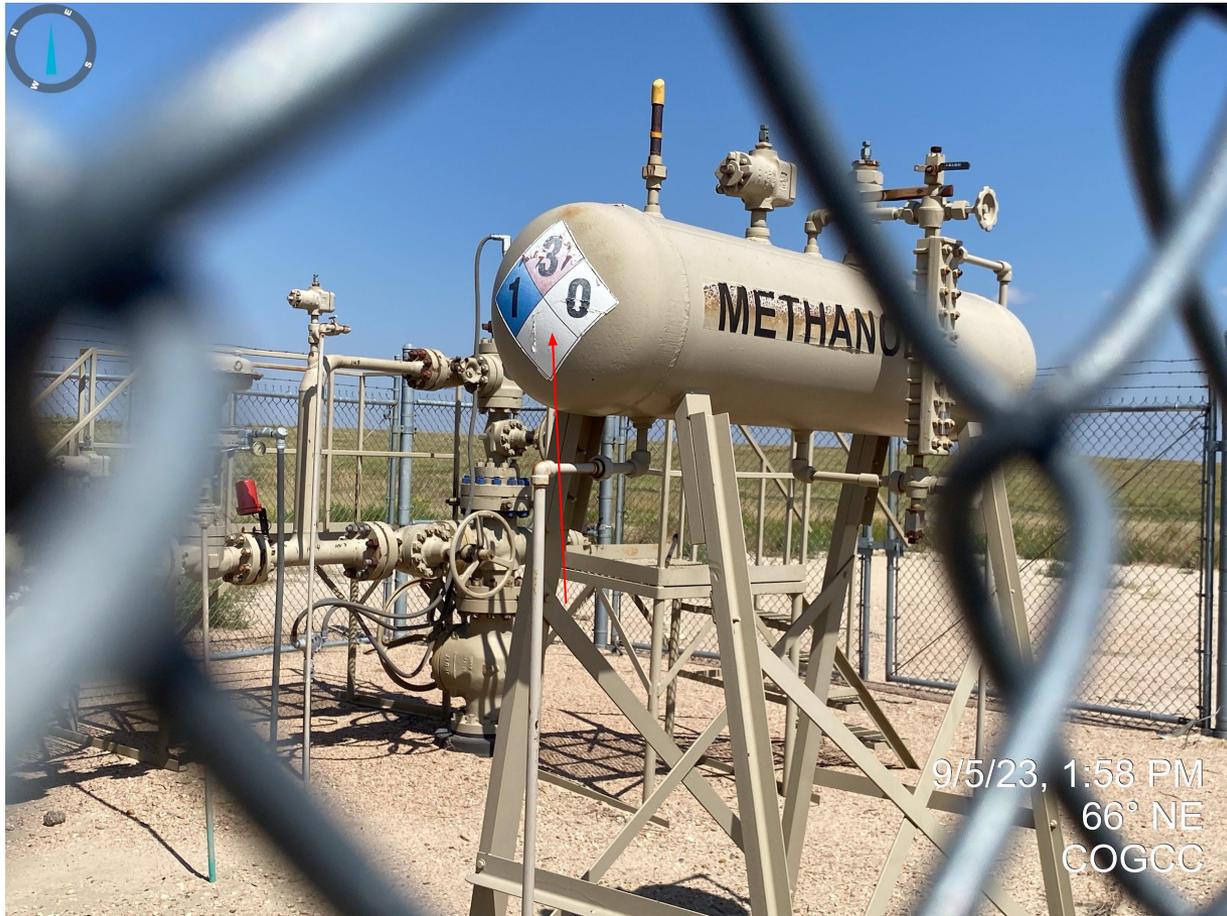
**Photo 9.** NFPA placard is faded/peeling/cracked and requires replacement.

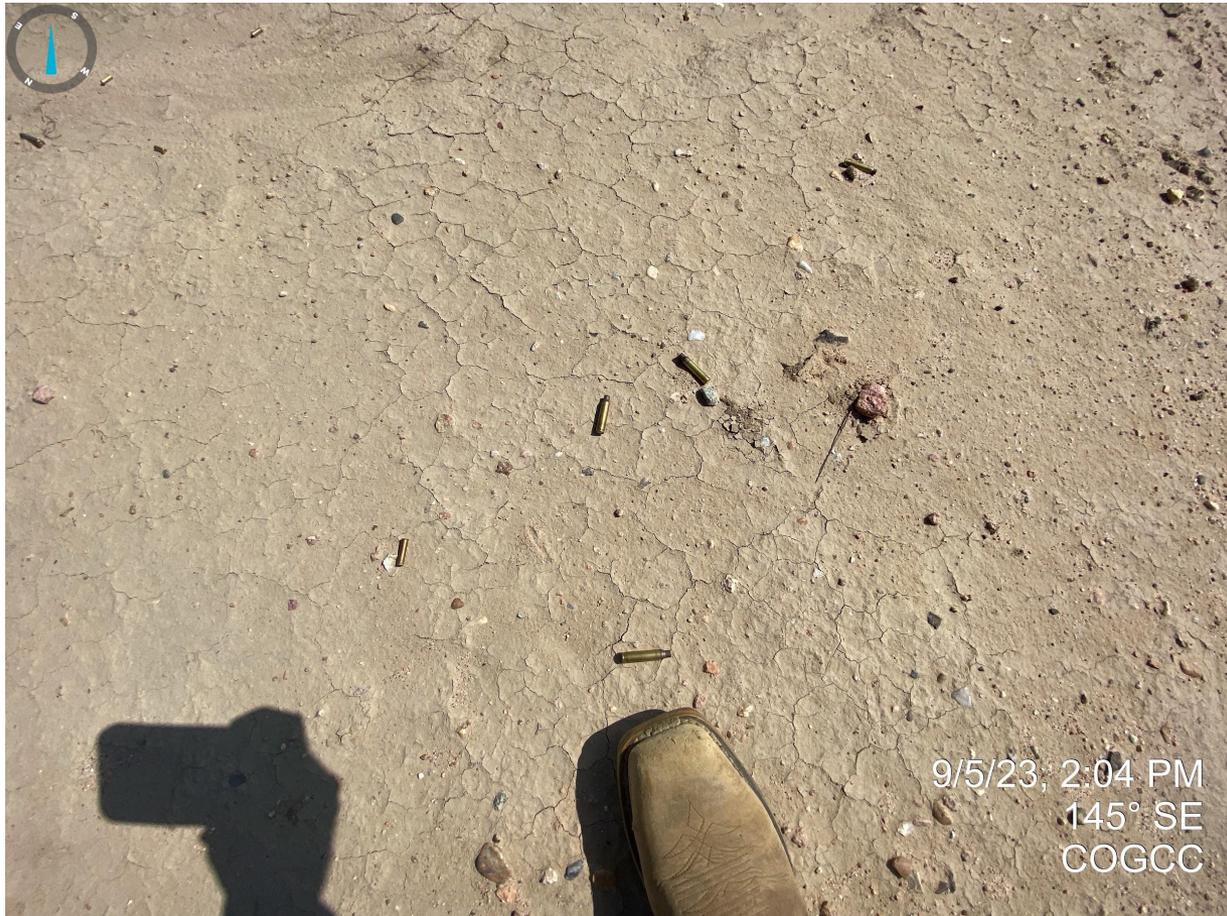
**Photo 10.** Bullet casing observed on the center/eastern portion of the location. Operator shall remove debris and it's advised posting against such activities on an active location.
